NATURAL FEATURES AND WETLANDS REPORT

***Homestead North Residential
El Paso County, CO***

July 2020

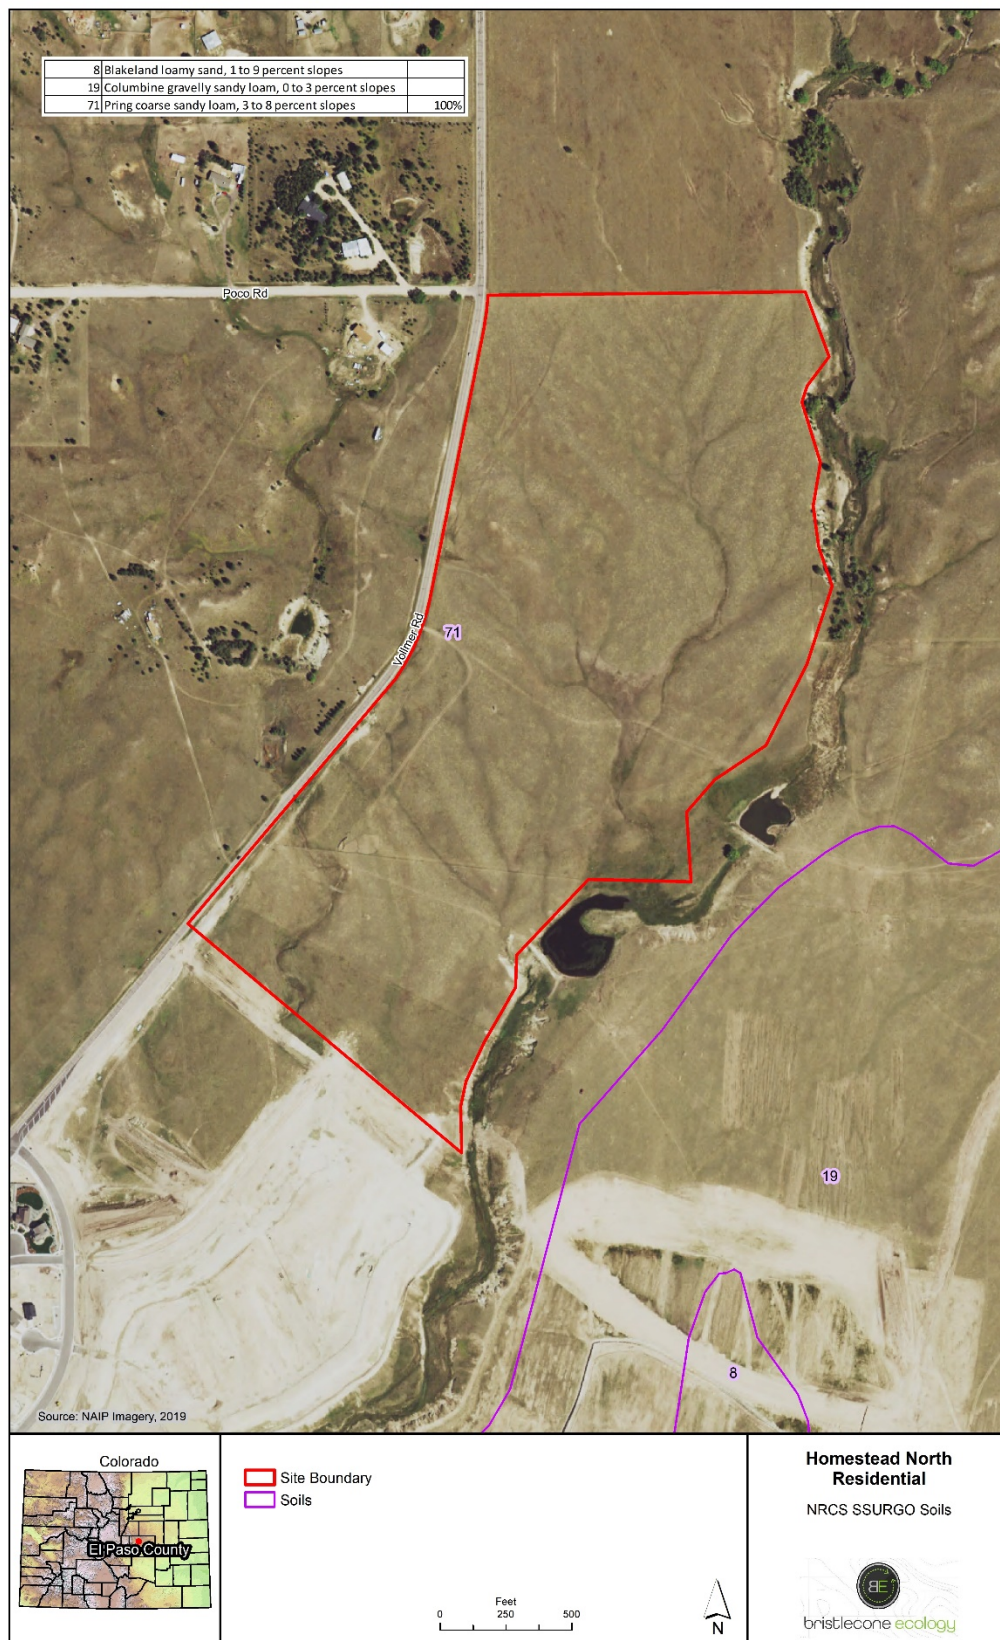
Figure 2: NRCS SSURGO Soils

County soil survey data indicate that the site is composed entirely of Pring coarse sandy loam (3 to 8 percent slopes); there are no other soils series or complexes within the Project area (Figure 2: NRCS SSURGO Soils). Other series and complexes nearby include Blakeland loamy sand (1 to 9 percent slopes) and Columbine gravelly sandy loam (0 to 3 percent slopes) (NRCS 2019a; Figure 2). The Pring series (0 to 3 percent slopes) is rated 'Not Limited' for the construction of dwellings, with or without basements, and "Somewhat Limited" for the construction of small commercial buildings (NRCS 2019b). While Pring is the dominant series occupying the entire Project area,

B.E. reviewed the hydric soil ratings for all soil components present on the Project site to aid in the identification of wetland habitats during the site reconnaissance. Hydric soils are those that form under conditions of saturation, flooding, or ponding long enough during the growing season to develop anaerobic conditions, and their formation is required in order for wetlands to become established. The Pring series (0 to 3% slopes) was described as having a hydric rating of zero in El Paso County, meaning less than 1% of this complex is expected to be hydric. Hydric ratings are on a scale of 1 to 100, with 100 having greater hydric components (NRCS 2019a). A minor component of this complex, the Pleasant series, is rated as hydric in El Paso County and is typically found in depressions where ponding can occur. Based on these ratings, the suitability of the site for the development of hydric soils, and thus the presence of wetlands, is very low.

The Pring series is grouped into Hydrologic Group B, according to NRCS soils data (NRCS 2019a). This grouping includes soils that have a moderate infiltration rate, which results in the soils having a corresponding moderate rate of surface and ground water transmission.

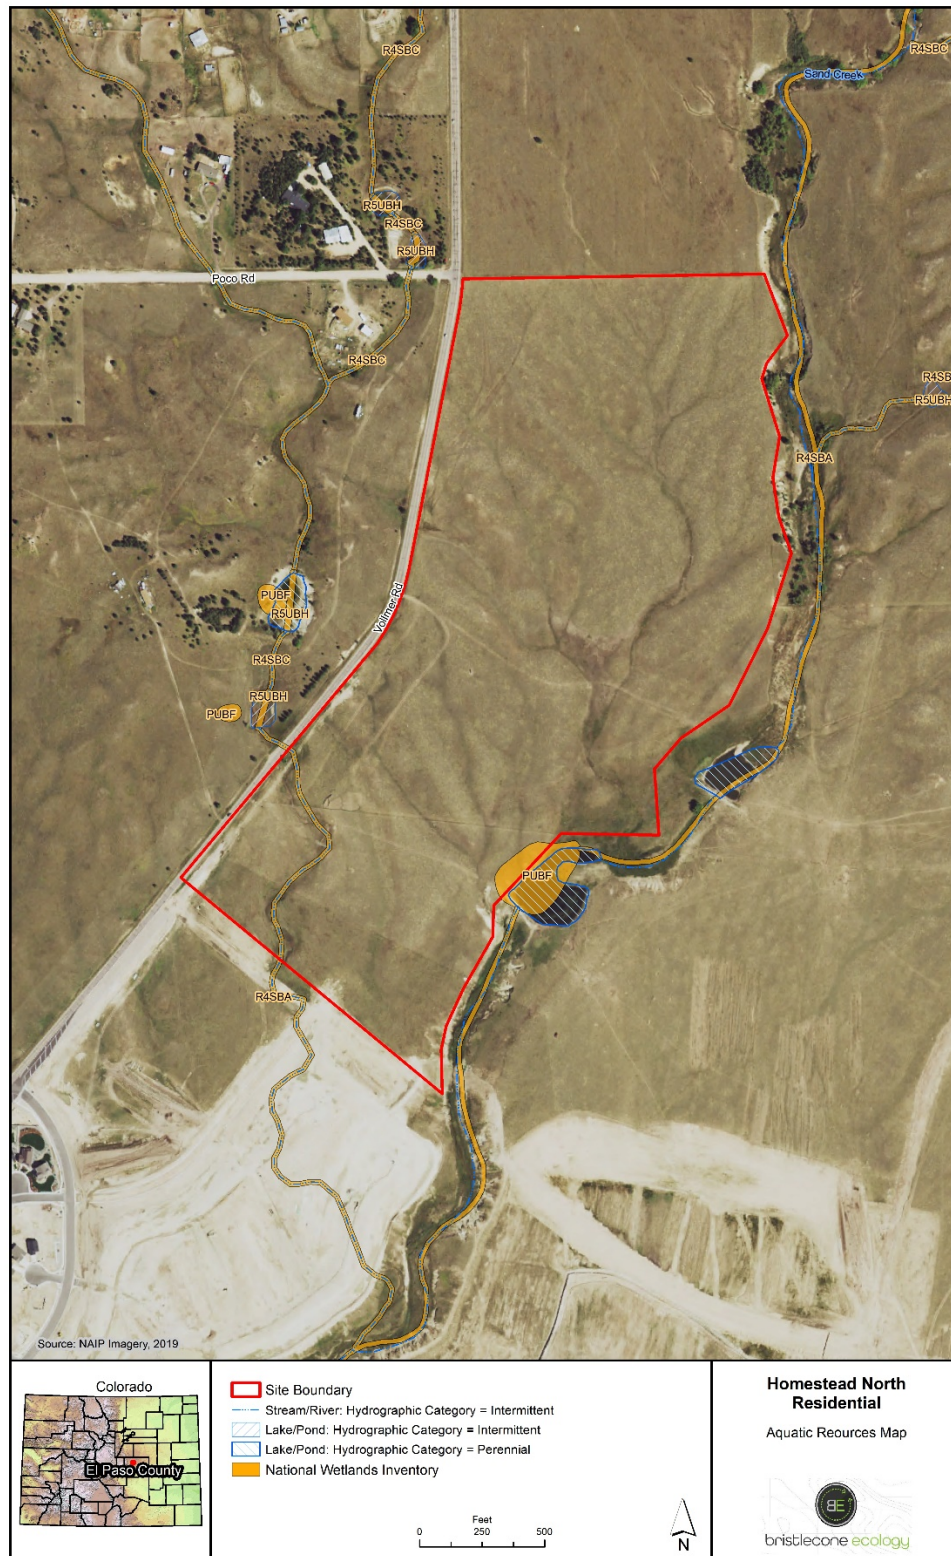
Figure 3: Aquatic Resources Map

- Sand Creek is generally present as mapped in the NWI and NHD data, just east of the Project area boundary. The NHD classification of intermittent is partly accurate in areas where flowing water was not present during the site inspection; in other areas, where flowing water was observed and could reasonably be expected to flow throughout other seasons, Sand Creek is perhaps best classified as perennial. This is particularly true for areas downstream of the two inline impoundments.

- The perennial lake/pond mapped in the NHD data is located north of the prior wetland and is also jurisdictional despite being impounded. There is no wetland vegetation evident in the feature, and it is best classified as a jurisdictional pond/open water.
- There are many Palustrine-Emergent (PEM) wetlands associated with Sand Creek that were not mapped in the NWI data. B.E. delineated all wetlands associated with Sand Creek along the length of the Project area, most of which were outside the Project area boundary. A small section of these wetlands between the two mapped ponds extend into the Project area; all field-delineated wetlands are presumed to be jurisdictional.

Based on the information obtained from the site reconnaissance, the wetlands present on the Project site maintain a hydrologic connection to other jurisdictional aquatic features and are thus presumed jurisdictional. While only the U.S. Army Corps of Engineers (USACE) may determine the regulatory status of aquatic features under the Clean Water Act, it is B.E.'s professional opinion that the field-delineated wetlands on the site would be considered jurisdictional.

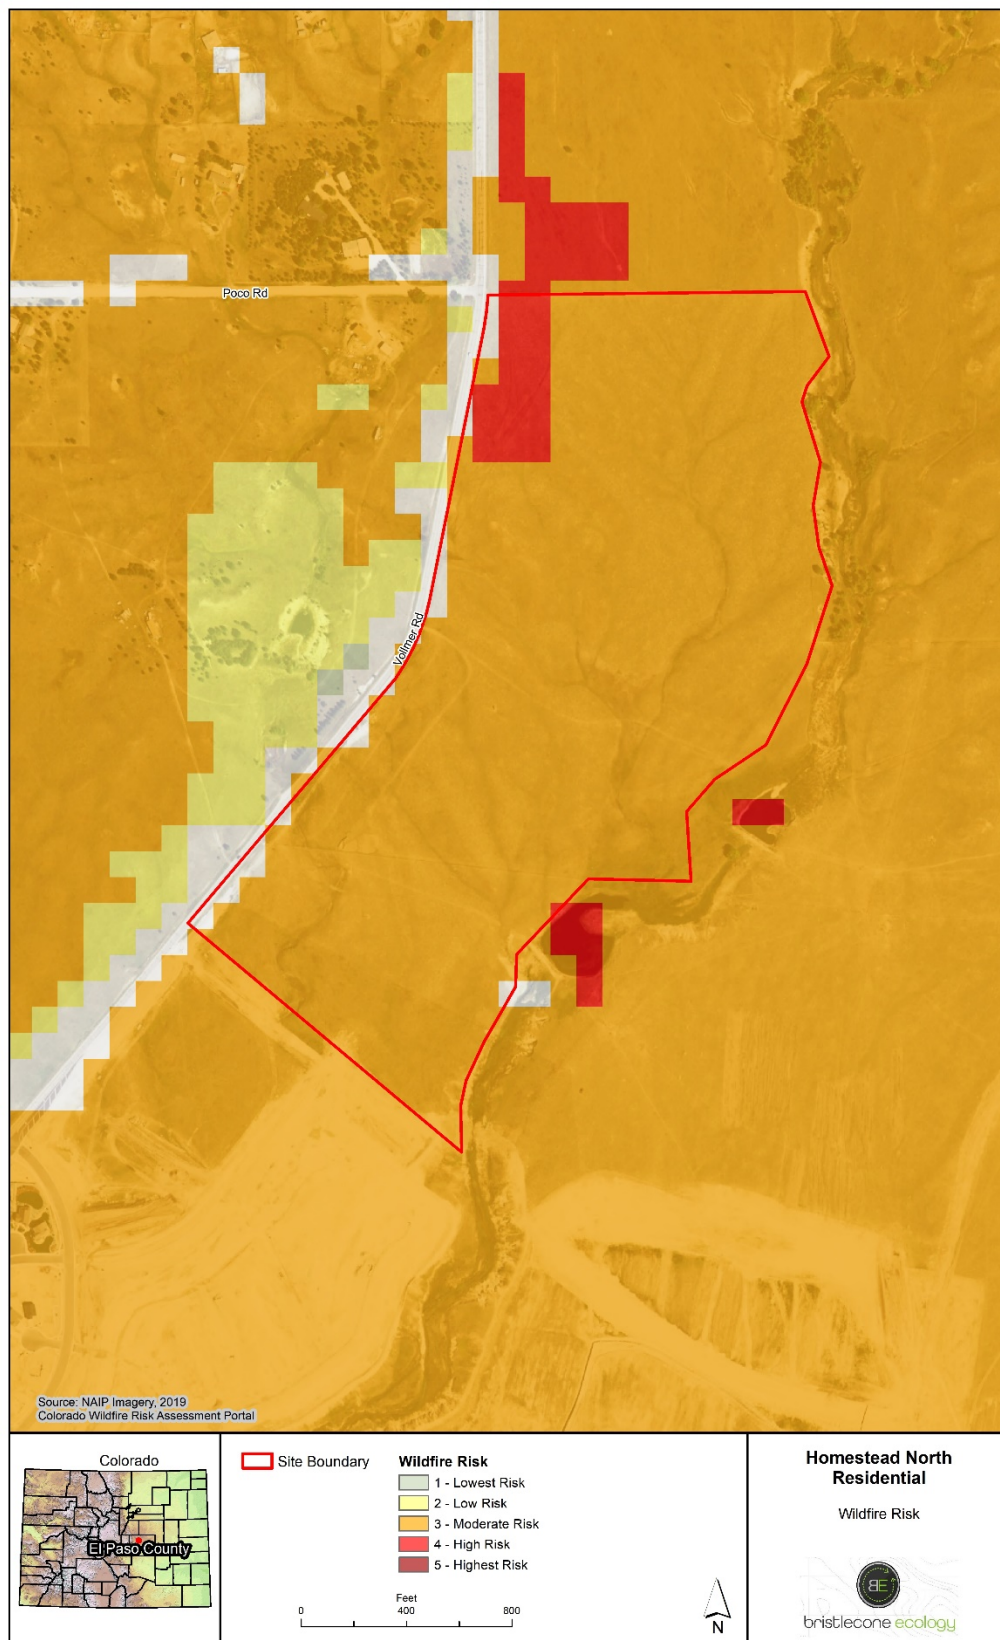
Figure 5: Wildfire Hazard Map – Wildfire Risk

Wildfire hazard for the Project site was evaluated using the Colorado State Forest Service's (CSFS) online Wildfire Risk Assessment Portal (WRAP; CSFS 2018). WRAP allows professional, planners, and the public to access the best scientific information regarding wildfire risk and establish prevention and mitigation measures accordingly. According to WRAP, the wildfire risk for the majority of the Project site is listed as "Moderate Risk" (CSFS 2018). There is one small pocket of "High Risk" land comprising approximately 5-10% of the site in the northwestern most portion near Poco Road (CSFS 2018; Figure 5: *Wildfire Hazard Map – Wildfire Risk*). "Wildfire Risk" is determined by CSFS by combining the burn probability rating of a site with the values-at-risk rating. While the Project site has a low to very low rating of values and assets that would be adversely impacted by wildfire, the burn probability for the entire site is rated "Moderate-High" (CSFS 2018; Figure 6: *Wildfire Hazard Map – Burn Probability*).

The majority of the Project area is mapped as “Moderate” wildfire risk with a few small pockets of “High” risk present. The site is rated low-very low in terms of values and assets present that could be lost to wildfire; it is rated “Moderate-High” in terms of burn probability based on the available fuels at the site. The nearest fire response is the Black Forest Fire Protection District Station 1, which is 3.67 miles away.
