**RE: Response to El Paso County Comments on the Impact Identification Report
The Retreat at Timber Ridge Residential Development
El Paso County, Colorado**

EXECUTIVE SUMMARY	III
1.0 INTRODUCTION	4
2.0 SITE DESCRIPTION	4
3.0 METHODS.....	4
4.0 BACKGROUND DOCUMENTATION REVIEW.....	5
4.1 Aerial Photograph Review Results.....	5
4.2 National Wetlands Inventory Map Review	5
4.3 USGS Topographic Map Review.....	6
4.4 FEMA FIRM Floodplain Review	6
4.5 County Soil Survey Map Review.....	6
5.0 RESULTS	6
5.1 Watercourses Including Jurisdictional Channels.....	6
5.2 Wetlands	7
5.3 Soils.....	9
5.4 Hydrology	10
5.5 Vegetation	11
6.0 CONCLUSIONS AND RECOMMENDATIONS	12
REFERENCES	13

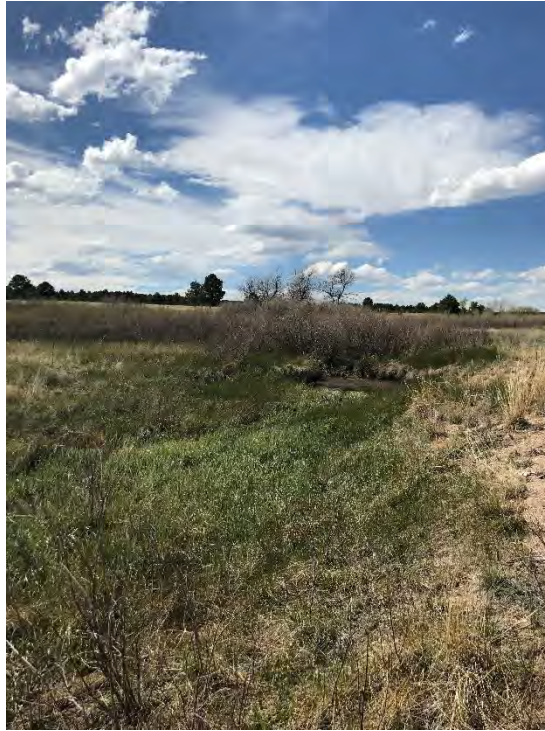
South of Aroya Lane, looking north at SCCW 3

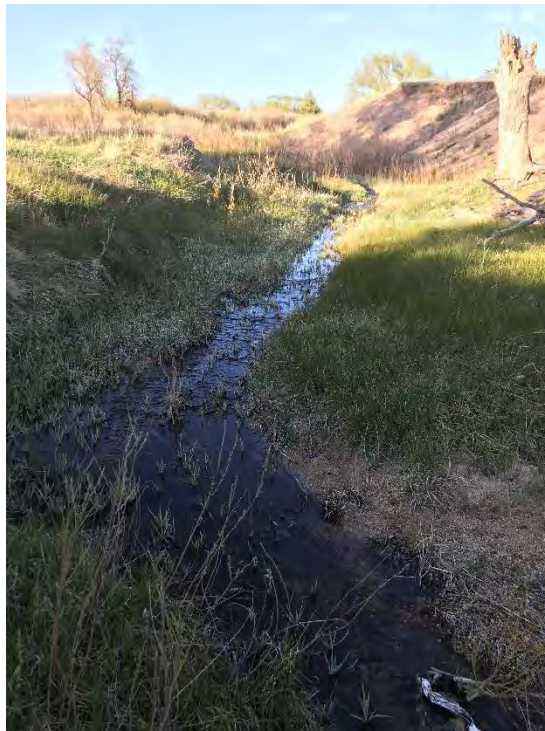
SCCW 3, facing north

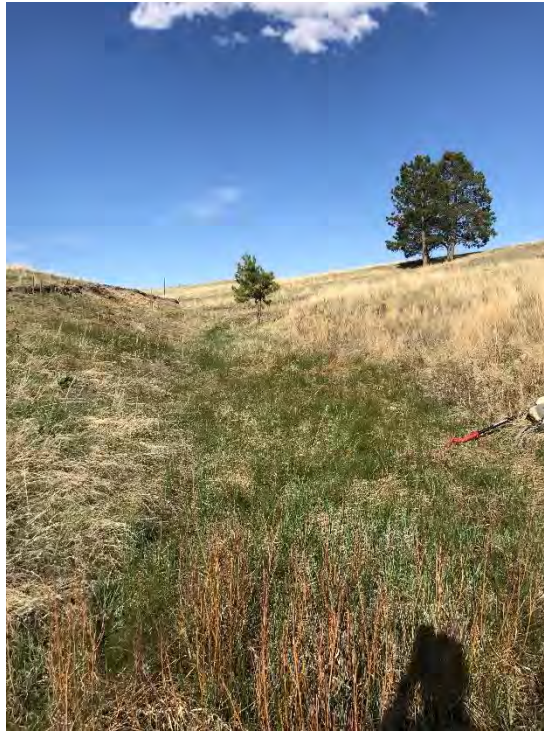
Eastern tributary, facing east

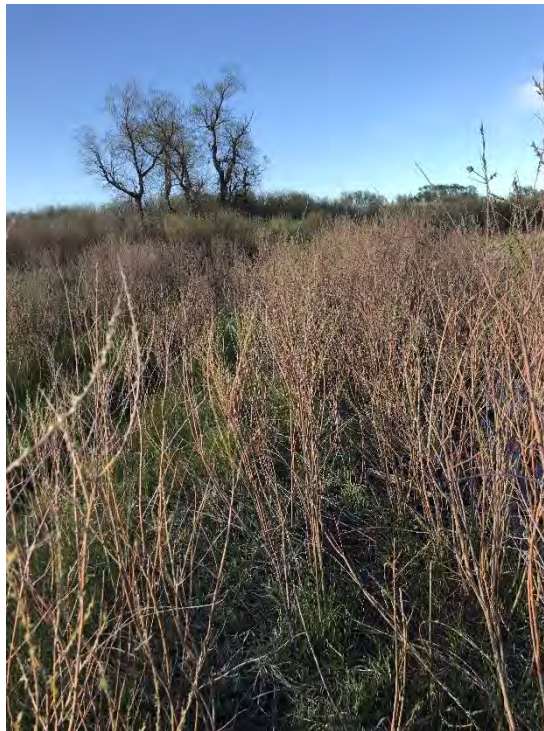
Western tributary, facing west

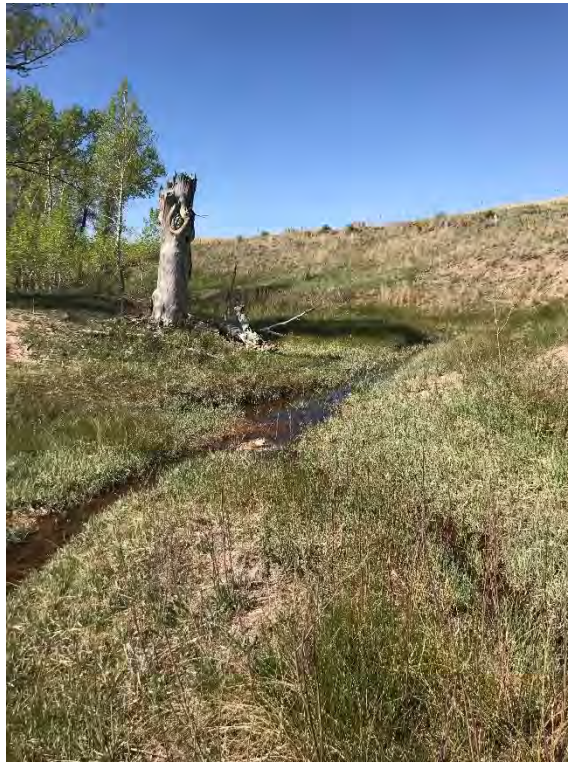
Southern portion of Sand Creek main channel, facing south at SCCW 6

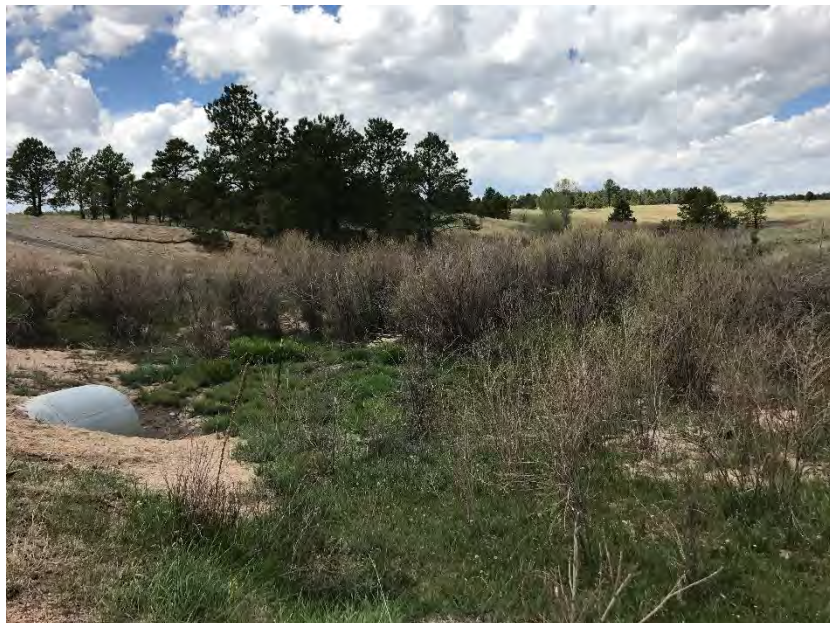
Immediately north of Arroya Lane, facing north at SCCW 2

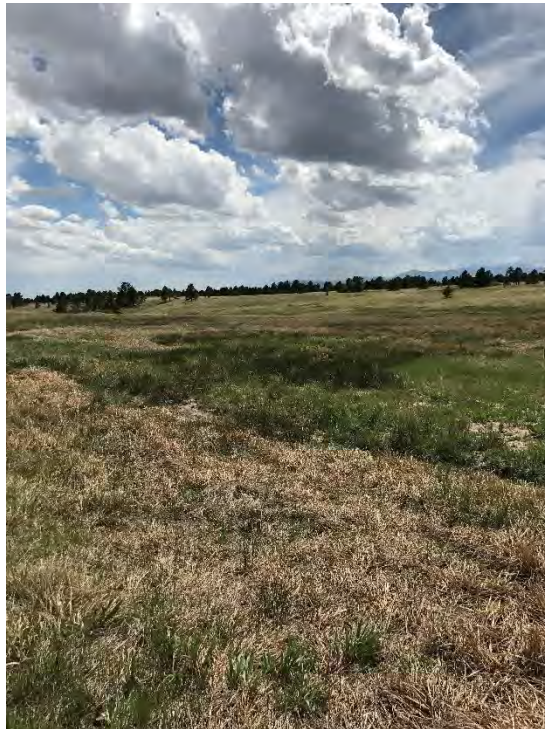
Wetland 2 (wet meadow) looking southwest

headwater complex; surface water and/or saturation was present throughout Wetland 2 and dense monotypic stands of Booth's willow were present in the northern half of Wetland 2. Dense herbaceous cover of hydrophytic vegetation was observed throughout the southern half of Wetland 2 (**Appendix II**). A culvert maintains hydrologic connectivity between SCCW 2 and SCCW 3 north and south of Arroya Lane. Field indicators included surface water and dense hydrophytic vegetation lining the channels. Field sampling indicated the presence of hydric soils and hydrologic indicators within the boundaries of SCCW 2 (immediately outside of the Project). SCCW 2 was characterized as riverine, intermittent, stream bed, intermittently flooded (R4SBJ); surface water was present in portions of the channel. Field sampling within SCCW 3 indicated the presence of anoxic soil conditions; surface water and/or saturation was observed throughout SCCW 3 (**Appendix II**). SCCW 3 was characterized as R2UBF. A depressional wetland (Wetland 3) was observed outside of the stream channel abutting SCCW 3, south of Arroya Lane (**Figure 5, Table 5-1**).

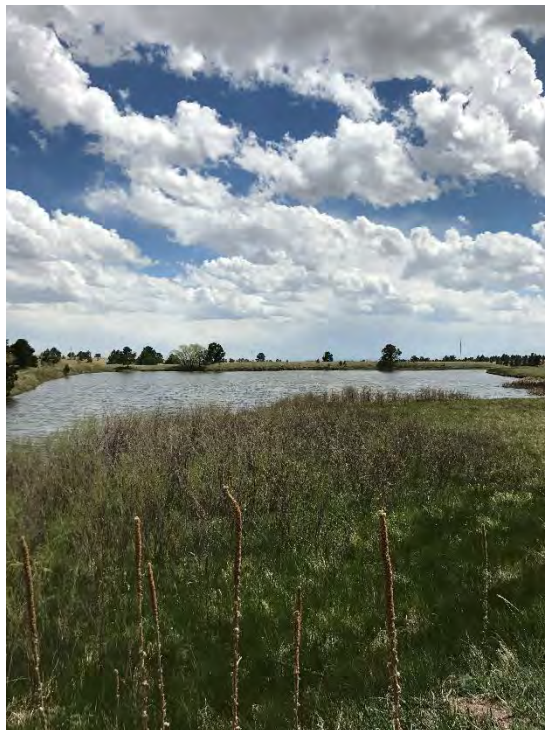
North edge of Wetland I, looking south

The hydrology of Sand Creek and its unnamed tributaries north of Arroya Lane is provided intermittently by year-round precipitation events. A large, manmade stock pond (Wetland 1) is located across the main channel of Sand Creek within the northern portion of the Project. SCCW 1 is likely a result of the outfall structure since the NHD database does not identify SCCW 1 as a known tributary. The hydrology of Wetland 2 is also likely largely influenced by the outfall of Wetland 1; SCCW 1 drains to Wetland 2 and provides year-round inundation. Saturation was observed across Wetland 2 at the time of the site visit. Surface water was not present within SCCW 2; however, field sampling indicated the presence of highly distinct oxidized rhizospheres on living roots (C3). Hydrology of SCCW 2 was characterized as intermittent since surface water was not observed during the growing season at the time of the site visit.

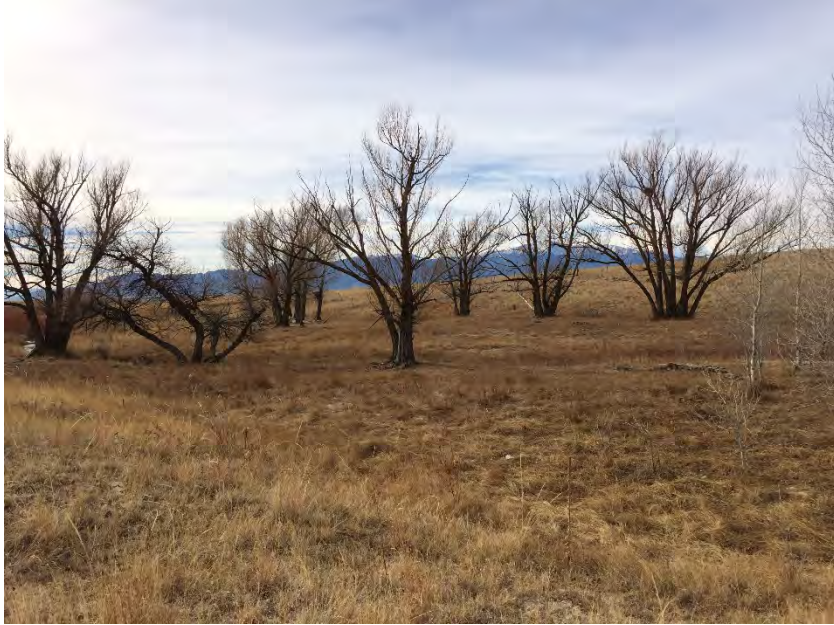
Southern portion of Project facing west, raptor nest visible to the right (north)

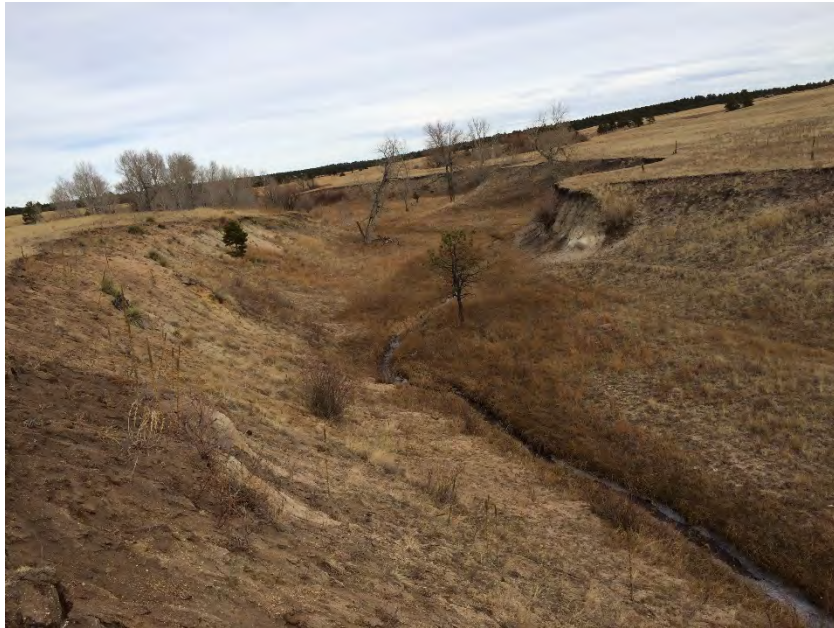
Steep banks within southern portion of the Project

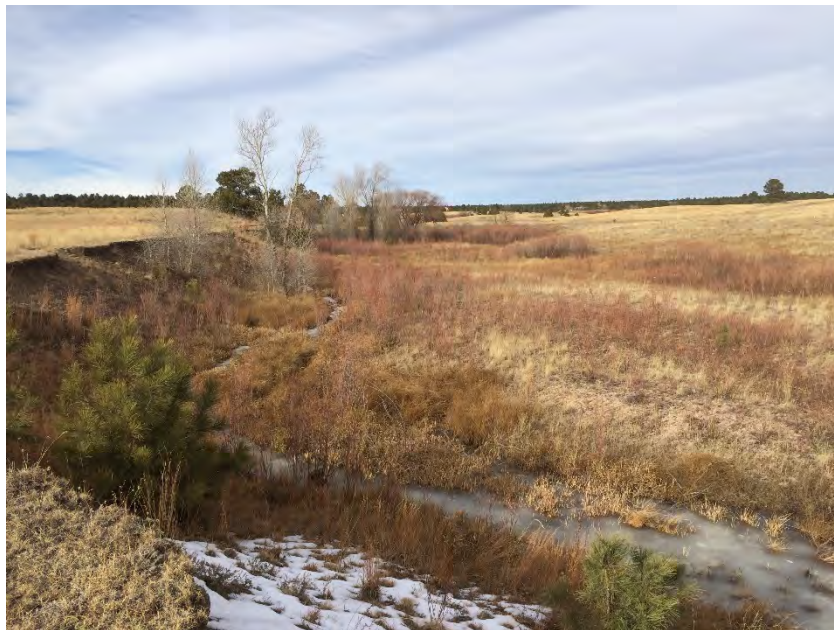
Main channel of Sand Creek south of Arroya Lane, facing north

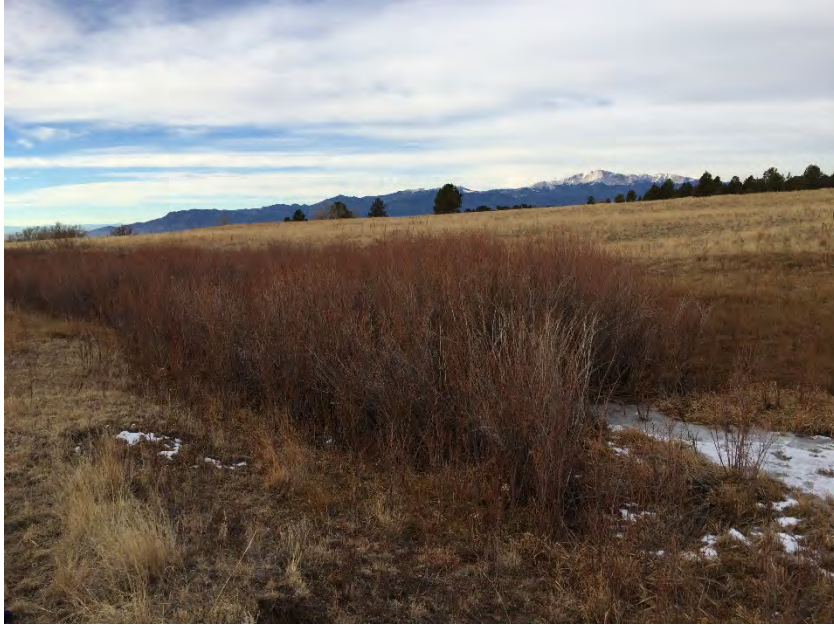
Well-developed riparian corridor and surface water, south of Arroya Lane
facing southwest

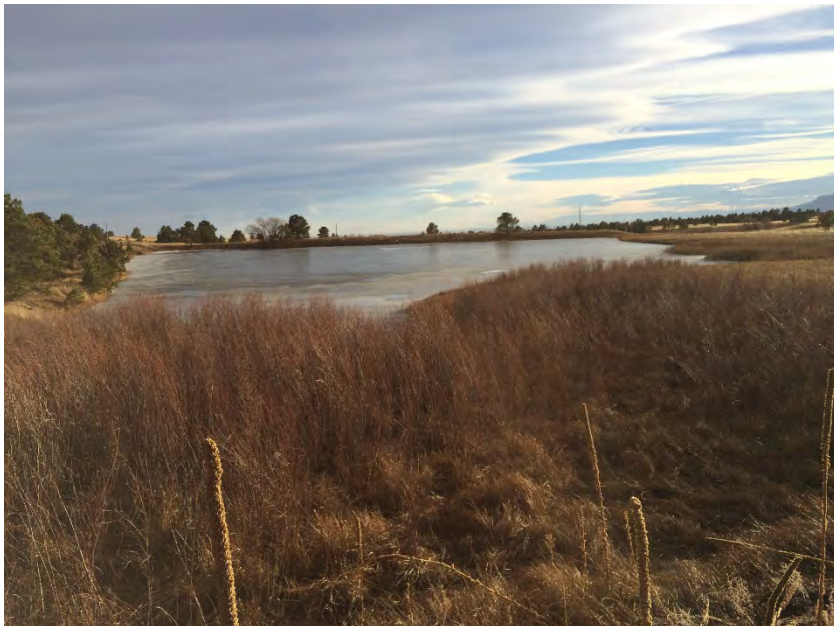
Large stock pond in northcentral portion of Project and adjacent wet meadow on west side,
facing southwest
