Wetlands Assessment Report

Bentgrass Meadows St & E. Woodman Rd, Falcon, CO

Date: July 11, 2022; Project No: 0207-CS22

Reference: Wetlands Assessment, Proposed residential development, Bentgrass Meadows St & E. Woodman Rd, Falcon, CO

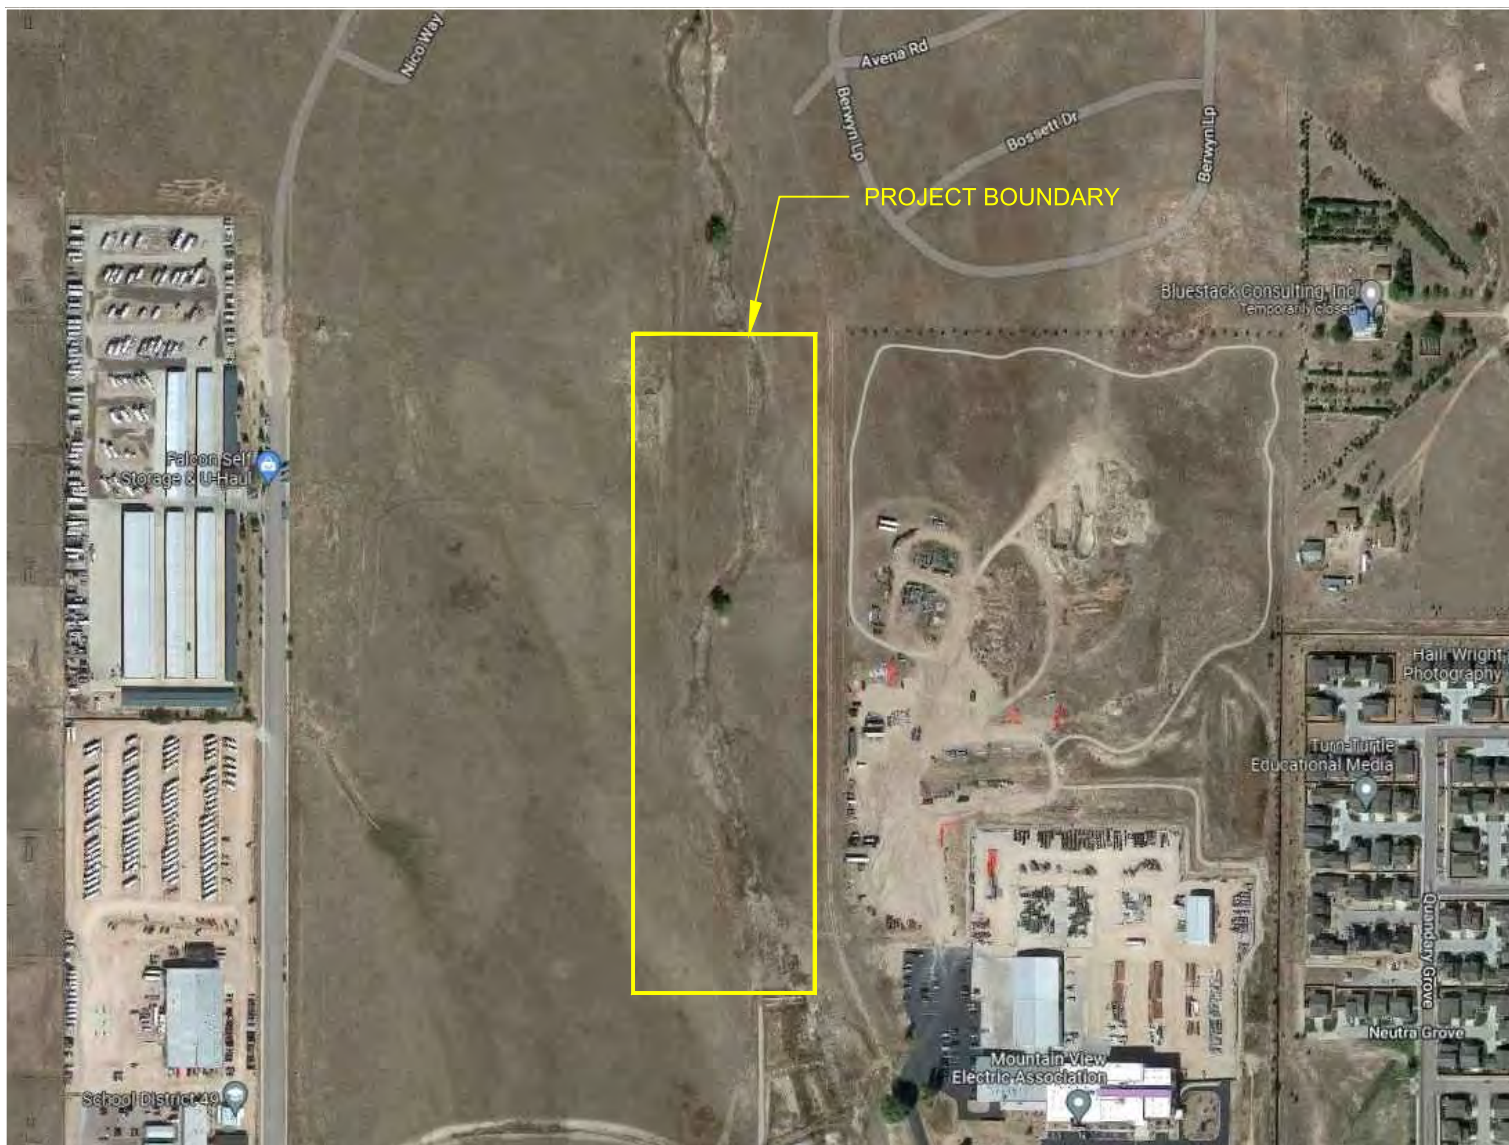
FIGURE 2: SCHEMATIC SITE PLAN

NOTE:
SCHEMATIC PLAN TO SHOW APPROXIMATE SUBSURFACE EXPLORATION LOCATION ONLY; NOT SURVEYED.

DESIGNATES SUBSURFACE INFILTRATION LOCATION, BY AMERICAN GEOSERVICES, LLC. , JUNE 2022 SEE EXPLORATION LOG IN APPENDIX FOR FURTHER DETAILS.

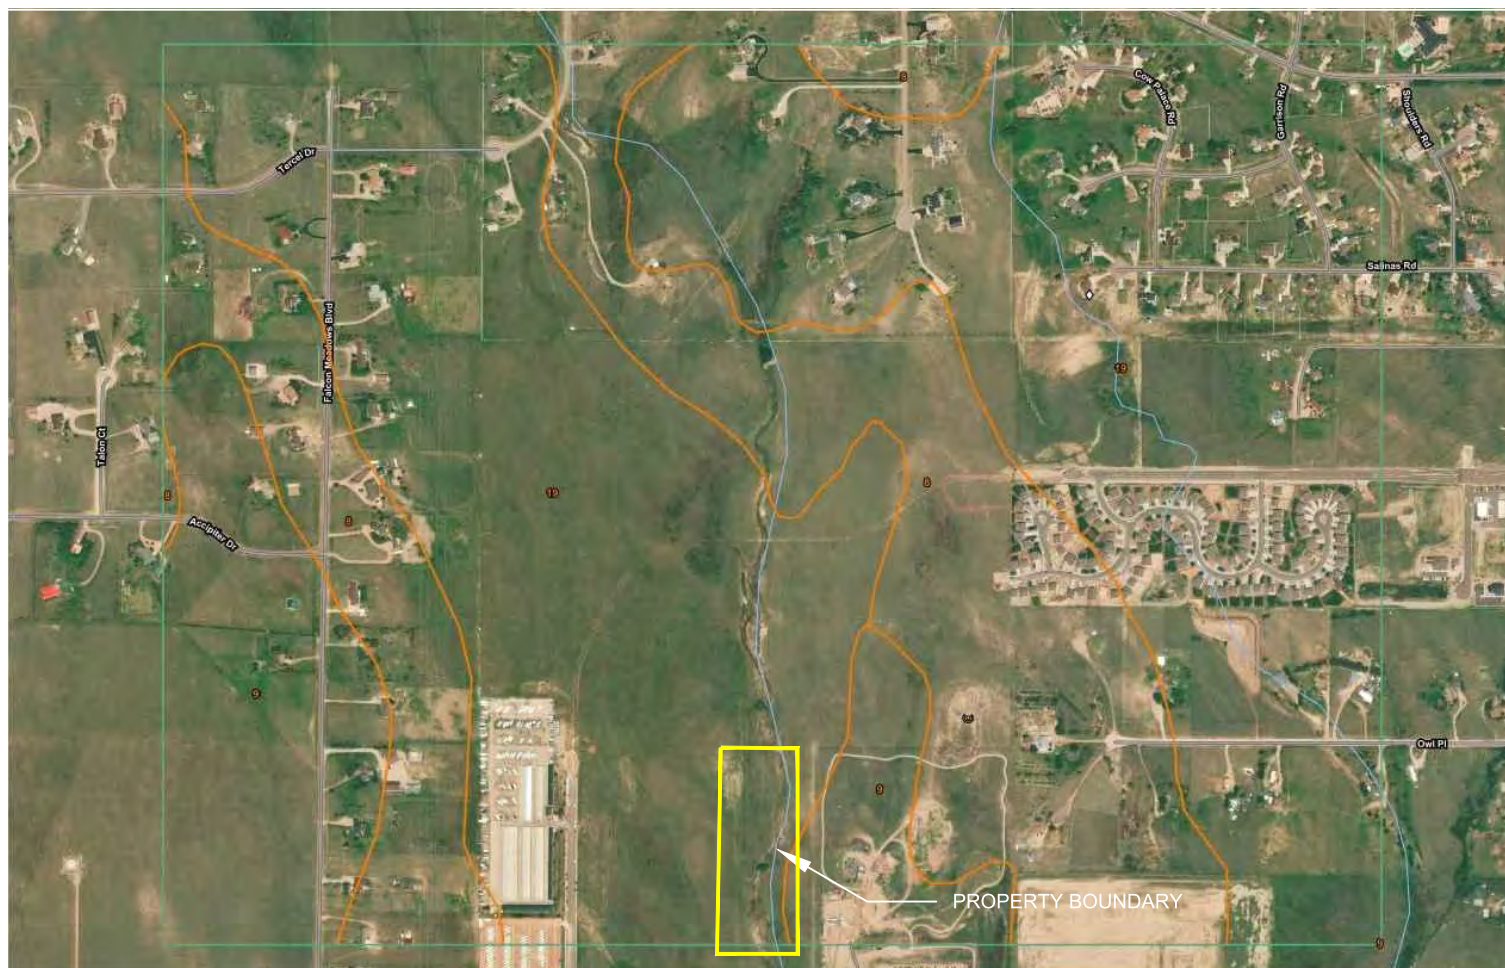
FIGURE 4: SOIL SURVEY MAP

El Paso County Area, Colorado (C0625)			
El Paso County Area, Colorado (C0625)			
Map Unit Symbol	Map Unit Name	Acres in AOI	Percent of AOI
8	Blakeland loamy sand, 1 to 9 percent slopes	157.2	25.2%
9	Blakeland-Fluvaquentic Haplaquolls	77.1	12.3%
19	Columbine gravelly sandy loam, 0 to 3 percent slopes	390.3	62.5%
Totals for Area of Interest		624.5	100.0%

The El Paso County Soil Survey indicates the project area is primarily underlain by Columbine gravelly sandy loam (0 to 3 percent slopes). These soils are not classified as a hydric soil in El Paso County by the Natural Resources Conservation Service (NRCS).
