# Wetland, Wildlife and Natural Features Report for Davis Subdivision in El Paso County, Colorado

June 19, 2023

Project Number: 2022-22-1

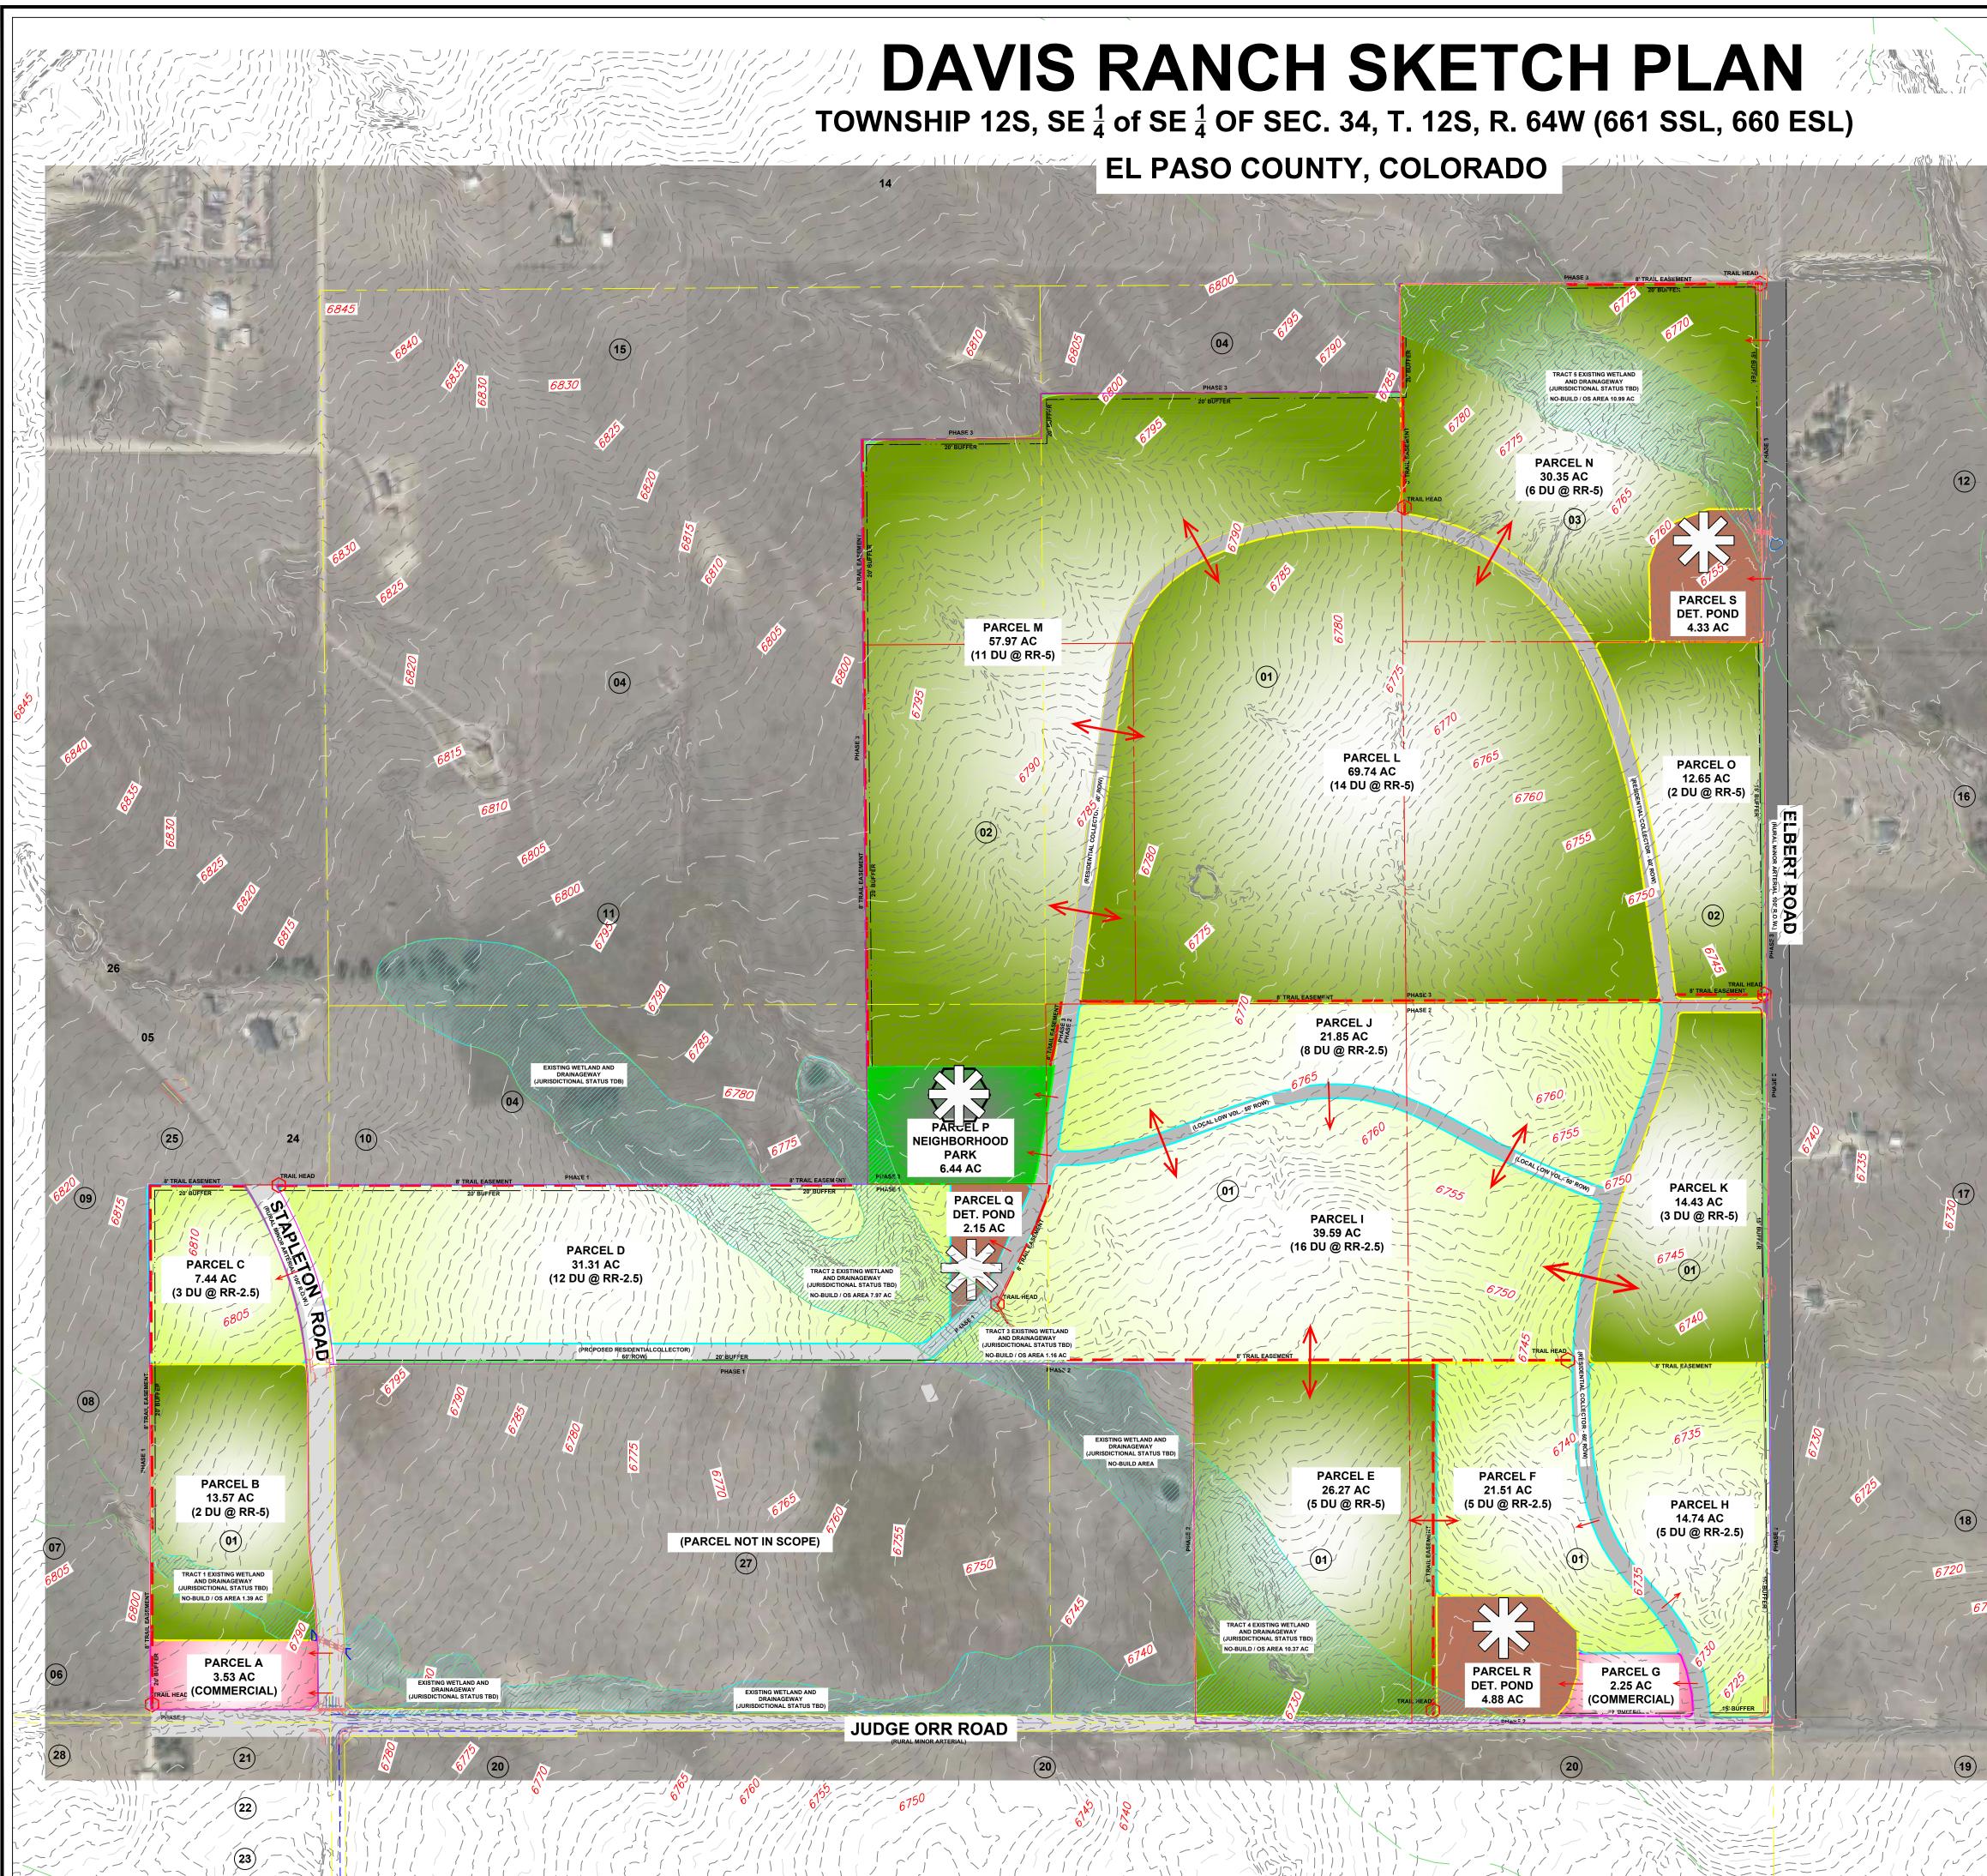
Figure 3 Sketch Plan

USE SUMMA			E MAXIMUM UNITS	2
/		LOW DENSITY RR-2.5 ZONING		32%	49	,
		LOW DENSITY RR-5 ZONING	226.30 ac	57%	43	
		COMMERCIAL CS ZONING	5.78 ac	1.5%	n.a.	
		OPEN SPACE	6.44 ac	1.7%	n.a.	
151		PARK ZONING	31.89 ac	n.a.	n.a.	
		NO-BUILD / OS	11.35 ac	2.9%	n.a.	
1		NO-BUILD	2.69 ac	1.0%	n.a.	
		TRAIL HEAD				
		15-20' BUFFER	n.a.	n.a.	n.a.	
		PROPOSED R.O.W.	20.68 ac	4.4%	n.a.	
		TOTAL: PLAIN - NO BUILD / OS' ACREAGE I ATED AS SUCH FOR EACH LOT WH			<b>92</b> ACREAGE AS "PRIVATE OPEN SPAC	E" AND IS
11	BUILD /	OS.			ASEMENTS, AND PRIVATE FLOODP	
	FLOODP	ASEMENT' INCLUDES A PROPOSE LAIN - NO BUILD / OS AREAS.	D 8' WIDE COUNTY TRAIL	EASEMENT TO PROV	IDE CONNECTIVITY TO PARK AND	
20	PARCE PARCE A	L SUMMARY L ACREAGE 3.53		ED USE/ZO IMERCIAL	NE MAXIMUM U n.a.	NITS
}	B C D	13.57 7.44 31.31	RR-5 RR-2	2.5	2 DU 3 DU

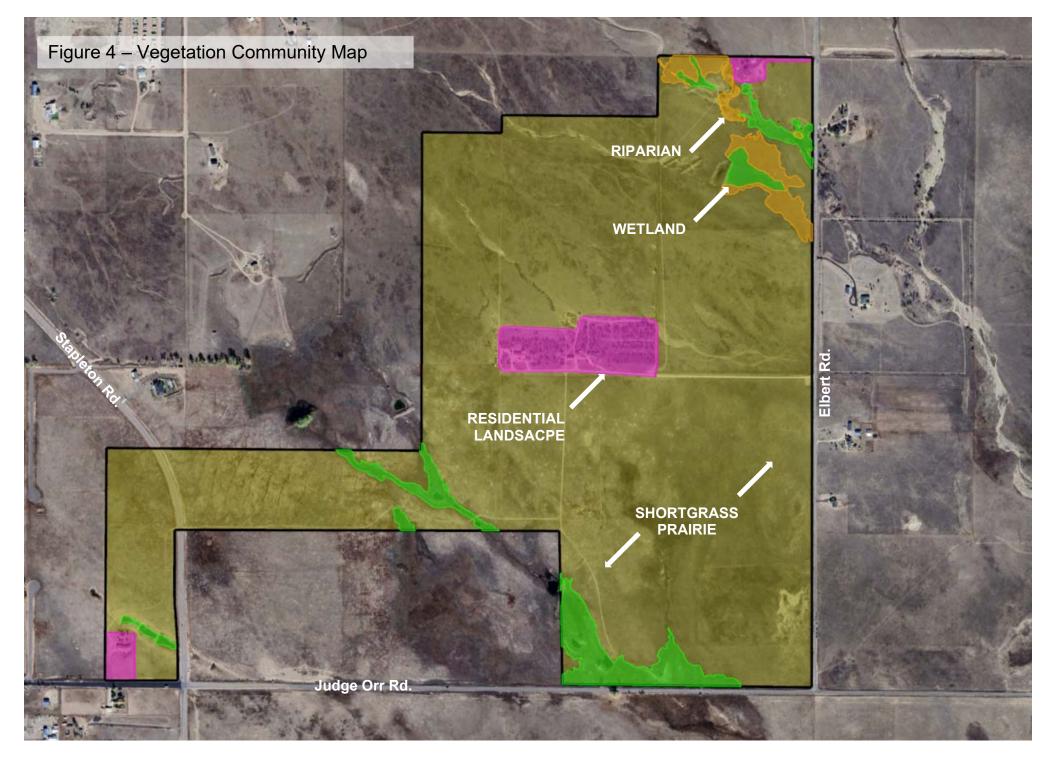
Source: Google Earth Aerial Image, 10/31/2022 & Ecosystem Services, LLC Site Assessment, 5/23/2023

Riparian habitat within the Site is comprised of more robust short-grass prairie where moist, mesic soils are present adjacent to wetlands (described above) and small pockets of open water that were excavated for stock ponds (refer to Figures 4 and 6). Trees and shrubs are primarily absent, with the exception of narrowleaf and Plains cottonwood (*Populus angustifolia and deltoides*) and sandbar willow dispersed throughout the Site but mostly in the northeastern drainages. Refer to Figure 4, Vegetation Community Map and Figure 6. CNHP Riparian Habitat Map.

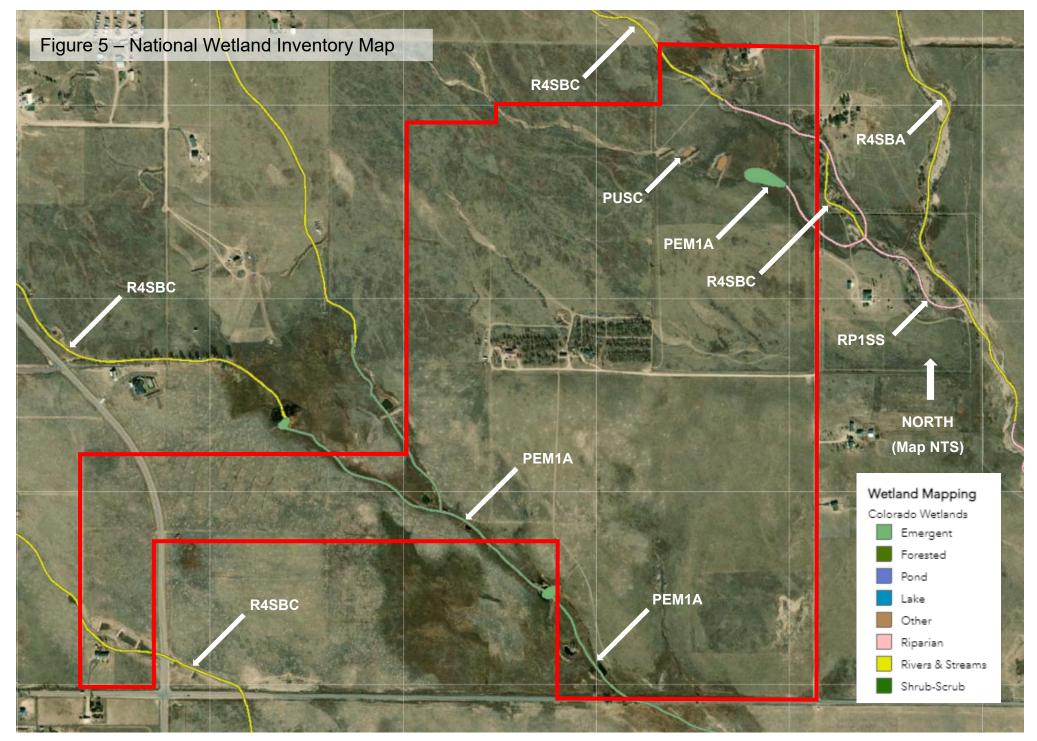
**Figure 5** National Wetland Inventory Map

Source: Colorado Natural Heritage Program (CNHP) Wetland Mapper / U.S fish and Wildlife Service National Wetland Inventory (NWI)

<u>Colorado Wetland and Information Center – Wetlands Mapper</u>: CNHP has incorporated some of the data provided by the NWI for wetland habitat and has produced updated photo-interpretation of wetland mapping in several areas. On this Site, that data concurs with the NWI data. However, the lower reaches of the southwestern and eastern branches of the northeastern drainage are identified as Riparian Temporary Flooded Scrub-Shrub (RP1SS), a riparian habitat type that occurs adjacent to streams and is generally found on the banks of an incised channel. Refer to Figure 5, National Wetland Inventory Map and Figure 6, CNHP Riparian Habitat Map.

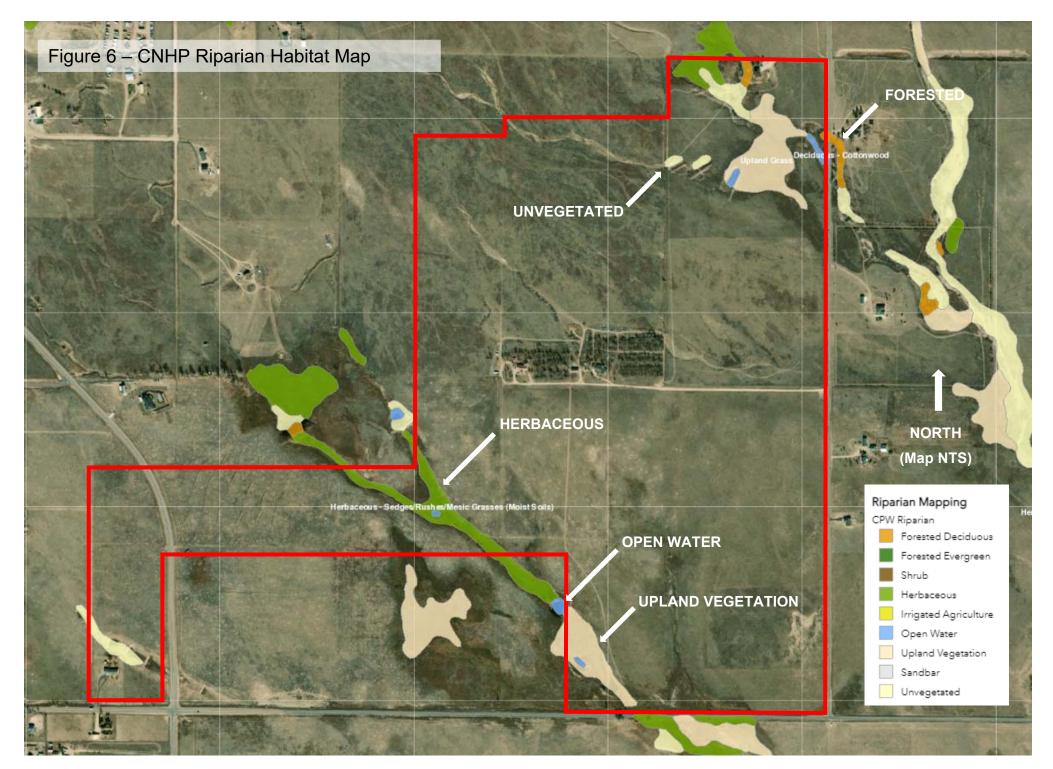
CNHP Riparian Habitat Map

Source: Colorado Natural Heritage Program (CNHP) Wetland Mapper

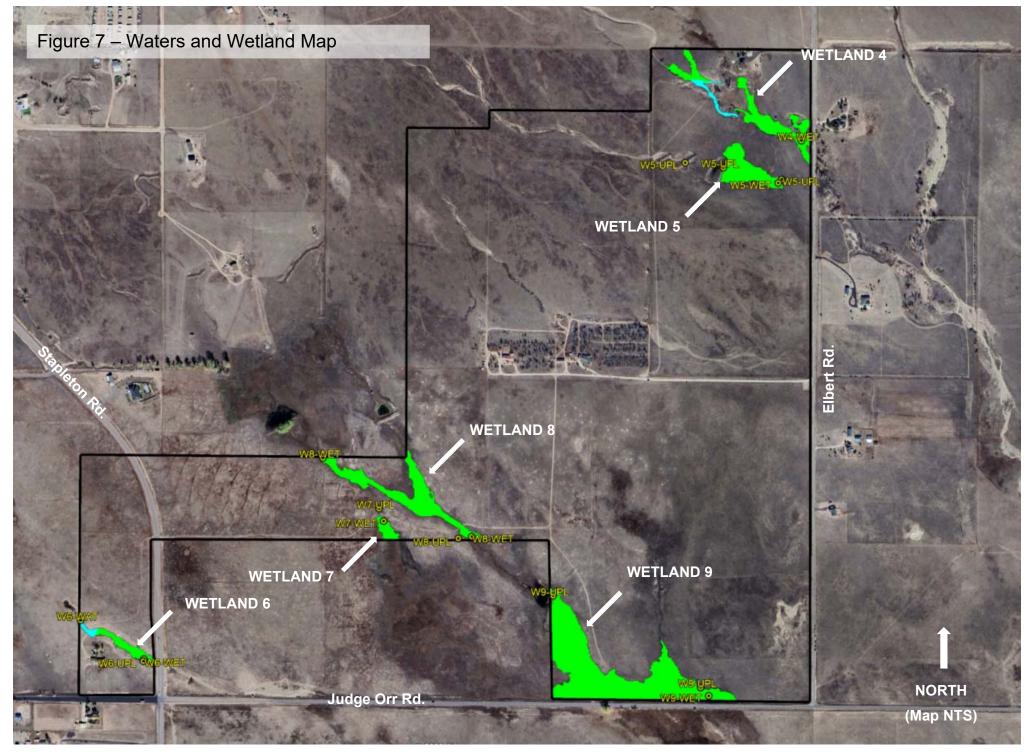
#### **FIGURE 7.** WOTUS Survey Map

Source: Google Earth Aerial Image, 10/31/2023 & Ecosystem Services, LLC Wetland Delineation, 5/23/2023

No other potential wetland habitat or water bodies (natural or manmade) are evident on the aerial imagery. Refer to Figure 2, Davis Existing Conditions Aerial Photo and Figure 7, Davis Preliminary Waters and Wetlands Map.

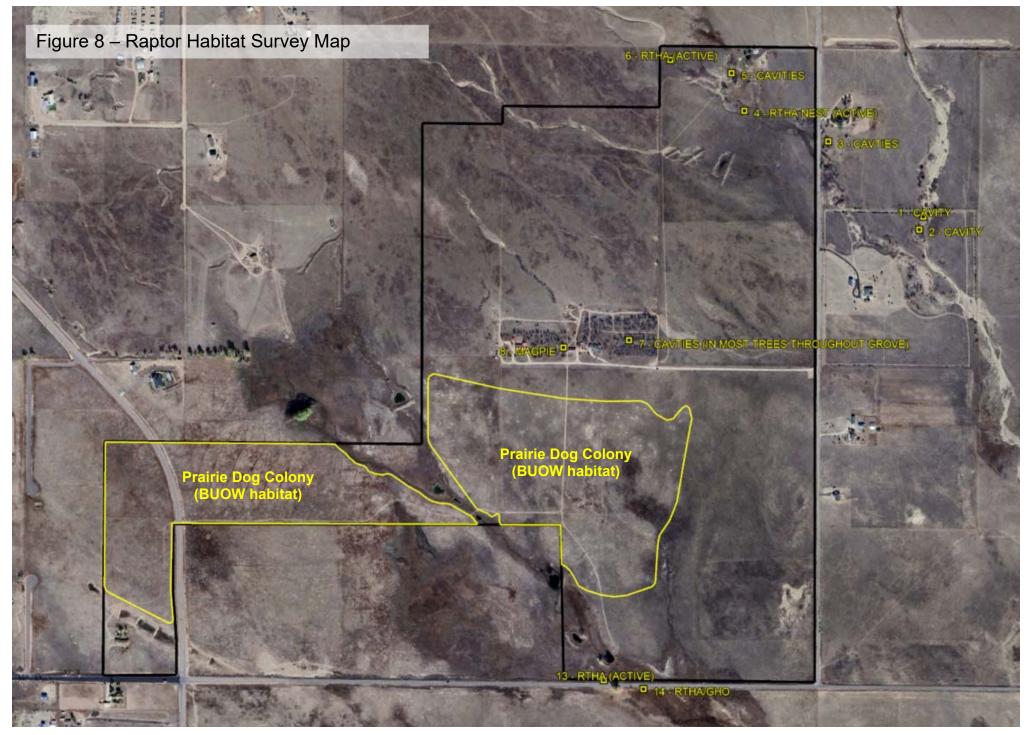
Raptor Habitat Survey Map

Source: Google Earth Aerial Image, 10/31/2023 & Ecosystem Services, LLC MBTA Survey, 5/23/2023

No raptor nests have been mapped within one mile outside of the Site (COGCC 2023. However, migratory bird and raptor nests, and expansive prairie dog colonies that are potential habitat for burrowing owls were observed within the Site (refer to Section 5.3). Given the seasonal and transitory nature of migratory birds and raptors, including burrowing owls, ECOS recommends a nesting bird survey immediately prior to any construction activity to identify any new or active nests or burrows within the Site or within the CPW recommended buffers of the Site. Construction activities should be restricted during the breeding season near any identified active migratory bird nest or burrow.

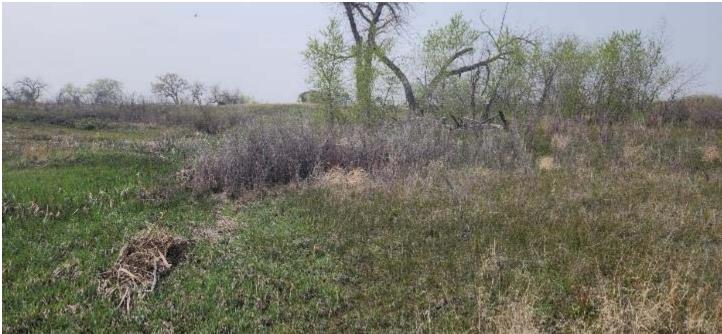
Photo Point W4 WET – Photo looking northwest of riparian and wetland habitat in the north branch of the Northeast drainage (Wetland 4).

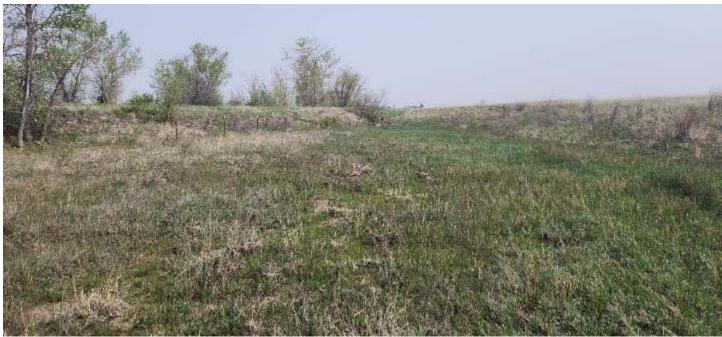
Photo Point W4 WET – Photo looking southeast of riparian and wetland habitat in the north branch of the Northeast drainage (Wetland 4) near Elbert Road.

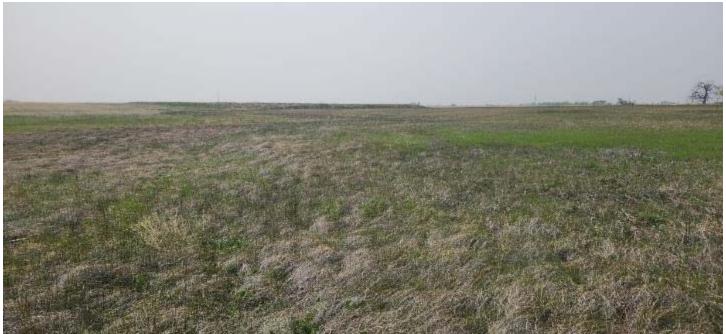
Photo Point W5 WET – Photo looking northwest of riparian and wetland habitat in the south branch of the Northeast drainage (Wetland 5).

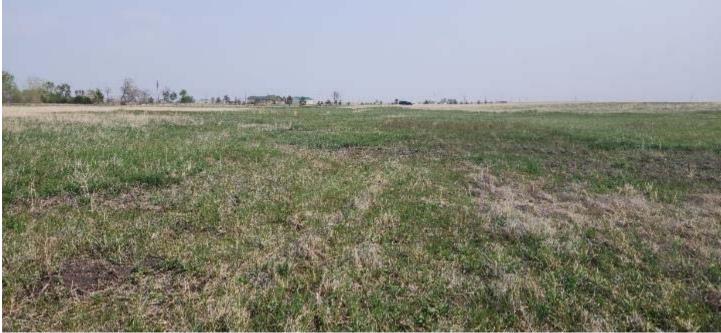
Photo Point W5 WET – Photo looking southeast of riparian and wetland habitat in the south branch of the Northeast drainage (Wetland 5) near Elbert Road.

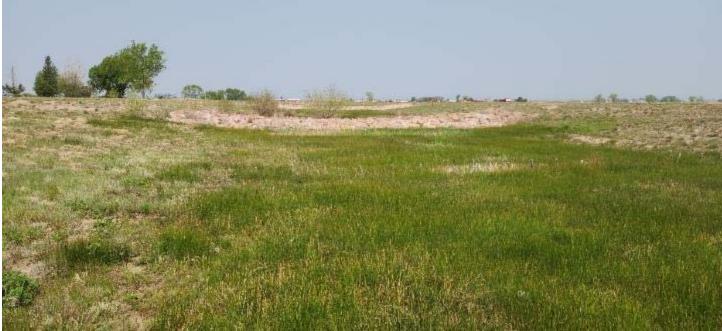
Photo Point W6 WET – Photo looking southeast of wetland habitat between drop structures in Southwest drainage (Wetland 6).

<u>Southwest drainage (Wetland 6)</u>: The data for this branch is summarized on the W6-WET datasheet in Appendix C. The NWI correctly identifies the upstream portion of this drainage as R4SBC; however, the downstream reach should be classified as PEM1A. It is a broad, wetland swale that is comprised of Baltic rush, common spikerush, and clustered field sedge, with inclusions of narrowleaf cattail. It is underlain by clayey sand that exhibits hydric hue and values in its matrices. Surface water was present up to approximately 1-inch depth and the soil was saturated to the surface. This area meets all 3 parameters for jurisdictional wetland habitat.

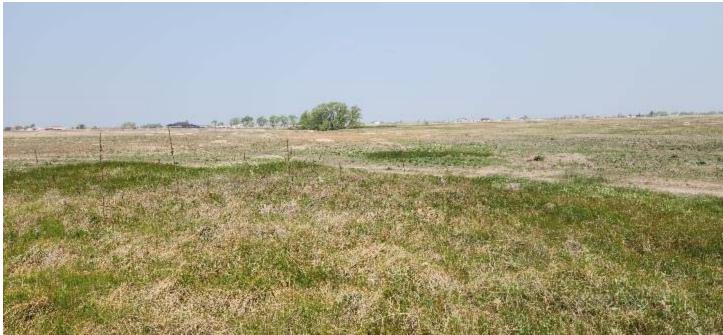
Photo Point W7 WET – Photo looking north of upper end of groundwater fed wetland (Wetland 7) within the south branch of the South-central drainage.

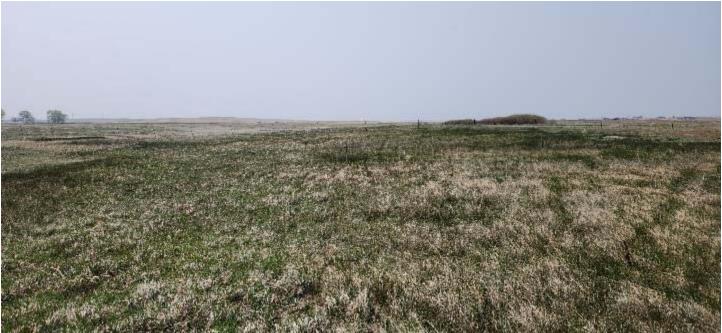
Photo Point W7 WET – Photo looking south of ground water fed wetland complex (Wetland 7) within the south branch of the South-central drainage.

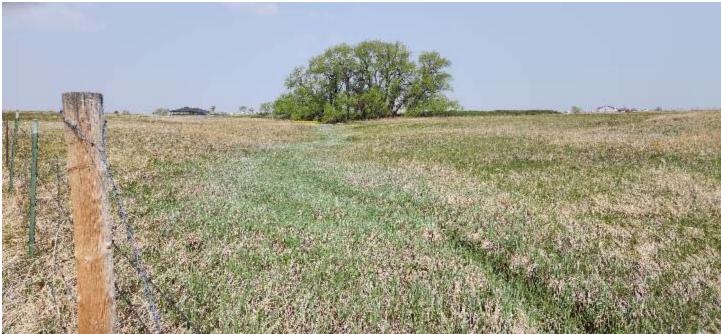
Photo Point W8 WET US – Photo looking northwest (upstream/off-site) of wetland habitat in the north branch of the South-central drainage (Wetland 8).

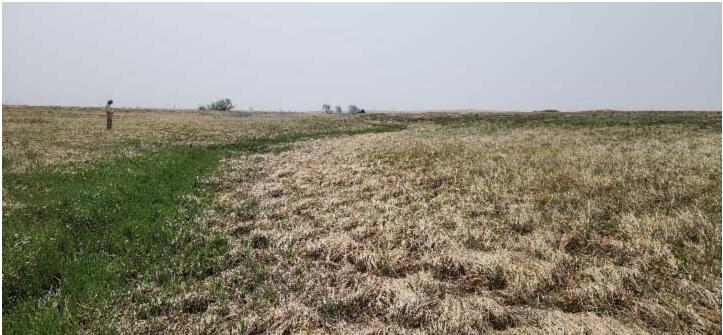
Photo Point W8 WET DS – Photo looking southeast (downstream/on-site) of wetland habitat in the north branch of the South-central drainage (Wetland 8).

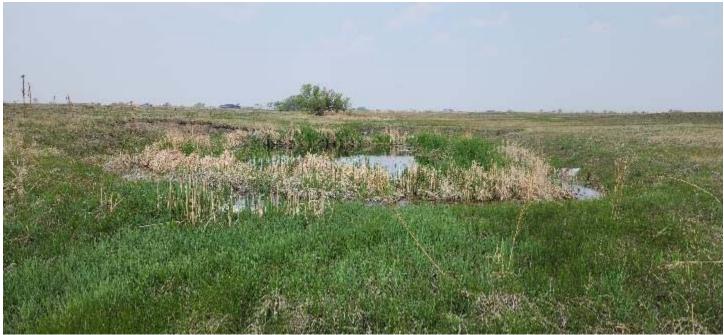
Photo Point W8 WET DS – Photo looking northwest (downstream/on-site) of riparian and wetland habitat in the north branch of the South-central drainage (Wetland 8).

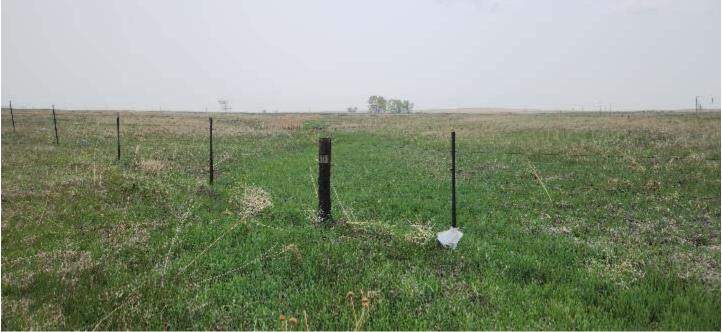
Photo Point W8 WET DS – Photo looking southeast (downstream/off-site) of and wetland habitat in the north branch of the South-central drainage (Wetland 8) flowing toward Wetland 9.

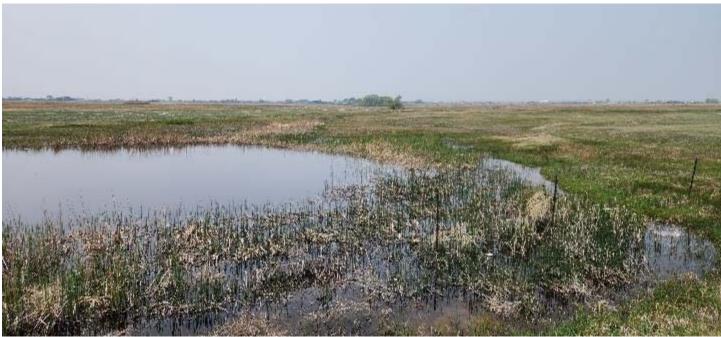
Photo Point WP 9 UPL – Photo looking northwest (upstream/off-site) from stock pond berm of riparian and wetland habitat in the north branch of the South-central drainage (Wetland 9). Wetland 9 is connected to Wetland 8.

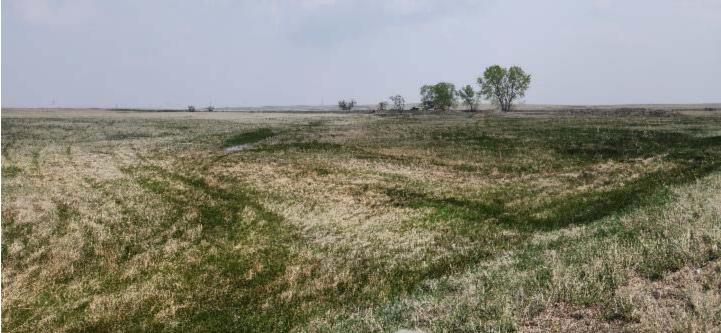
Photo Point WP 9 UPL – Photo looking southeast (downstream/on-site) from stock pond berm of riparian and wetland habitat in the north branch of the South-central drainage (Wetland 9) near Judge Orr Road.

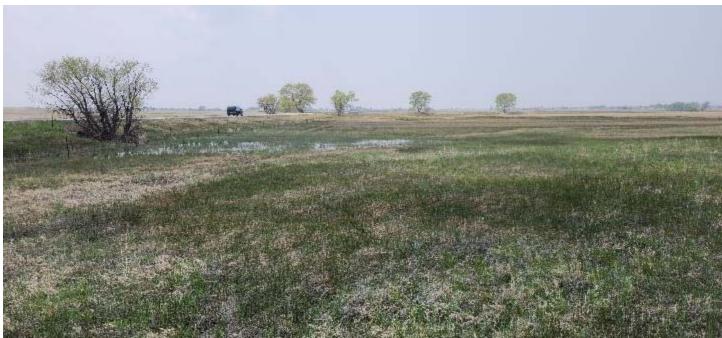
Photo Point WP 9 WET – Photo looking west of wetland habitat where the north and south branches of the South-central drainage combine (Wetlands 8 and 9) adjacent to Judge Orr Road.

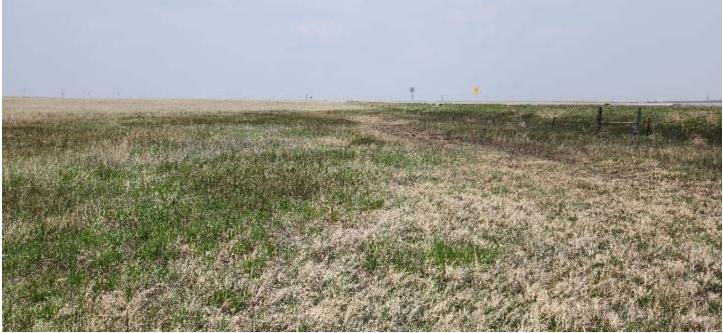
Photo Point WP 9 WET – Photo looking east of wetland habitat where the north and south branches of the South-central drainage combine (Wetlands 8 and 9) adjacent to Judge Orr Road.
