# Geotechnical Pavement Section Design

## Curtis Road and Davis Road

3050 Curtis Road

ProTeX Job No.: 8619

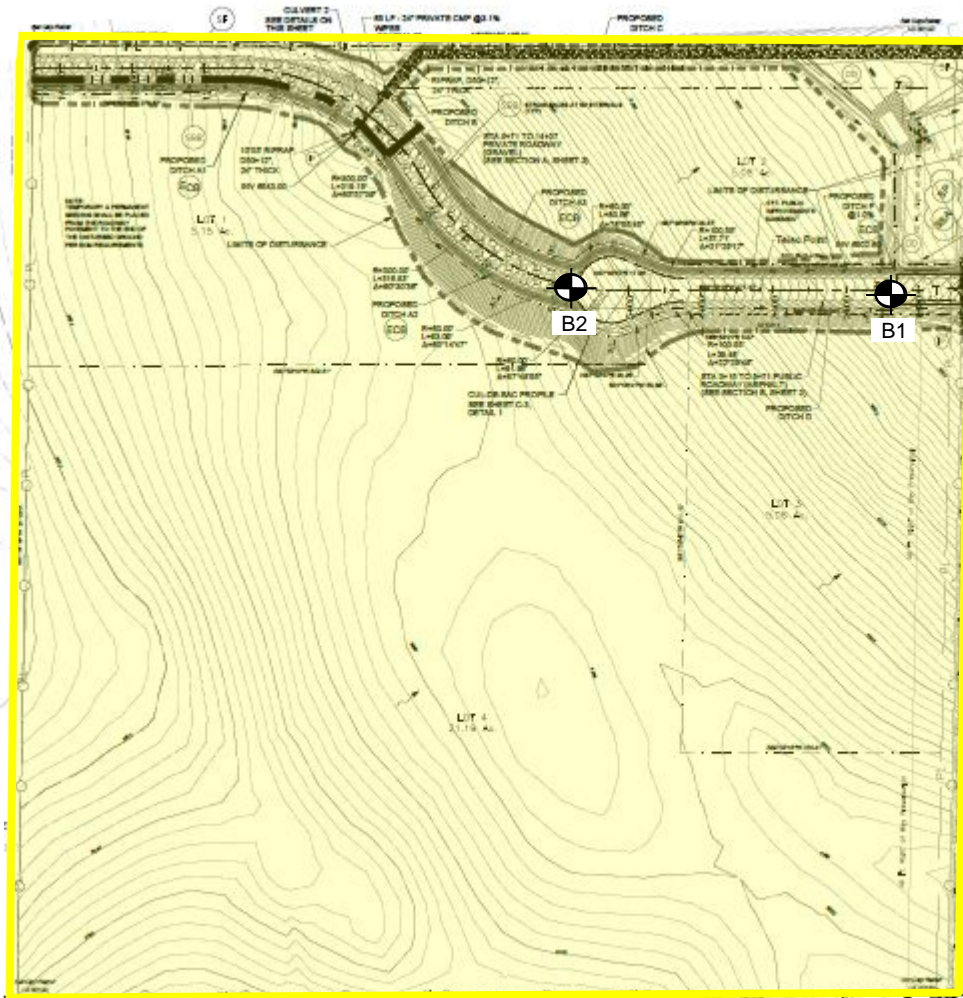
## Site Plan

Approximate Boring Location

A total of 2 test holes (test holes TP1 and TP2) were completed within the proposed roadways alignment for the purpose of pavement section design. The soils were sampled at the anticipated depth of the proposed roadway. At each test hole location, the soils encountered were visually observed, classified, logged and representative samples were obtained where applicable. Refer to the site plan in Appendix B for approximate test hole locations.
