Job No. 187749

Re: Wastewater Study

Winslow Drive

Estates at Cathedral Pines El Paso County, Colorado This does not meet the criteria of an OWTS report. Please review LDC Sec. 8.4.8.E.2.d and revise to ensure the requirements on the Code are being met with this report.

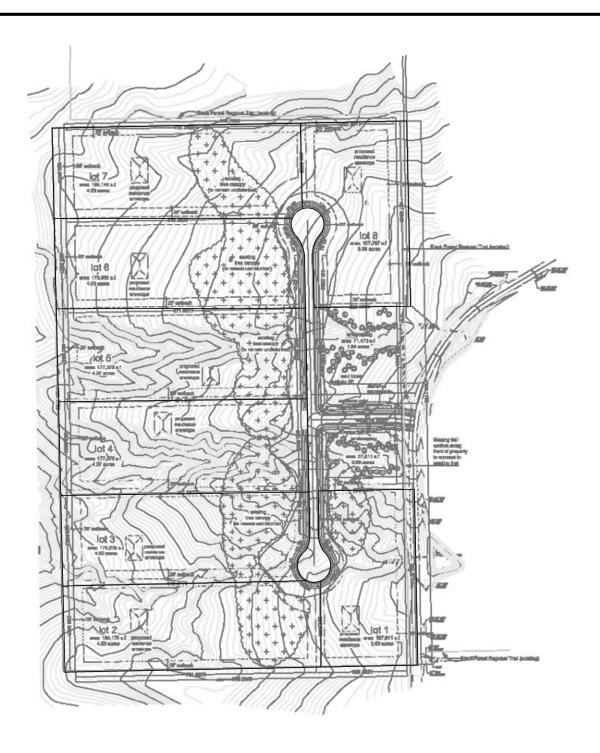
FIG No. 2

The site consists of approximately 35 acres of undeveloped land. It is our understanding the existing 35-acre parcel is to be subdivided into a total of eight new lots, each with a single-family residence. Each new lot is to be serviced by an on-site wastewater treatment system (OWTS) and an individual domestic water supply well. The site is to be accessed from Winslow Drive. A site Vicinity Map and Proposed Lot Layout Map is included as Figure 1 and 2.

PROPOSED LOT LAYOUT

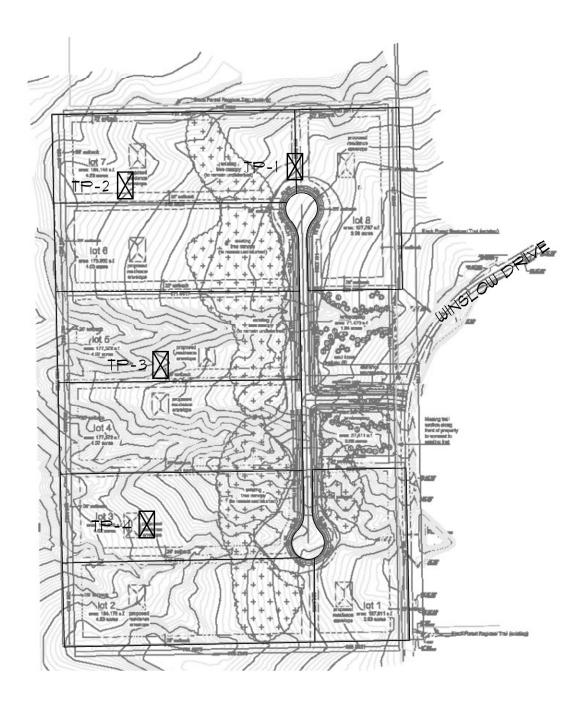
FIG No. 3

Personnel of RMG performed a reconnaissance visit on March 21, 2022. The purpose of the reconnaissance visit was to evaluate the site surface characteristics including landscape position, topography, vegetation, natural and cultural features, and current and historic land uses. Four 8-foot deep test pits were observed on March 31, 2022. The test pit locations are presented on the Test Pit Location Map, Figure 3.

DENOTES APPROXIMATE LOCATION OF TEST PITS

TEST PIT LOCATION MAP

Personnel of RMG performed a soil evaluation to include four 8-foot deep test pits, on March 31, 2022 (Test Pit TP-1 through TP-4), utilizing the visual and tactile method for the evaluation of the site soils. The test pits were excavated in areas that appeared most likely to be used for residential construction. The Test Pit Logs are presented in Figure 4. A Septic Suitability Map is presented in Figure 5.

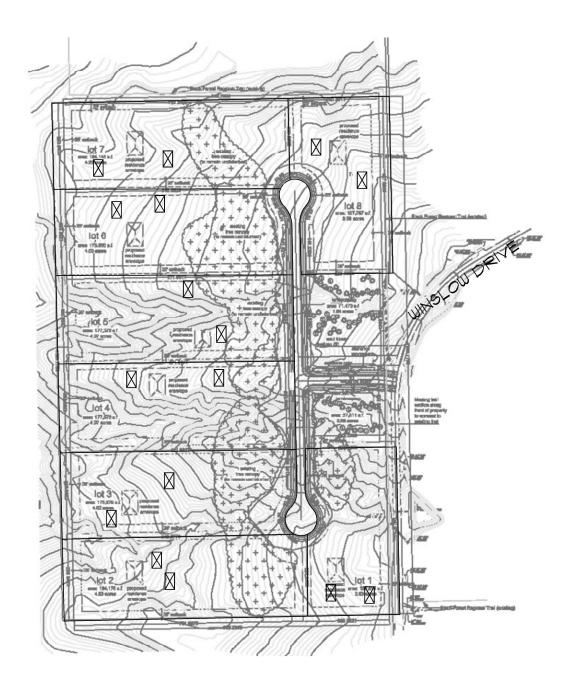
FIG No. 5

DENOTES PRIMARY AND ALTERNATE SEPTIC LOCATIONS

SEPTIC SUITABILITY MAP

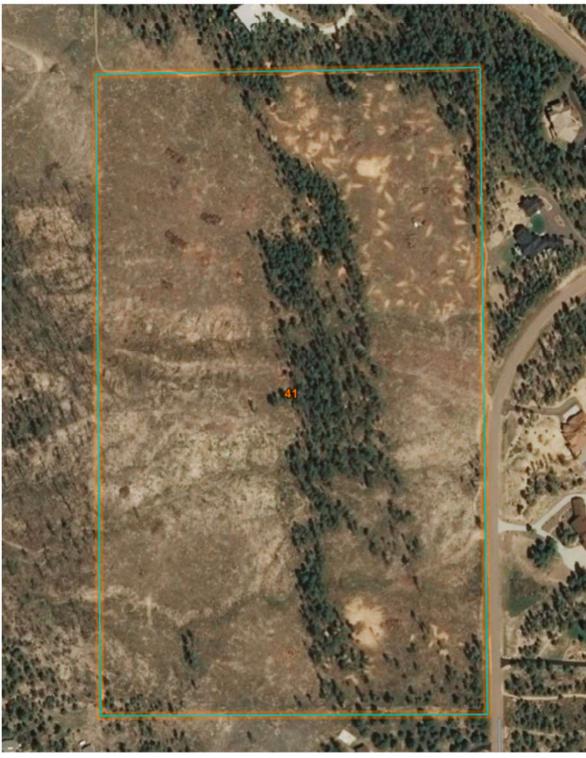
FIG No. 6

The soil conditions as indicated by the NRCS data are anticipated to consist of Kettle gravelly loamy sand with 8 to 40 percent slopes. Properties of the gravelly loamy sand include somewhat excessively drained soils, depth of the water table is anticipated to be greater than 80 inches, runoff is anticipated to be medium, frequency of flooding and/or ponding is anticipated to be none, and landforms include hills.

The USDA Soil Survey Map is presented in Figure 6.

41 - Kettle gravelly loamy sand, 8 to 40 percent slopes

USDA SOIL SURVEY MAP
