**WASTEWATER (OWTS) STUDY
THE RETREAT AT TIMBERRIDGE, FILING 2
VOLLMER ROAD AND ARROYA LANE
EL PASO COUNTY, COLORADO**

April 26, 2021
Revised October 29, 2021

Entech Job No. 211066
AAprojects/2021/211066 county ww(owts)

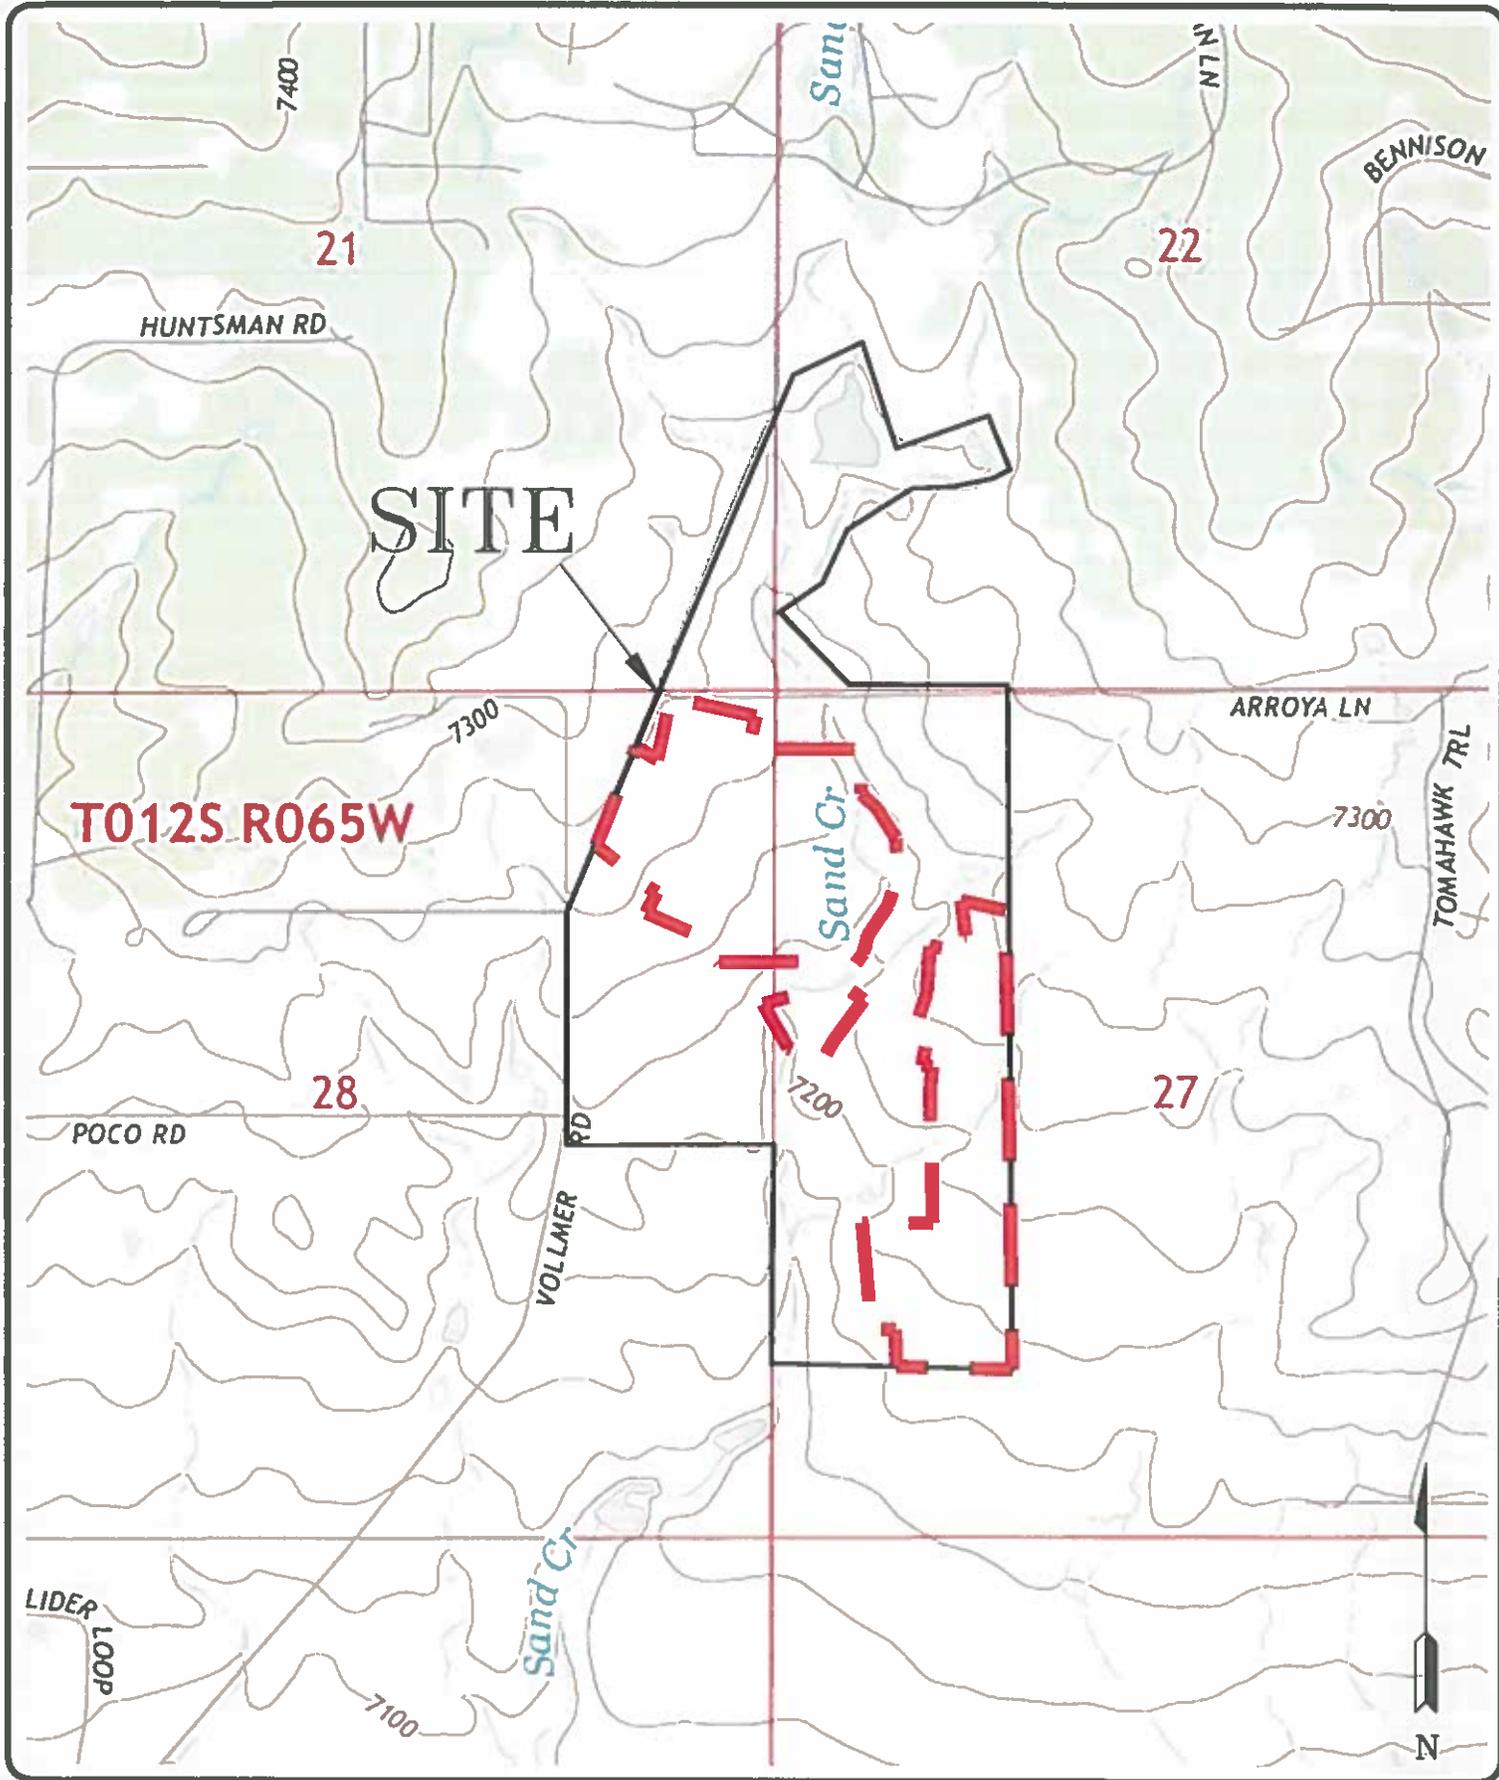
USGS MAP
 TIMBERRIDGE, FILING #2
 VOLLMER ROAD AND ARROYA LANE
 EL PASO COUNTY, CO.
 FOR: TIMBERRIDGE DEVELOPMENT GROUP, LLC

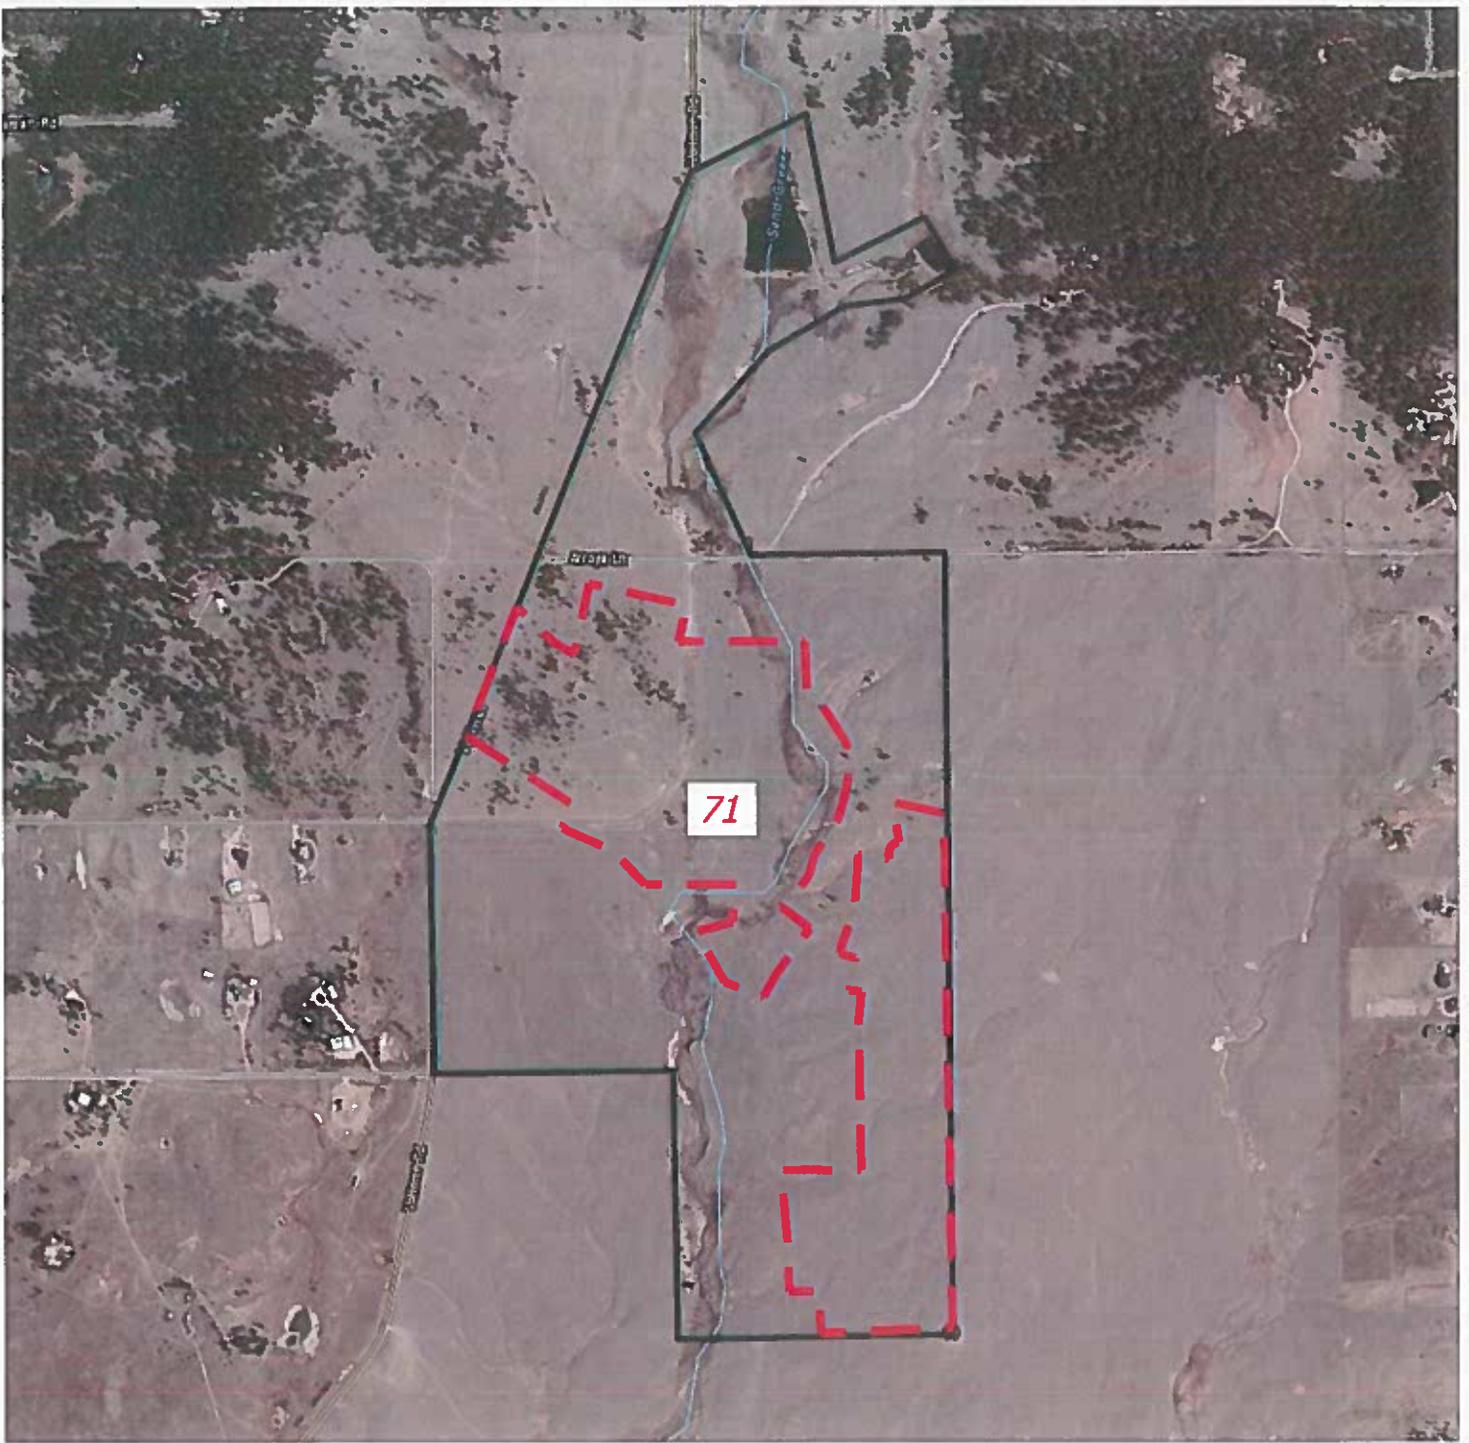
FIG NO:
5

SOIL SURVEY MAP
 TIMBERRIDGE, FILING #2
 VOLLMER ROAD AND ARROYA LANE
 EL PASO COUNTY, CO.
 FOR: TIMBERRIDGE DEVELOPMENT GROUP, LLC

Complete descriptions of each soil type are presented in Appendix D. The soils have generally been described to have moderate to moderately rapid permeabilities. Possible hazards with soil

erosion are present on the site. The erosion potential can be controlled with vegetation. The majority of the soils have been described to have slight to moderate erosion hazards.

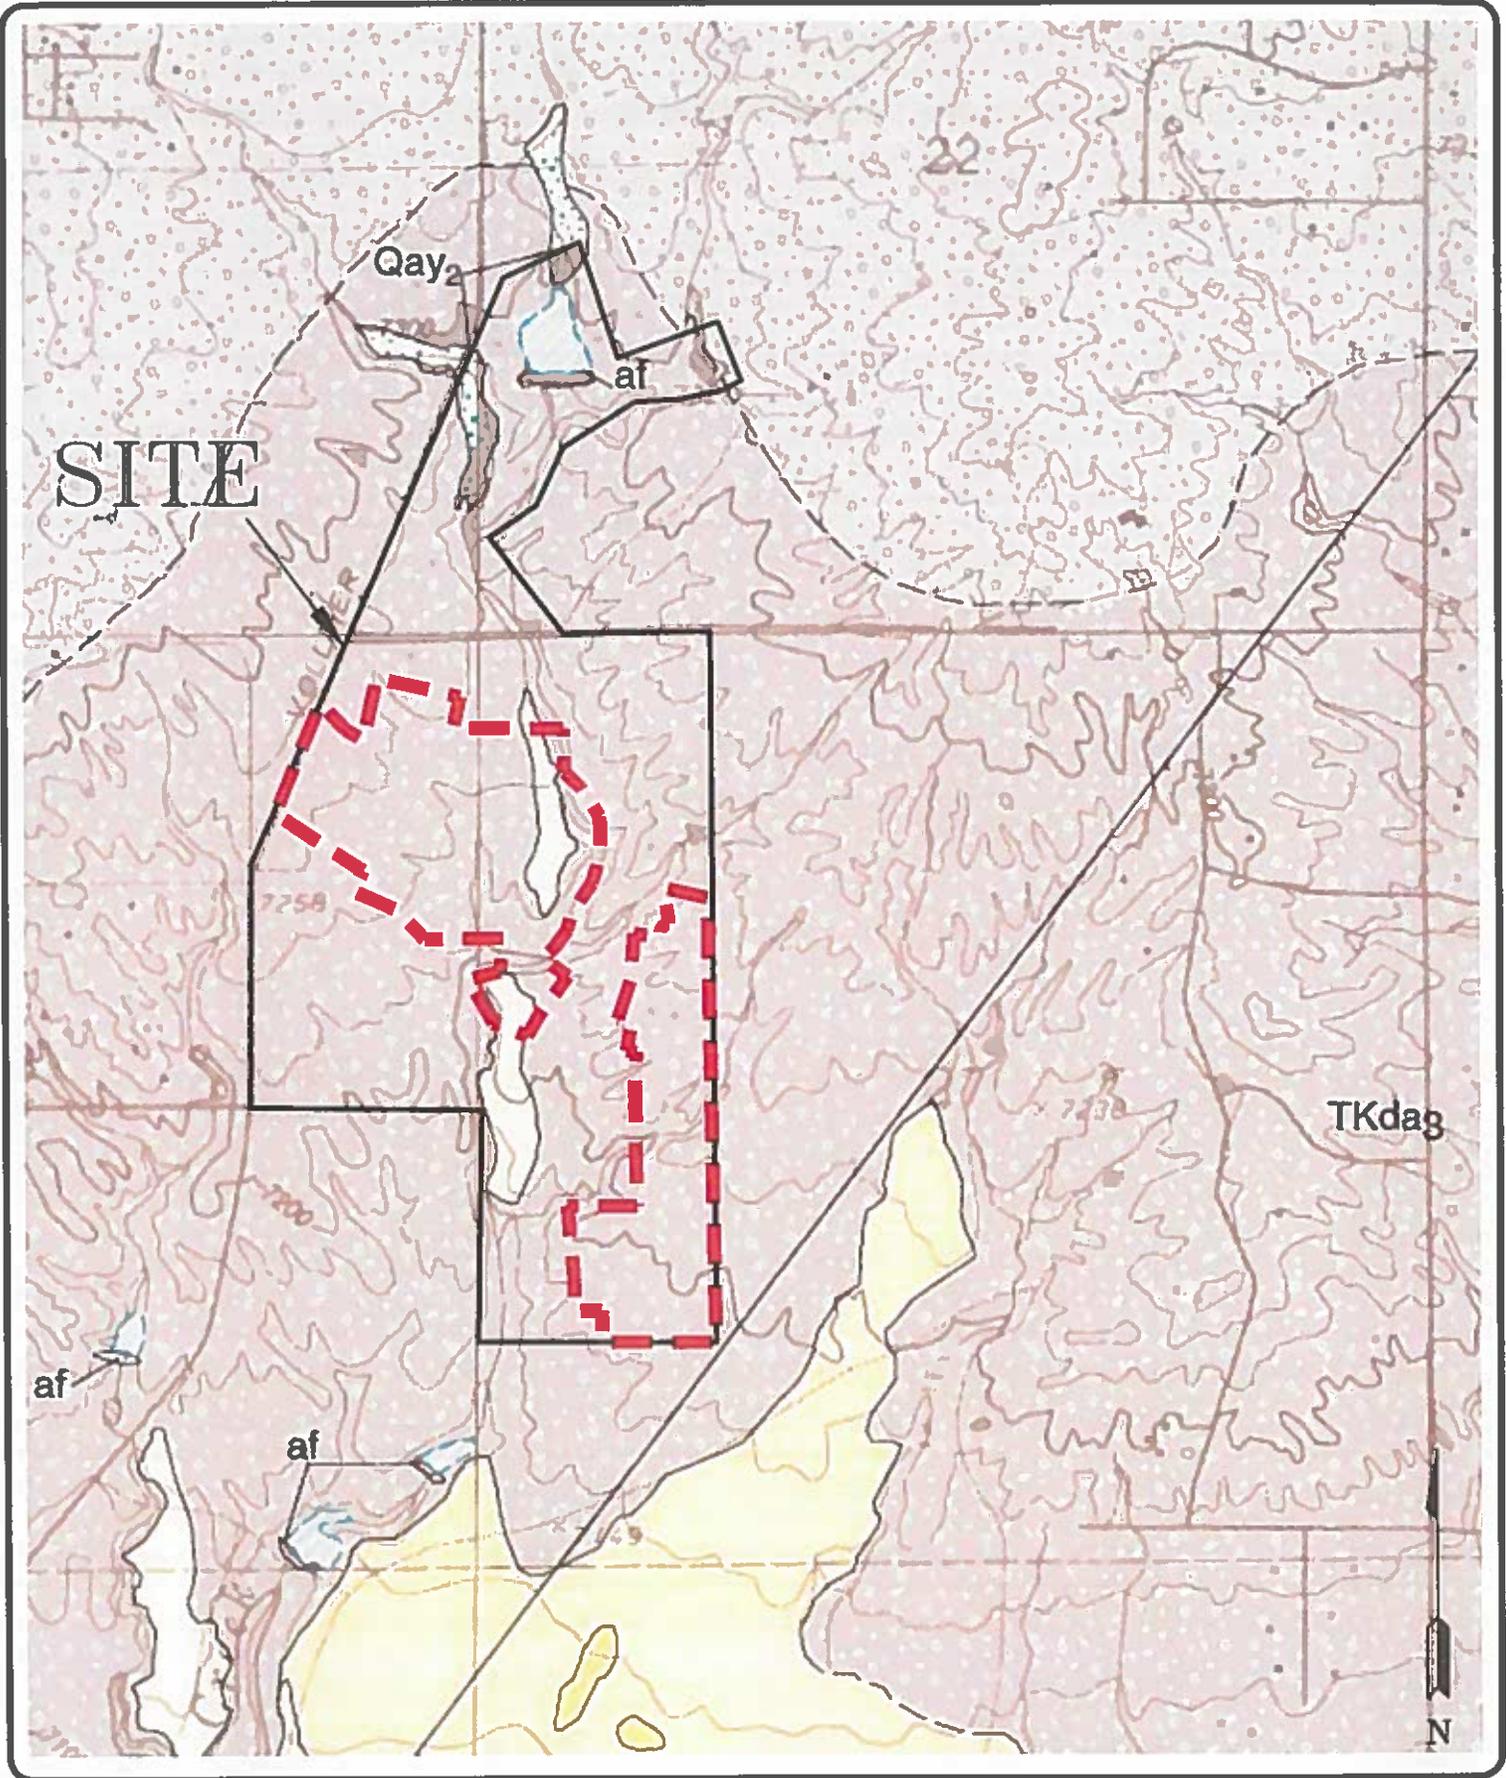
FALCON NW QUADRANGLE GEOLOGY MAP
 TIMBERRIDGE, FILING #2
 VOLLMER ROAD AND ARROYA LANE
 EL PASO COUNTY, CO.
 FOR: TIMBERRIDGE DEVELOPMENT GROUP, LLC

Our field investigation for the soils, geology, and geologic hazard report consisted of the preparation of a geologic map of any bedrock features and significant surficial deposits. The soils and geology report was also used in this OWTS evaluation. The Natural Resource Conservation Service (NRCS), previously the Soil Conservation Service (SCS) survey was also

reviewed to evaluate the site. The position of mappable units within the subject property are shown on the Geologic Map. Our mapping procedures involved both field reconnaissance and measurements and air photo reconnaissance and interpretation. The same mapping procedures have also been utilized to produce the Engineering Geology Map which identified pertinent geologic conditions affecting development.

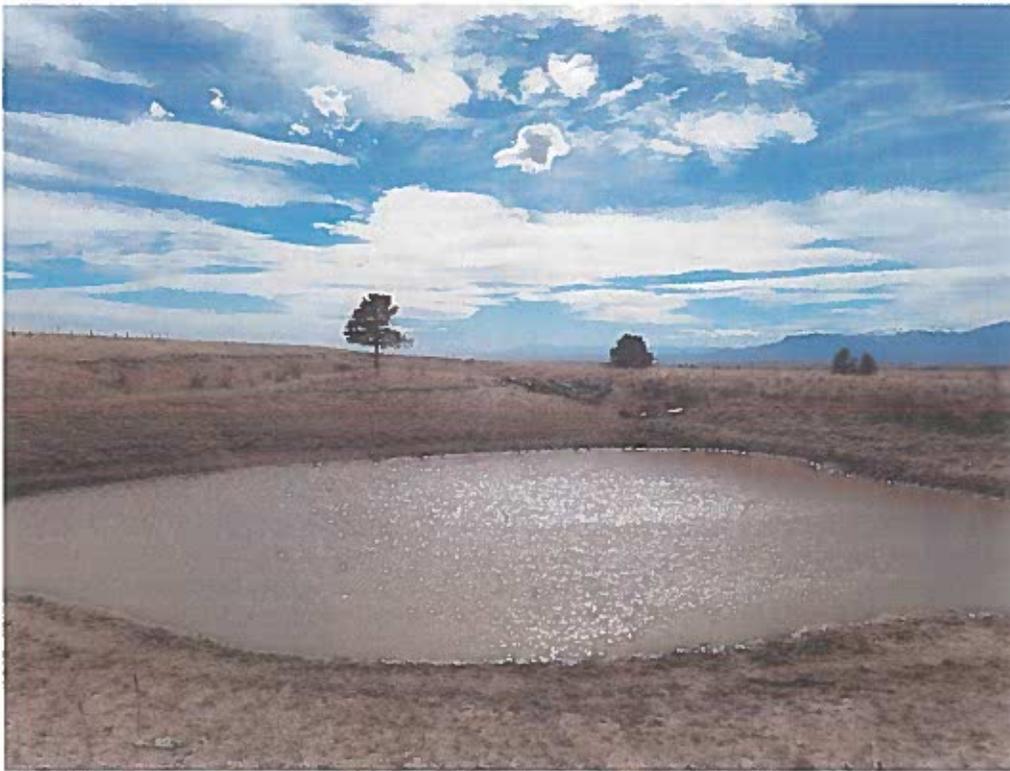
Looking southwest from the eastern portion of the site at the existing pond.

Areas within the drainages on-site have been identified as areas of seasonally wet and/or seasonally high groundwater areas. Water was observed in the three ponds on-site, and flowing in Sand Creek. The majority of the drainages across the site were dry. The site is mapped within floodplain zones according to the FEMA Map No. 08041CO535G, Figure 8 (Reference 7). The floodplain area is to consist of open space/ park for the development. These areas are discussed as follows:

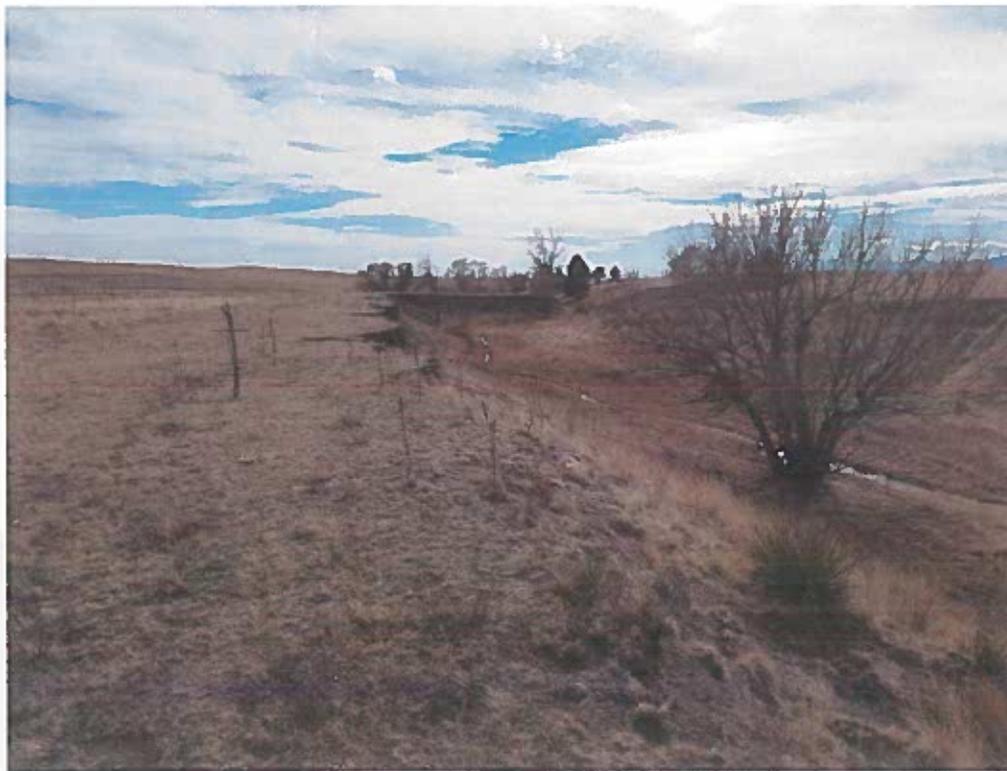
**Looking south along
Sand Creek from the
central portion of the
site.**

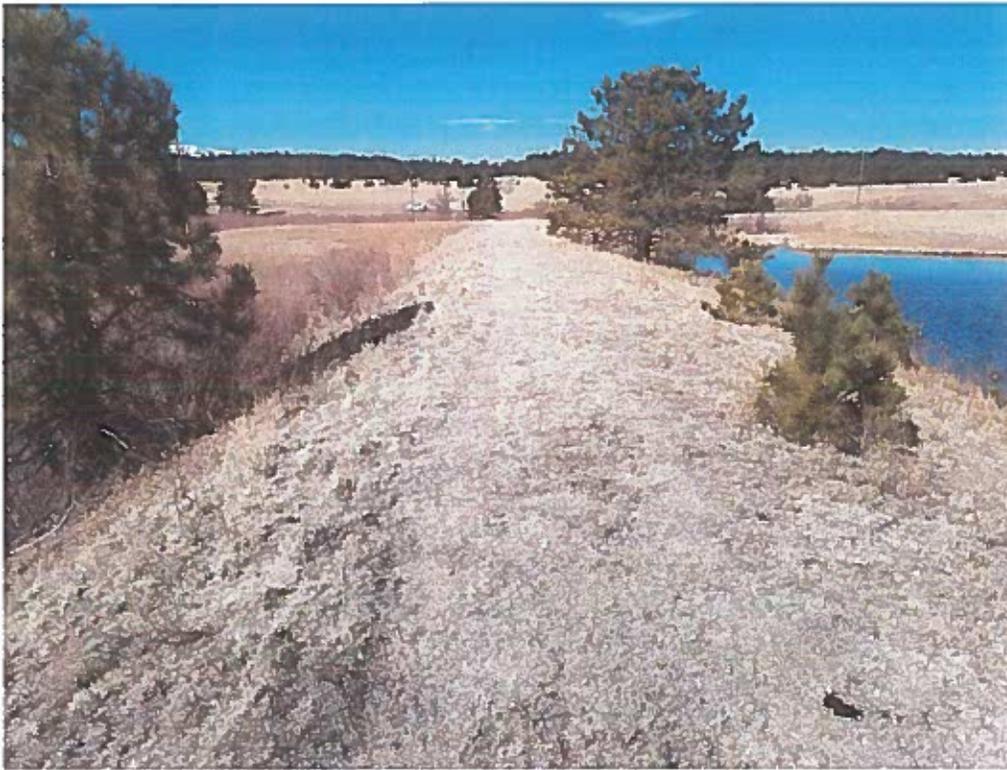
**Looking west along
the crest of the dam in
the northern portion of
the site.**

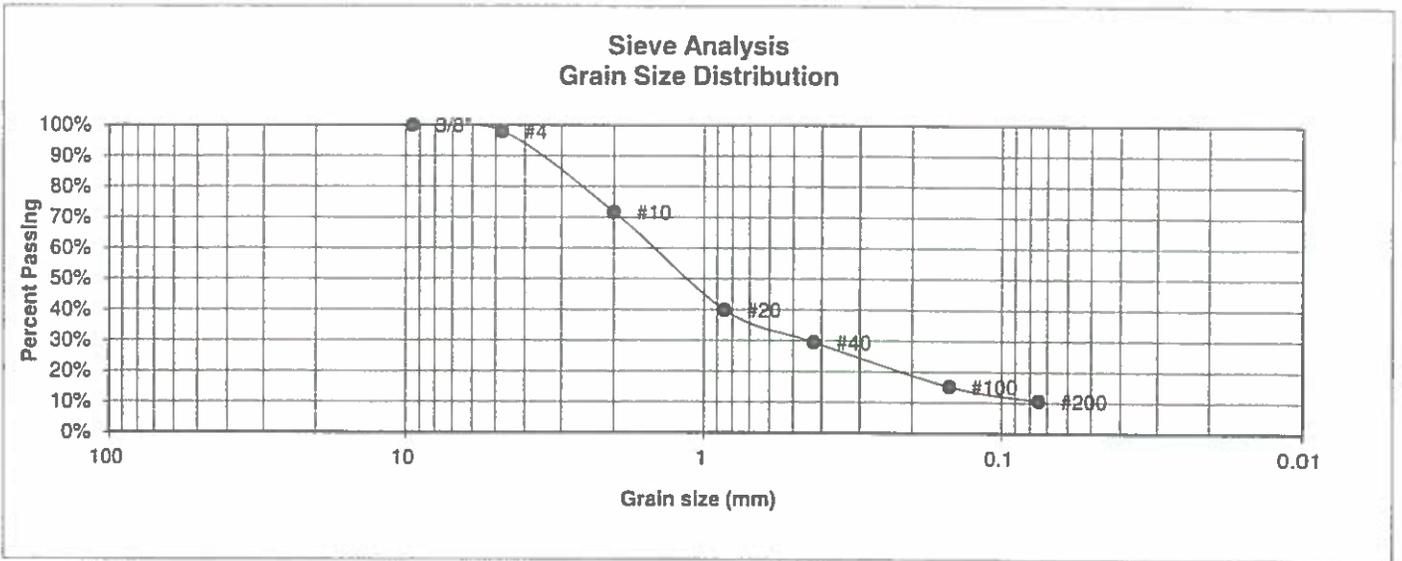
<u>UNIFIED CLASSIFICATION</u>	SM-SW	<u>CLIENT</u>	ARROYA INVESTMENTS
<u>SOIL TYPE #</u>	1	<u>PROJECT</u>	THE RETREAT AT TIMBER RIDGE
<u>TEST BORING #</u>	5	<u>JOB NO.</u>	170020
<u>DEPTH (FT)</u>	2-3	<u>TEST BY</u>	BL

<u>U.S. Sieve #</u>	<u>Percent Finer</u>
3"	
1 1/2"	
3/4"	
1/2"	
3/8"	100.0%
4	97.9%
10	71.7%
20	40.0%
40	29.4%
100	15.2%
200	10.5%

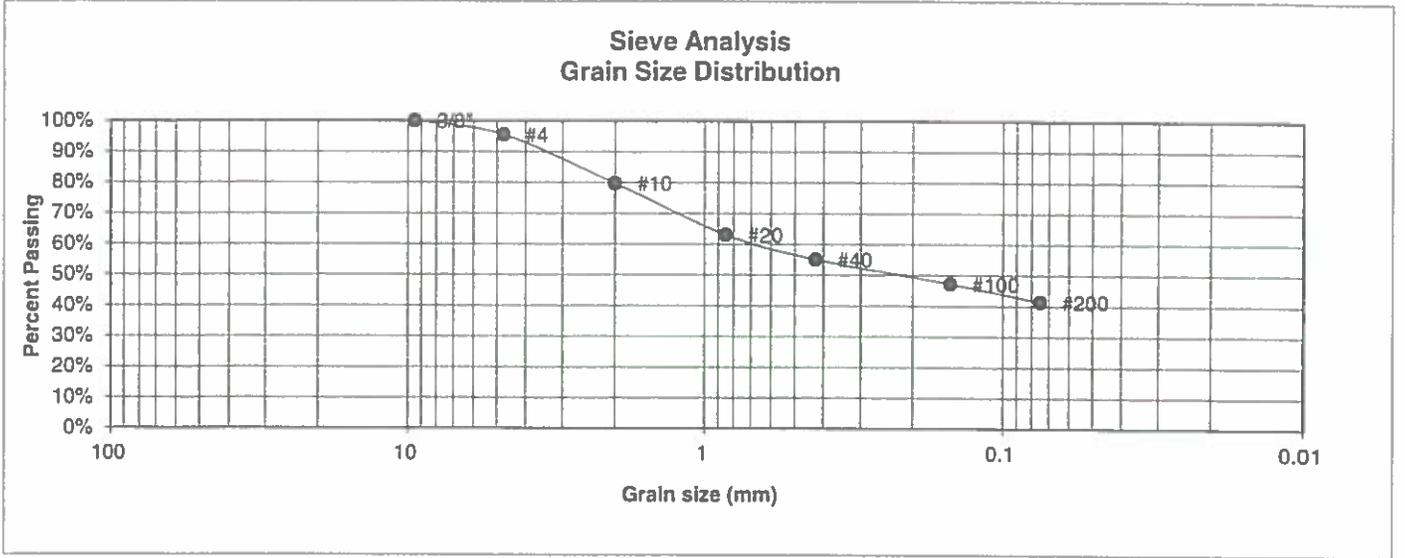
<u>UNIFIED CLASSIFICATION</u>	SC	<u>CLIENT</u>	ARROYA INVESTMENTS
<u>SOIL TYPE #</u>	1	<u>PROJECT</u>	THE RETREAT AT TIMBER RIDGE
<u>TEST BORING #</u>	6	<u>JOB NO.</u>	170020
<u>DEPTH (FT)</u>	5	<u>TEST BY</u>	BL

U.S. Sieve #	Percent Finer
3"	
1 1/2"	
3/4"	
1/2"	
3/8"	100.0%
4	95.6%
10	79.8%
20	63.1%
40	55.1%
100	47.2%
200	41.3%

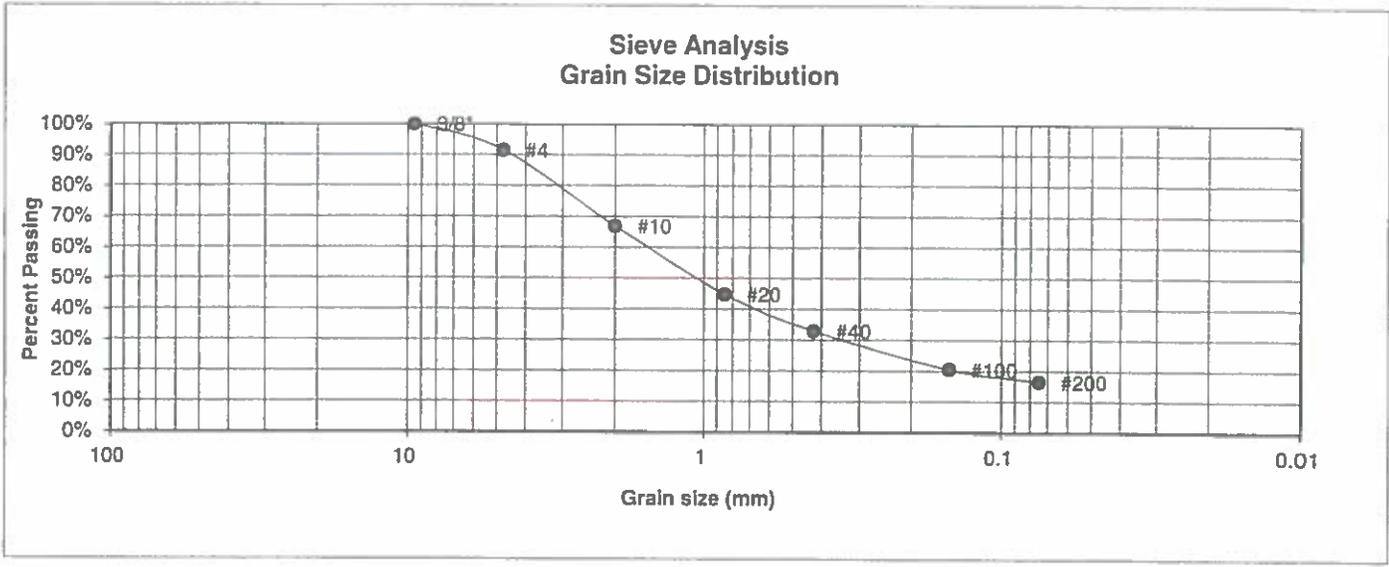
<u>UNIFIED CLASSIFICATION</u>	SM	<u>CLIENT</u>	ARROYA INVESTMENTS
<u>SOIL TYPE #</u>	1	<u>PROJECT</u>	THE RETREAT AT TIMBER RIDGE
<u>TEST BORING #</u>	11	<u>JOB NO.</u>	170020
<u>DEPTH (FT)</u>	5	<u>TEST BY</u>	BL

<u>U.S. Sieve #</u>	<u>Percent Finer</u>	<u>Atterberg Limits</u>
3"		Plastic Limit
1 1/2"		Liquid Limit
3/4"		Plastic Index
1/2"		
3/8"	100.0%	
4	91.5%	<u>Swell</u>
10	66.9%	Moisture at start
20	44.8%	Moisture at finish
40	32.9%	Moisture increase
100	20.5%	Initial dry density (pcf)
200	16.5%	Swell (psf)

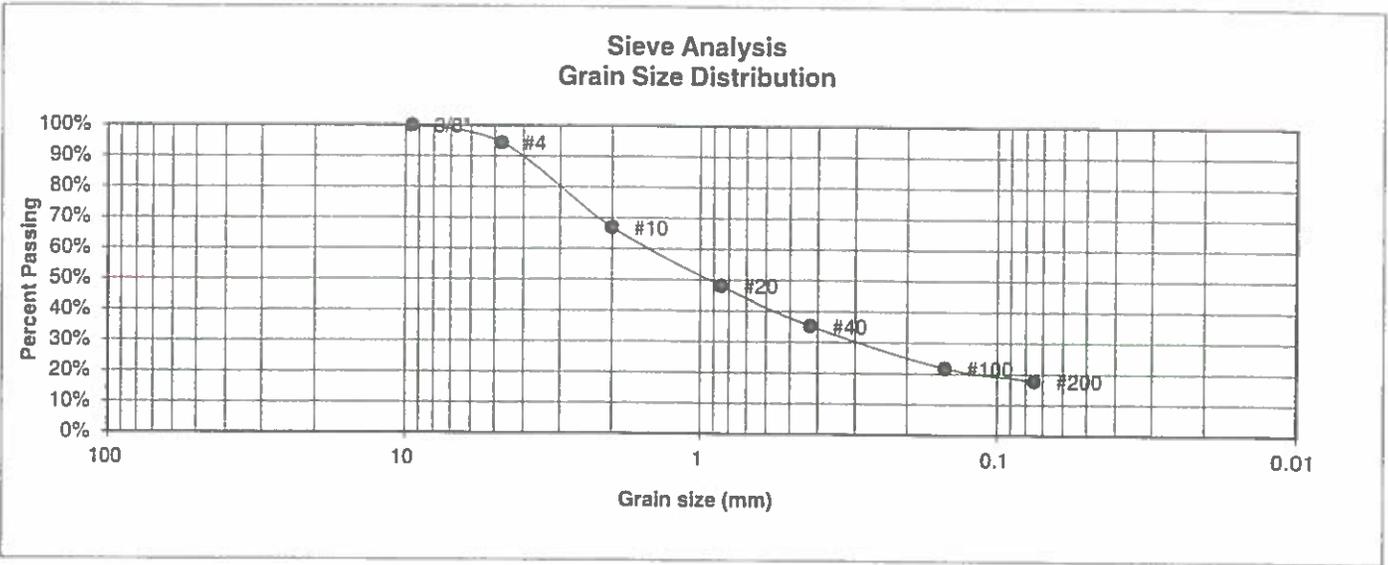
<u>UNIFIED CLASSIFICATION</u>	SM	<u>CLIENT</u>	ARROYA INVESTMENTS
<u>SOIL TYPE #</u>	1	<u>PROJECT</u>	THE RETREAT AT TIMBER RIDGE
<u>TEST BORING #</u>	13	<u>JOB NO.</u>	170020
<u>DEPTH (FT)</u>	2-3	<u>TEST BY</u>	BL

<u>U.S. Sieve #</u>	<u>Percent Finer</u>
3"	
1 1/2"	
3/4"	
1/2"	
3/8"	100.0%
4	94.4%
10	67.0%
20	48.2%
40	35.2%
100	21.8%
200	17.8%

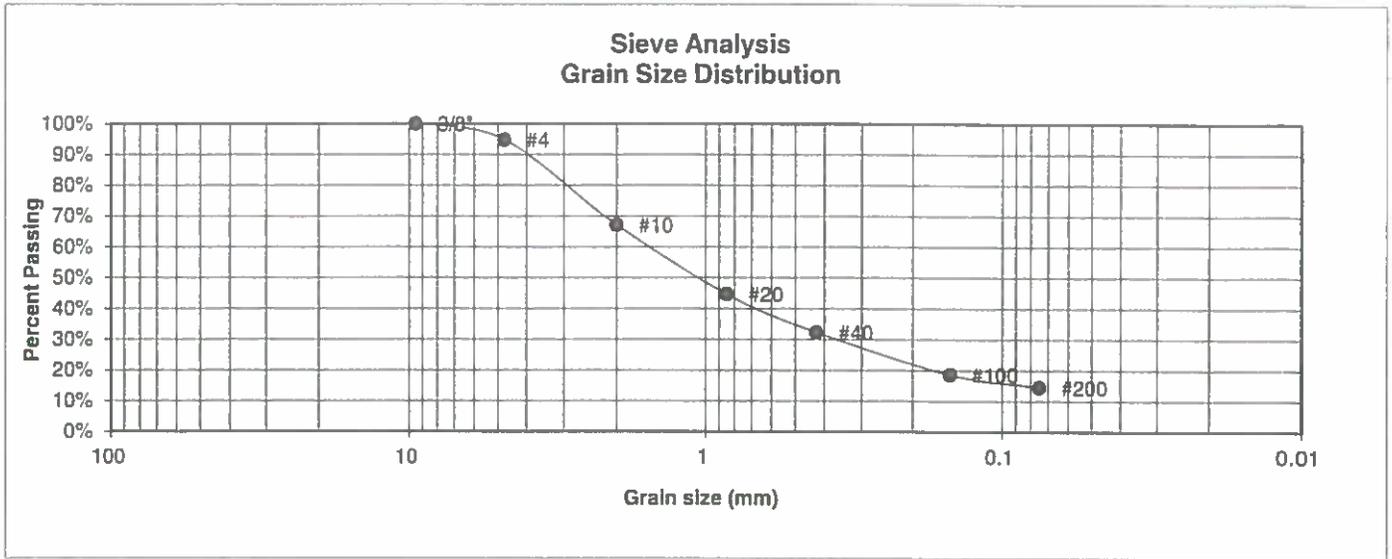
UNIFIED CLASSIFICATION	SM	CLIENT	ARROYA INVESTMENTS
SOIL TYPE #	1	PROJECT	THE RETREAT AT TIMBER RIDGE
TEST BORING #	9	JOB NO.	170020
DEPTH (FT)	2-3	TEST BY	BL

U.S. Sieve #	Percent Finer
3"	
1 1/2"	
3/4"	
1/2"	
3/8"	100.0%
4	94.8%
10	67.2%
20	44.7%
40	32.3%
100	18.6%
200	14.6%

Atterberg Limits	
Plastic Limit	NP
Liquid Limit	NV
Plastic Index	NP

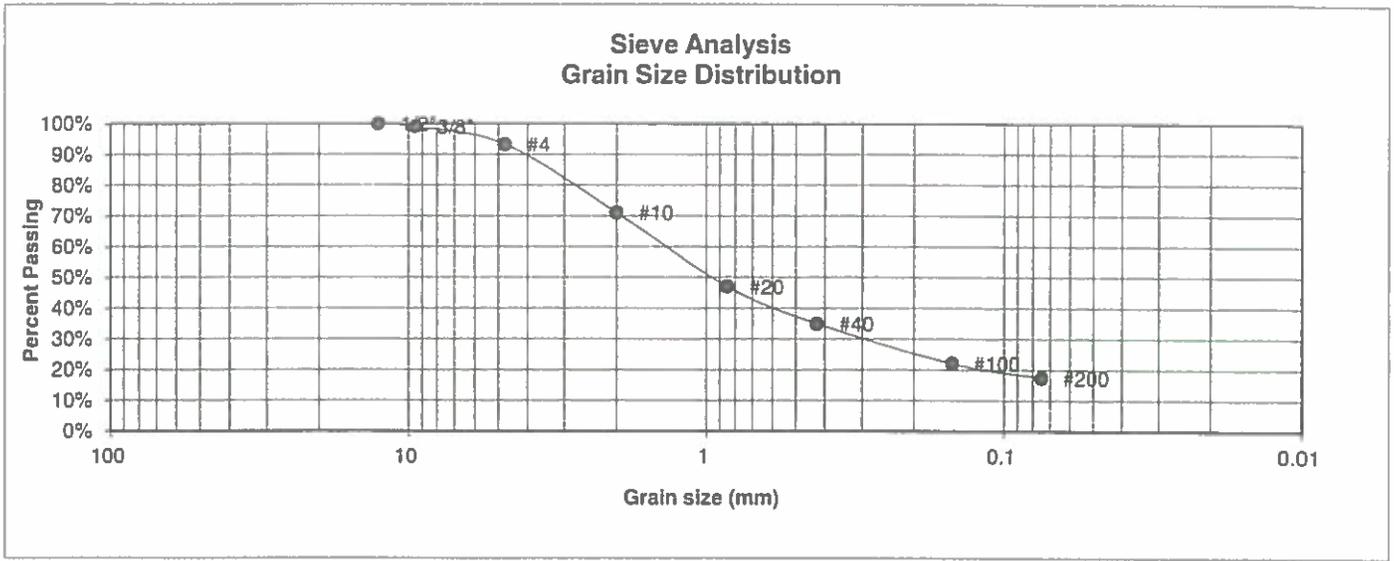
<u>UNIFIED CLASSIFICATION</u>	SM	<u>CLIENT</u>	ARROYA INVESTMENTS
<u>SOIL TYPE #</u>	1	<u>PROJECT</u>	THE RETREAT AT TIMBER RIDGE
<u>TEST BORING #</u>	10	<u>JOB NO.</u>	170020
<u>DEPTH (FT)</u>	5	<u>TEST BY</u>	BL

<u>U.S. Sieve #</u>	<u>Percent Finer</u>
3"	
1 1/2"	
3/4"	
1/2"	100.0%
3/8"	99.1%
4	93.3%
10	71.0%
20	47.0%
40	35.0%
100	22.0%
200	17.4%

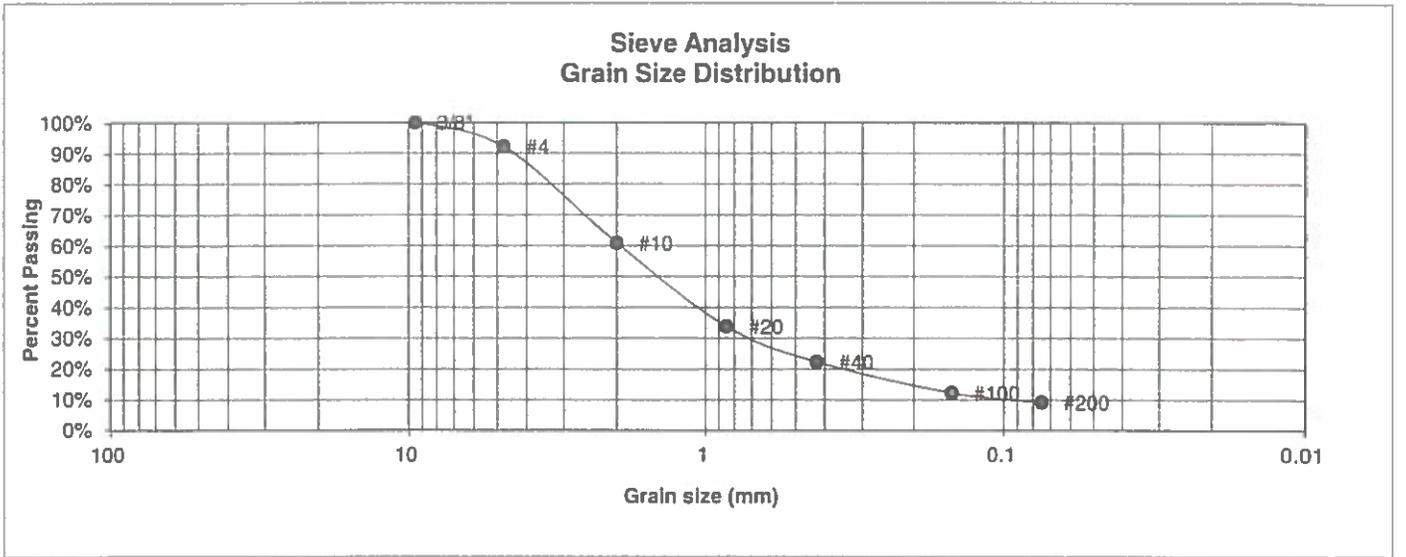
<u>UNIFIED CLASSIFICATION</u>	SM-SW	<u>CLIENT</u>	ARROYA INVESTMENTS
<u>SOIL TYPE #</u>	1	<u>PROJECT</u>	THE RETREAT AT TIMBER RIDGE
<u>TEST BORING #</u>	2	<u>JOB NO.</u>	170020
<u>DEPTH (FT)</u>	10	<u>TEST BY</u>	BL

U.S. Sieve #	Percent Finer
3"	
1 1/2"	
3/4"	
1/2"	
3/8"	100.0%
4	92.1%
10	60.9%
20	33.9%
40	22.3%
100	12.3%
200	9.2%

Atterberg Limits	
Plastic Limit	NP
Liquid Limit	NV
Plastic Index	NP

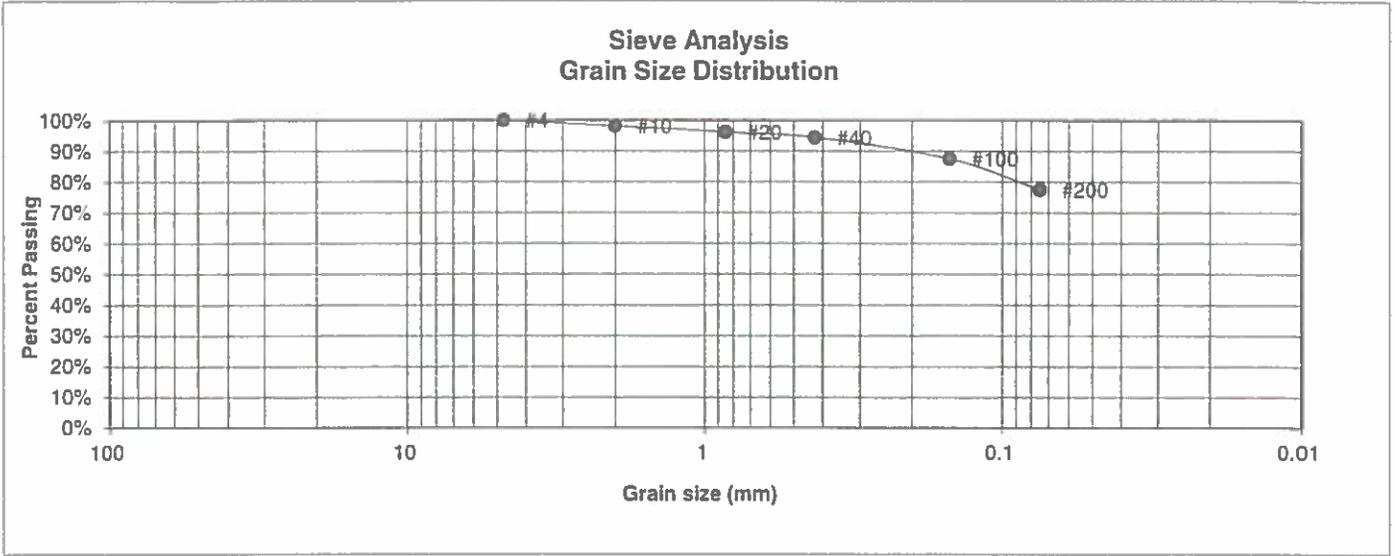
<u>UNIFIED CLASSIFICATION</u>	CL	<u>CLIENT</u>	ARROYA INVESTMENTS
<u>SOIL TYPE #</u>	2	<u>PROJECT</u>	THE RETREAT AT TIMBER RIDGE
<u>TEST BORING #</u>	1	<u>JOB NO.</u>	170020
<u>DEPTH (FT)</u>	2-3	<u>TEST BY</u>	BL

<u>U.S. Sieve #</u>	<u>Percent Finer</u>
3"	
1 1/2"	
3/4"	
1/2"	
3/8"	
4	100.0%
10	98.2%
20	96.2%
40	94.4%
100	87.5%
200	77.5%

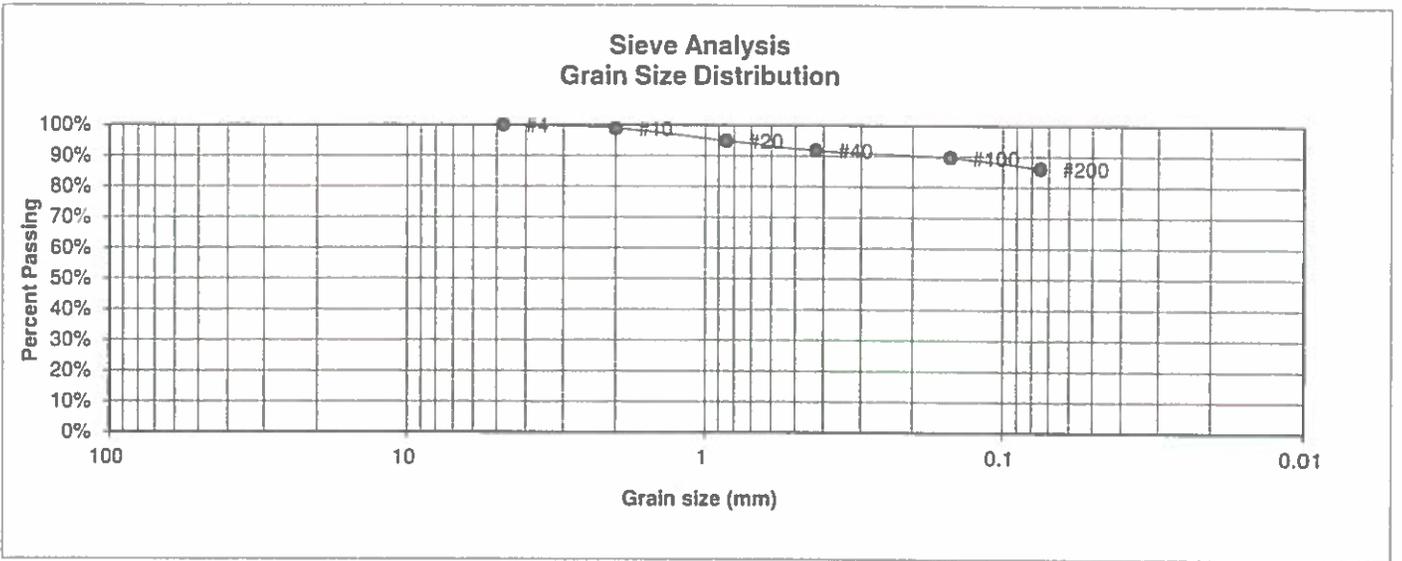
<u>UNIFIED CLASSIFICATION</u>	CL	<u>CLIENT</u>	ARROYA INVESTMENTS
<u>SOIL TYPE #</u>	2	<u>PROJECT</u>	THE RETREAT AT TIMBER RIDGE
<u>TEST BORING #</u>	2	<u>JOB NO.</u>	170020
<u>DEPTH (FT)</u>	4	<u>TEST BY</u>	BL

U.S. Sieve #	Percent Finer
3"	
1 1/2"	
3/4"	
1/2"	
3/8"	
4	100.0%
10	98.9%
20	94.9%
40	91.8%
100	89.6%
200	86.1%

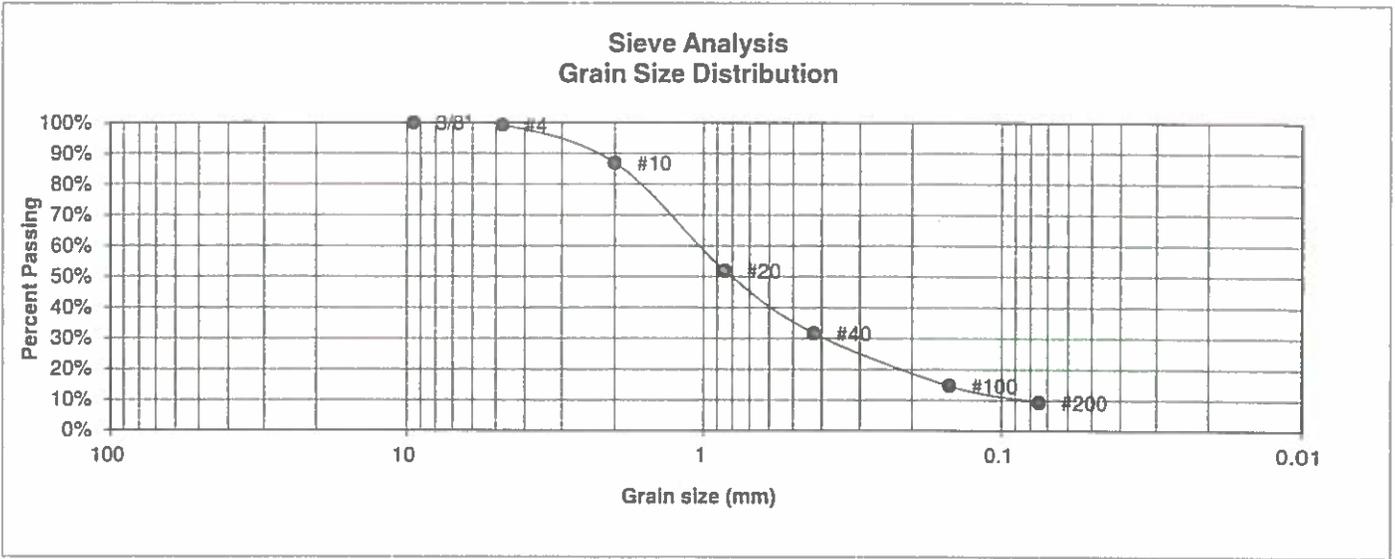
<u>UNIFIED CLASSIFICATION</u>	SM-SW	<u>CLIENT</u>	ARROYA INVESTMENTS
<u>SOIL TYPE #</u>	3	<u>PROJECT</u>	THE RETREAT AT TIMBER RIDGE
<u>TEST BORING #</u>	1	<u>JOB NO.</u>	170020
<u>DEPTH (FT)</u>	10	<u>TEST BY</u>	BL

<u>U.S. Sieve #</u>	<u>Percent Finer</u>
3"	
1 1/2"	
3/4"	
1/2"	
3/8"	100.0%
4	99.3%
10	87.0%
20	52.0%
40	31.6%
100	14.7%
200	9.3%

<u>Atterberg Limits</u>	
Plastic Limit	NP
Liquid Limit	NV
Plastic Index	NP

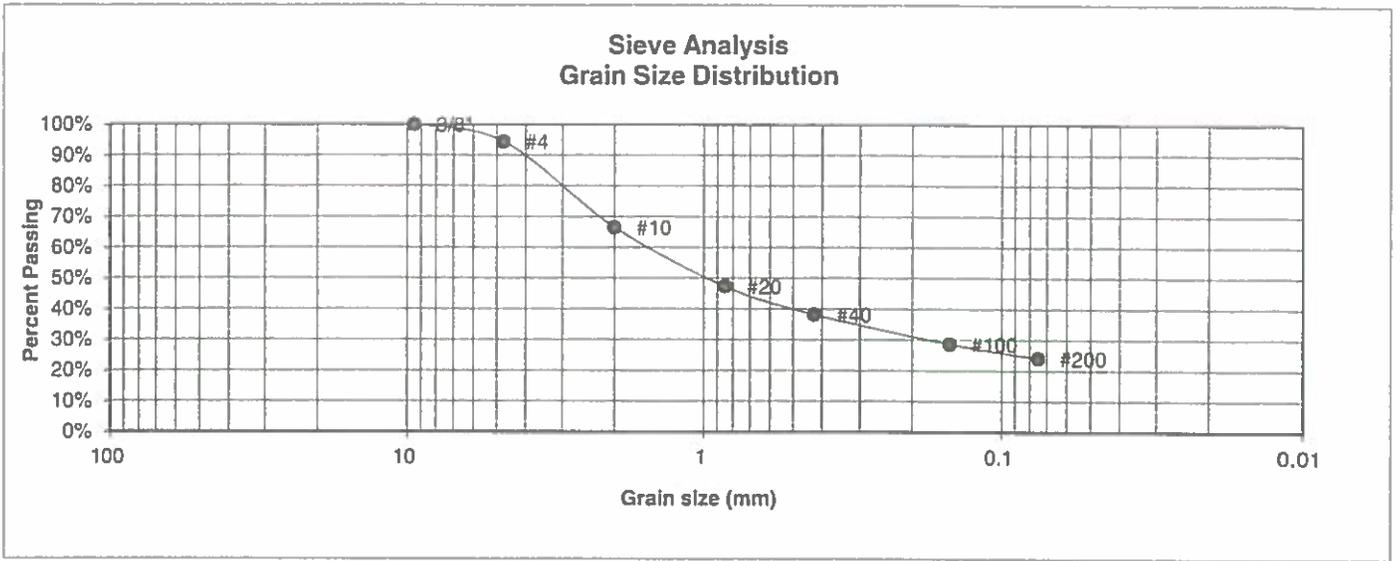
<u>UNIFIED CLASSIFICATION</u>	SM	<u>CLIENT</u>	ARROYA INVESTMENTS
<u>SOIL TYPE #</u>	3	<u>PROJECT</u>	THE RETREAT AT TIMBER RIDGE
<u>TEST BORING #</u>	3	<u>JOB NO.</u>	170020
<u>DEPTH (FT)</u>	5	<u>TEST BY</u>	BL

<u>U.S. Sieve #</u>	<u>Percent Finer</u>
3"	
1 1/2"	
3/4"	
1/2"	
3/8"	100.0%
4	94.4%
10	66.5%
20	47.4%
40	38.2%
100	28.7%
200	24.0%

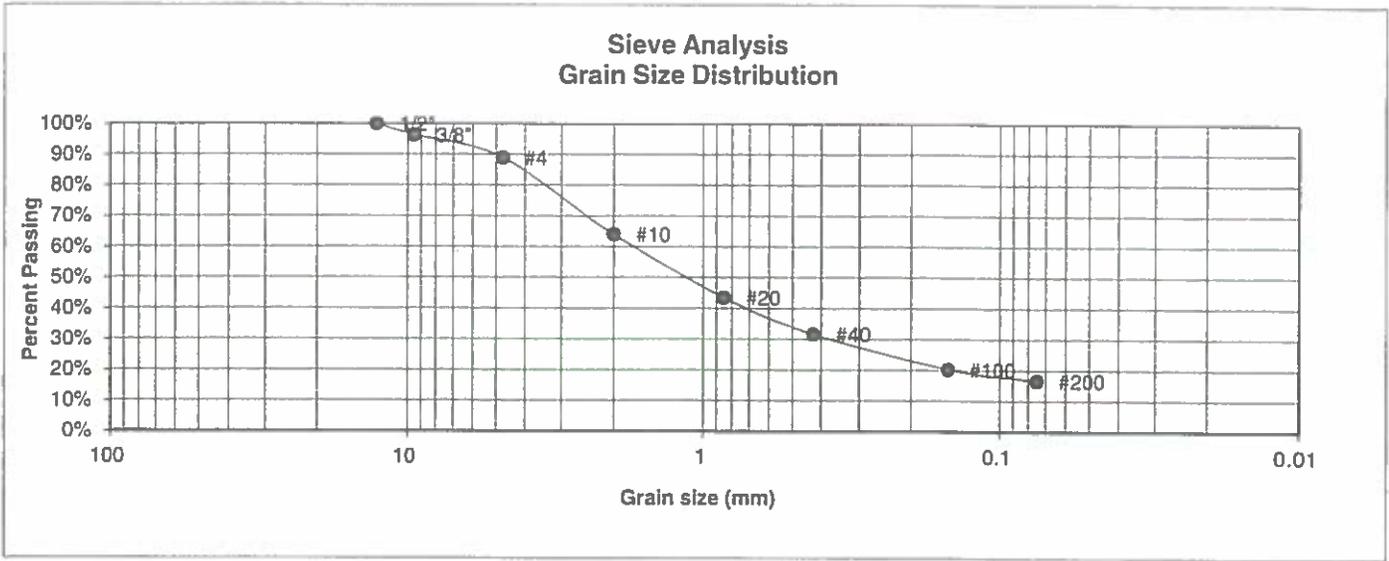
<u>UNIFIED CLASSIFICATION</u>	SM	<u>CLIENT</u>	ARROYA INVESTMENTS
<u>SOIL TYPE #</u>	3	<u>PROJECT</u>	THE RETREAT AT TIMBER RIDGE
<u>TEST BORING #</u>	7	<u>JOB NO.</u>	170020
<u>DEPTH (FT)</u>	20	<u>TEST BY</u>	BL

<u>U.S. Sieve #</u>	<u>Percent Finer</u>
3"	
1 1/2"	
3/4"	
1/2"	100.0%
3/8"	96.3%
4	88.9%
10	64.0%
20	43.5%
40	31.6%
100	20.3%
200	16.6%

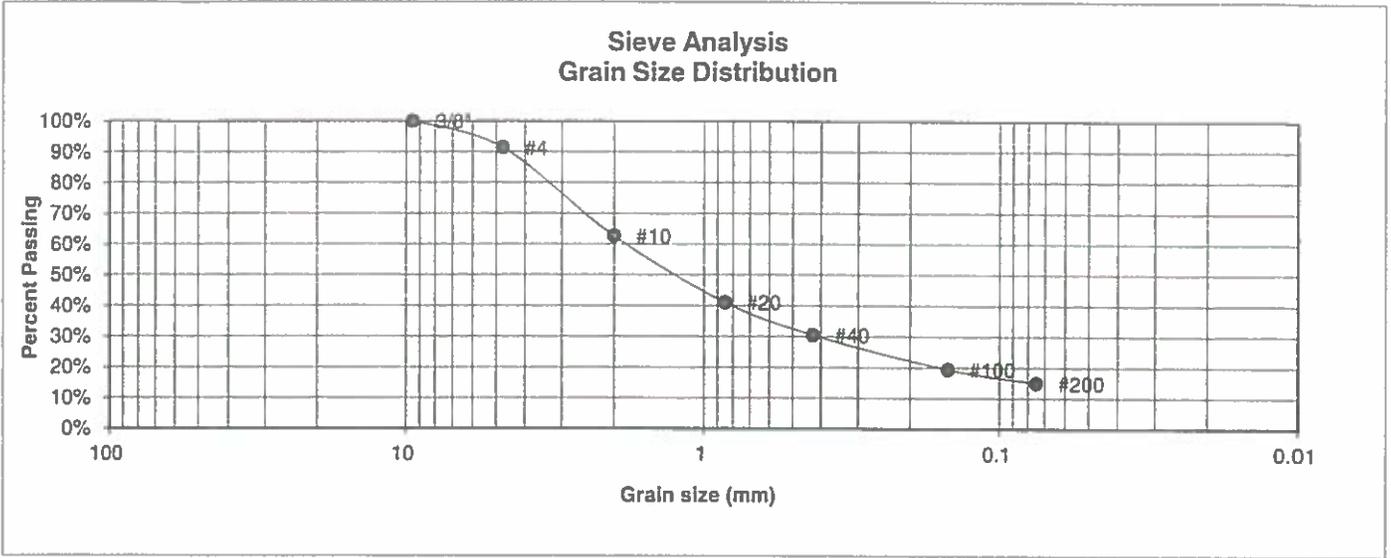
<u>UNIFIED CLASSIFICATION</u>	SM	<u>CLIENT</u>	ARROYA INVESTMENTS
<u>SOIL TYPE #</u>	3	<u>PROJECT</u>	THE RETREAT AT TIMBER RIDGE
<u>TEST BORING #</u>	8	<u>JOB NO.</u>	170020
<u>DEPTH (FT)</u>	5	<u>TEST BY</u>	BL

<u>U.S. Sieve #</u>	<u>Percent Finer</u>
3"	
1 1/2"	
3/4"	
1/2"	
3/8"	100.0%
4	91.3%
10	62.6%
20	41.1%
40	30.5%
100	19.4%
200	14.9%

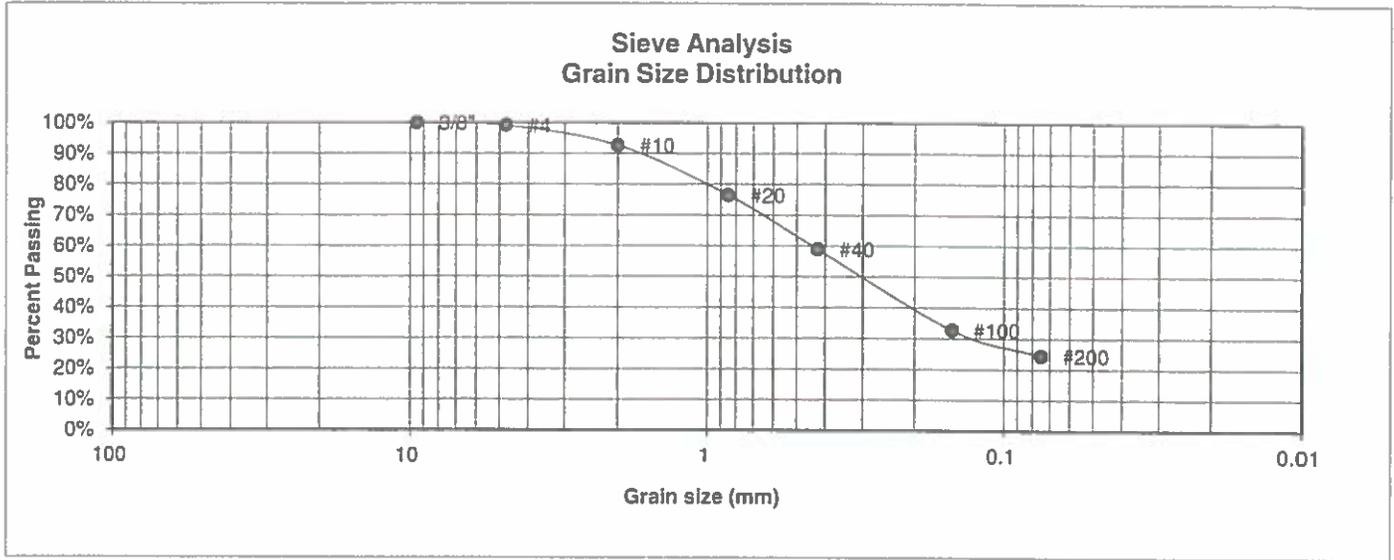
<u>UNIFIED CLASSIFICATION</u>	SC	<u>CLIENT</u>	ARROYA INVESTMENTS
<u>SOIL TYPE #</u>	3	<u>PROJECT</u>	THE RETREAT AT TIMBER RIDGE
<u>TEST BORING #</u>	12	<u>JOB NO.</u>	170020
<u>DEPTH (FT)</u>	10	<u>TEST BY</u>	BL

<u>U.S. Sieve #</u>	<u>Percent Finer</u>
3"	
1 1/2"	
3/4"	
1/2"	
3/8"	100.0%
4	99.1%
10	92.7%
20	76.5%
40	58.9%
100	32.7%
200	24.4%
