**WASTEWATER (OWTS) STUDY
THE RETREAT AT TIMBERRIDGE, FILING 2
VOLLMER ROAD AND ARROYA LANE
EL PASO COUNTY, COLORADO**

April 26, 2021
Revised October 29, 2021

Entech Job No. 211066
AAprojects/2021/211066 county ww(owts)

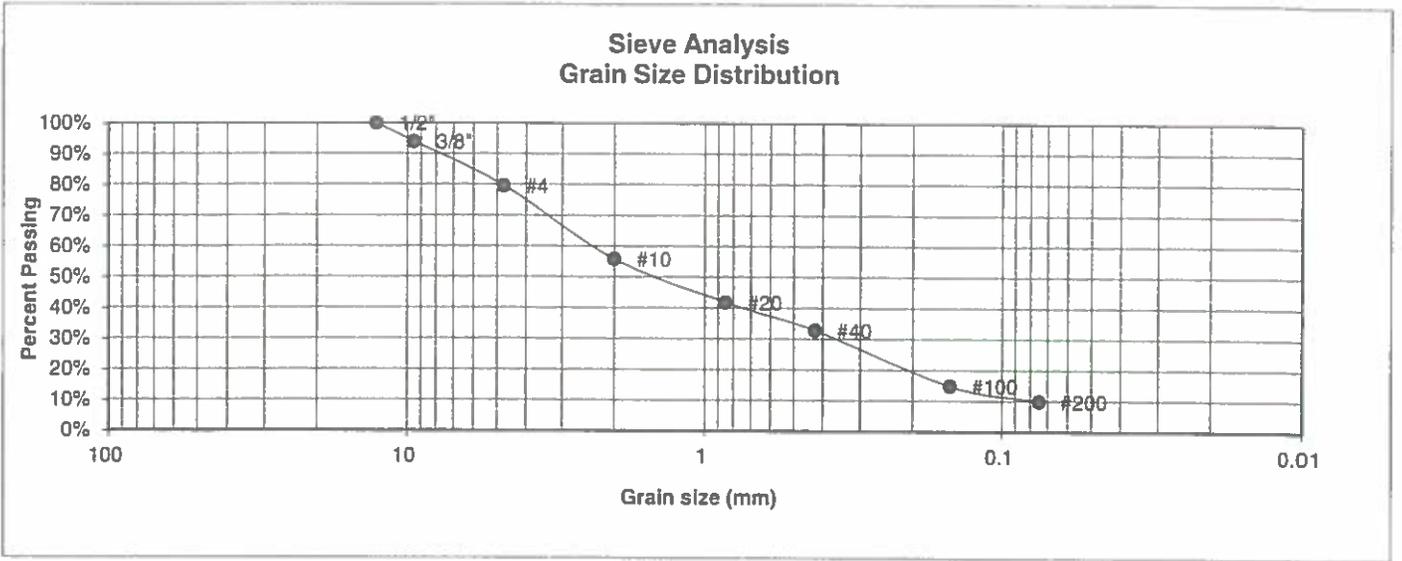
<u>UNIFIED CLASSIFICATION</u>	SM-SW	<u>CLIENT</u>	ARROYA INVESTMENTS
<u>SOIL TYPE #</u>	3	<u>PROJECT</u>	THE RETREAT AT TIMBER RIDGE
<u>TEST BORING #</u>	9	<u>JOB NO.</u>	170020
<u>DEPTH (FT)</u>	15	<u>TEST BY</u>	BL

U.S. Sieve #	Percent Finer
3"	
1 1/2"	
3/4"	
1/2"	100.0%
3/8"	93.9%
4	79.6%
10	55.8%
20	41.8%
40	32.8%
100	14.8%
200	9.9%

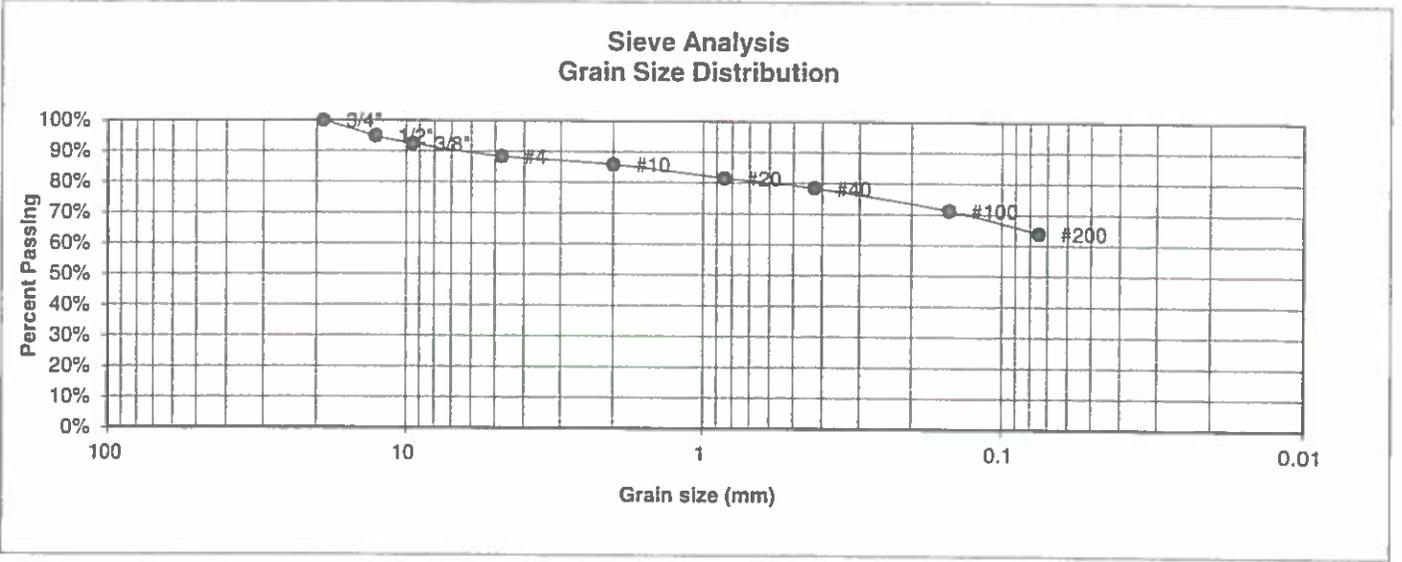
<u>UNIFIED CLASSIFICATION</u>	CL	<u>CLIENT</u>	ARROYA INVESTMENTS
<u>SOIL TYPE #</u>	4	<u>PROJECT</u>	THE RETREAT AT TIMBER RIDGE
<u>TEST BORING #</u>	4	<u>JOB NO.</u>	170020
<u>DEPTH (FT)</u>	15	<u>TEST BY</u>	BL

U.S. Sieve #	Percent Finer
3"	
1 1/2"	
3/4"	100.0%
1/2"	94.9%
3/8"	92.5%
4	88.4%
10	85.9%
20	81.5%
40	78.4%
100	71.3%
200	63.9%

Atterberg Limits	
Plastic Limit	24
Liquid Limit	44
Plastic Index	20

Soil Type 4 sandy to very sandy claystone (CL), encountered in Test Boring Nos. 4 and 5 at depths ranging from 7 to 9 feet bgs and extending to depths ranging from 16 to 19 feet bgs. The claystone was encountered at hard consistencies and at moist conditions. Samples tested had

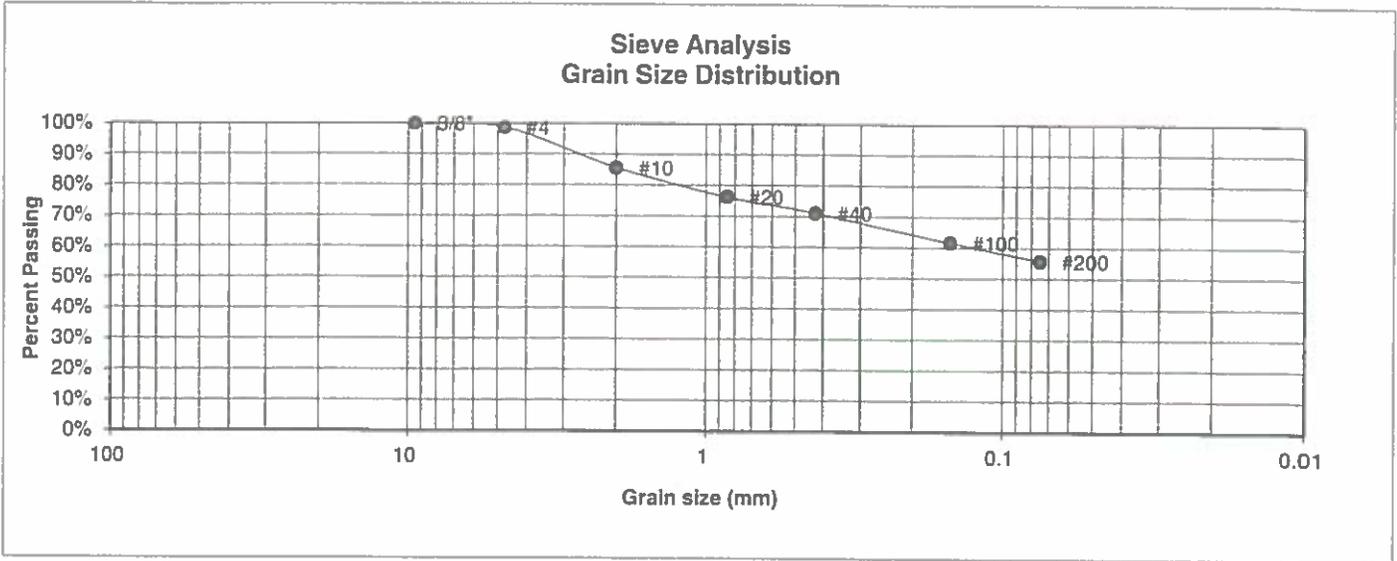
<u>UNIFIED CLASSIFICATION</u>	CL	<u>CLIENT</u>	ARROYA INVESTMENTS
<u>SOIL TYPE #</u>	4	<u>PROJECT</u>	THE RETREAT AT TIMBER RIDGE
<u>TEST BORING #</u>	5	<u>JOB NO.</u>	170020
<u>DEPTH (FT)</u>	10	<u>TEST BY</u>	BL

<u>U.S. Sieve #</u>	<u>Percent Finer</u>
3"	
1 1/2"	
3/4"	
1/2"	
3/8"	100.0%
4	98.6%
10	85.6%
20	76.2%
40	71.0%
100	61.6%
200	55.7%

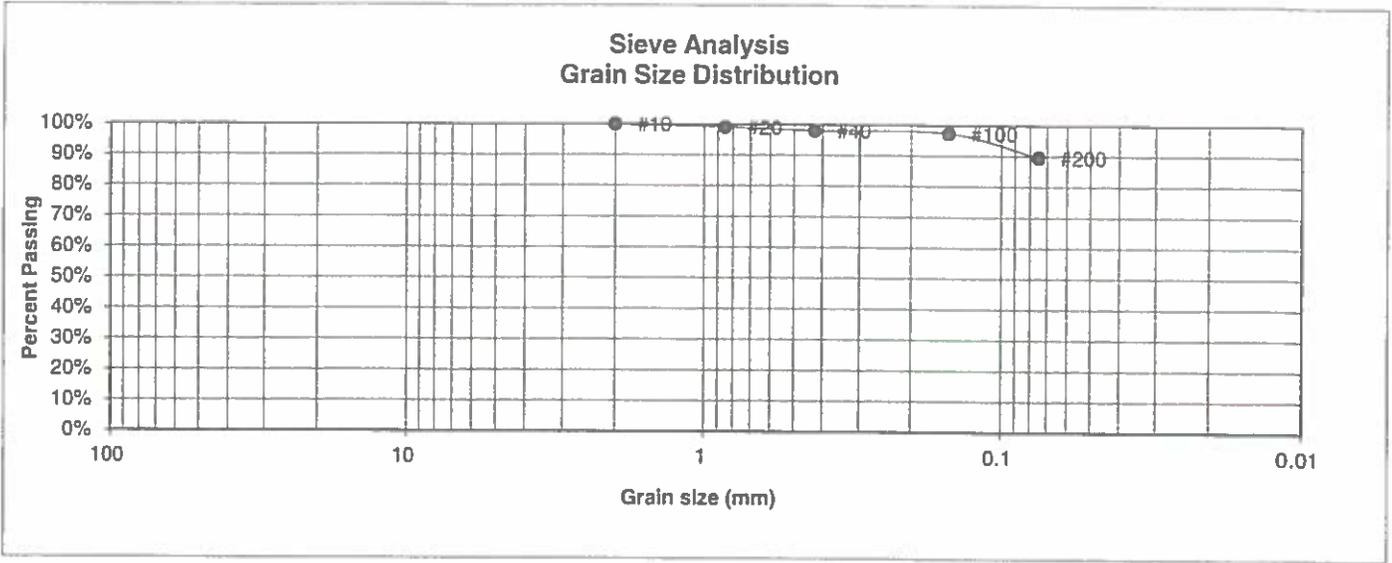
<u>UNIFIED CLASSIFICATION</u>	CL	<u>CLIENT</u>	ARROYA INVESTMENTS
<u>SOIL TYPE #</u>	4	<u>PROJECT</u>	THE RETREAT AT TIMBER RIDGE
<u>TEST BORING #</u>	7	<u>JOB NO.</u>	170020
<u>DEPTH (FT)</u>	15	<u>TEST BY</u>	BL

U.S. Sieve #	Percent Finer
3"	
1 1/2"	
3/4"	
1/2"	
3/8"	
4	
10	100.0%
20	99.1%
40	98.1%
100	97.3%
200	89.5%

<u>Atterberg Limits</u>	
Plastic Limit	26
Liquid Limit	47
Plastic Index	21

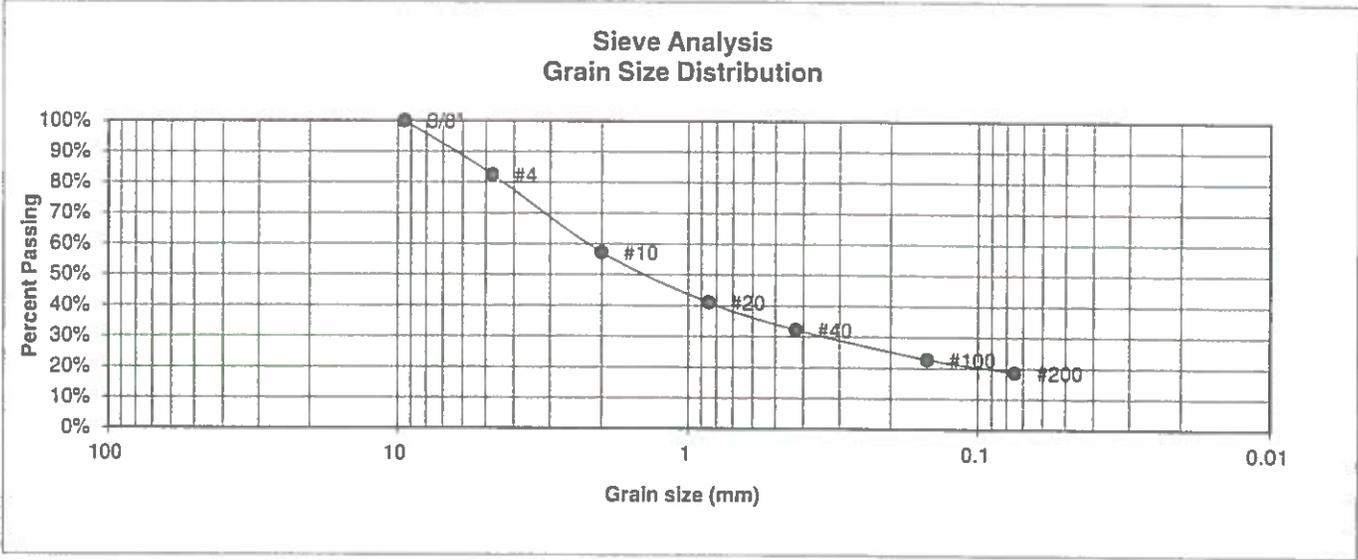
BORING NO.	TP-2	<u>UNIFIED CLASSIFICATION</u>	SM	<u>TEST BY</u>	BL
DEPTH(ft)	3	<u>AASHTO CLASSIFICATION</u>		<u>JOB NO.</u>	170020
CLIENT	ARROYA INVESTMENTS				
PROJECT	THE RETREAT AT TIMBER RIDGE

U.S. Sieve #	Percent Finer
3"	
1 1/2"	
3/4"	
1/2"	
3/8"	100.0%
4	82.5%
10	57.3%
20	41.0%
40	32.3%
100	22.9%
200	18.7%

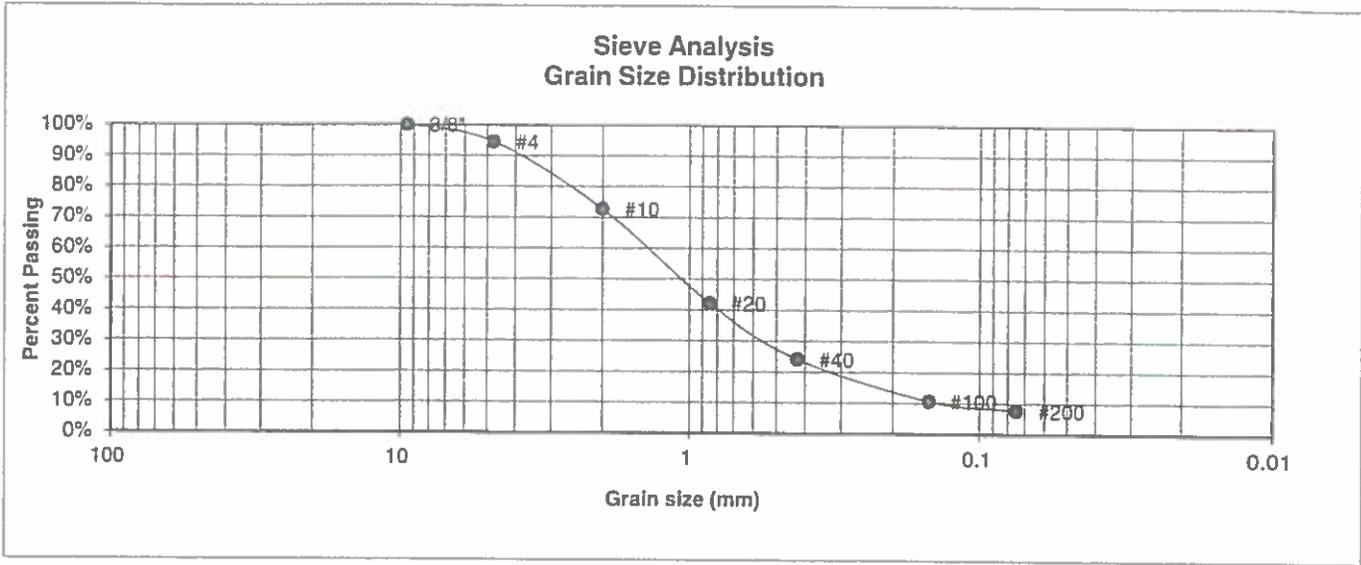
BORING NO.	TP-4	UNIFIED CLASSIFICATION	SM-SW	TEST BY	BL
DEPTH(ft)	4	AASHTO CLASSIFICATION		JOB NO.	170020
CLIENT	ARROYA INVESTMENTS				
PROJECT	THE RETREAT AT TIMBER RIDGE

U.S. Sieve #	Percent Finer
3"	
1 1/2"	
3/4"	
1/2"	
3/8"	100.0%
4	94.6%
10	72.7%
20	42.2%
40	24.1%
100	10.6%
200	7.7%

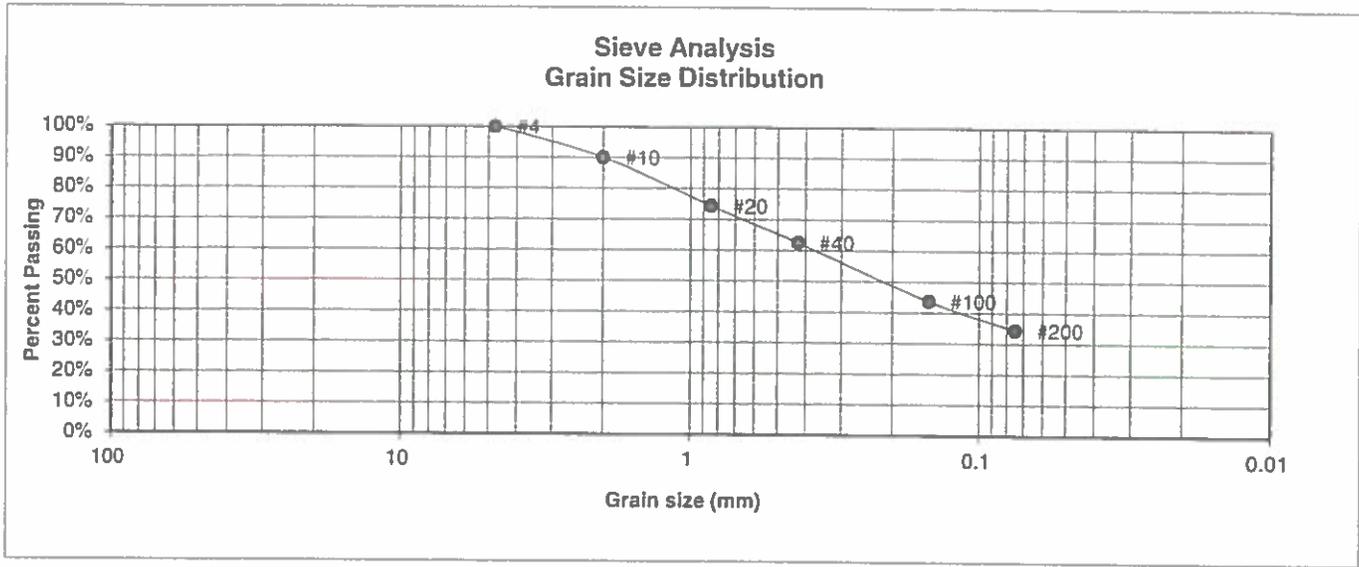
BORING NO.	TP-5	UNIFIED CLASSIFICATION	SC	TEST BY	BL
DEPTH(ft)	7-8	AASHTO CLASSIFICATION		JOB NO.	170020
CLIENT	ARROYA INVESTMENTS				
PROJECT	THE RETREAT AT TIMBER RIDGE

U.S. Sieve #	Percent Finer
3"	
1 1/2"	
3/4"	
1/2"	
3/8"	
4	100.0%
10	90.1%
20	74.4%
40	62.5%
100	43.8%
200	34.4%

Soils encountered in the tactile test pits consisted of loamy sand to gravelly loamy sand, sandy loam to gravelly sandy loam, sandy clay and silty clay with underlying clayey to silty sandstone. The limiting layers encountered in the test pits are the sandy loam, silty clay and silty to clayey sandstone, which corresponds to an LTAR values of 0.10 to 0.50 gallons per day per square foot. The bedrock was encountered at 5 to 7.5 feet in four of the test pits. The conditions encountered in the majority of the test pits will require a designed system. Signs of seasonal shallow groundwater were observed at depths 7 feet in Test Pit Nos. 3 and 5.

Absorption fields must be maintained a minimum of 4 feet above groundwater or bedrock. signs of seasonally occurring groundwater were observed in Test Pit Nos. 3 and 5 at depths of 7 feet.

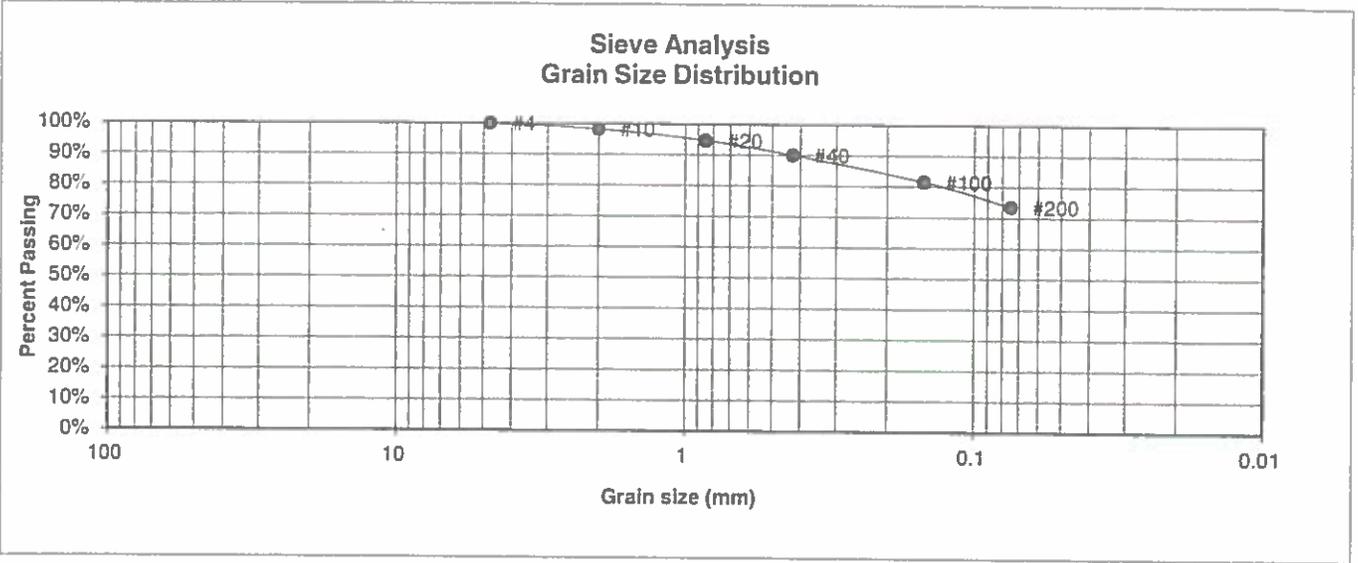
BORING NO.	TP-6	UNIFIED CLASSIFICATION	CL	TEST BY	BL
DEPTH(ft)	2	AASHTO CLASSIFICATION		JOB NO.	170020
CLIENT	ARROYA INVESTMENTS				
PROJECT	THE RETREAT AT TIMBER RIDGE

<u>U.S. Sieve #</u>	<u>Percent Finer</u>	<u>Atterberg Limits</u>
3"		Plastic Limit
1 1/2"		Liquid Limit
3/4"		Plastic Index
1/2"		
3/8"		
4	100.0%	<u>Swell</u>
10	98.3%	Moisture at start
20	94.7%	Moisture at finish
40	90.0%	Moisture increase
100	81.6%	Initial dry density (pcf)
200	73.6%	Swell (psf)
