Proposed Carvana/Adesa Expansion Lot – Fountain, CO

Land Analysis Report

Subject: Accessory Vehicle Storage Lot Development for Carvana

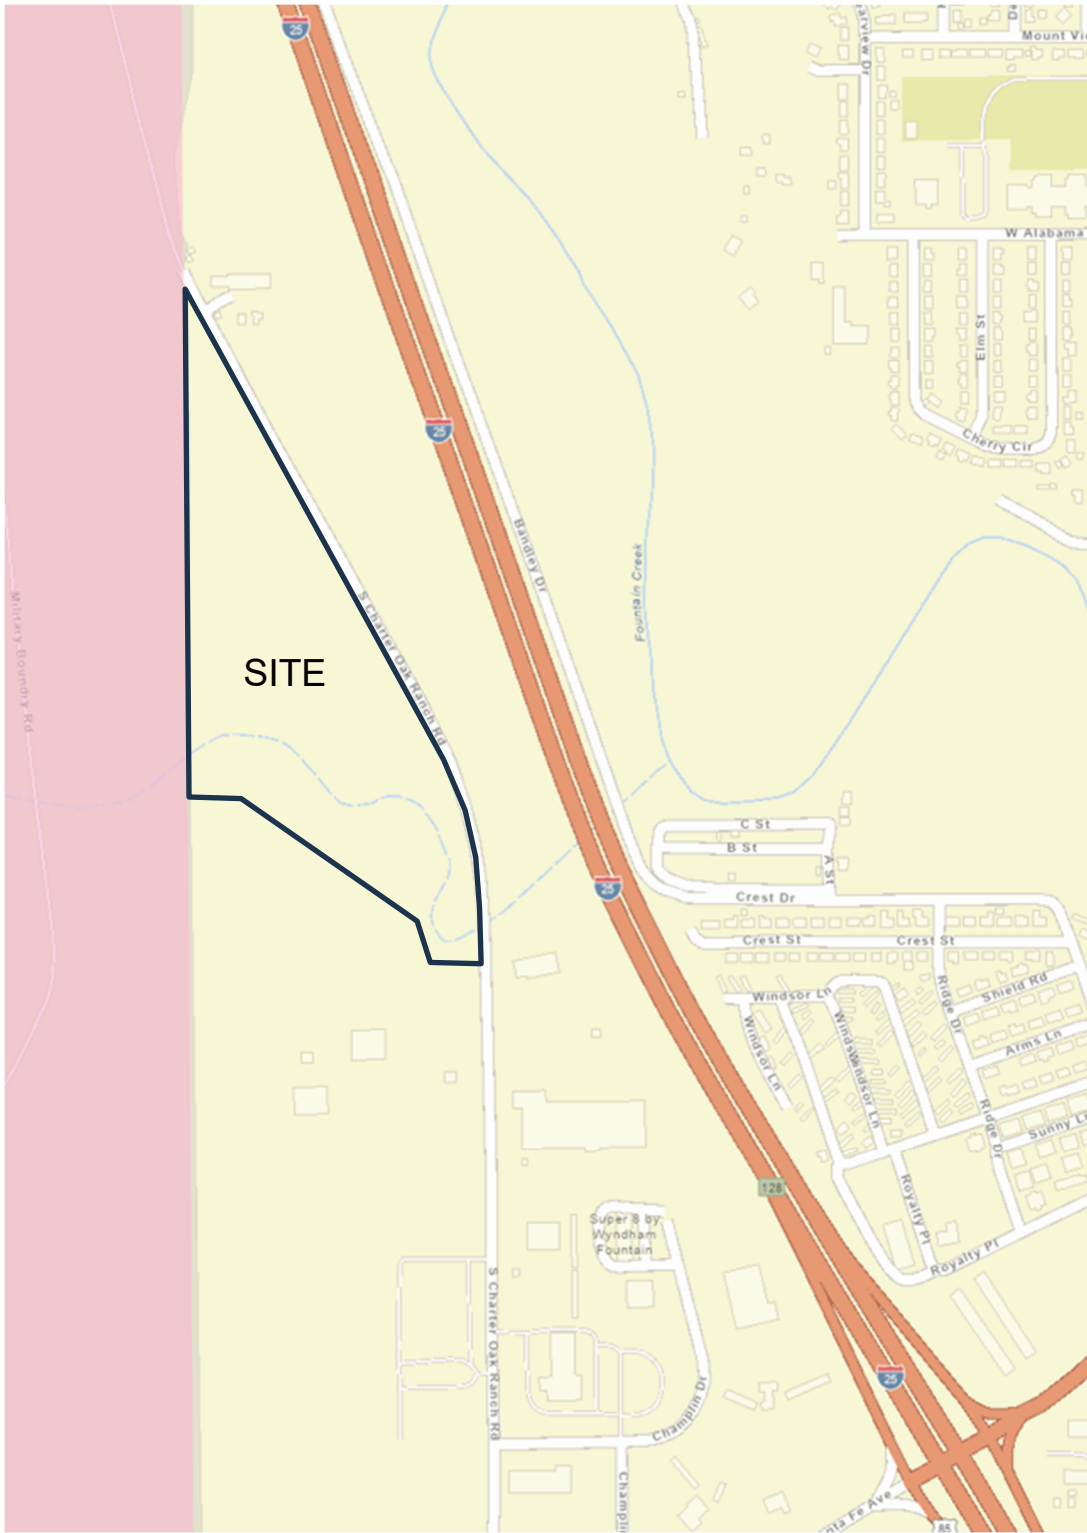
SITE CONTEXT MAP

The site is comprised of approximately 28.99 acres. A majority of this will be developed into a paved parking/car storage area. This site will also construct a box culvert across the wash and a driveway that heads south (across the wash and said box culvert) and connects to the existing Adesa site. The site is an irregularly shaped parcel located west of Charter Oak Ranch Road. The majority of the site drains from north to south, towards the wash with slopes that vary from 4% to 22%. Currently, the site is vacant grasslands, with no structures and not much vegetation on it.

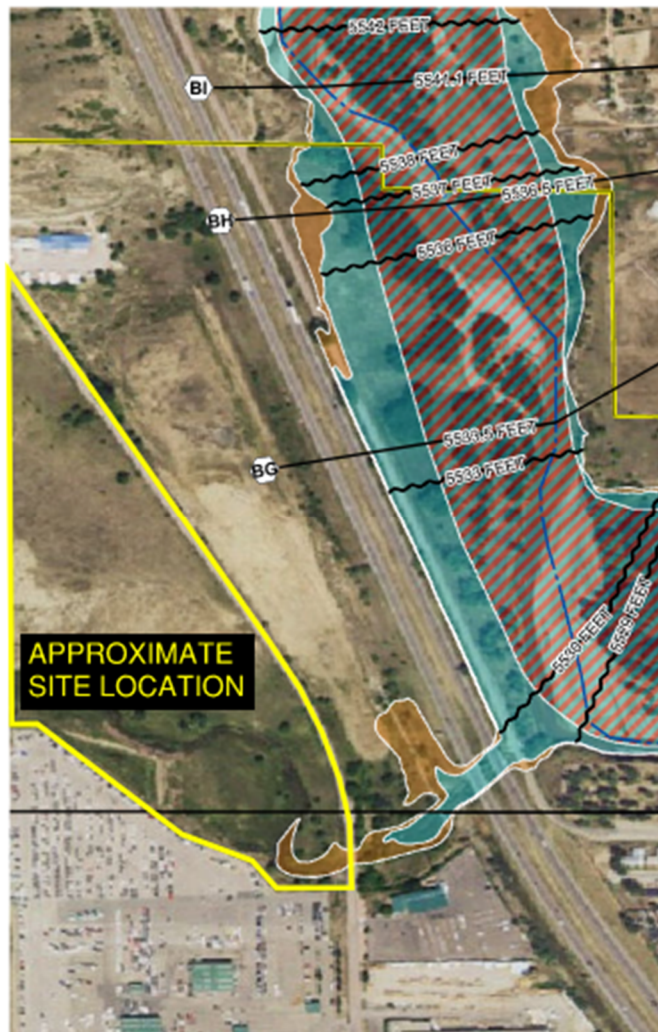
FLOODPLAIN

There are no floodplains located onsite. This was confirmed via correspondence with the PPRBD floodplain administrator.

The site is located on FEMA FIRM map 08041C0962G with an effective date of December 07, 2018.

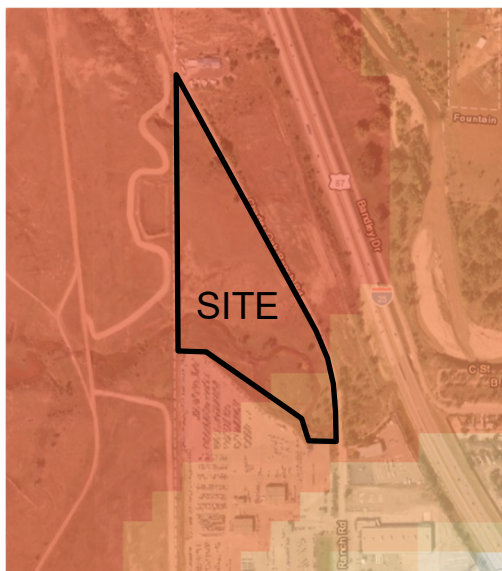
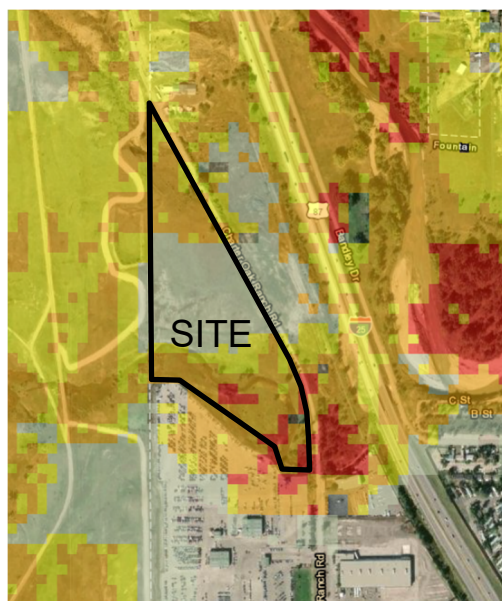
FIRE RISK

Burn Probability Risk is the annual probability of any particular location burning due to a wildfire. The Colorado Wildfire Risk Map shows a majority of the property as having a high annual burn probability. Fire Intensity measures the potential strength of a fire in a particular area, this means a wildfire's ability to spread, and the difficulty and level of equipment required to suppress it. The lowest fire intensity has very small, slow-moving flames, that are easy to suppress with basic equipment. On the other hand, high fire intensity can have massive flames capable of medium range spotting, that are very difficult to suppress even with training and specialized equipment. The Colorado Wildfire Risk Map shows the fire intensity on the site spreading across the full range but a majority of the site being either the lowest intensity or moderate intensity.

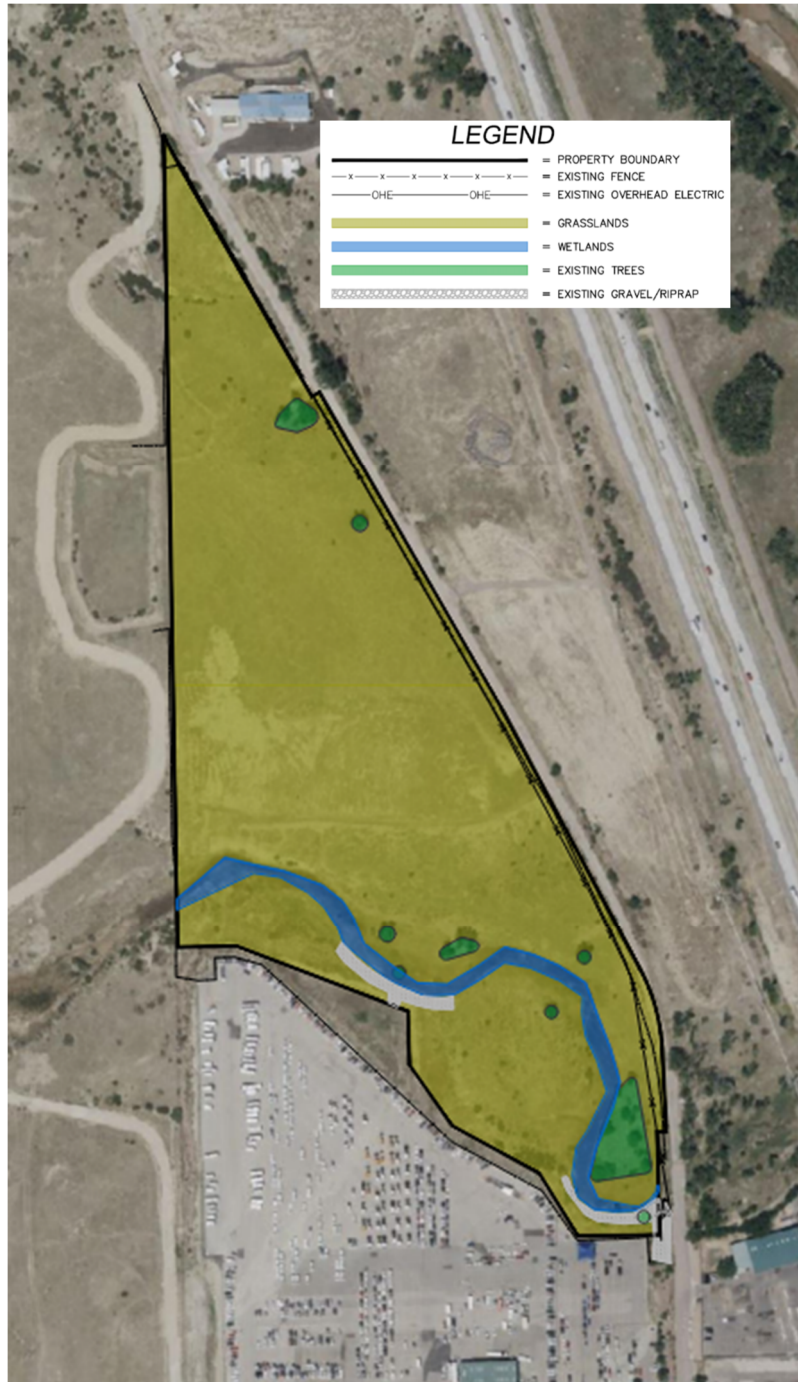
MANMADE AND NATURAL FEATURES

The property is occupied by vacant grassland with only a few trees, and there is also a small watercourse that traverses the south portion of the site. Additionally, there is a fence surrounding the site on all sides and an overhead electric line along the east property boundary. Charter Oak Ranch Road, a paved street, also lies along the east side of the property.
