Re: Response to Review Comments
Monument Ridge East
Monument Hill Road and Palmer Divide Road
El Paso, Colorado
Entech Job No. 230248

LEVEL 2 WETLAND DELINEATION REPORT

Monument Ridge East Development

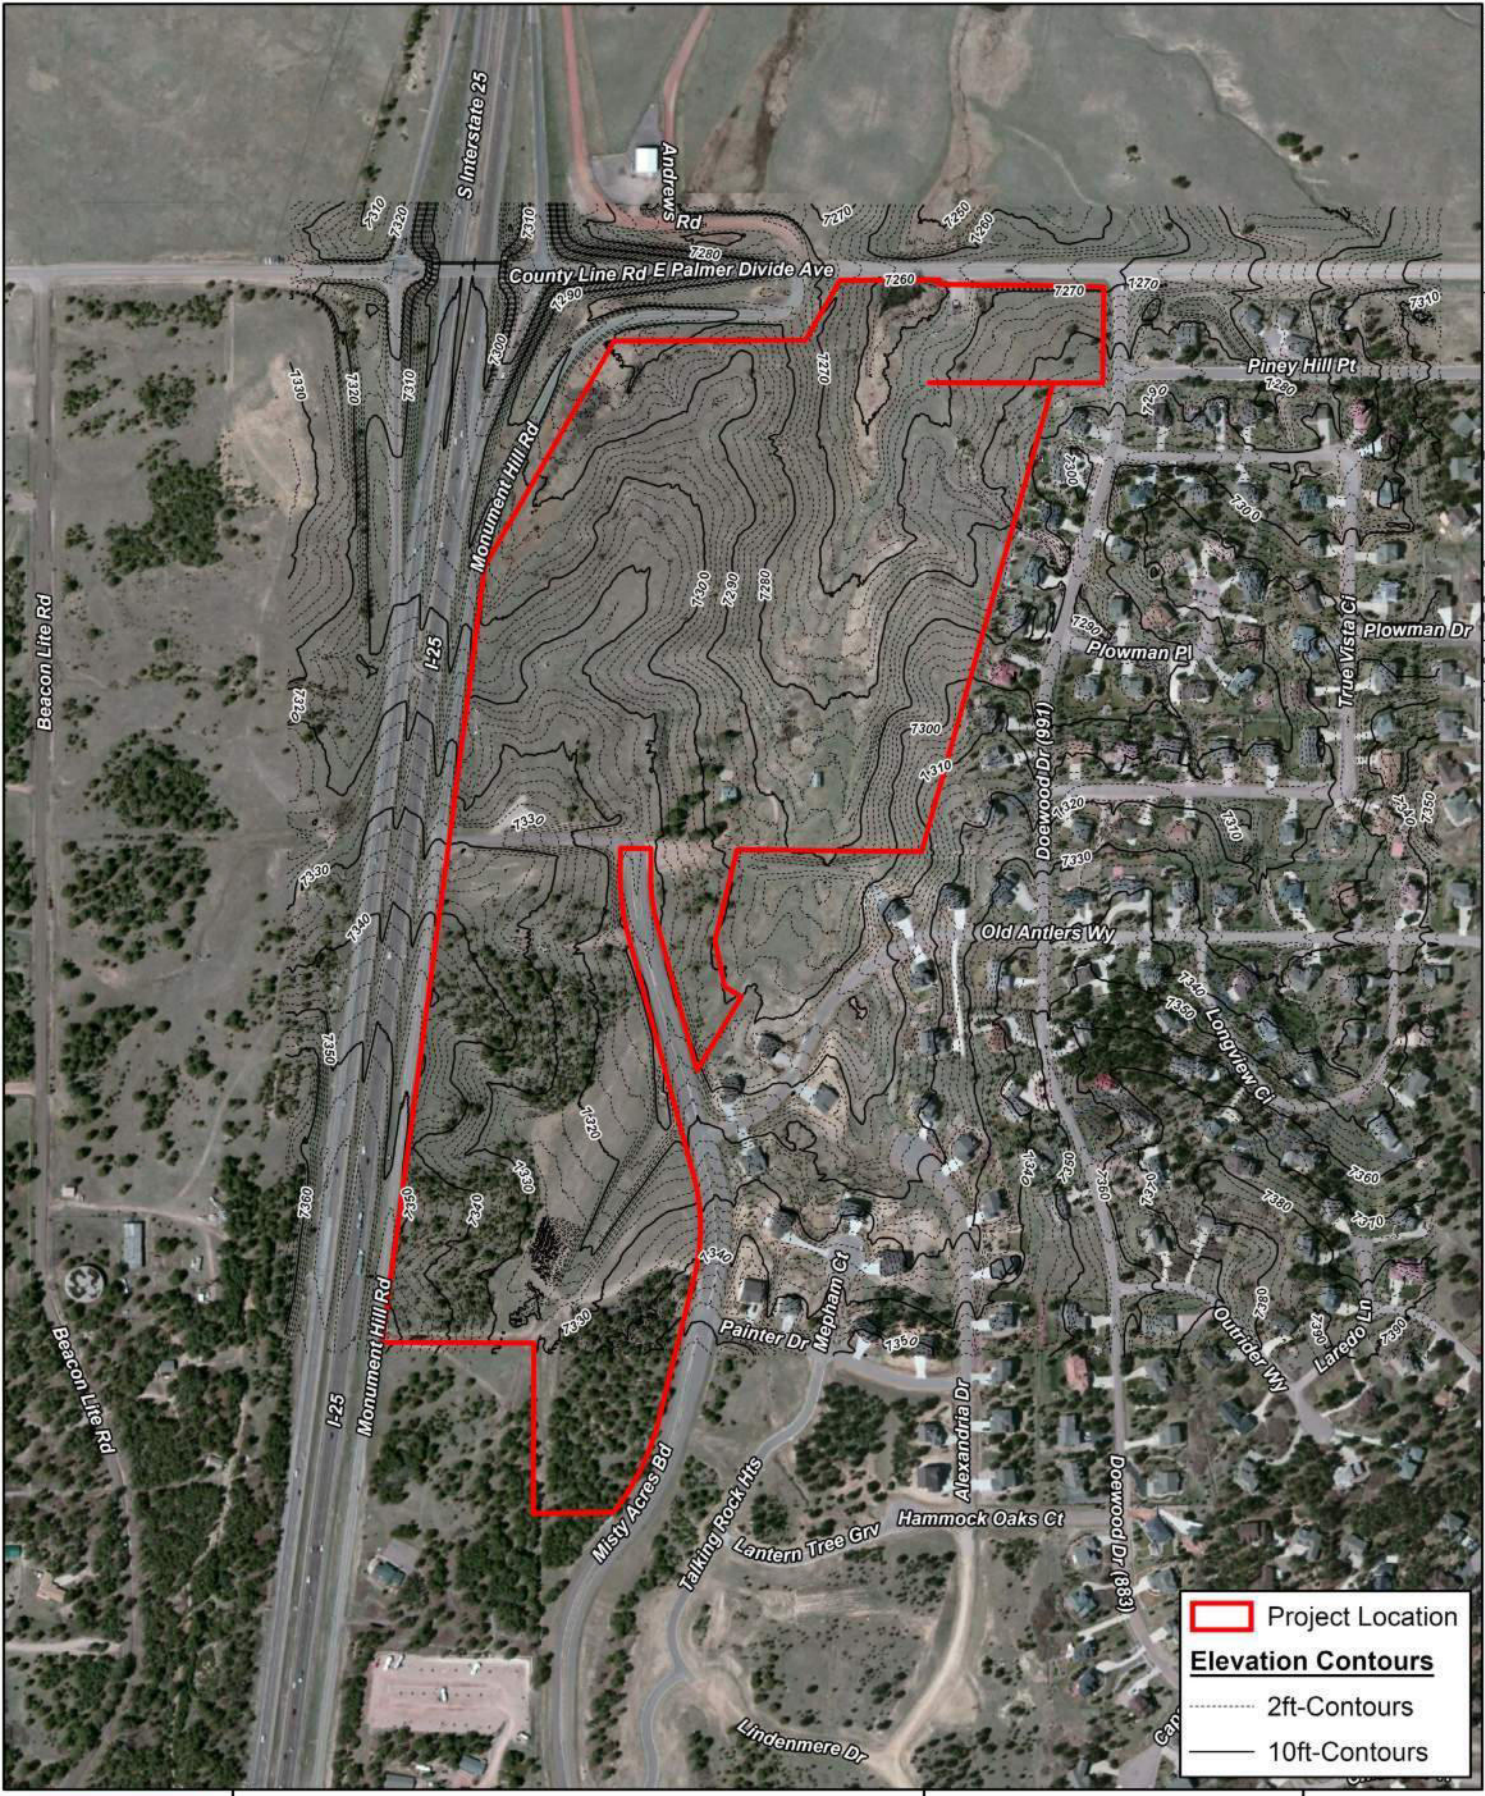
Figure 2 - Topography

Topography: The landform consists of sloping hills and two wetlands. The wetlands were located at two mapped low drainageways. Water generally flows north (**Figure 2, Appendix A**).

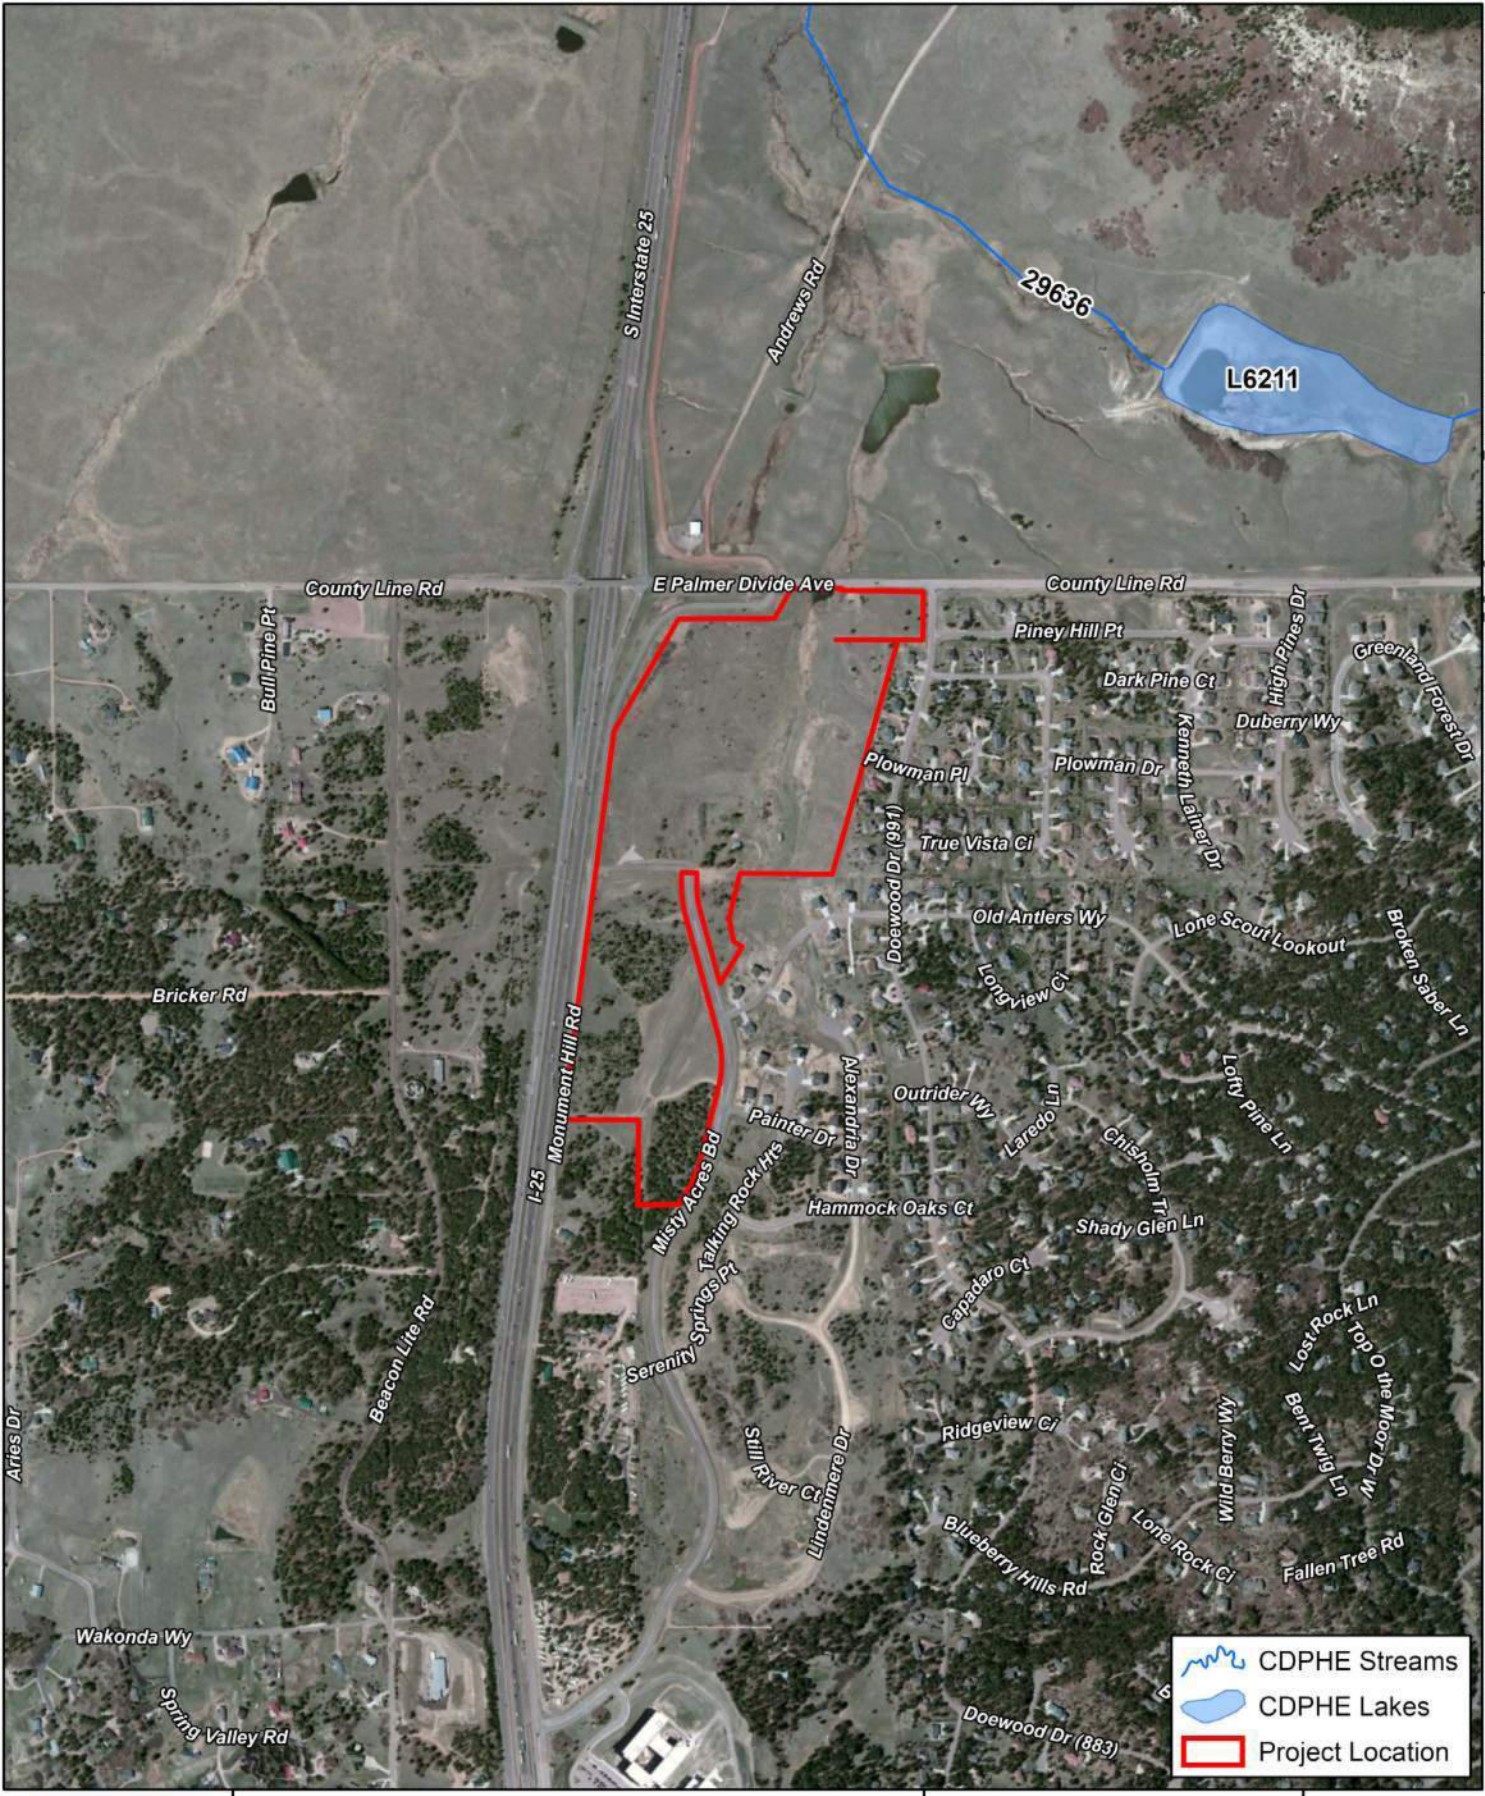
Figure 3 - CDPHE Public Waters

The Colorado Department of Public Health and Environment – Water Quality Control Division 2020 *Spatial Representation of Stream Segment* data (CDPHE 2020) shows no stream segments in the project area (**Figure 3, Appendix A**).

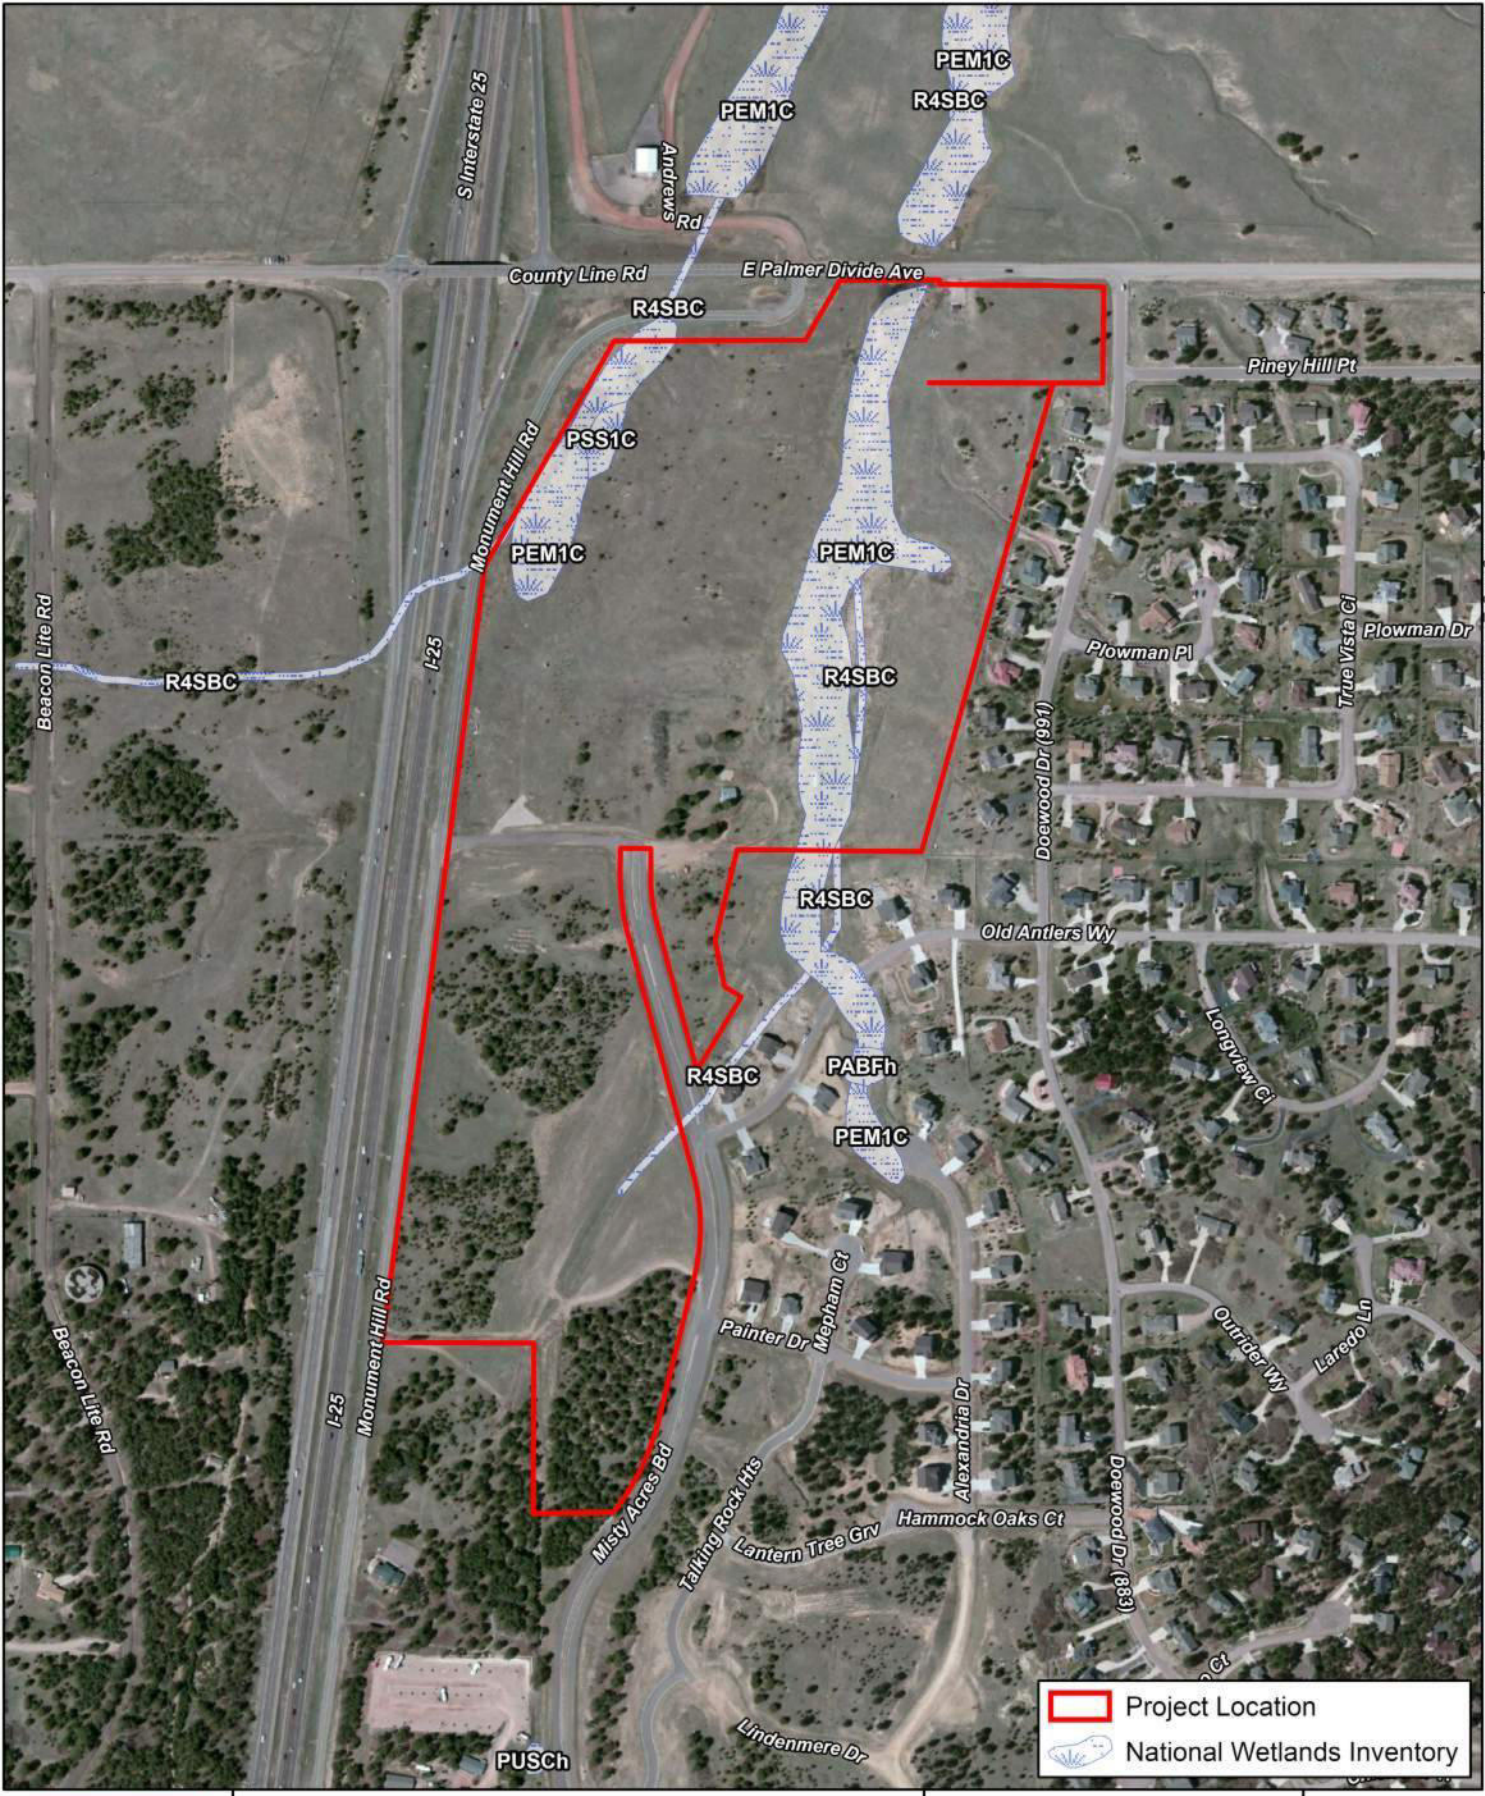
Figure 4 - National Wetlands Inventory

The *National Wetlands Inventory Map* (US Fish and Wildlife Service) identified three wetland types as part of the National Wetlands Inventory (NWI) (**Figure 4, Appendix A**). The NWI identifies the following wetland types: PEM1C, PSS1C, and R4SBC.

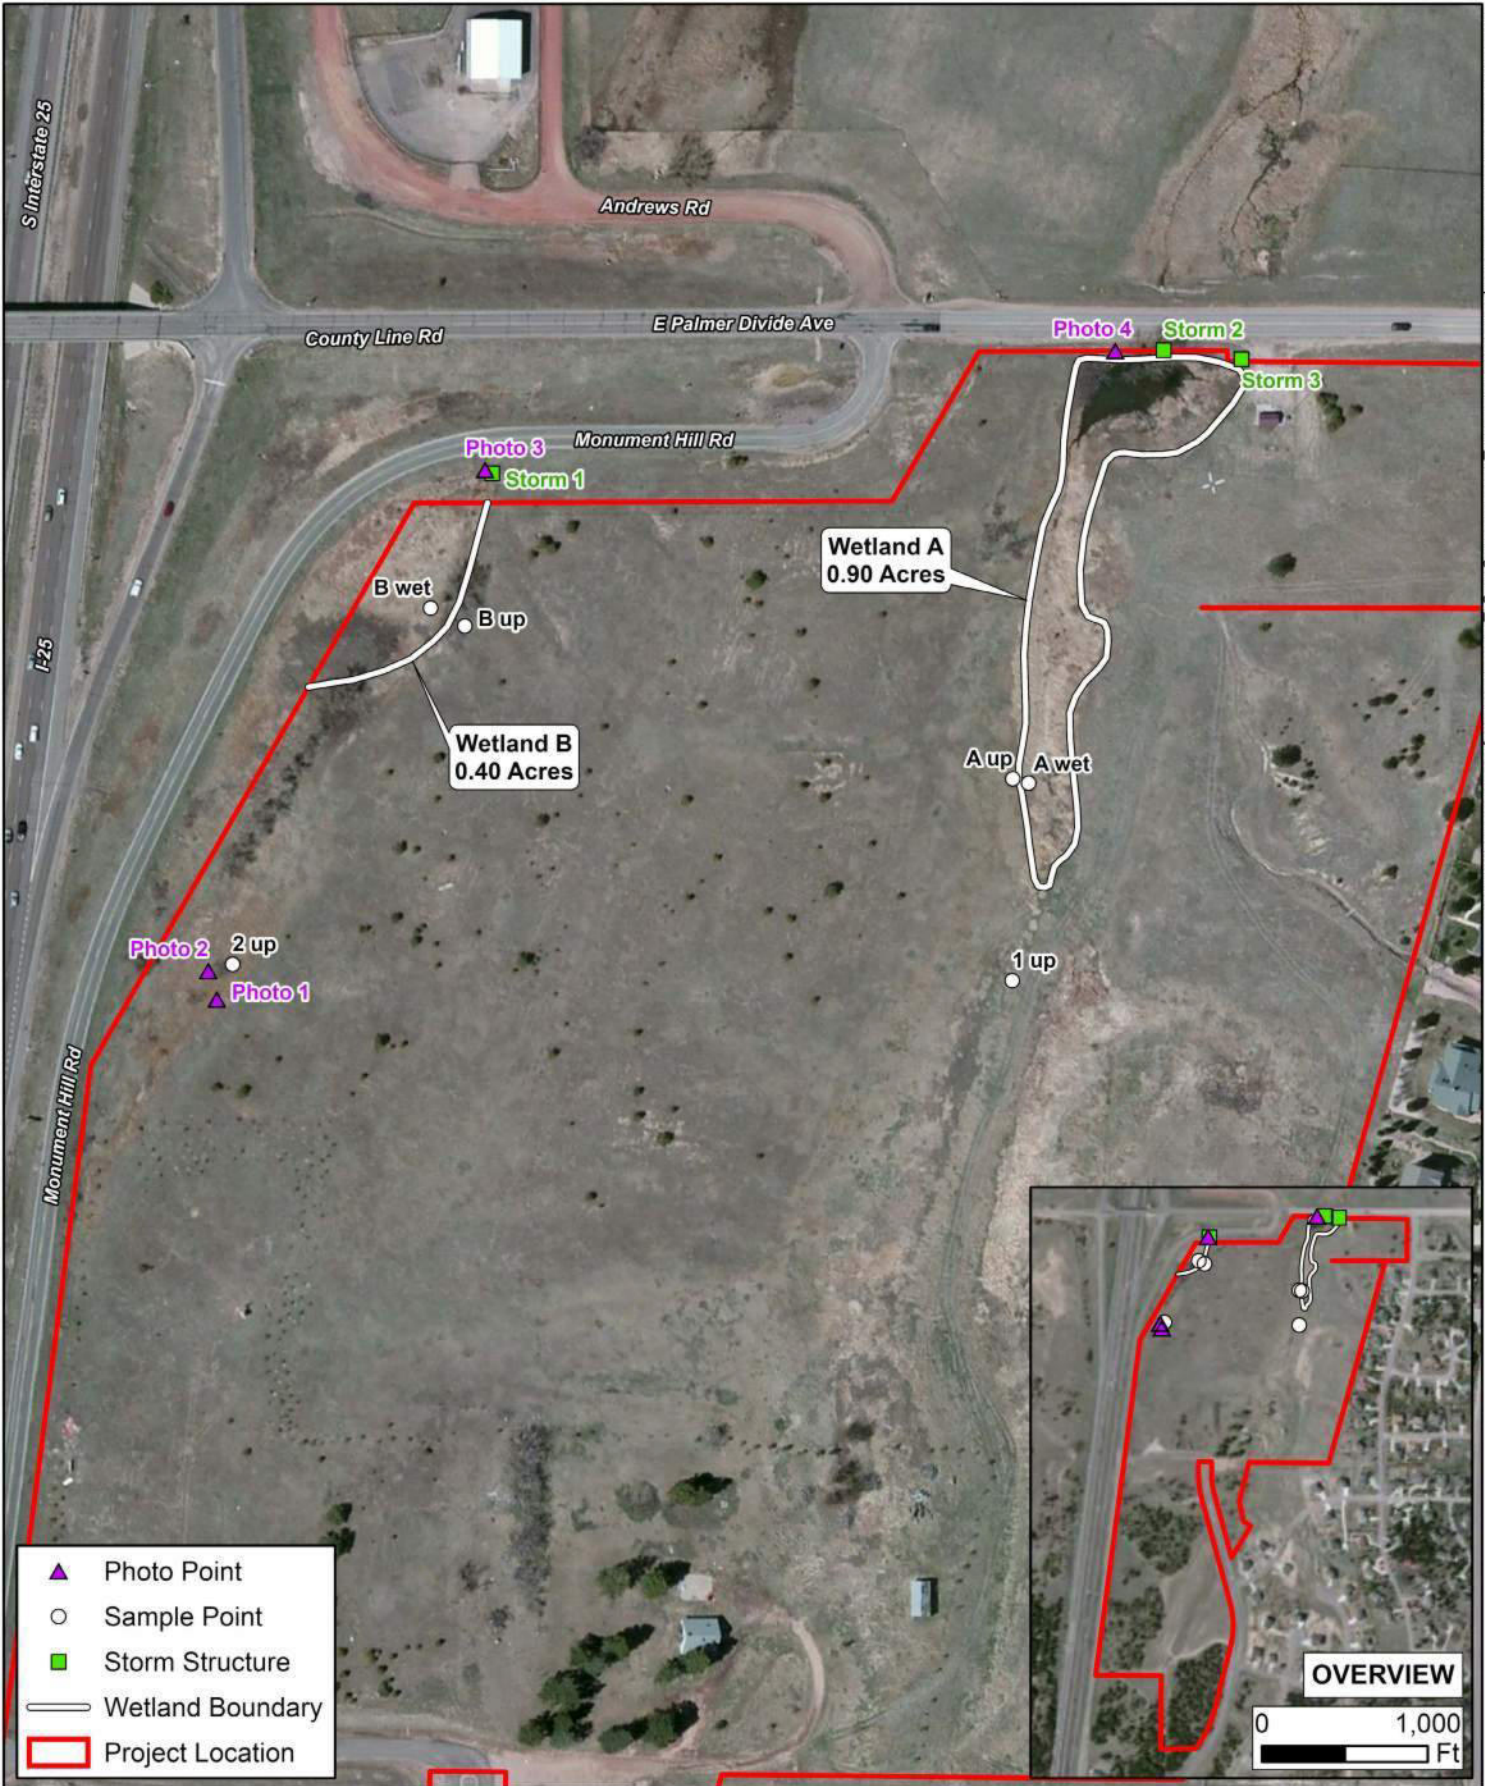
Figure 6 - Wetland Boundary

Western Mountains, Valleys, and Coast Regional Supplement Routine Wetland Delineation data forms were used to record vegetation, hydrology, and soil characteristics at sample points in and adjacent to the wetlands (**Appendix B**). Sampling transects were taken along the wetland-upland boundary of the wetland. Transects and delineated wetland boundaries were field surveyed using a sub-meter accuracy hand-held GPS unit. Approximate sampling points and delineated wetland edges are shown on **Figure 6, Appendix B**. Pictures of each wetland can be found in **Appendix C**.

The wetland boundary was placed along a slight topographic break where wetland hydrology was no longer observed. Wetland A flows from south to north, and conveys water under Palmer Divide Road via a culvert.

The wetland boundary was placed along a defined topographic break where wetland hydrology was no longer observed. Wetland B flows from southwest to northeast, and conveys water under Palmer Divide Road via a culvert.
