## **SOILS AND GEOLOGY STUDY**

**The Ridge at Lorson Ranch  
El Paso County, Colorado**

**JOB NO. 175706**

**March 22, 2021**

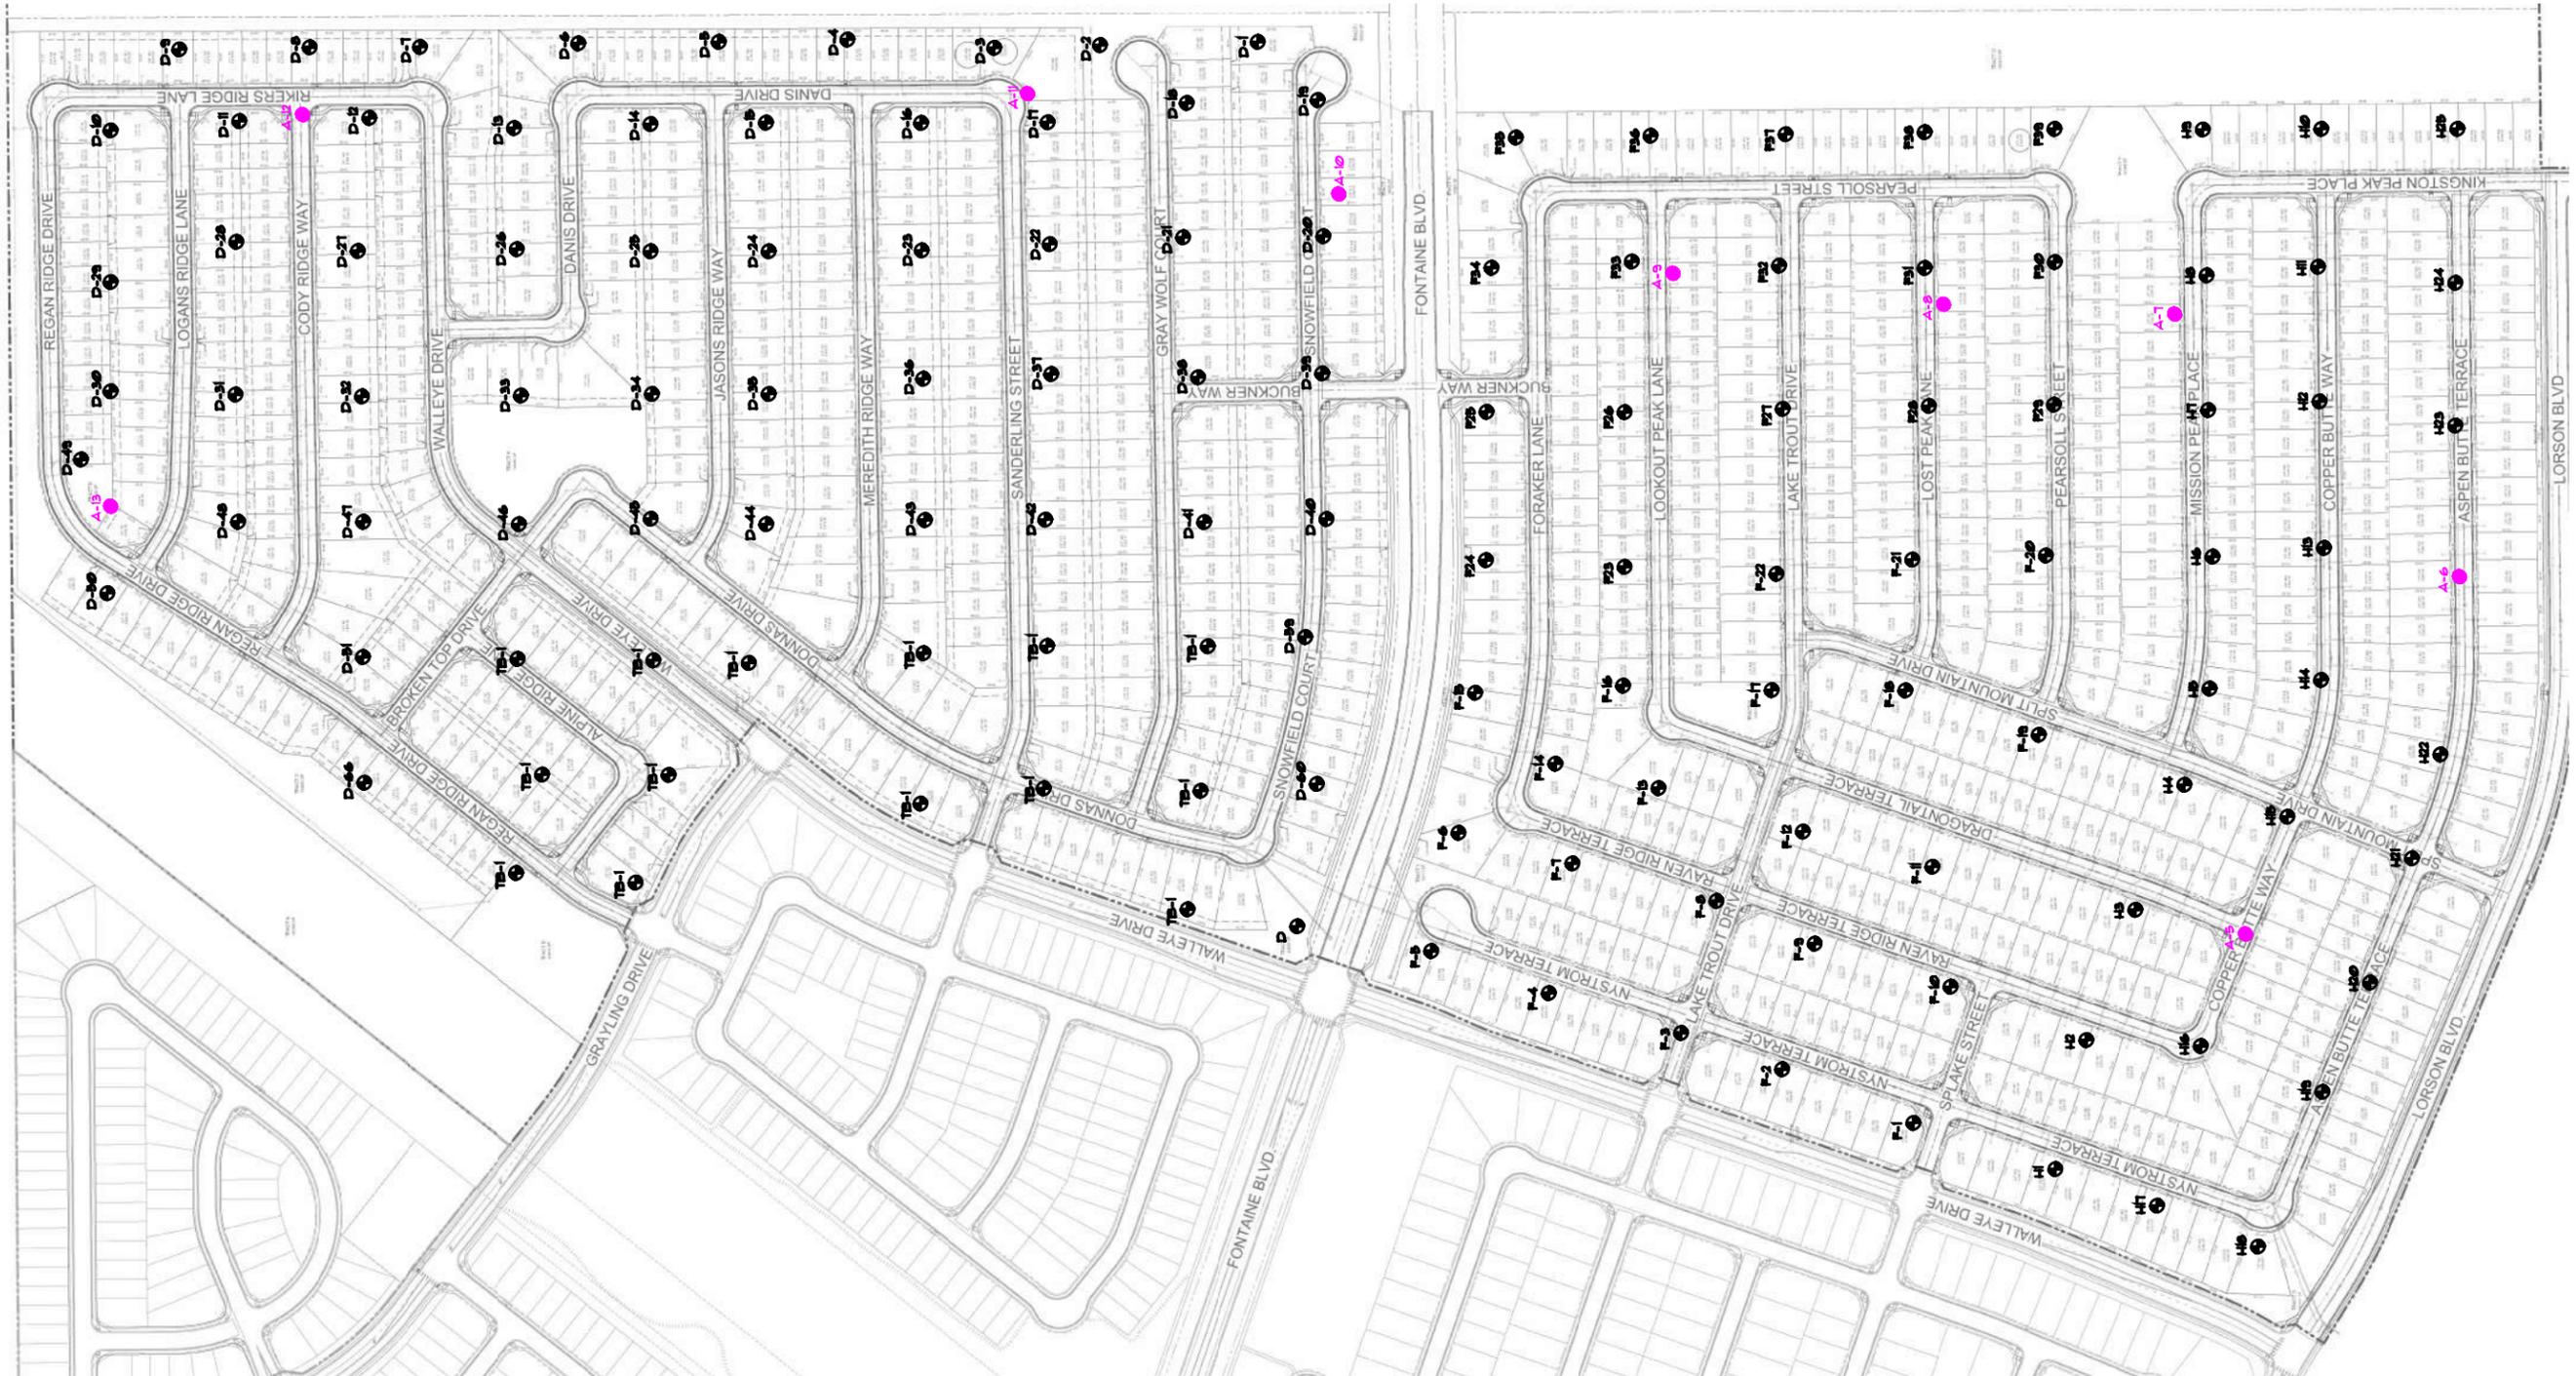
⊕ DENOTES APPROXIMATE LOCATION OF TEST BORINGS PERFORMED FOR THIS INVESTIGATION

● DENOTES APPROXIMATE LOCATION OF PRELIMINARY TEST BORINGS TO DETERMINE THE DEPTH OF BEDROCK

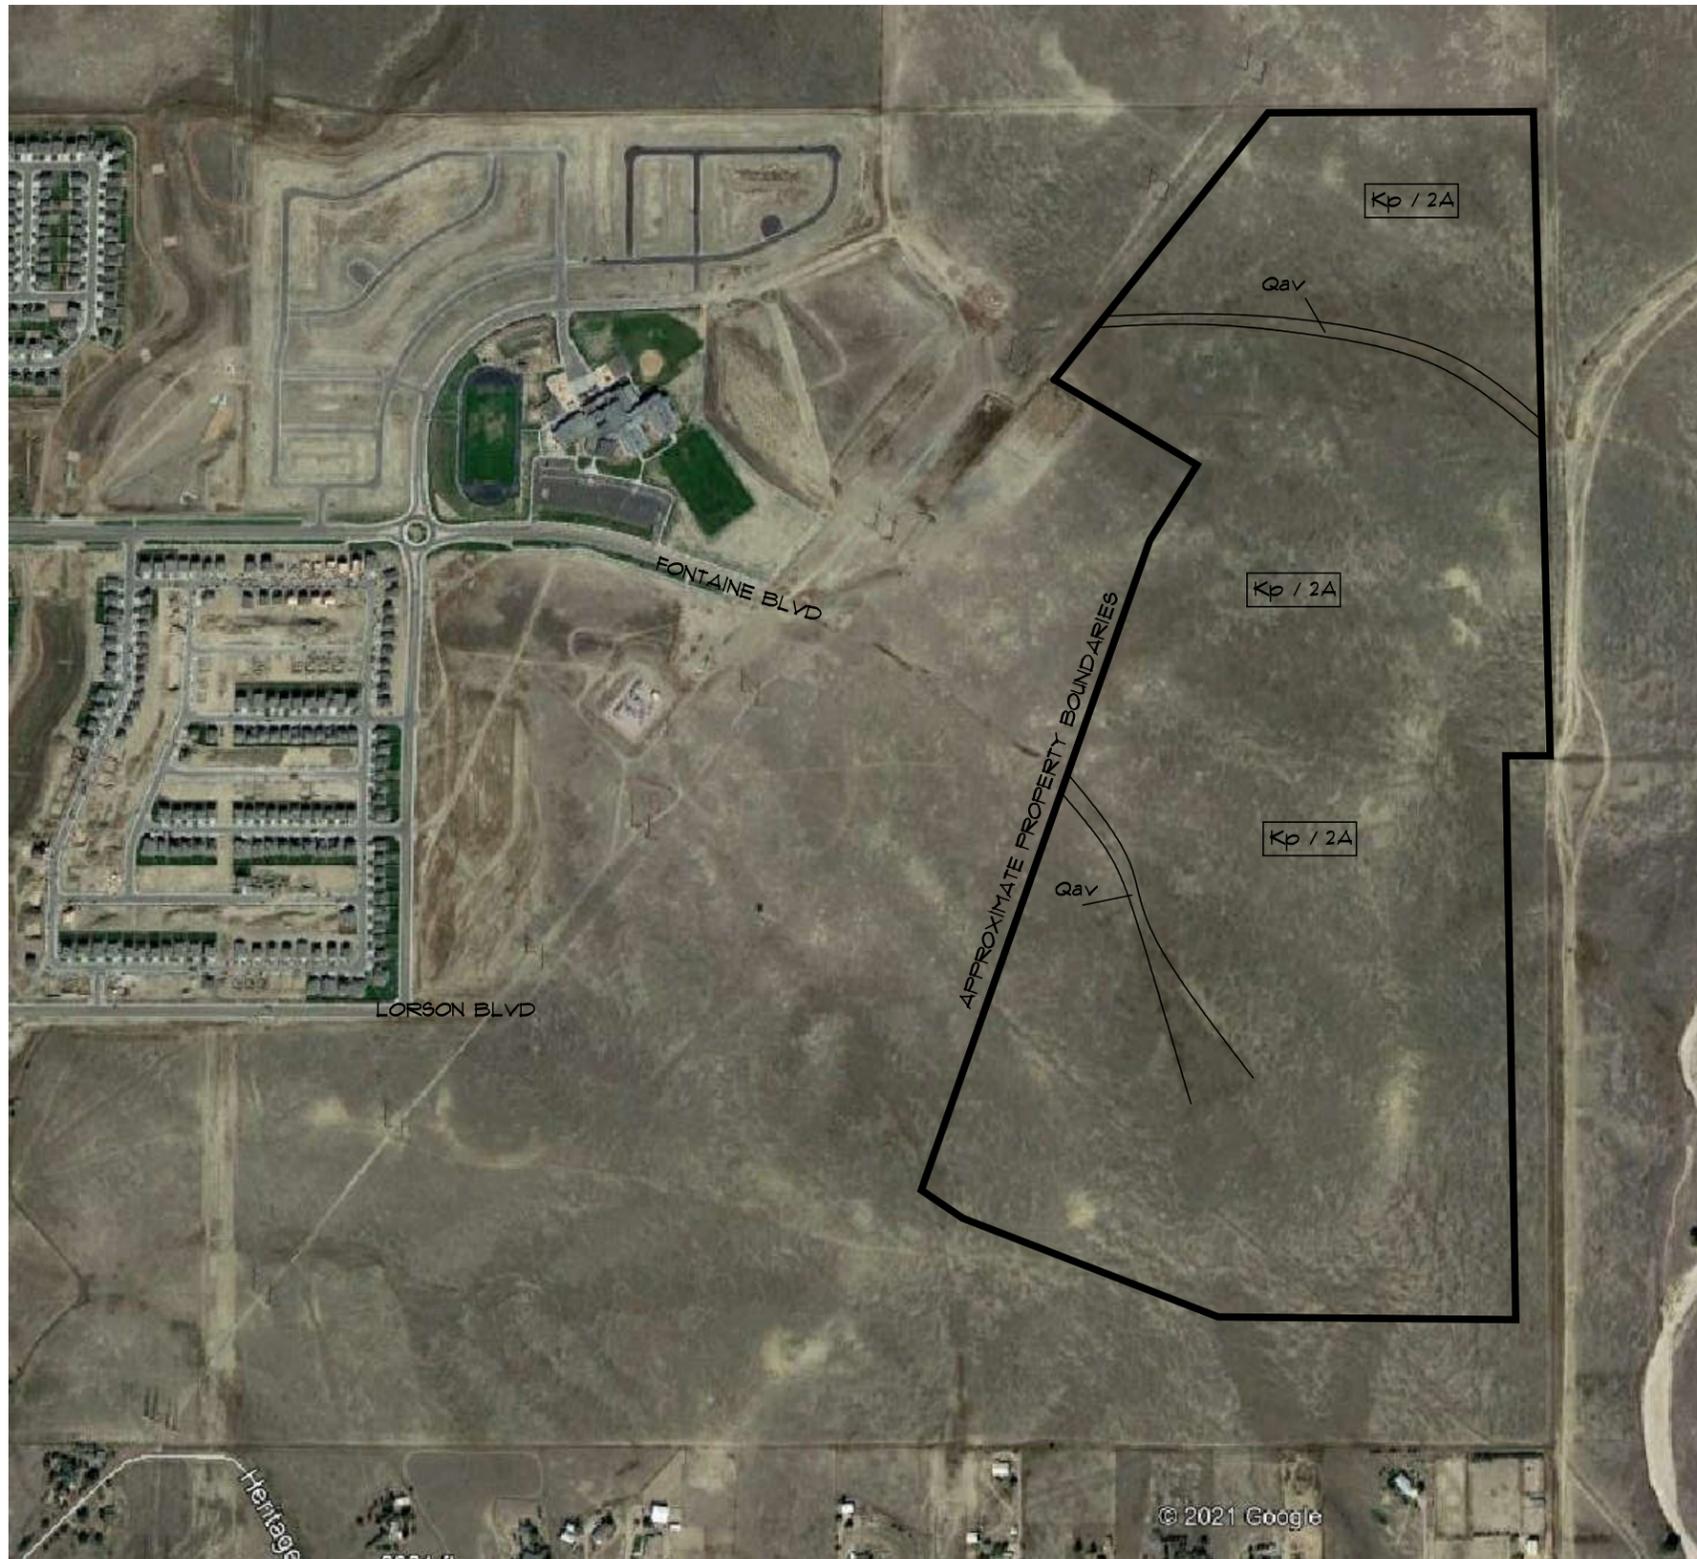
FIG-143

Geologic

*Qav - Valley-fill alluvium (Holocene) - unsorted to poorly sorted, weakly stratified, sandy to silty clay deposited as valley fill in broad drainage swales on low hillsides of the central and eastern parts of the quadrangle where underlain by Pierre Shale*

Based on our field observations, the USDA map, and the Geologic Map of the Fountain Quadrangle, an interpreted geologic map of significant surficial deposits and features was mapped for the site. The identified geologic conditions affecting the development are presented in the Engineering and Geology Map, Figure 143.

The engineering geology is presented in the Engineering and Geology Map, Figure 143.

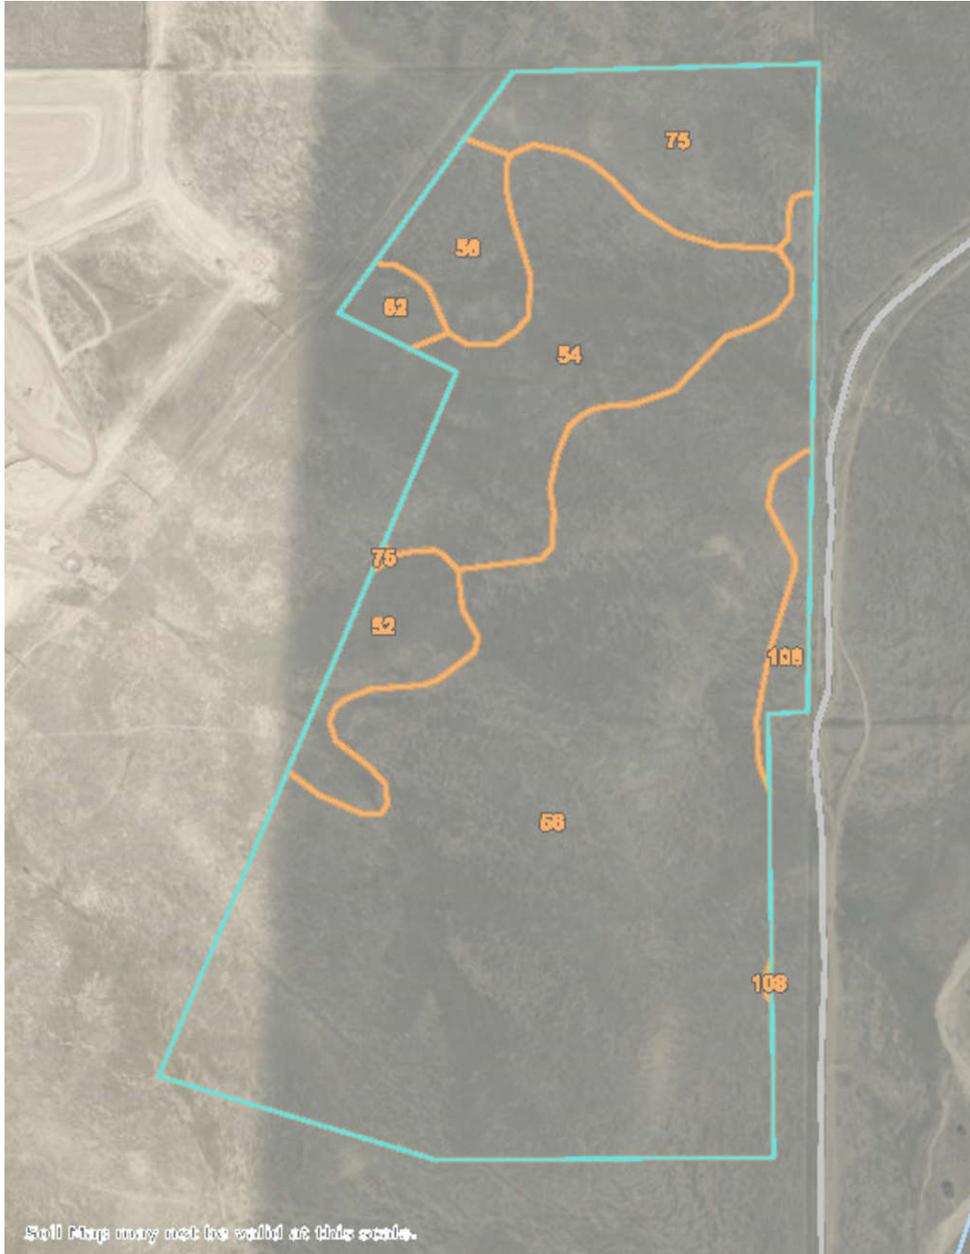
- 52 - Mansanet clay loam, 0 to 3% slopes
- 54 - Midway clay loam, 0 to 25% slopes
- 56 - Nelson-Tassel, fine sandy loam 3 to 18% slopes
- 75 - Razor-Midway complex
- 108 - Wiley silt loam, 3 to 9% slopes
