**DEPARTMENT OF THE ARMY**  
ALBUQUERQUE DISTRICT, CORPS OF ENGINEERS  
1970 EAST 3RD AVENUE, SUITE 109  
DURANGO, COLORADO 81301-5025

SUBJECT: Notice of Violation (SPA-2021-00338)

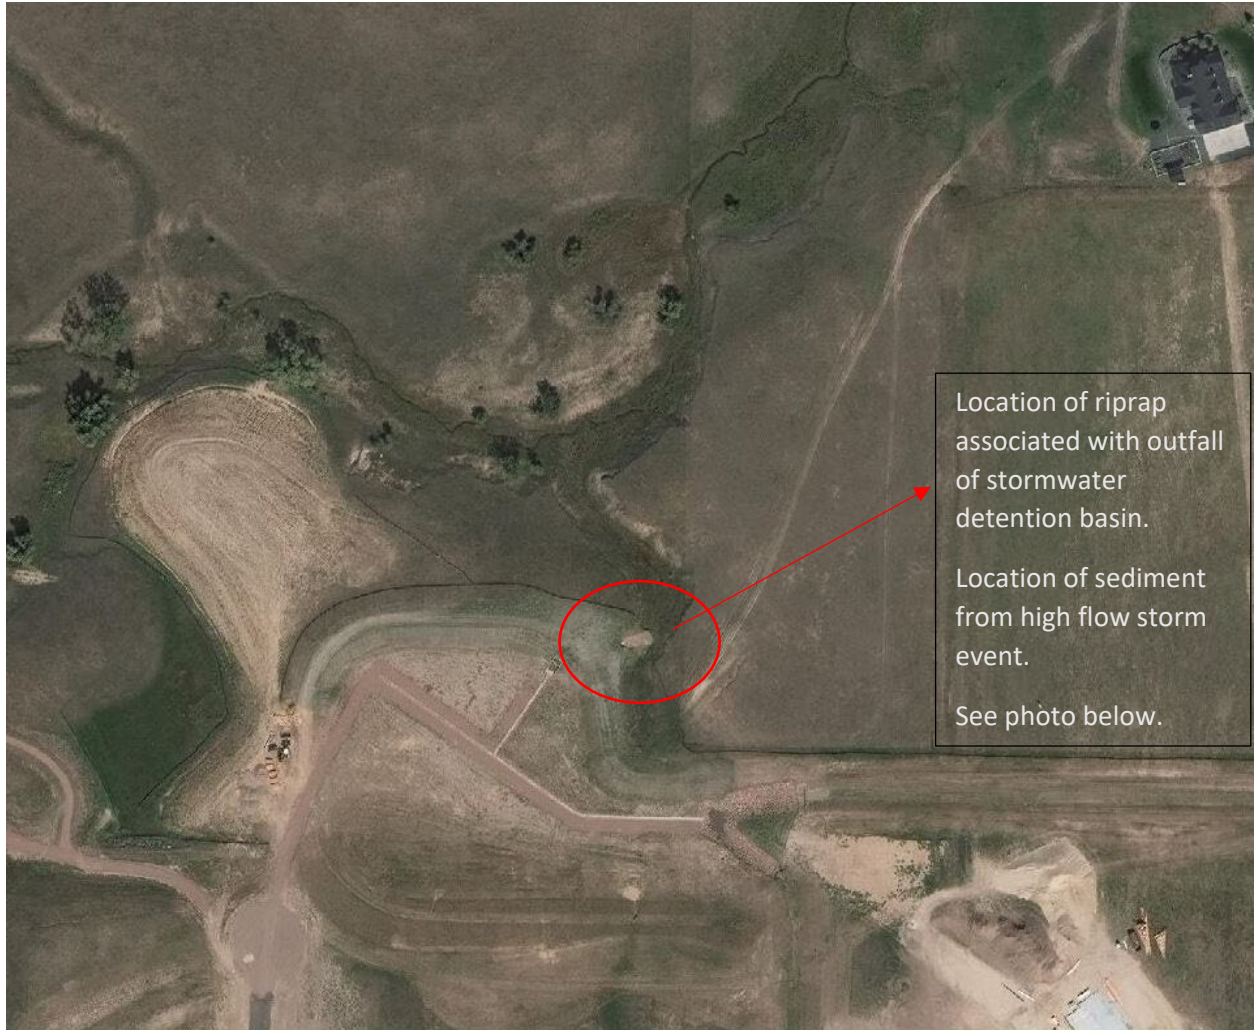
Digital Globe – aerial 9/7/2022

On September 16, 2022, the Corps observed unauthorized fill within a wetland area identified as W2 on the delineation map set within Appendix A of the wetland delineation report prepared by Bristlecone Ecology, LLC (see photo provided within Enclosure 2). We have sufficient information at this time to determine that you discharged dredged or fill material into the referenced wetland, which is a water of the United States, without a Department of the Army (DA) permit.

By email dated November 22, 2022, the Corps was notified that the discharge of fill material at W2 had been removed and the area voluntarily restored to pre-existing contours. The purpose of this letter is to inform you that this discharge of fill resulted in violation.

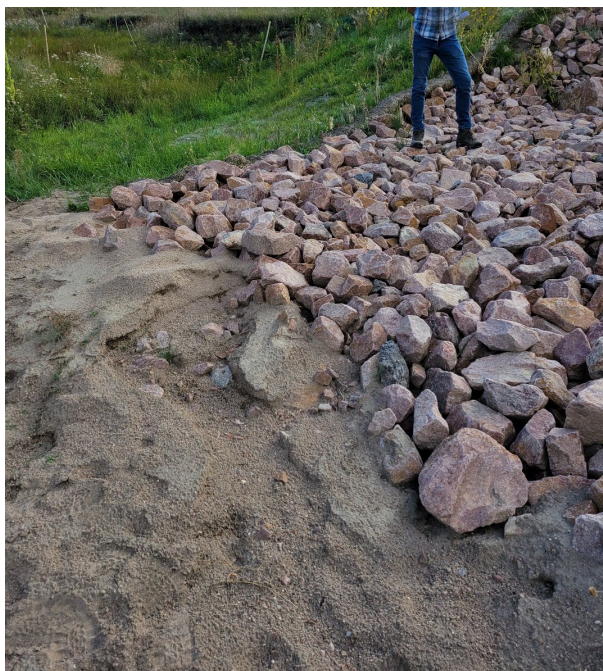
Photo 9/16/2022 – taken by USACE (Zdimal); standing within aquatic resource W2; looking southwest and upslope towards constructed stormwater detention basin. Bristlecone Ecology staff is shown standing on rip rap below the outfall near the boundary of aquatic resource W2, indicating a portion of the riprap was been placed in W2, and fill/sediment has been placed/ deposited below the riprap.
