AMERICAN
GEOSERVICES

May 7, 2019

PROJECT NO: 0224-CS19

Reference: Summary Letter, Initial Wildlife/Biological Assessment for Mouse Habitat & Initial Wetlands Assessment, Proposed residential development, Bentgrass Meadows St, Falcon, CO

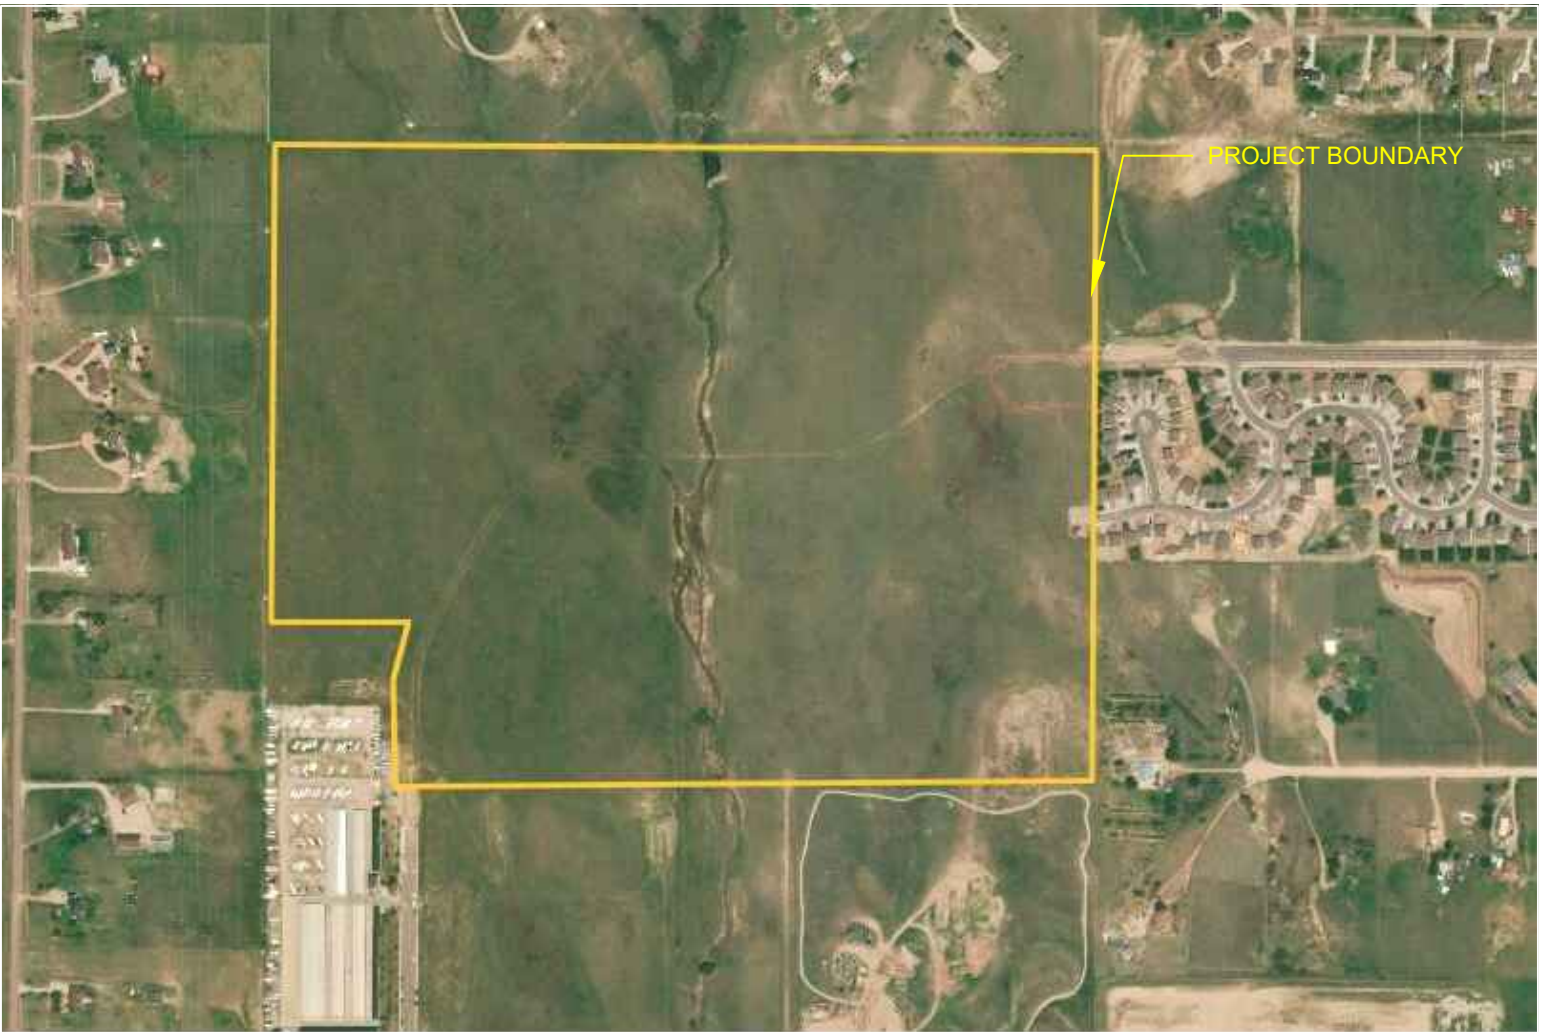
FIGURE 2: SCHEMATIC SITE PLAN

NOTE:
SCHEMATIC PLAN TO SHOW APPROXIMATE SUBSURFACE EXPLORATION LOCATION ONLY; NOT SURVEYED.

DESIGNATES SUBSURFACE INFILTRATION LOCATION, BY AMERICAN GEOSERVICES, LLC. , NOVEMBER 2018 SEE EXPLORATION LOG IN APPENDIX FOR FURTHER DETAILS.

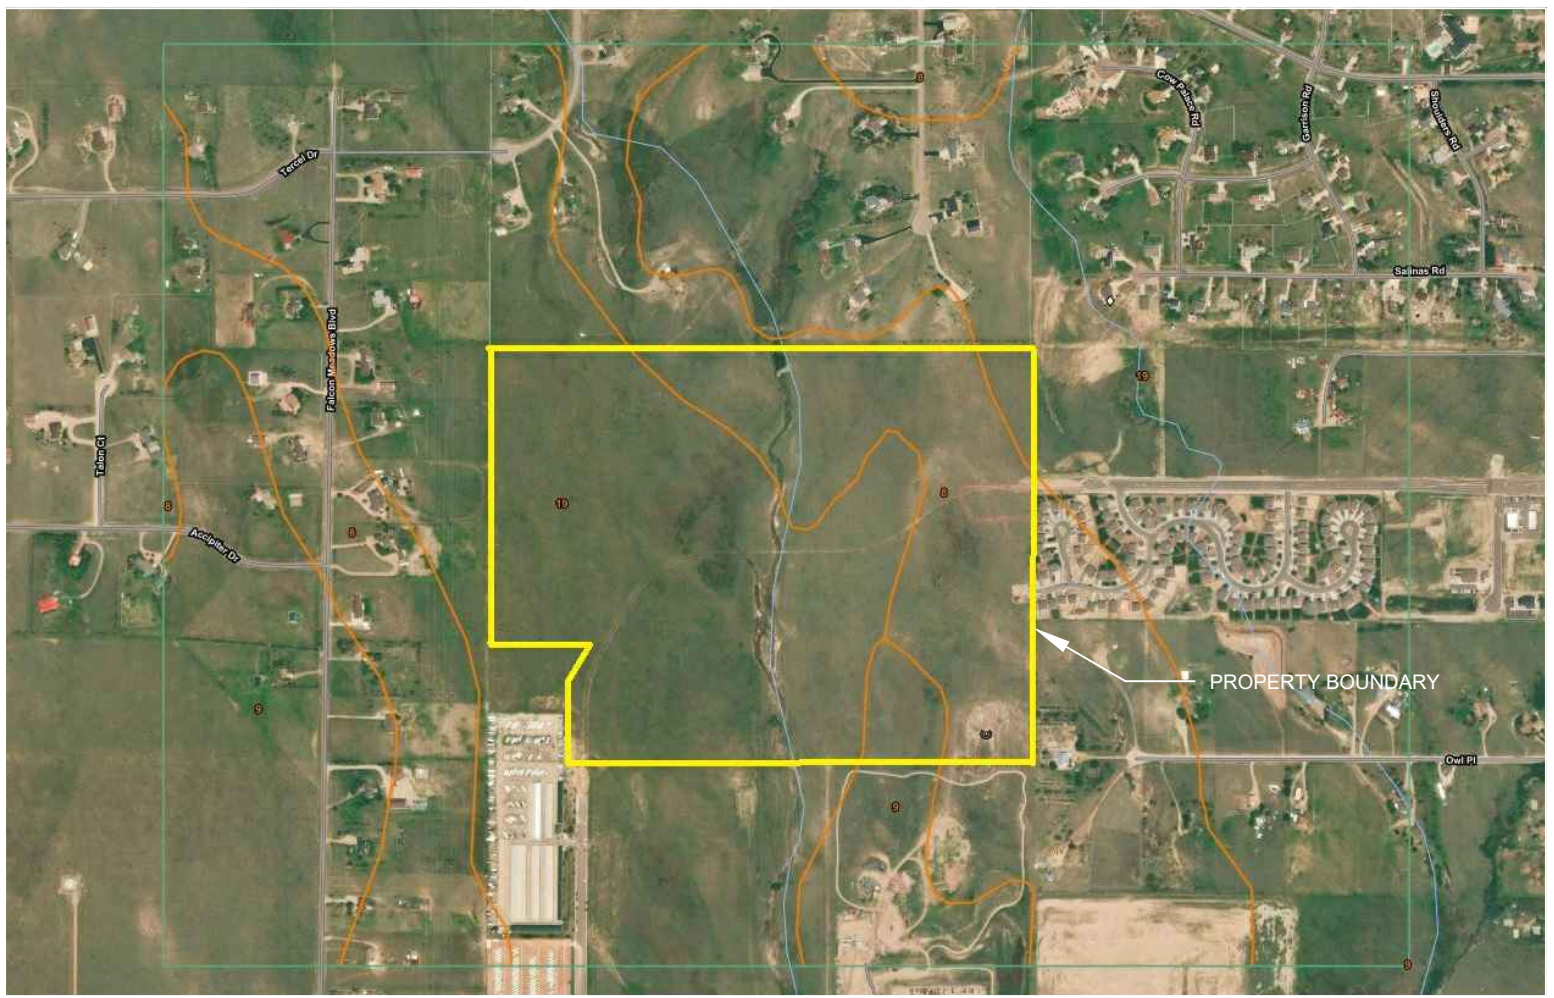
FIGURE 4: SOIL SURVEY MAP

Soil Survey Maps: The El Paso County Soil Survey indicates the project area traverses three soil associations including Blackland loamy sand (1 to 9 percent slopes), Blackland-Fluvaquentic Haplaquolls, and Columbine gravelly sandy loam (Figure 4). None of these soils are classified as a hydric soil in El Paso County by the Natural Resources Conservation Service (NRCS).

El Paso County Area, Colorado (CO625)			
El Paso County Area, Colorado (CO625)			
Map Unit Symbol	Map Unit Name	Acres in AOI	Percent of AOI
8	Blakeland loamy sand, 1 to 9 percent slopes	157.2	25.2%
9	Blakeland-Fluvaquentic Haplaquolls	77.1	12.3%
19	Columbine gravelly sandy loam, 0 to 3 percent slopes	390.3	62.5%
Totals for Area of Interest		624.5	100.0%

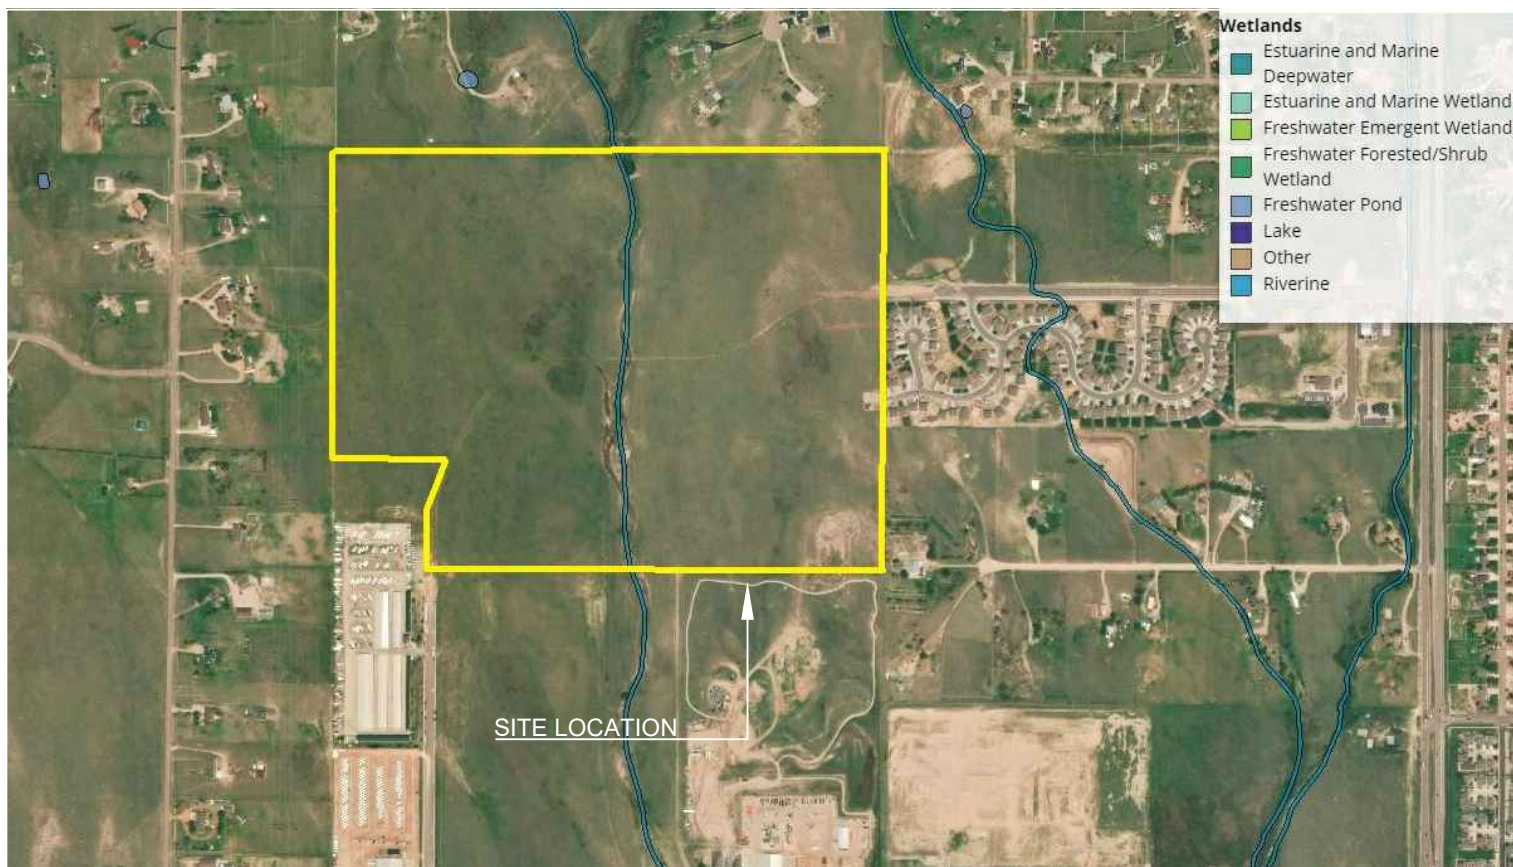
**FIGURE 5:
NATIONAL WETLANDS INVENTORY
MAP**

National Wetlands Inventory Maps: A review of NWI maps (USFWS) was conducted to determine the potential presence, location, size, and type of wetlands located within the Project boundaries. The USFWS generates NWI maps through aerial photograph interpretation. NWI maps may not accurately depict the extent or existence of wetland systems in a specific area, nor do maps consistently and accurately identify wetland type. As such, the maps were utilized for preliminary analysis only. Field reconnaissance was conducted to determine the true extent and type of wetlands located within the Project, and to verify the information gathered through NWI data review. NWI data did not depict any wetlands within the project boundaries (Figure 5).

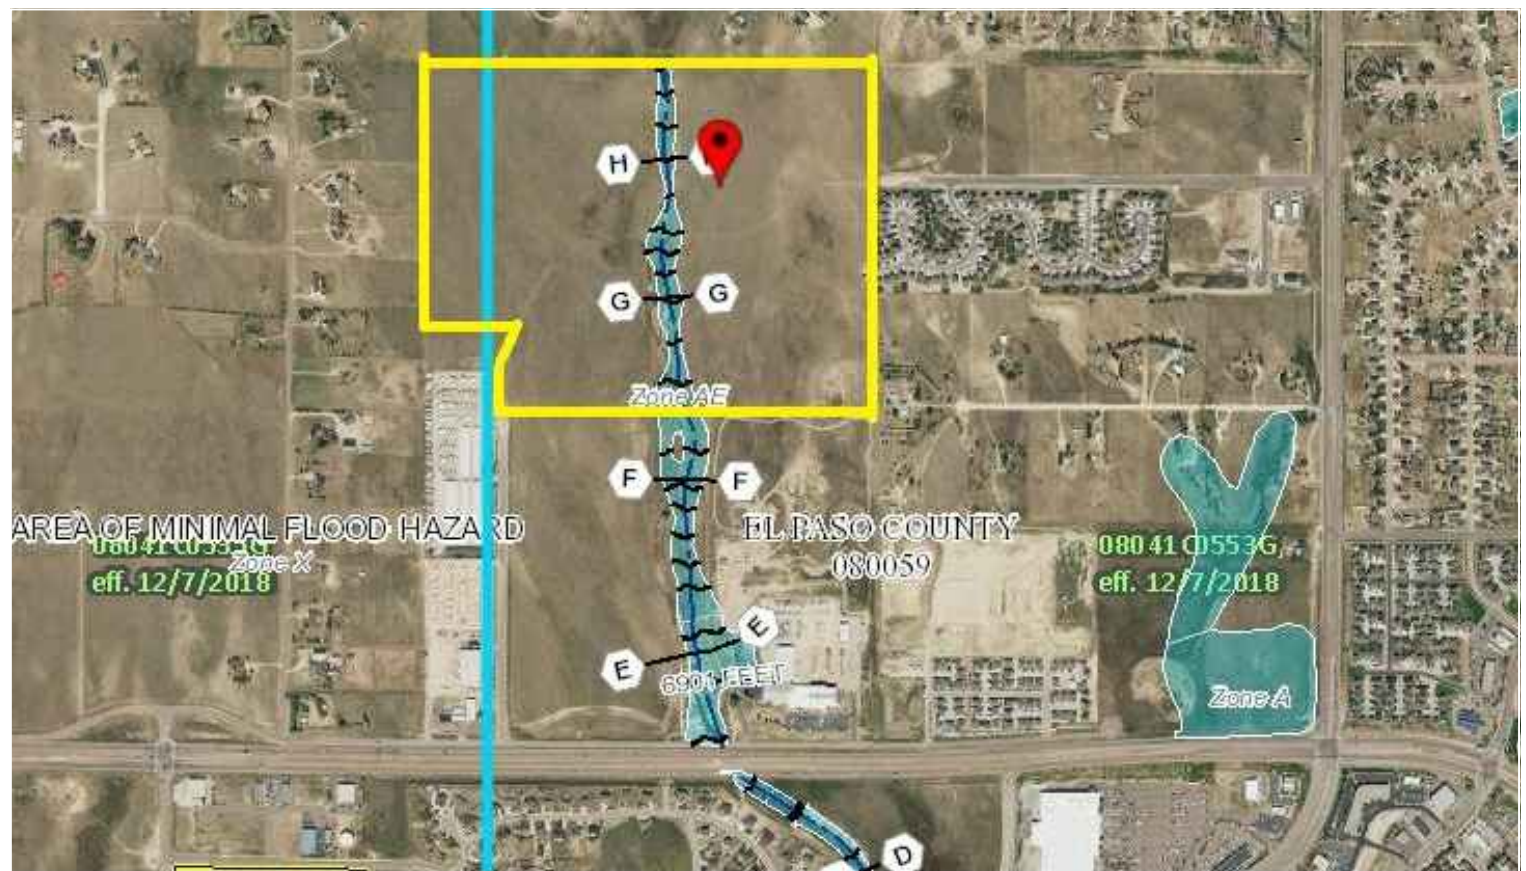
FIGURE 9: FLOOD HAZARD MAP

FEMA Maps: A review of FEMA FIRM floodplain maps (FEMA) was conducted to determine the existence, location, and extent of floodplains located within the project boundaries. The FIRM maps depict floodplain areas along rivers and tributaries. The maps record the following data: 100-year floodplains (1% chance of annual flooding) and 500-year floodplains (0.2% annual chance of flooding), the height of the base flood (Base Flood Elevations), and the risk premium zones developed from topographical information across a floodplain. The FEMA generates FIRM floodplain maps for flood insurance purposes. A review of El Paso County FEMA FIRM panels indicate portions of the project area adjacent to an unnamed tributary to Black Squirrel Creek No. 2 are at risk of inundation by a 100-year flood (Figure 10 and 11). The remainder of the property is identified as Zone X flood zone, which consists of areas of minimal flood risk “outside the 1-percent and 0.2-percent-annual-chance floodplains” (FEMA 2005). The Project is located within FEMA FIRM panel 08041C0553G, El Paso County.
