## Final Acceptance (FA) – Punchlist from EPC Stormwater

Project Name:	Gleneagle Subdivision F2
PCD Filing Number:	VR1818
ESQ #:	ESQ1816
EPC Stormwater Personnel:	Ben Jones, Glenn Reese, Molly Layshock
Date of Walk-Thru:	12/15/2022
FA Walk-Thru #:	1

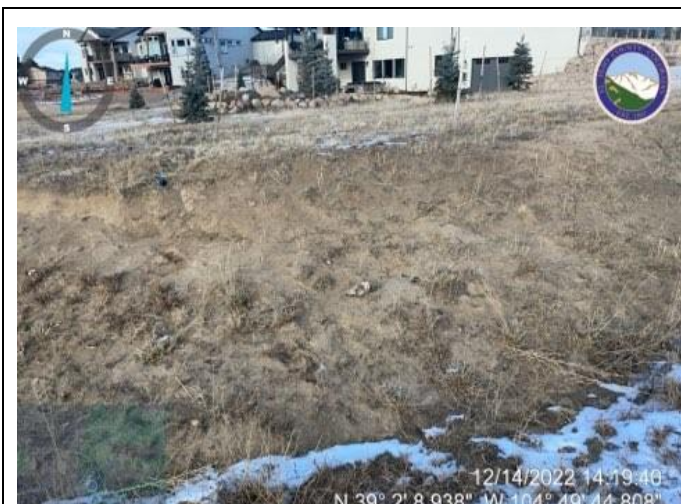
Photo 1: Stabilize slope of Swale K.

- Vegetate bare spots along slopes (Photo 1)
- Remove straw wattle temporary control measures
- Address erosion (Photo 2)

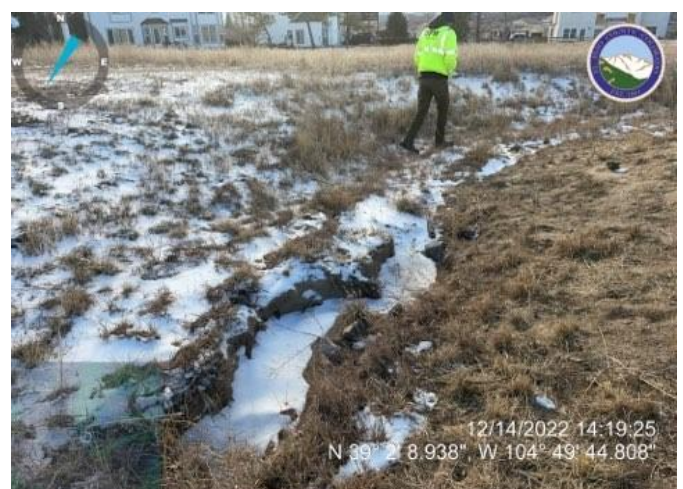
Photo 2: Address severe erosion in Swale K.

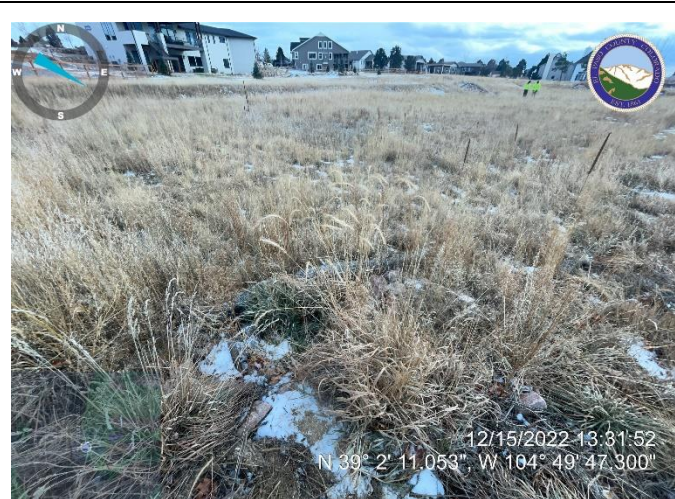
Photo 3: Remove straw wattle temporary control measure from upstream side of Swale J.

- Remove straw wattle from upstream side of swale at the end of concrete (Photo 3)

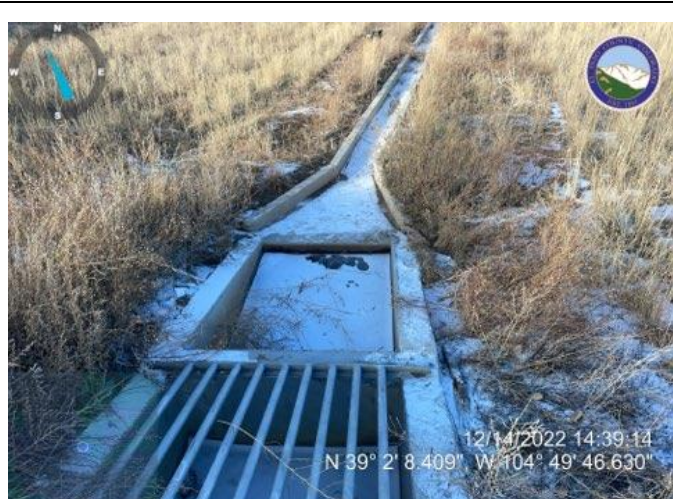
Photo 4: Where trickle channel meets micropool is not installed per approved plans; corners do not tie into the walls in the field.

- Trickle channel curb does not tie into wall of micropool (Photo 4)

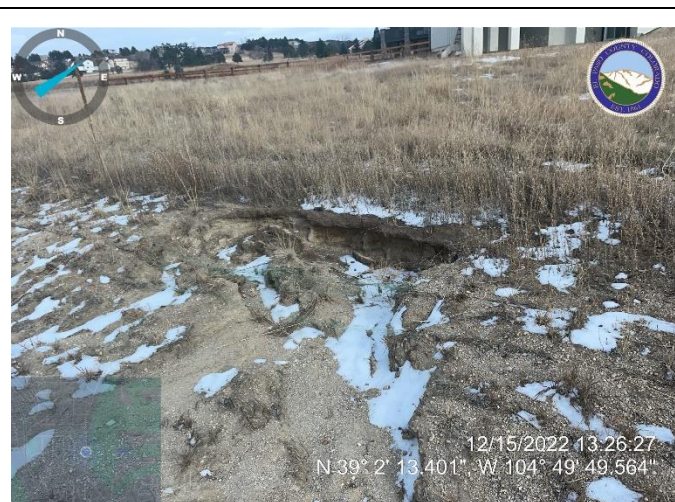
Photo 5: Repair erosion along concrete swale behind Lots 6-8 west of Stone Eagle Place.

- Remove sediment from upstream side of swale at the end of concrete
- Remove straw wattle at end of concrete
- Address erosion along concrete channel behind Lots 6-8 (Photo 5)
- Clean sediment from riprap at end of concrete channel

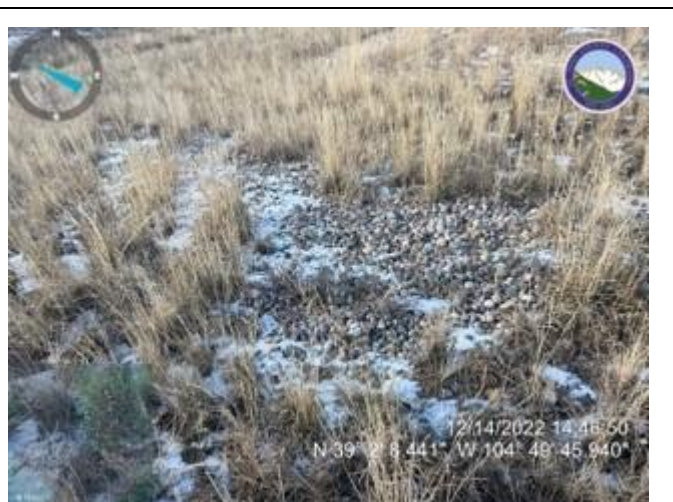
Photo 6: Install 12' gravel access road as per plans at Detention Basin C.

- Interior width of trickle channel was measured as 16" (Sheet C.3 shows 24" in two details and 12" in another detail)
  - Per DCMv2 – Chap 4.2, trickle channels should at a minimum provide capacity equal to twice the release capacity at the upstream forebay outlet. Have engineer confirm that the 16" channel meets this criteria.
- Remove temporary straw wattles and backfill and seed trench line so pond bottom matches grade with top of trickle channel curb
- Address multiple cracks in trickle channel
- Address west-facing bare area along embankment (Photo 7)
- Install 12' gravel access road as per plans (Photo 6)

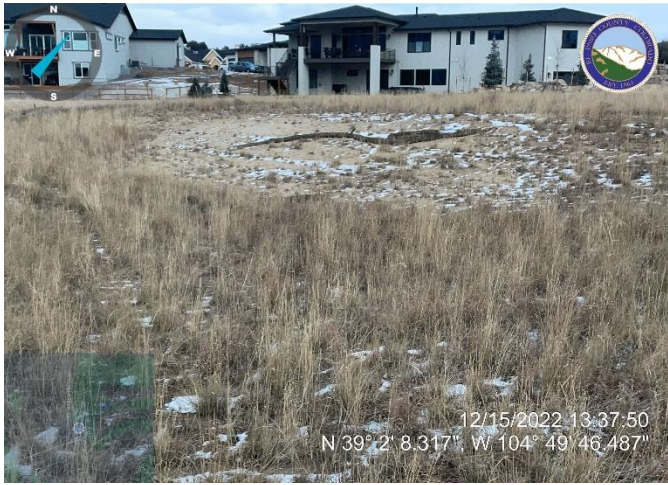
Photo 7: Address west-facing bare area along Detention Basin C embankment and remove temporary straw wattle.

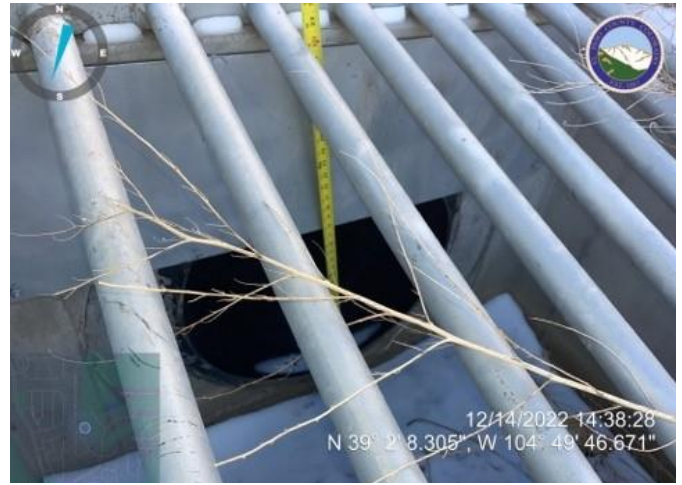
Photo 8: Restrictor plate not installed at correct height

- Stainless steel bolts or intermittent welds (see Figure OS-5) are not installed as per plans
- Gasket is not installed as per plans (Figure OS-5)
- Actual diameter of installed outlet pipe is 24". Two details on Sheet C.3 show 24" and one detail shows 18". Make sure this discrepancy is resolved in the as-builts. Drainage report calcs includes 24", so 24" installation is acceptable, the 18" detail callout is presumed to be a typo
- Restrictor plate not installed at correct height above outlet pipe invert as per plans (~12" in the field compared to 6" on plans)
