May 12, 2020

RE: Wetlands and Threatened & Endangered Species Report
Judge Orr Eastonville Commercial Center
El Paso County, Colorado

Wetlands Map

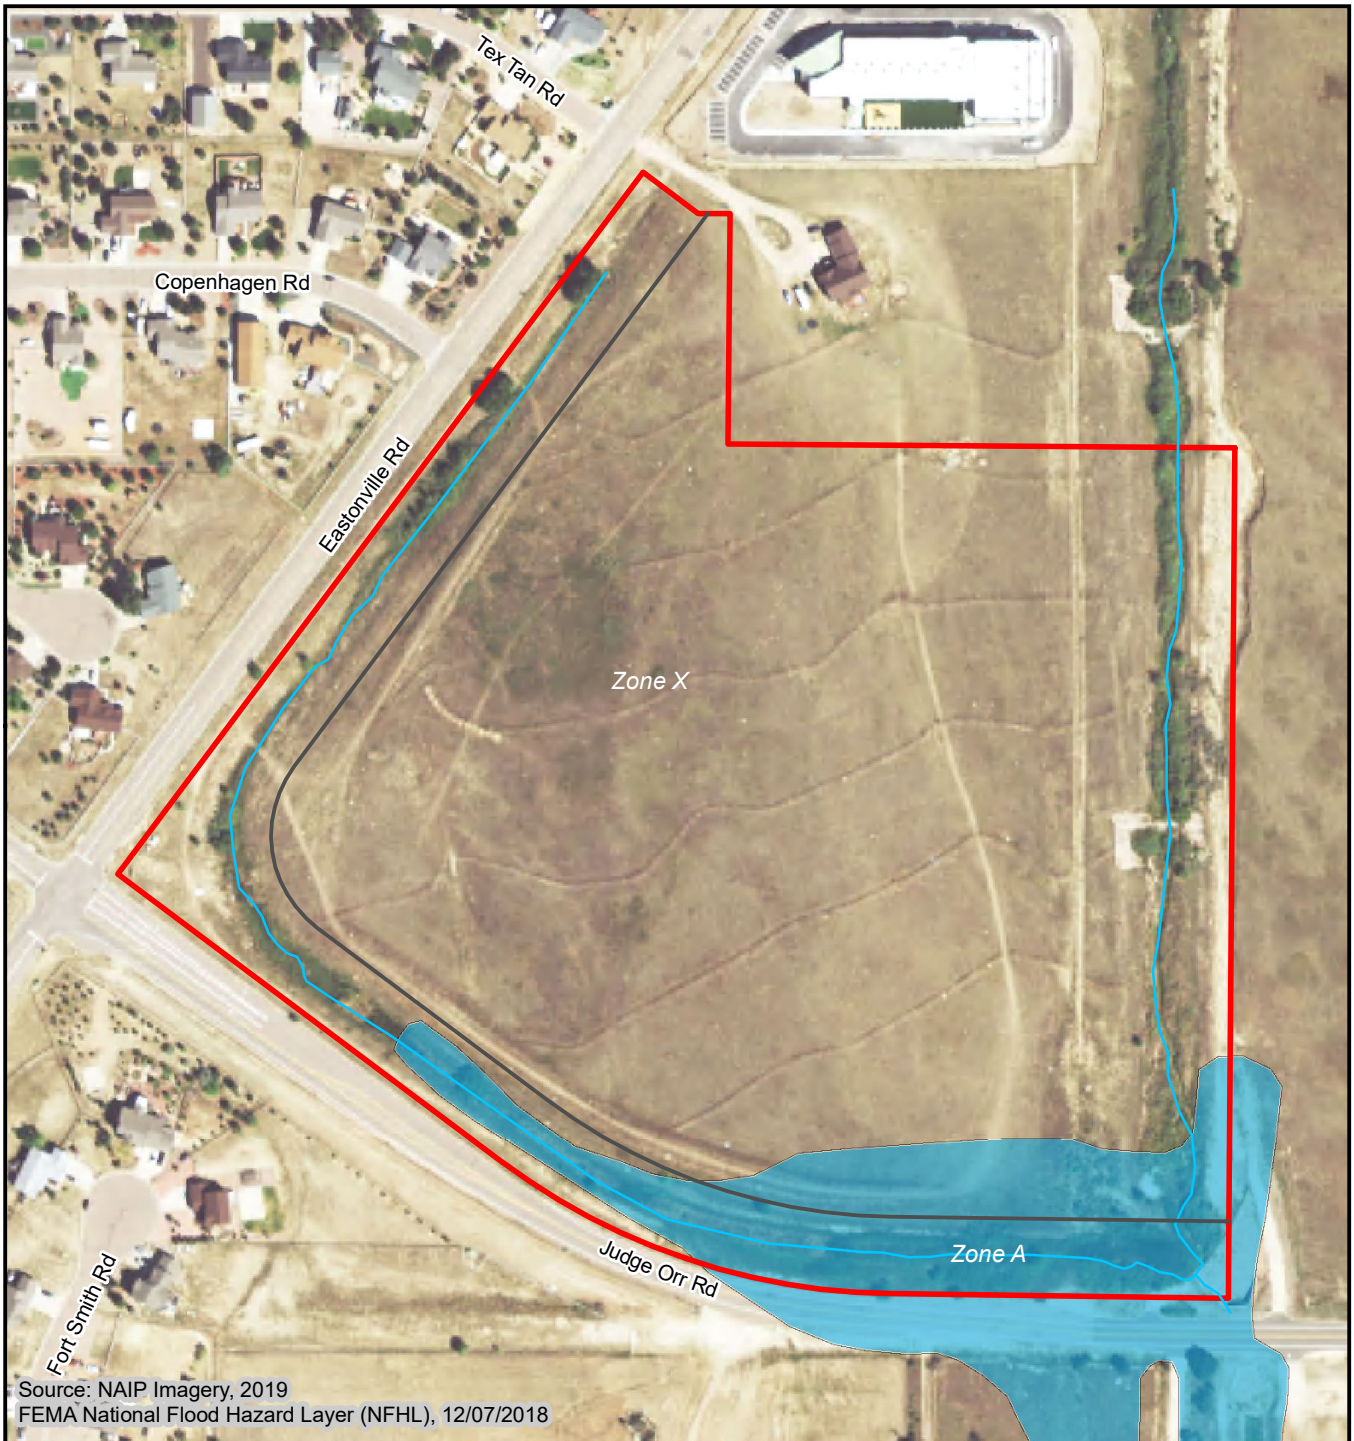
FEMA Floodplain Map

- Project Area
- Road Easement
- Stream
- Zone A
- Zone X, AREA OF MINIMAL FLOOD HAZARD

along rivers and tributaries. The maps depict the following data: 100-year floodplains (1% chance of annual flooding) and 500-year floodplains (0.2% annual chance of flooding), the height of the base flood (Base Flood Elevations), and risk premium zones developed from topographical information across a floodplain. A review of FEMA's National Flood Hazard maps (2018) indicated that some portions of the Project area are identified as a Zone A flood zone, which includes all areas within the 1-percent-annual-chance floodplains (Attachment III: FEMA Floodplain Map).

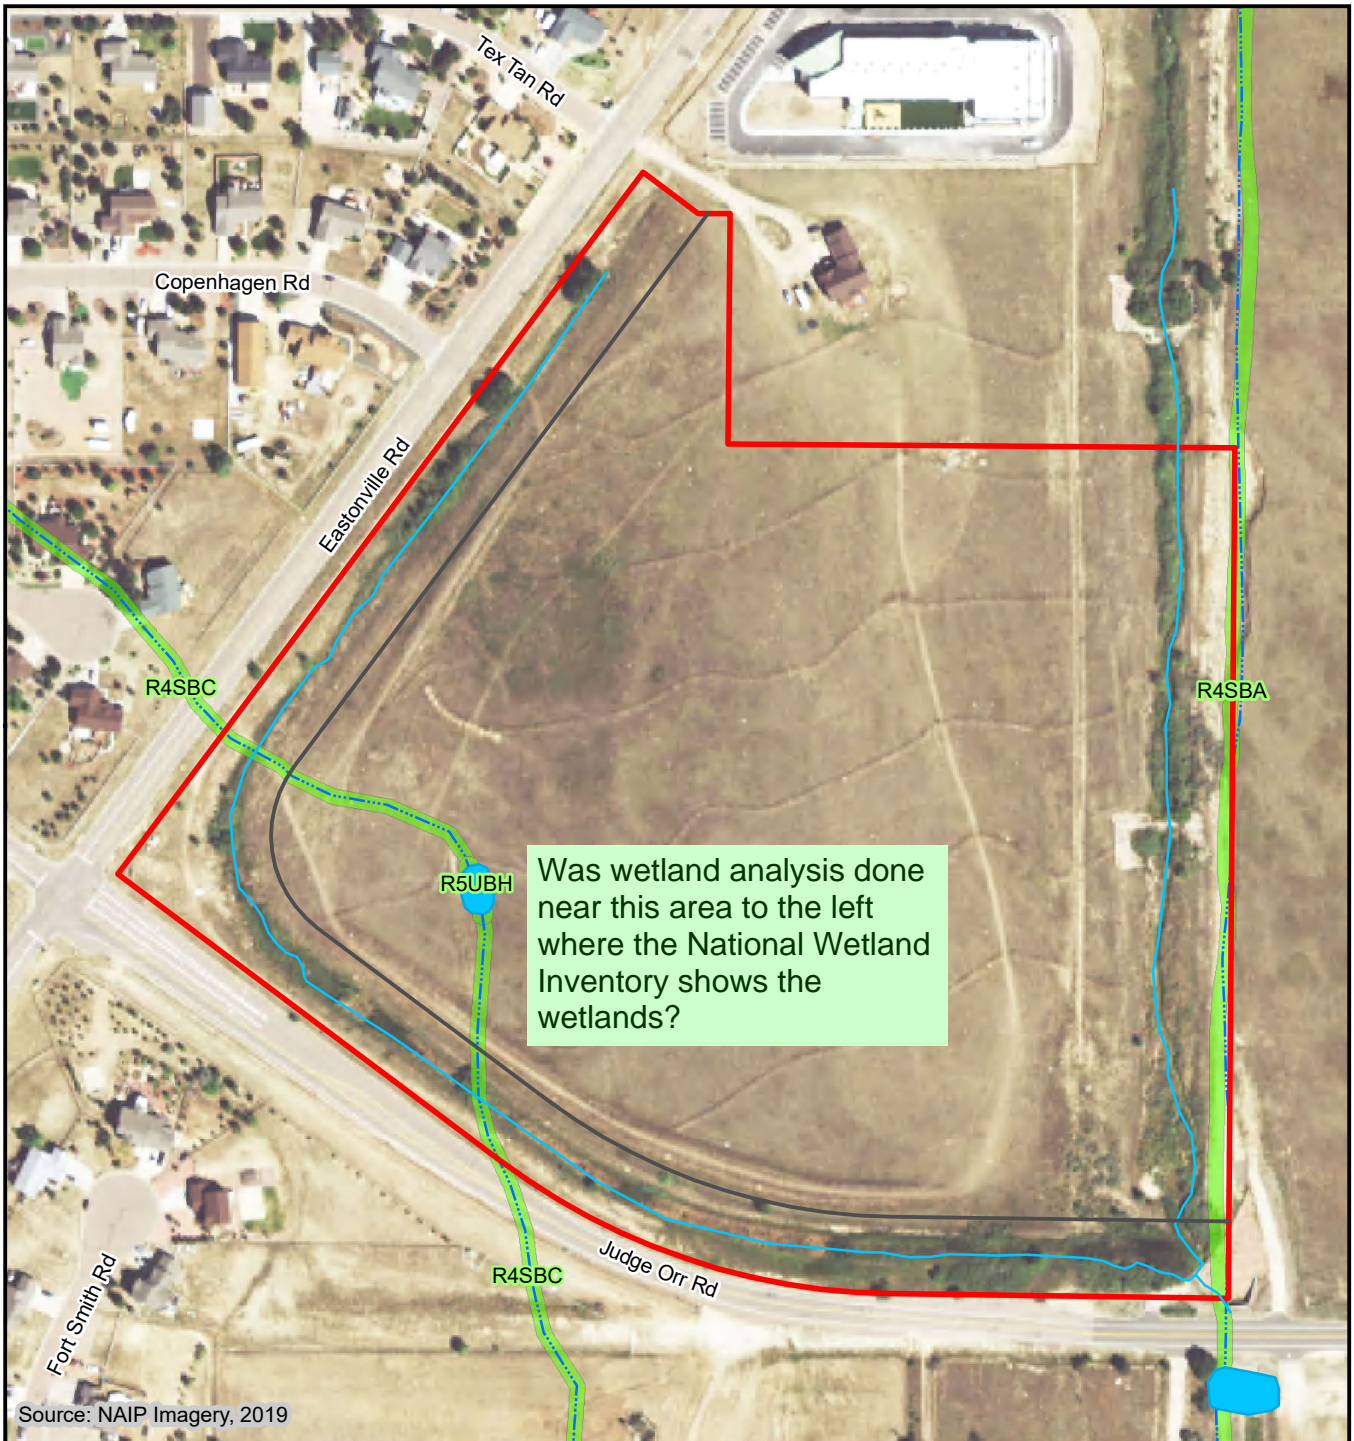
**Judge Orr Eastonville
Commerce Center**
National Hydrography Dataset
&
National Wetlands Inventory
Map

- Project Area
- Road Easement
- Stream
- NWI Wetland

A review of NHD data (USGS 2020) and NWI maps (USFWS 2020) was conducted to determine the potential presence, location, size, and type of wetlands located within the Project area. The NHD depicts the expected locations of flowlines for streams and rivers based on available topographic and data and aerial images. The USFWS generates NWI maps through aerial photograph interpretation. NHD and NWI maps may not accurately depict the extent or existence of wetlands or other aquatic features, nor do maps consistently and accurately identify wetland type. As such, the maps were used for preliminary analysis only. Field reconnaissance was conducted to determine the true extent and type of wetlands located within the Project area, and to verify the information gathered through NHD and NWI data review. The NHD depicted three flowlines, and NWI data depicted two Riverine wetlands within the Project area, one forming the eastern border of the site and one running through the southwest corner (Attachment II: National Hydrography Dataset & National Wetlands Inventory Map). Types and locations of NHD streams and NWI wetlands included:

- One NHD stream channel forming the western and southern boundaries of the property
- One NHD stream channel near the eastern boundary of the property
- One NHD pond coinciding with an NWI Riverine, unconsolidated bottom, permanently flooded wetland (R5UBH) in the southwest portion of the property
- One Riverine, intermittent, streambed, temporarily flooded wetland (R4SBA), roughly following the eastern border of the property, not co-located with the previous NHD stream
- One Riverine, intermittent, streambed, seasonally flooded wetland (R4SBC) running through the southwest corner of the property

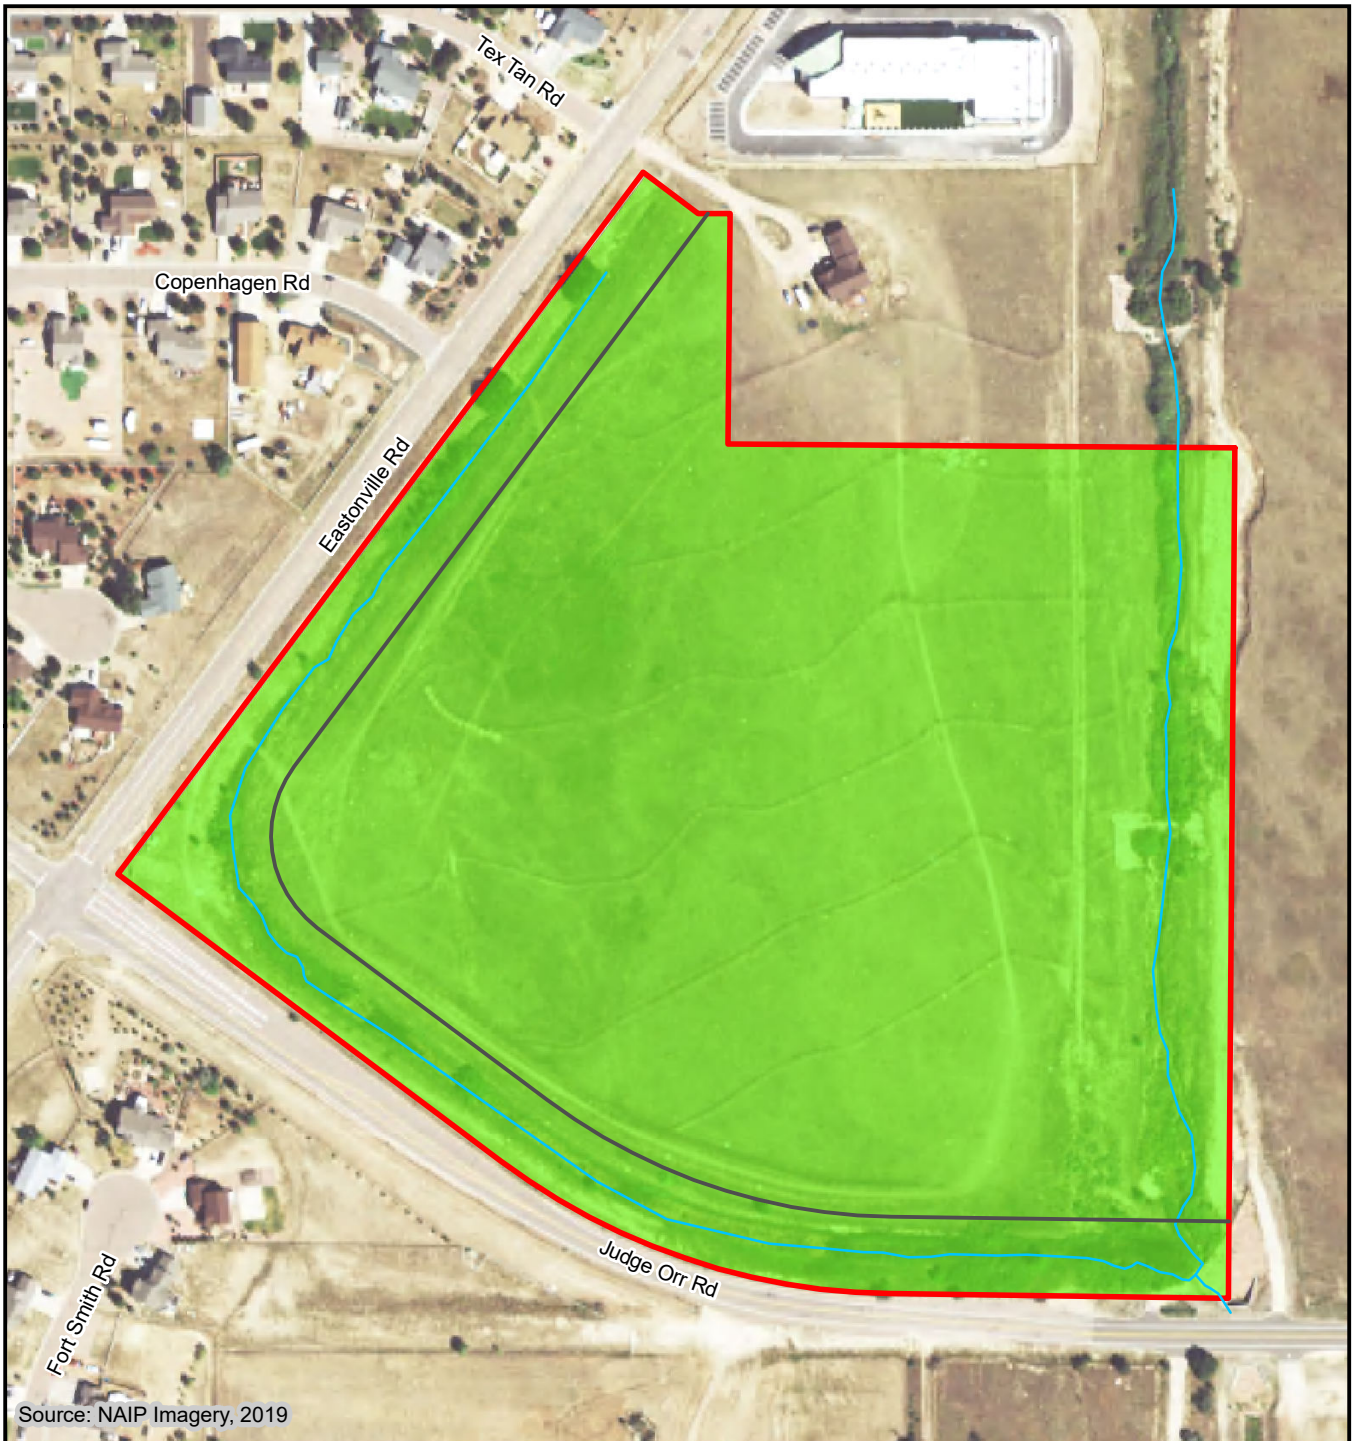
Soils Survey Map

- Project Area
- Road Easement
- Stream
- 19; Columbine gravelly sandy loam, 0 to 3 percent slopes

The NRCS Soil Survey indicates the Project area is entirely within a single soil association: Columbine gravelly sandy loam, 0 to 3% slopes (NRCS 2019) (Attachment IV: Soils Survey Map). Columbine gravelly sandy loam is classified as a hydric soil in El Paso County (NRCS 2020).

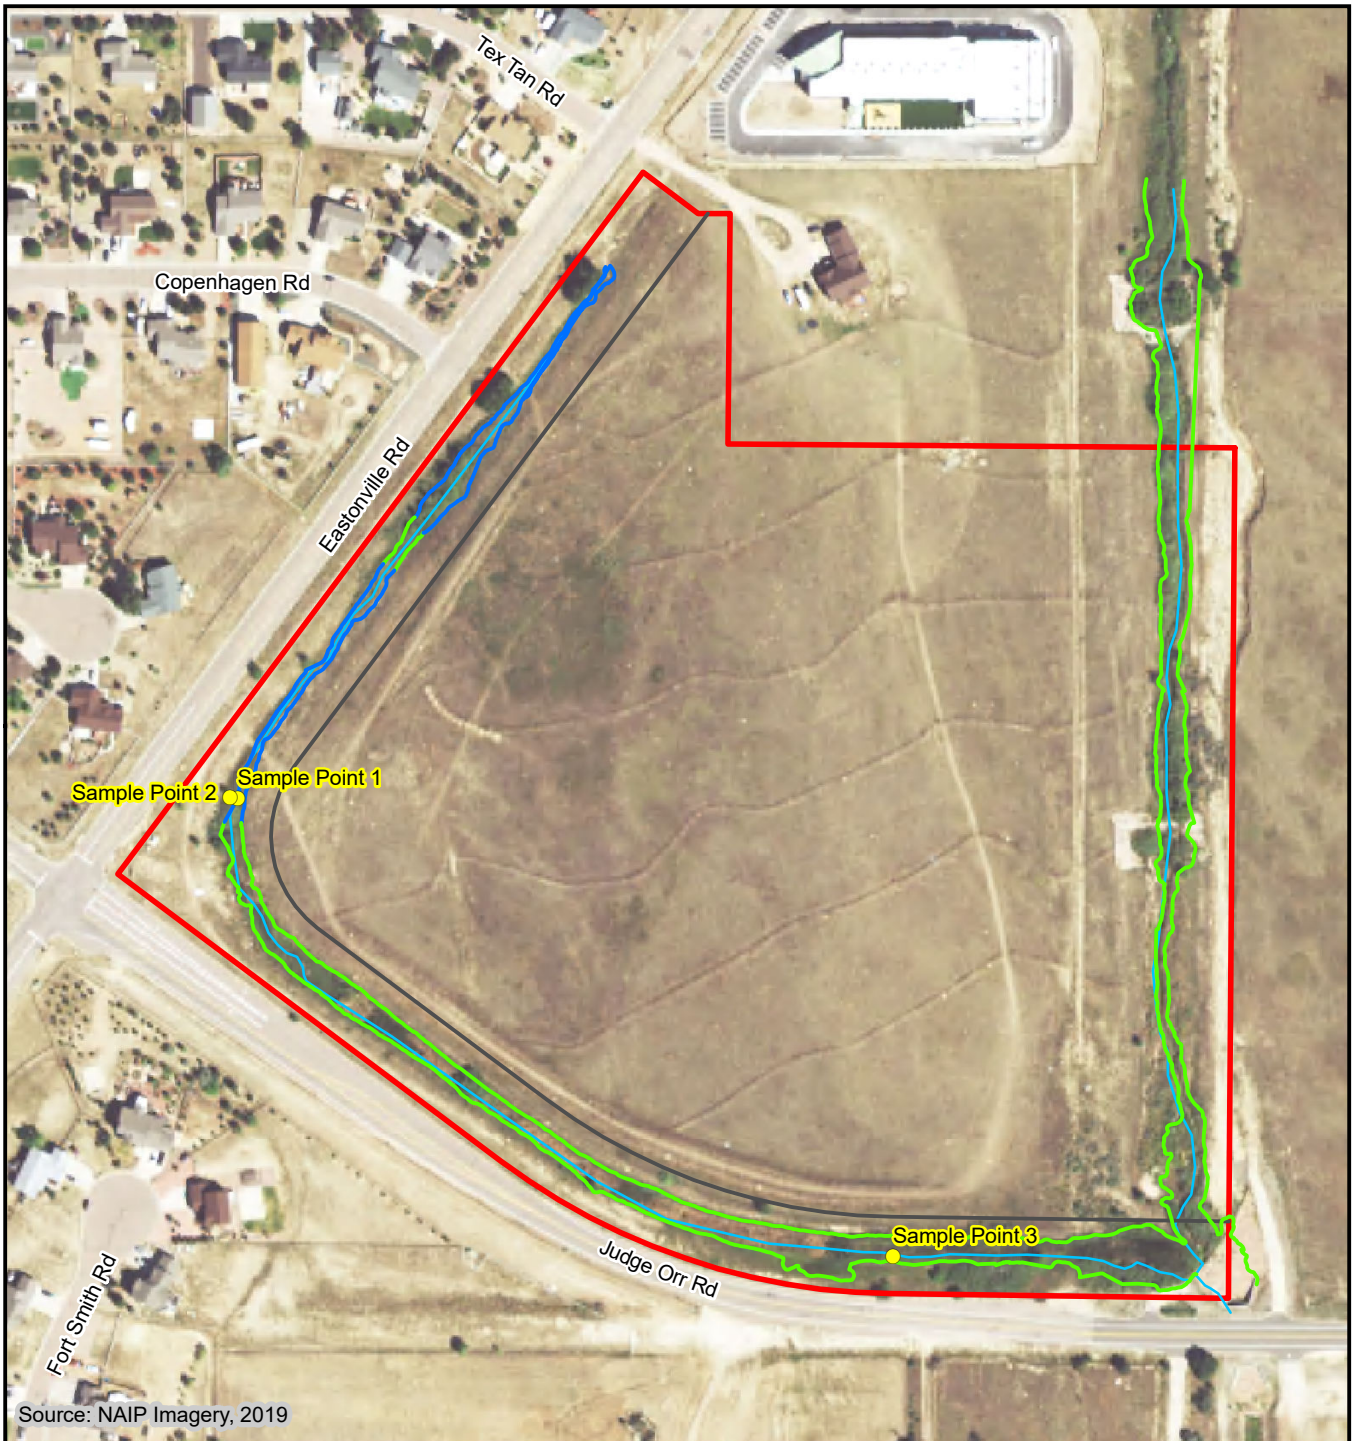
- Project Area
- Sample Point
- OHWM lacking wetlands
- Wetlands
- Road Easement
- Stream

Information gathered from the site reconnaissance indicated that there were two jurisdictional streams running through the Project area. Three of the features identified in the NHD/NWI data, the R5UBH wetland/NHD pond and the R4SBC wetland, both in the southwest portion of the property, are not depicted accurately in the desktop data. These features do not exist. The R4SBA wetland along the eastern boundary of the property does appear to exist as depicted in the NWI data, but it is located outside the Project area boundary as was not delineated. The NHD flowlines along the western-southern boundary and near the eastern boundary are present and were delineated (Attachment VI: Wetlands Map). Both were classified according to Cowardin *et al.* (1979) as R5UBF – Riverine, unknown perennial, unconsolidated bottom, semi-permanently flooded.

Hydrologic indicators, dominant vegetation, and soil samples were examined during the field reconnaissance to determine the presence/absence of wetlands. Sample points were taken at specific locations in order to provide an understanding of typical wetlands present at the site. Hydrologic indicators included High Water Table (A2), Saturation (A3), Water-stained Leaves (B9), Hydrogen Sulfide (C1), Dry-Season Water Table (C2), Oxidized Rhizospheres (C3), and FAC-Neutral Test (D5). Vegetation was largely composed of dominant obligate or facultative-wetland vegetation, including broadleaf cattail (*Typha latifolia*), softstem bulrush (*Schoenoplectus tabernaemontani*), arctic rush (*Juncus arcticus*), Nebraska sedge (*Carex nebrascensis*), and sandbar willow (*Salix exigua*). Soils were very gravelly and sandy; Sandy Redox (S5) and Hydrogen Sulfide (A4) indicators were both present.

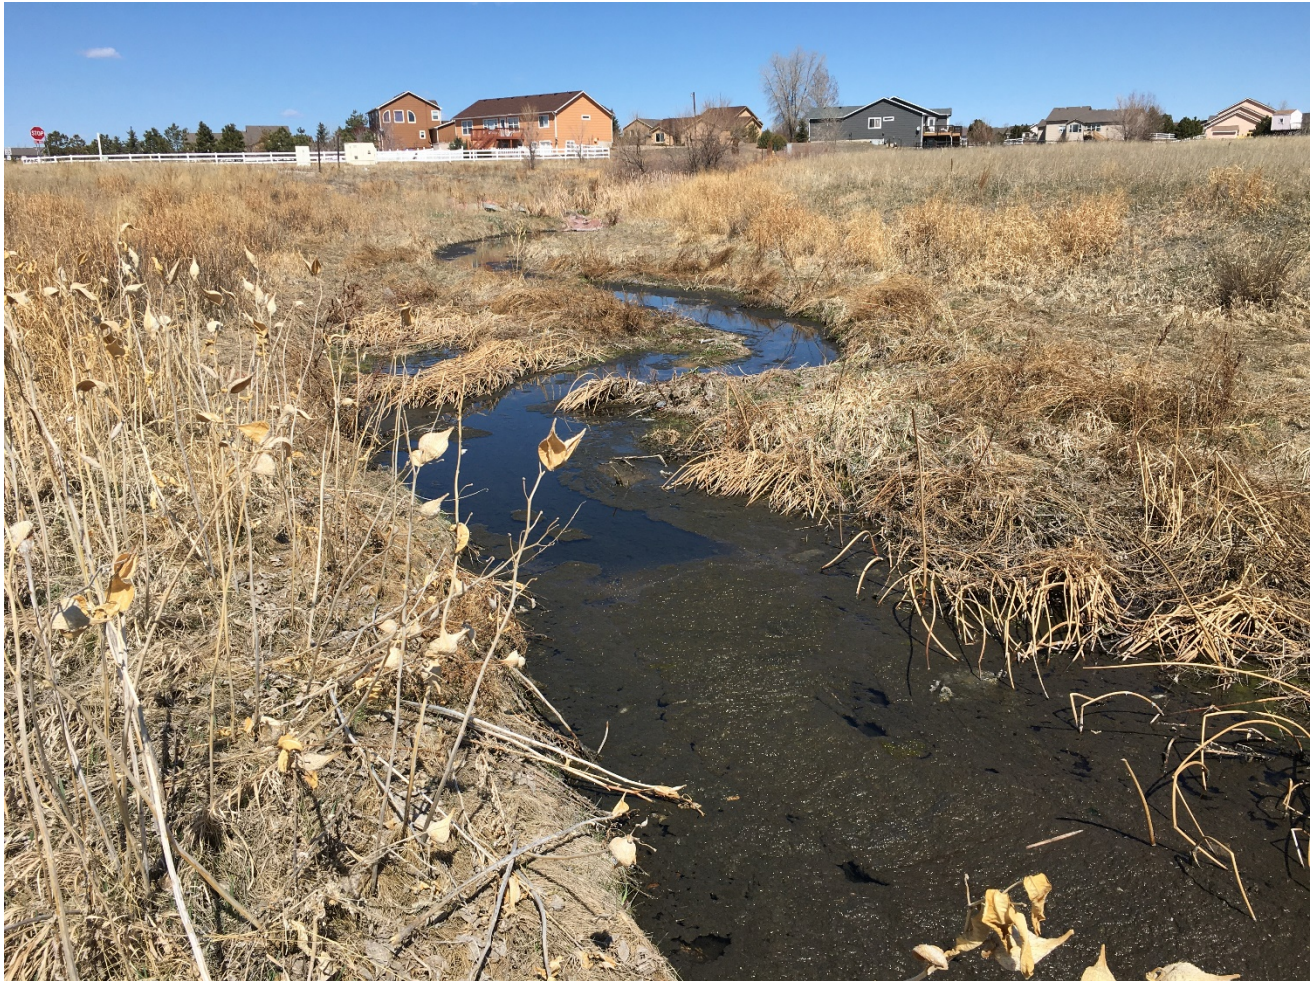
Photo 1. Riverine wetland (R5UBF) near the southwest corner of the property, facing northwest showing surface water and well-established rushes, bulrushes, sedges, and cattails.

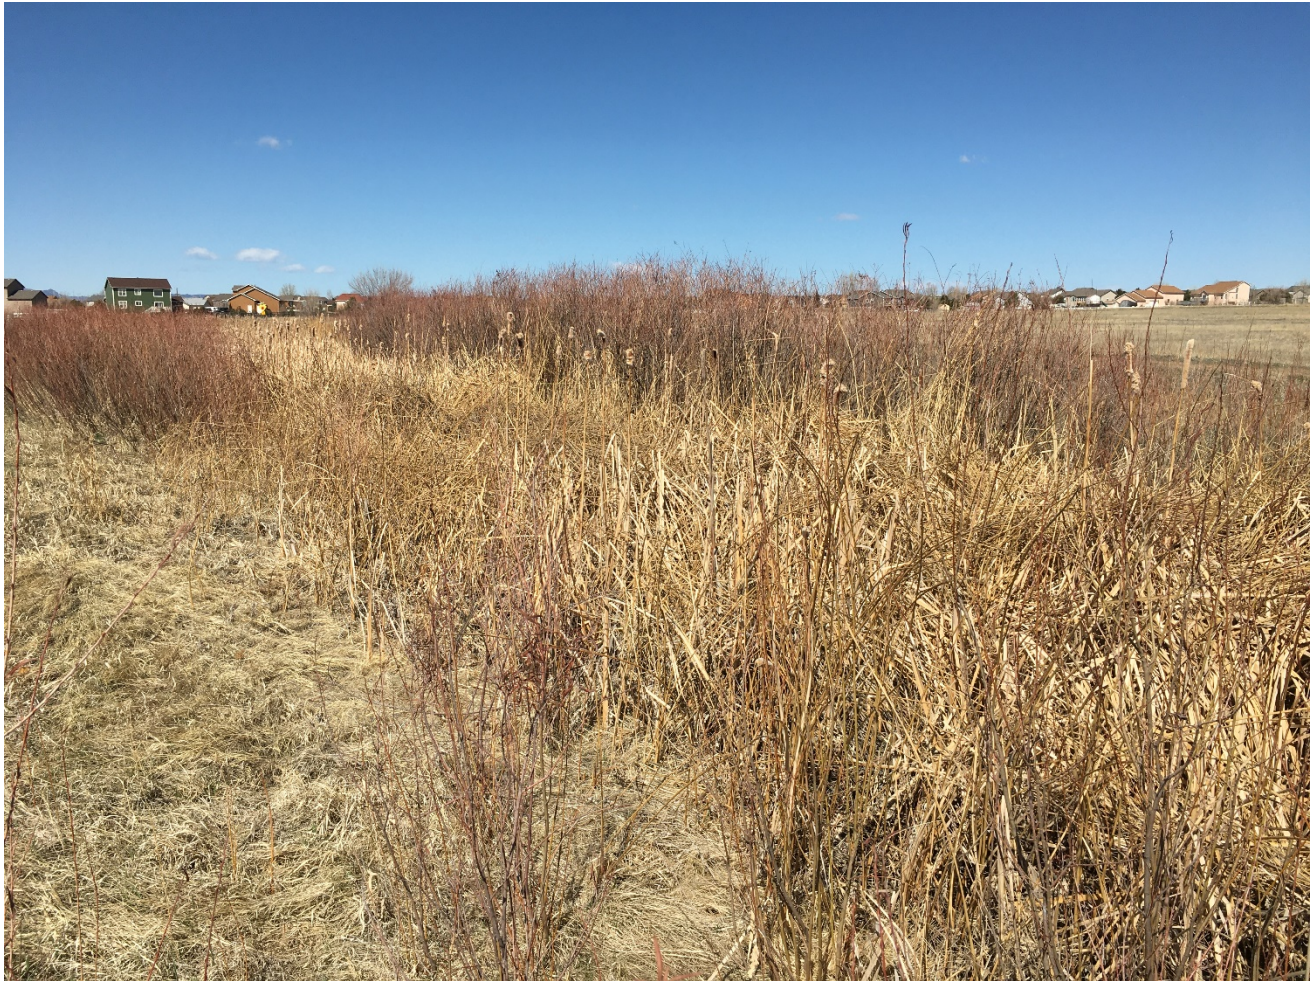
Photo 2. Thick wetland vegetation along the southern property boundary, Sample Point 3, facing west.

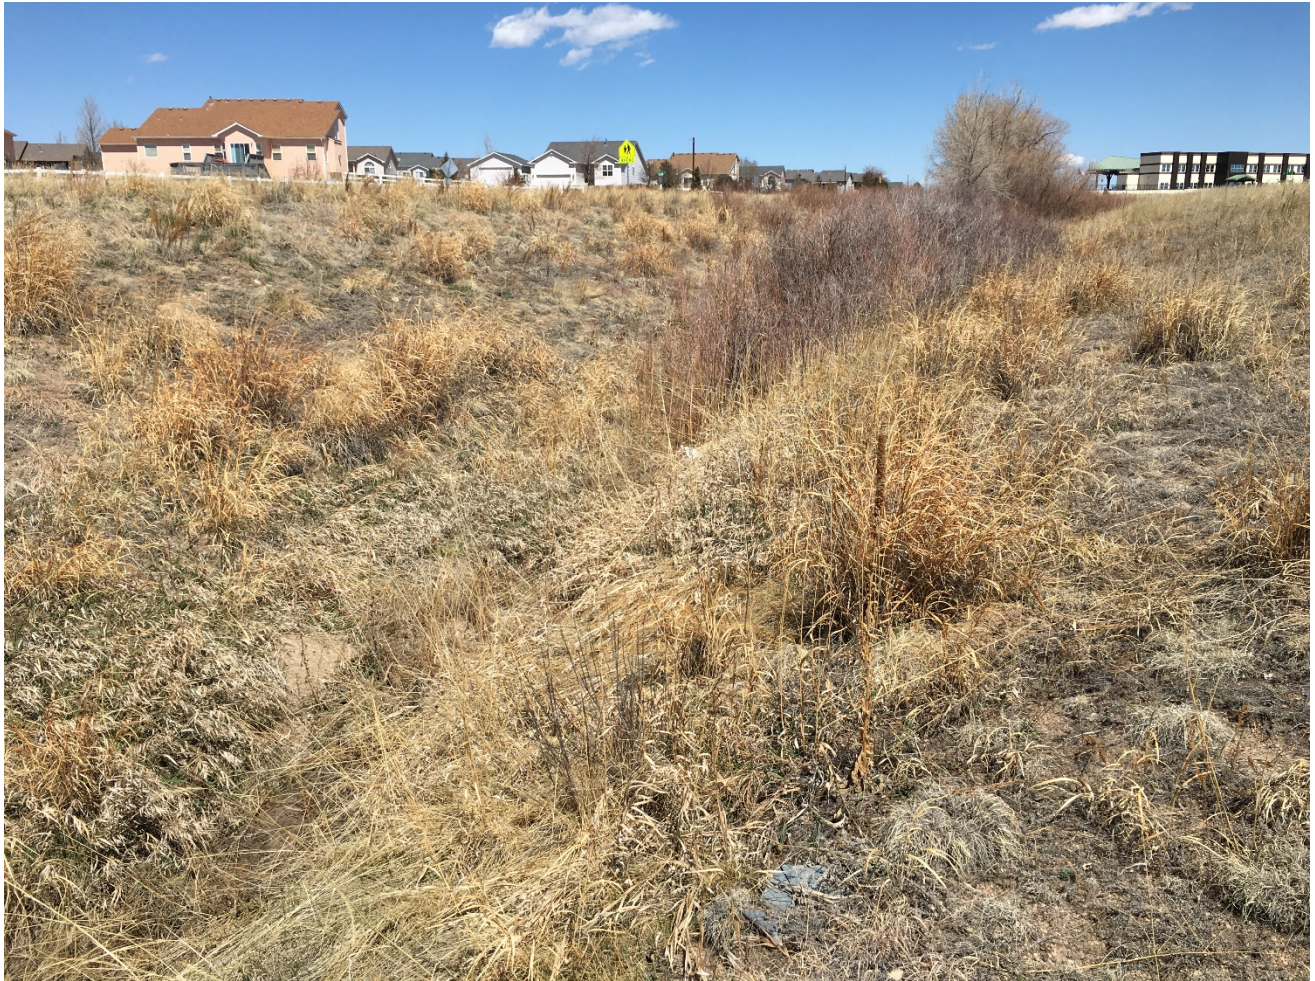
Photo 3. Facing northwest looking at the intermittent stream channel along the western property boundary. A break in wetland vegetation can be seen here, then wetlands beginning again where the thick willows occur. A jurisdictional channel maintains hydrologic connection throughout.

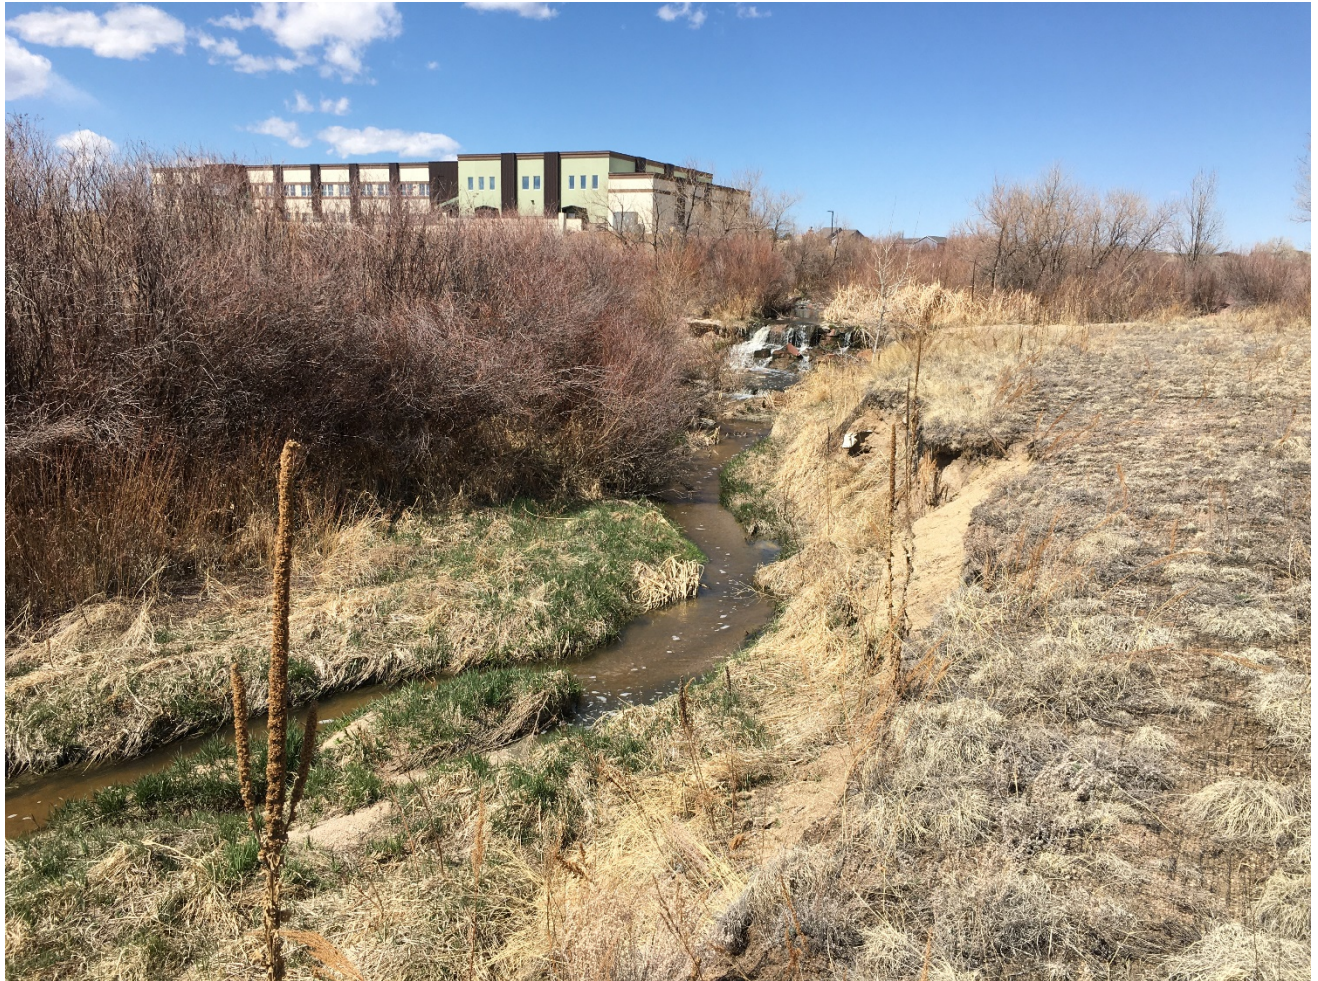
Photo 4. View of the eastern R5UBF wetland showing flowing surface water, a defined stream channel, and the presence of wetland vegetation along the banks and in the channel.
