RE: Request for Approved Jurisdictional Determination

Sterling Ranch Filing No. 4 El Paso County, Colorado

Approved Jurisdictional Determination Request Sterling Ranch Filing No. 4 El Paso County, Colorado

September 6, 2023

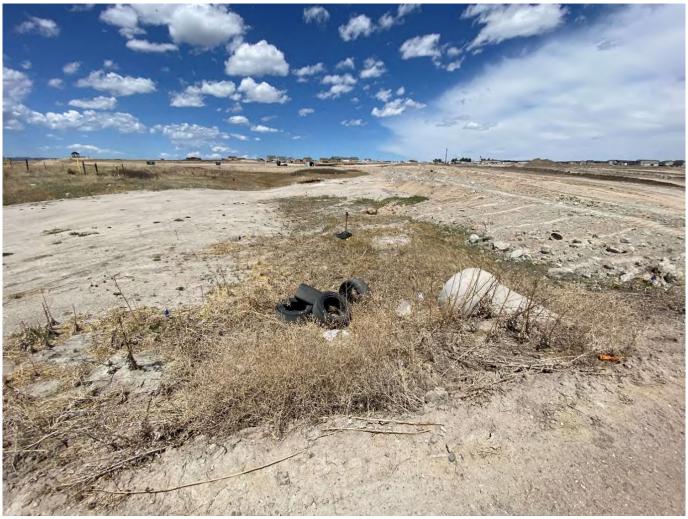
W4 and W5 – North-facing view from the construction road crossing south of W4. Darker brown areas are areas where wetland vegetation can be found, surrounded by areas impacted by grading. The culvert that connecting W4 to W6 is seen on the right side. Grading for Sterling Ranch Road can just be seen as a raided road grade just beyond W5 in the distance.

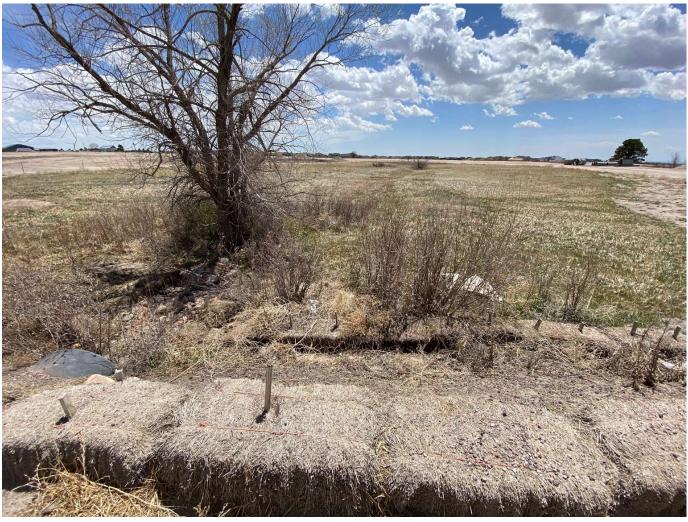
W6 – Northern extent of W6 facing south from the roadway separating W6 from W4 and W5 to the north. Wetlands are the darker vegetation along the narrow, shallow swale running directy away from the observer. The fields on either side of the swale are dominated by smooth brome.

Beyond W6, the extensive grading around the constructed basin can just be seen.

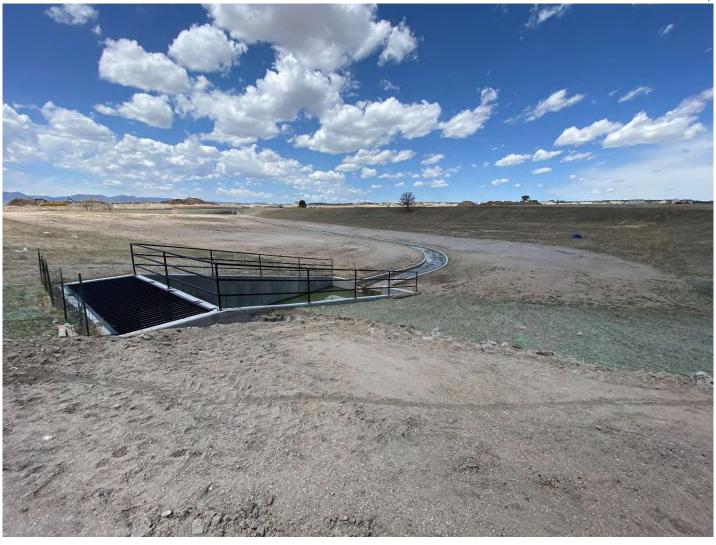
View of the detention basin located south of W6, facing NW. Stormwater flows from the surrounding development are piped into this basin, which lacks surface connection to any of the wetlands on the Project site.

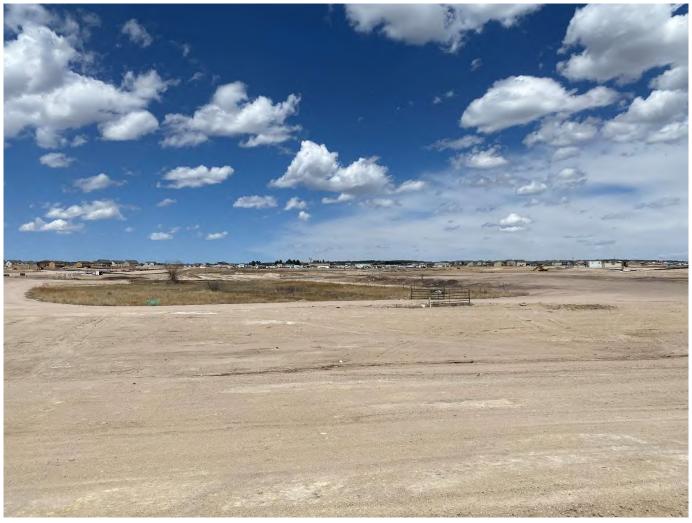
Graded areas immediately south of W6, facing north towards W6. Additional grading around W4, W5, and W1 can be seen in the distance. These graded areas, along with the more than 1,400 feet of fill along the former swale to the south in the Aspen Meadows development, disrupt surface connection to downstream WOTUS.

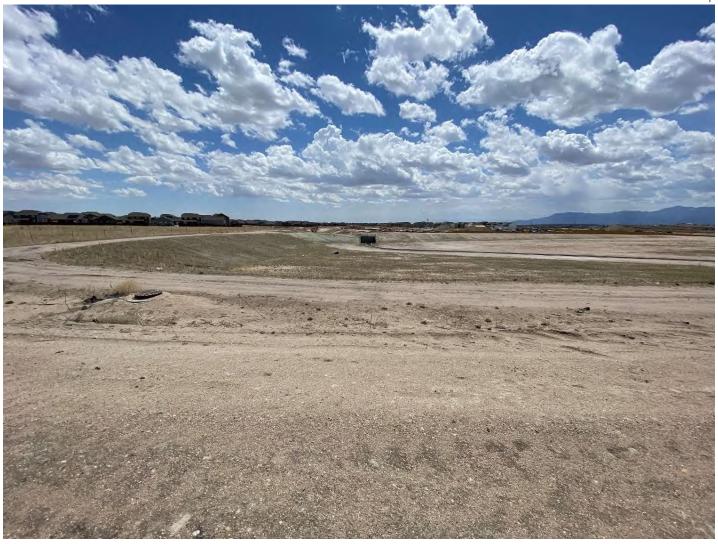
Extensive graded areas at the south end of the Project area, just north of the Aspen Meadows development; houses in this development can be seen from the righthand edge to the approximate center of the photo. The houses at left are from another offsite development.

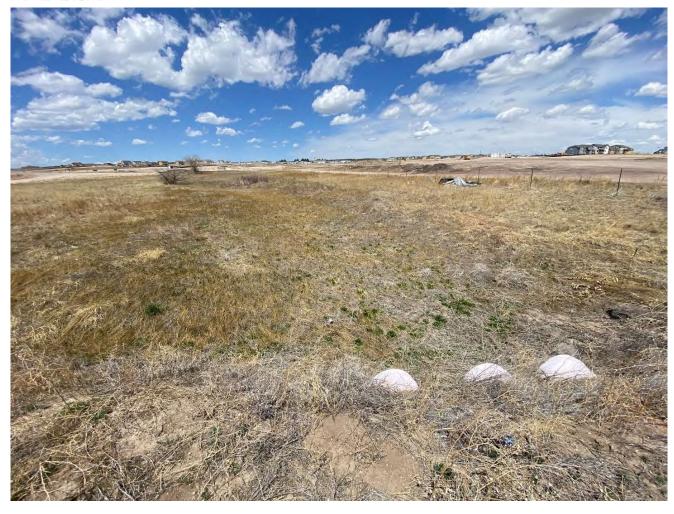
View of W6 facing north. Darker green-brown vegetation along the center of the image is wetland vegetation, surrounded by upland vegetation and some graded areas along the outside of the uplands. The triple culvert at the bottom right previously conveyed water along the same swale, which ran south off of the property and onto the Aspen Meadows site. Presently, the triple culvert conveys flows through underground pipes approximately 300 feet southwest to the concrete forebay to the large detention basin to the south.
