WETLAND DELINEATION REPORT

Arroya Lane Road Expansion El Paso County, Colorado

Bristlecone Ecology, LLC
2023 W. Scott Place
Denver, CO 80211
Contact: Dan Maynard
dmaynard@bristleconeecology.com

September 25, 2023

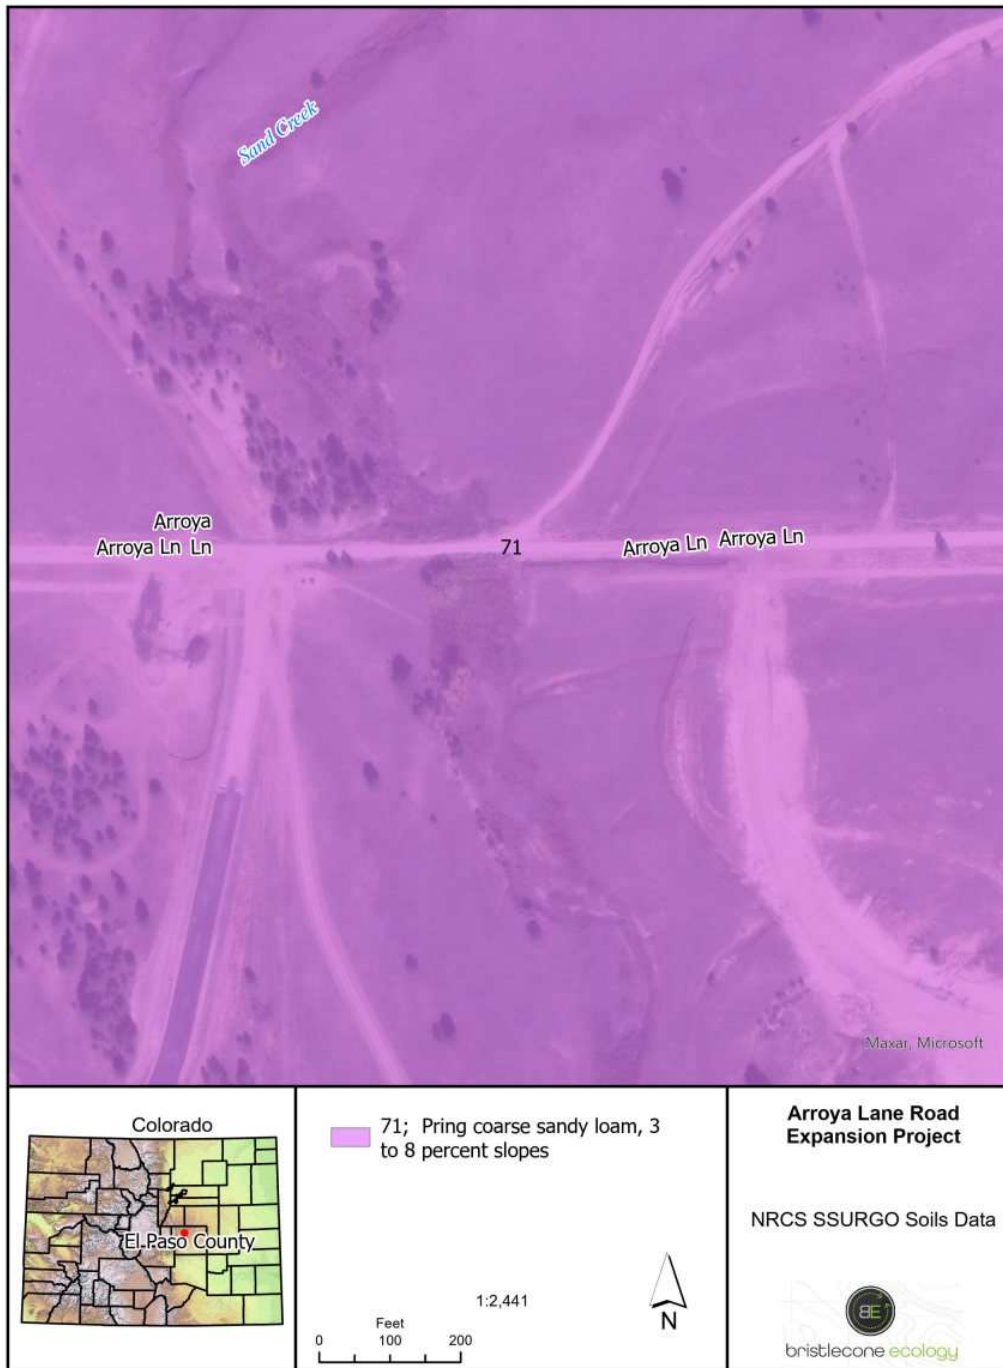
Figure 3: NRCS SSURGO Soils Data

County soil survey data indicate that the site is composed entirely of Pring coarse sandy loam, 3 to 8 percent slopes (**Figure 3: NRCS SSURGO Soils Data**). The Pring soils series is a consociation, so other, minor soil series may be present within it (NRCS 2023). The primary minor series that forms the remainder of the consociation is the Pleasant series, which is typically found in depressions and is rated as hydric in El Paso County (NRCS 2023).

A review of the hydric soil ratings for all soil components present in the Study Area was performed to aid in the determination of wetland habitats during the site reconnaissance. Hydric soils are those that form under conditions of saturation, flooding, or ponding long enough during the growing season to develop anaerobic conditions, and their formation is required for the establishment of wetlands to take place. The Pring series was described as having a hydric rating of zero (less than 1% hydric components) (NRCS 2023). The minor Pleasant component of the Pring consociation is rated as hydric in EPC under the criterion that it is “frequently ponded for long or very long duration during the growing season” (NRCS 2023). Based on these ratings, the suitability of the fluvial plain and other depressions where the Pleasant component is more likely to be found, and relatively low everywhere else. If wetlands occur onsite, they are most likely to form along the Sand Creek corridor, and possibly within other isolated depressions.

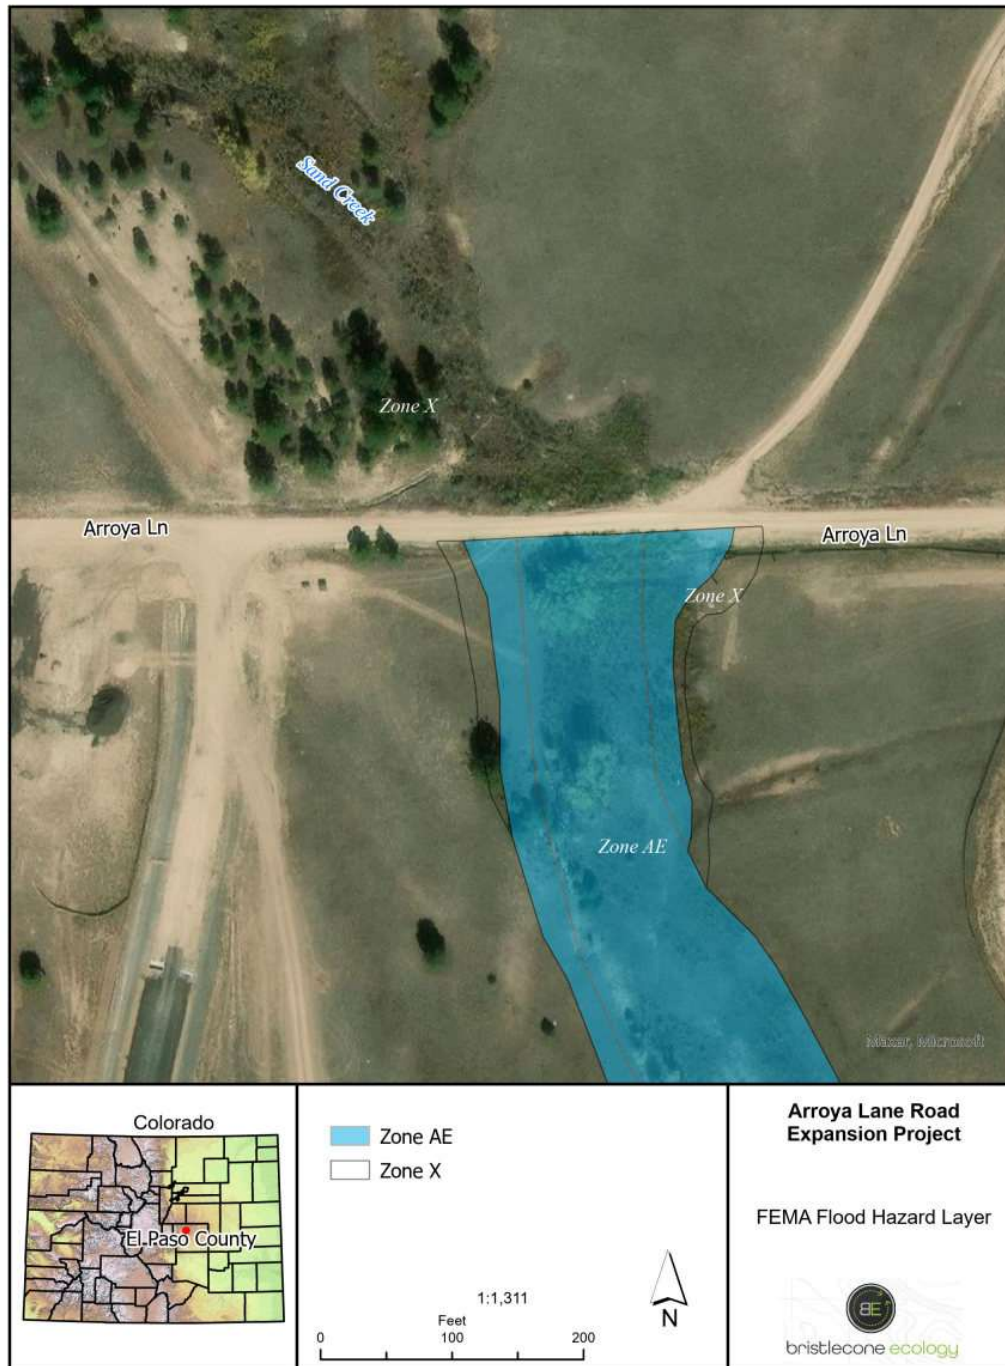
Figure 4: FEMA Flood Hazard Layer

A review of FEMA floodplain hazard maps (FEMA 2023) was conducted to determine the existence, location, and extent of floodplains located within the Study Area. The floodplain hazard maps depict floodplain areas along rivers and tributaries. The maps record the following data: 100-year floodplains (1% chance of annual flooding) and 500-year floodplains (0.2% annual chance of flooding), the height of the base flood (Base Flood Elevations), and the risk premium zones developed from topographical information across a floodplain. FEMA generates floodplain maps for flood insurance purposes.

A review of the National FEMA flood hazard layer (2023) indicated that portions of the Study Area within and adjacent to Sand Creek are in Zone AE, and are thus at risk of inundation by a 100-year flood (**Figure 4: FEMA Flood Hazard Layer**). In addition, a small portion of the remaining area within the Sand Creek fluvial plain is within the 500-year flood zone (0.2% annual chance of flooding) (**Figure 4**). The remainder of the property is identified as Zone X flood zone, which consists of areas of minimal flood risk “outside the 1-percent and 0.2-percent-annual-chance floodplains” (FEMA 2005).

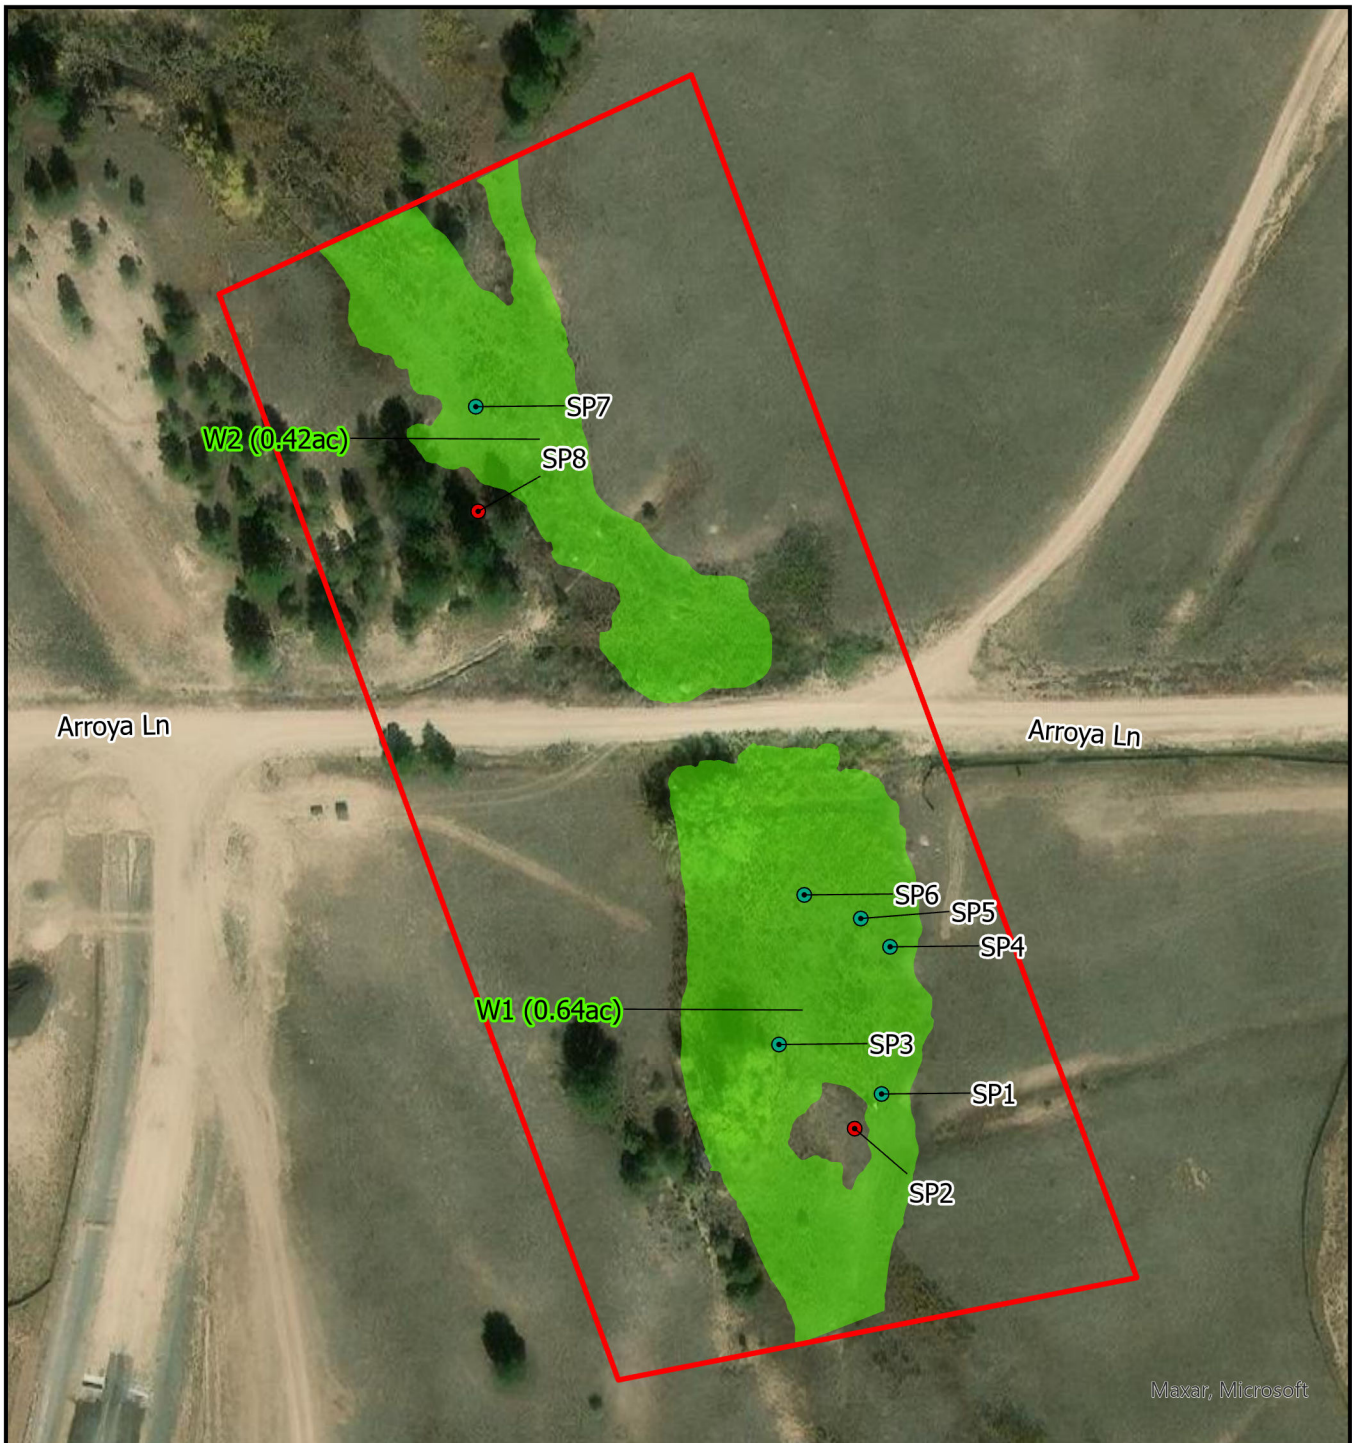
APPENDIX A:
WETLAND LOCATION MAP

- Study Area
- Wetlands (1.06 acres)
- Upland Point
- Wetland Point

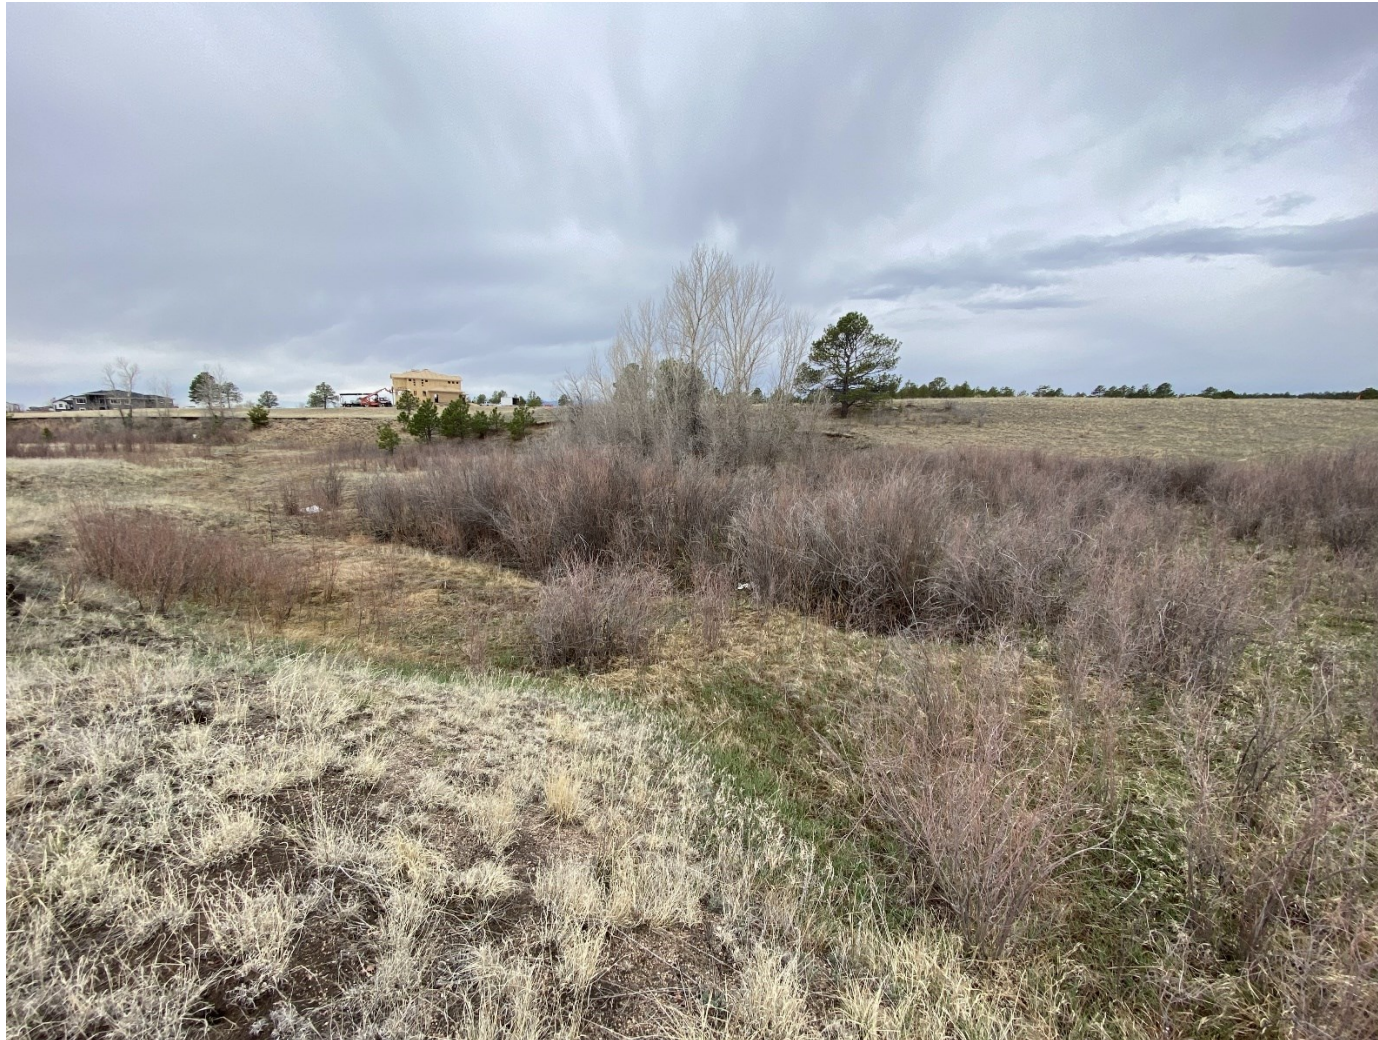
Scrub-shrub wetlands in the Sand Creek floodplain south of Arroya Lane, facing southwest. Wetlands on the site such as these were confined to a fluvial plain and highly dependent upon elevation. The transition to uplands is clearly visible at the toe of slope in the foreground.

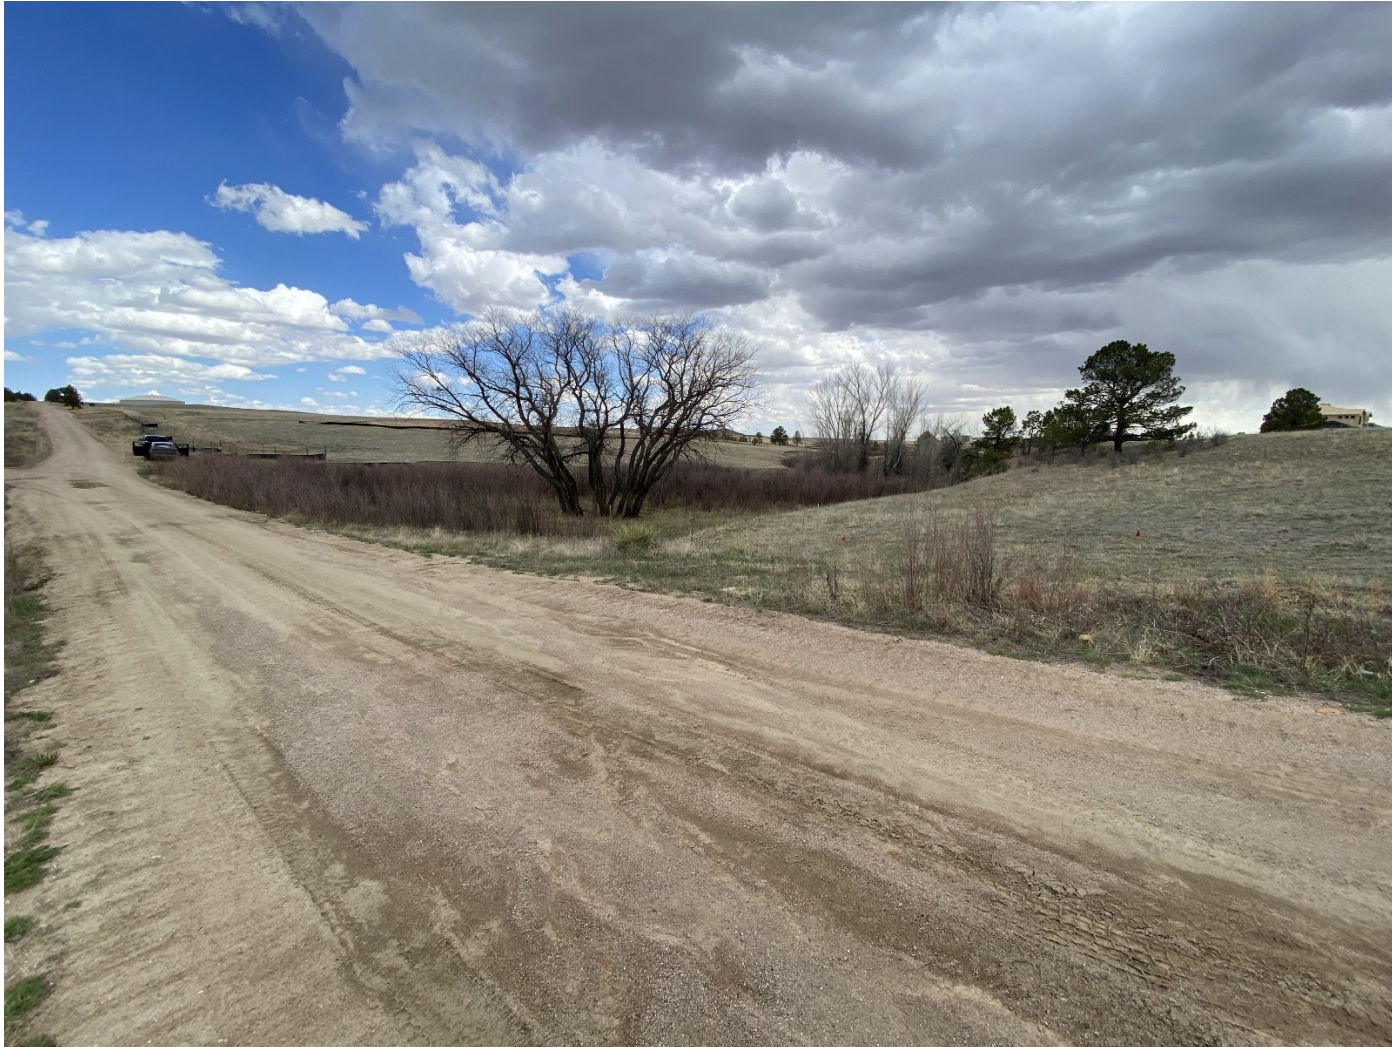
Another view of the wetlands south of Arroya Lane as seen from the roadway, facing southeast. A few large trees are visible in the floodplain, as well as a few stray ponderosas on the hillslopes above Sand Creek. The Arroya Lane expansion will affect wetlands on both sides of the roadway.

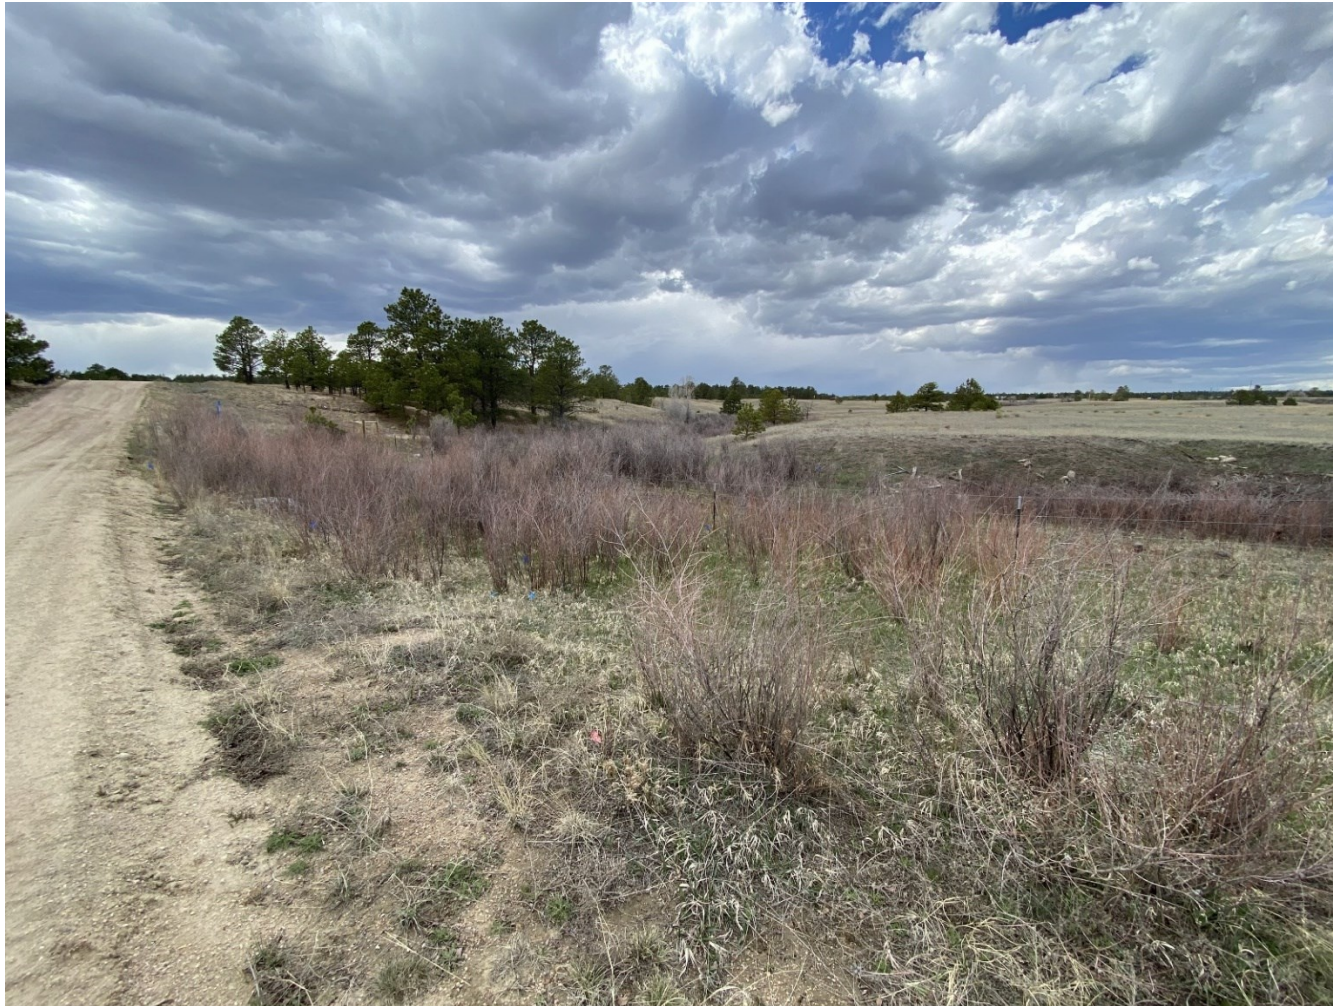
Wetlands north of Arroya Lane as seen from the roadway, facing northwest. Similarly to the area south of the road, wetlands closely follow the fluvial plain of Sand Creek, with the slightest increase in elevation resulting in a transition to upland areas dominated by ponderosa pine forests or grasslands.

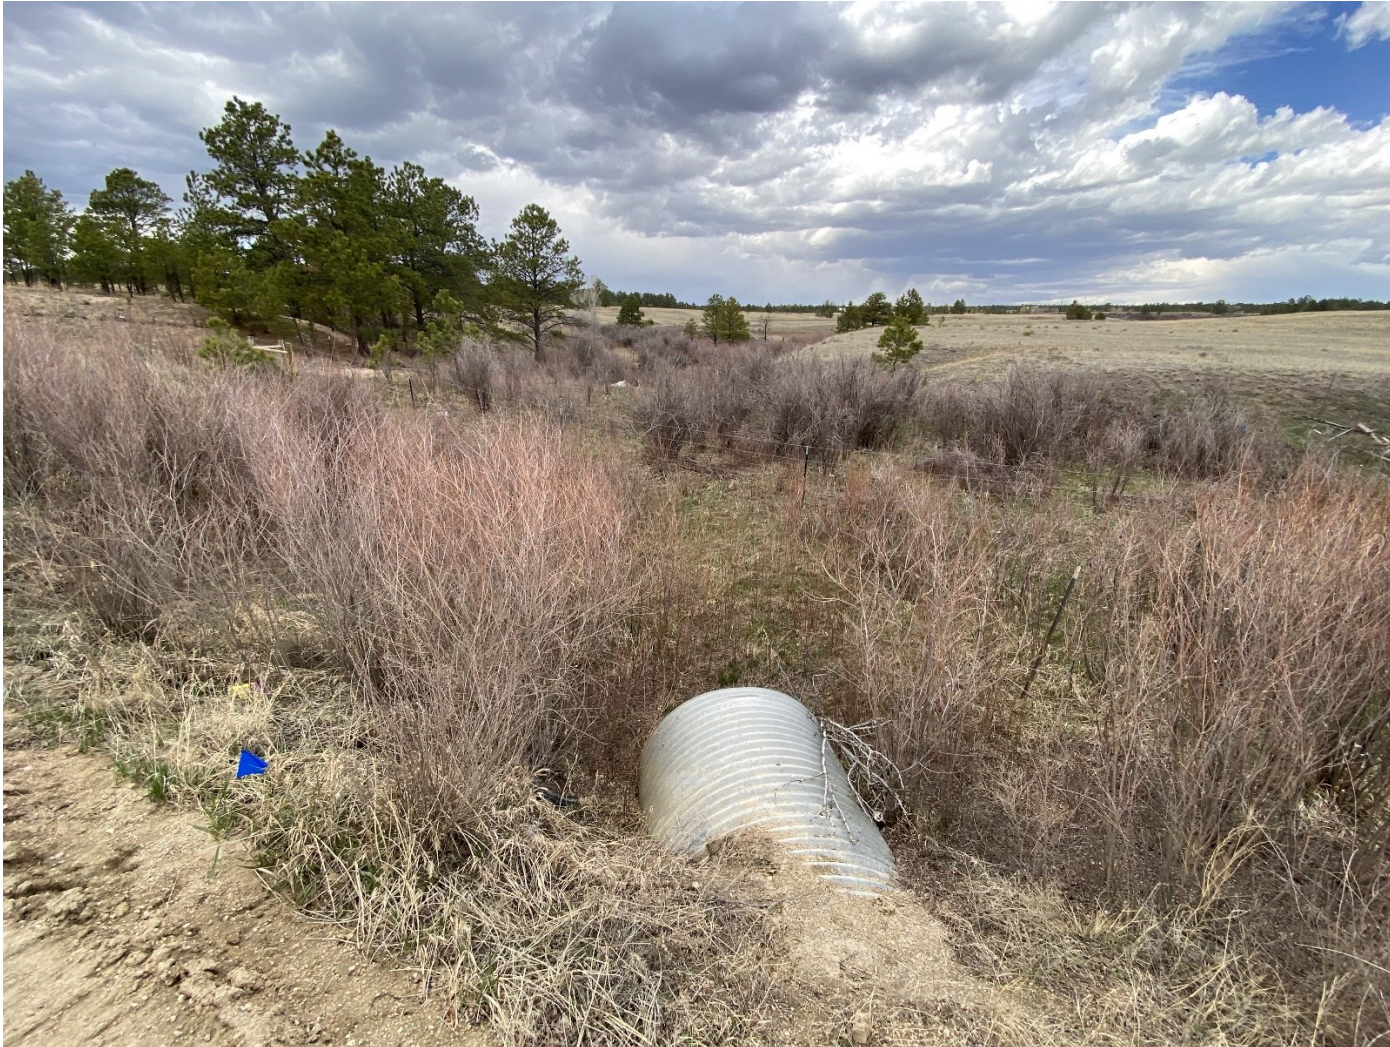
Another view of the wetlands north of Arroya Lane as seen from the roadway, facing north. The pines of the Black Forest can be seen in the distance, with a few creeping down the slopes toward Sand Creek. The large culvert conveys flows under the road.

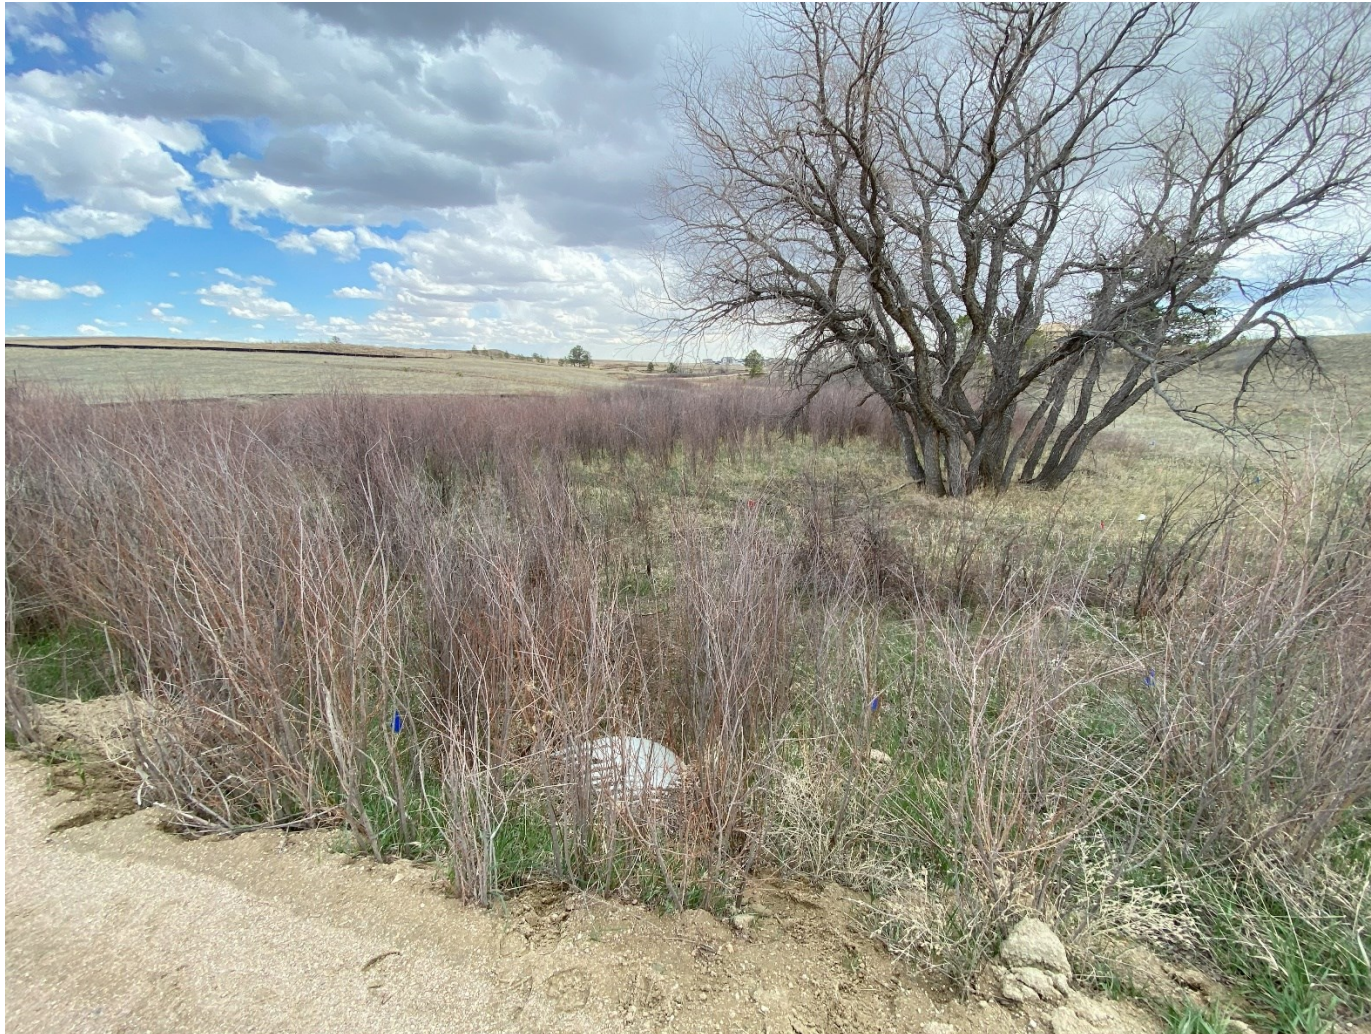
Final view from Arroya Lane looking into the willows in the floodplain with the culvert visible, facing south. There is no evidence of an OHWM present – no bed, no banks, no scour, no changes in sediment or topography – just a broad fluvial plain with willows.
