**WETLAND DELINEATION
FOR THE
STERLING RANCH DEVELOPMENT PROJECT**

EL PASO COUNTY, CO
PROJECT No. 15-001

MAY 7, 2015

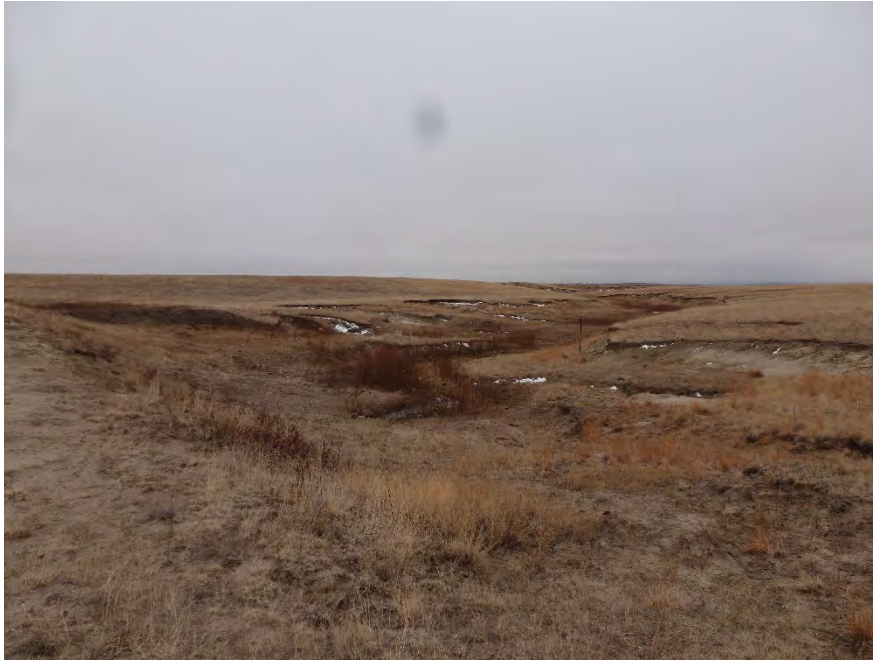
Sampling Point 1 (SP 1) Vicinity – Looking south down Sand Creek from just south of Pond 4. Typical Sand Creek stream channel characteristics and vegetation. 2/5/15

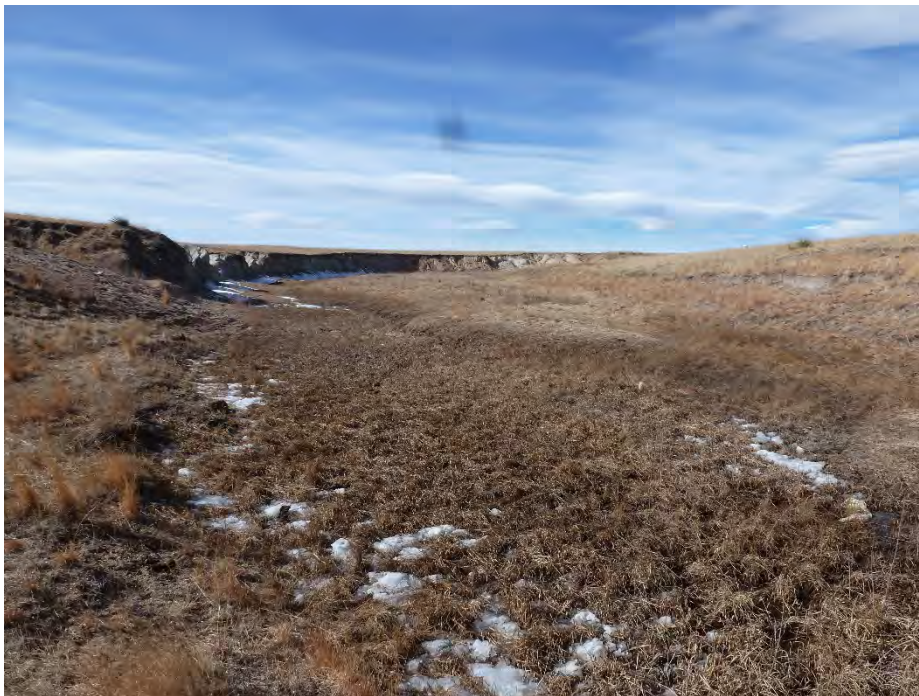
Sampling Point 2 Vicinity – Looking northwest (upstream) from proposed Sterling Ranch Road crossing. Typical Sand Creek stream channel characteristics and vegetation.

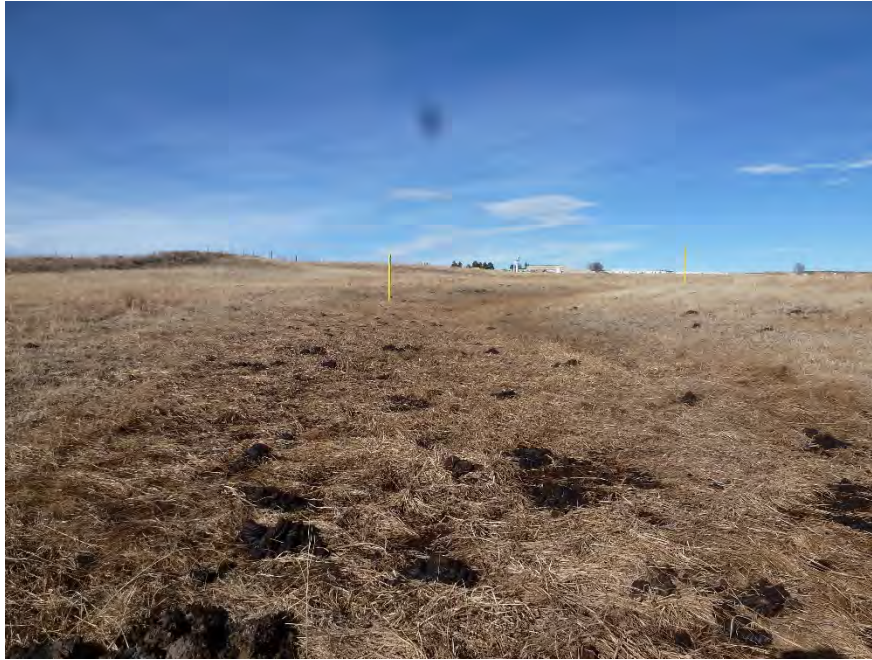
Sampling Point 3 Vicinity– Looking north along western tributary (Wetland 1) from proposed Sterling Ranch Road crossing. Area is typical of the northern half of the western tributary. Photo taken on 2/5/15 when cattle were still on the site.

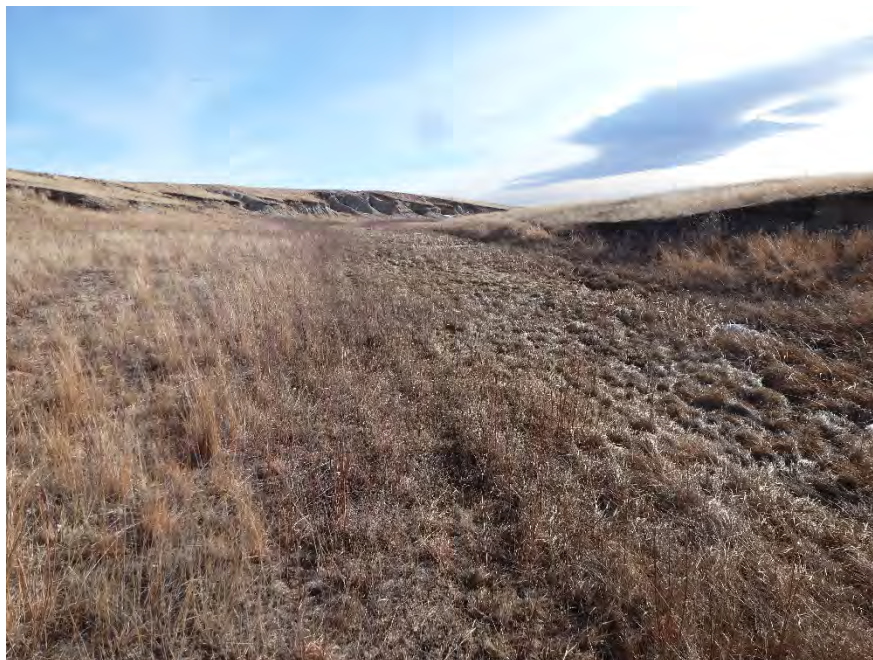
Sampling Point4 Vicinity – Near proposed Briargate Parkway crossing of Wetland 6. Typical Sand Creek stream channel characteristics and vegetation.
2/5/15

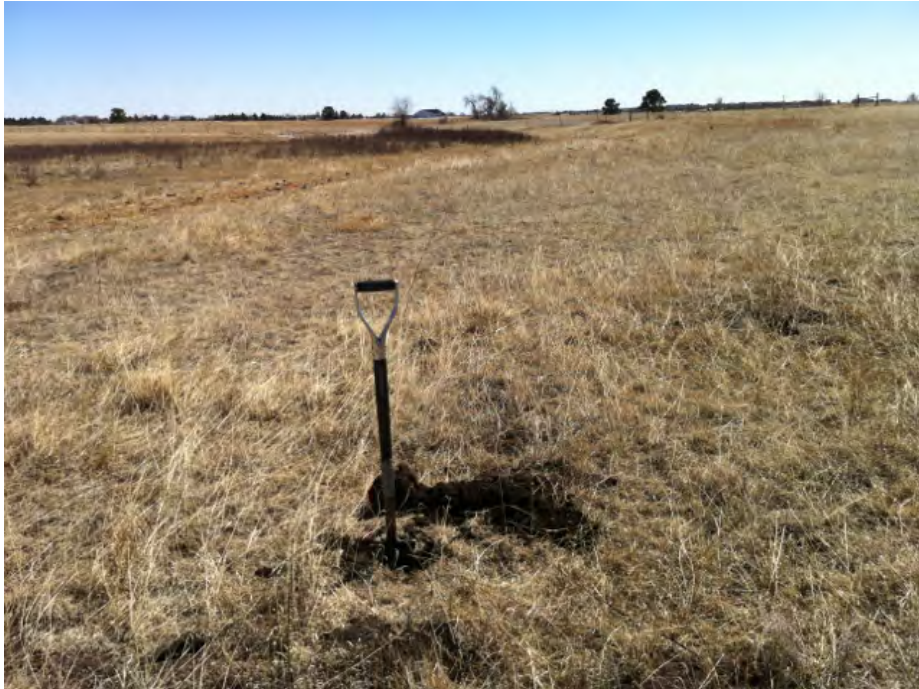
Sampling Point 5 – Upland near Western Tributary, facing southeast towards Western Tributary. 3/10/15

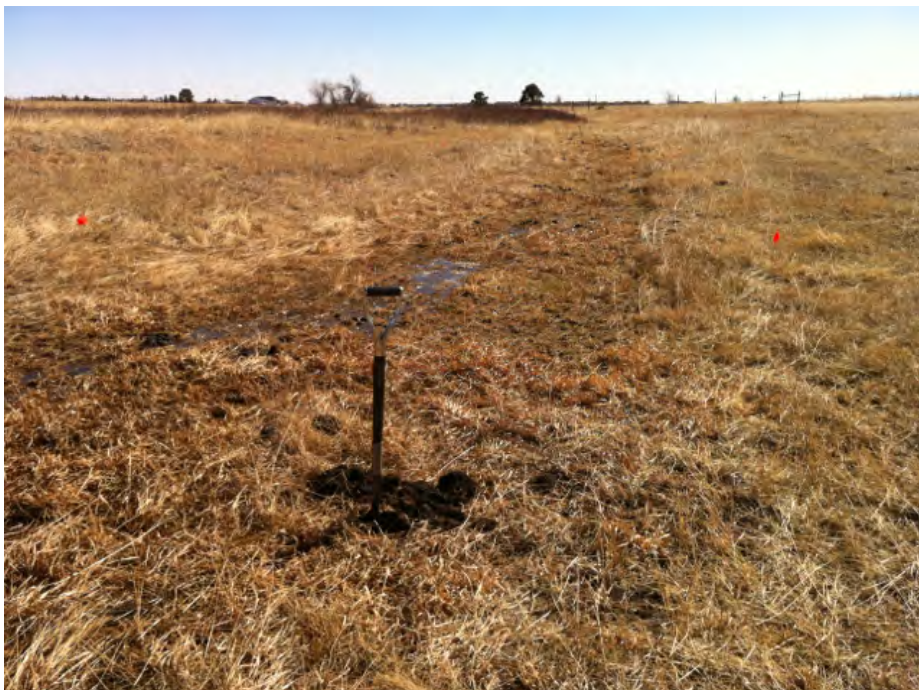
Sampling Point 6 – West side of Western Tributary wetland, looking south along Wetland 1 swale. Photo taken on 3/10/15; cattle had been removed 2-3 weeks earlier.

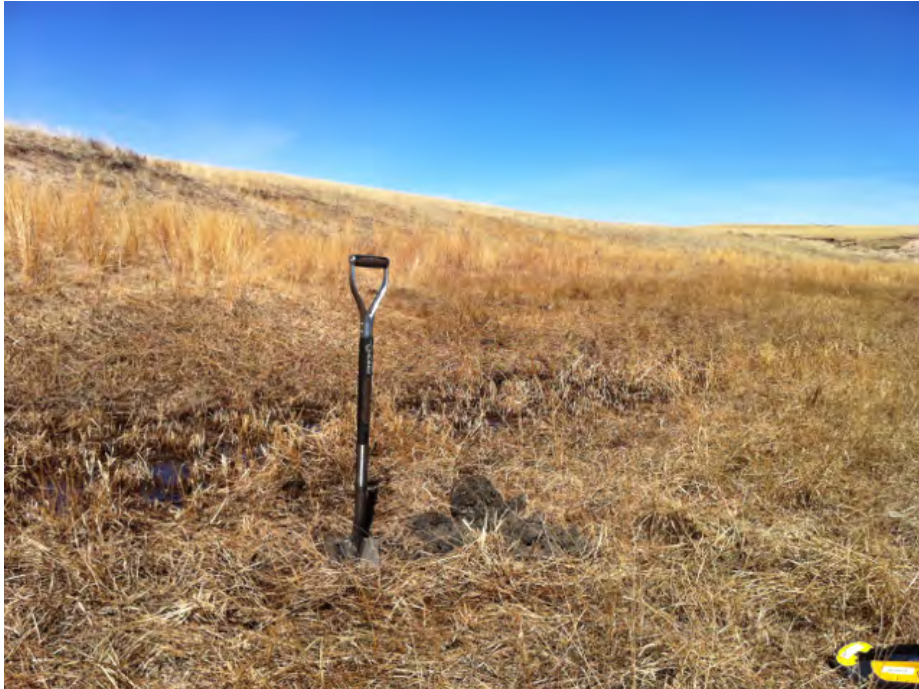
Sampling Point 7 – Wetland vegetation in Sand Creek, facing northwest. Note shallow, standing water on left side of photo. 3/11/15

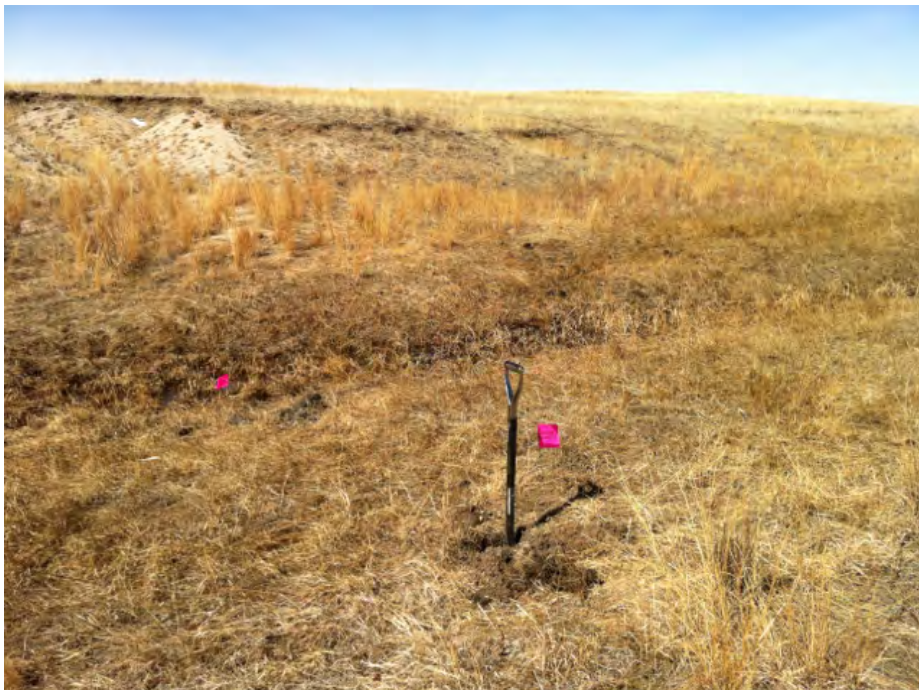
Sampling Point 8 – Wetland on low bench along east side of Sand Creek, facing west towards SP 7. 3/11/15

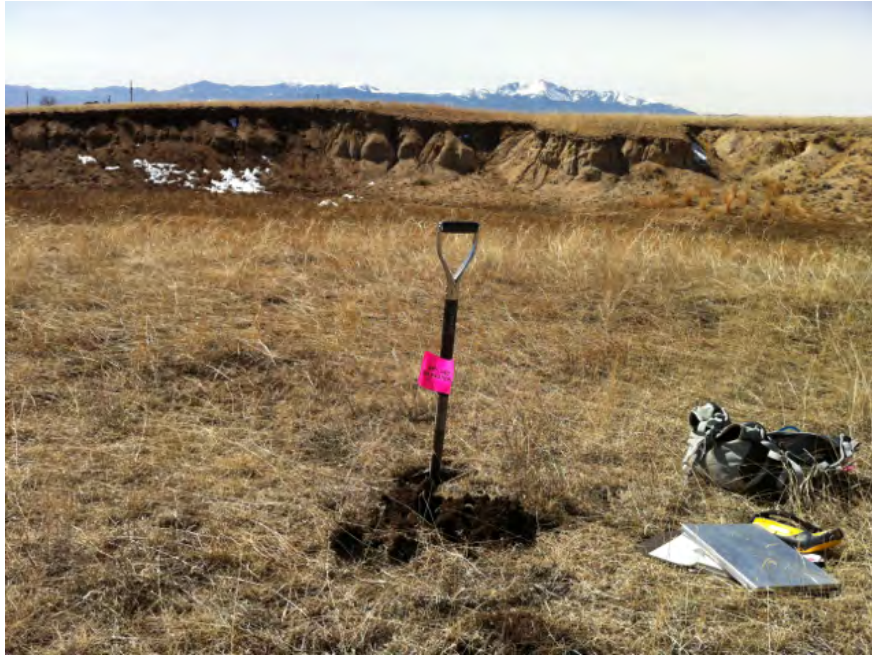
Sampling Point 8 – Upland above Sand Creek, facing west towards SP 7 and 8.
3/11/15

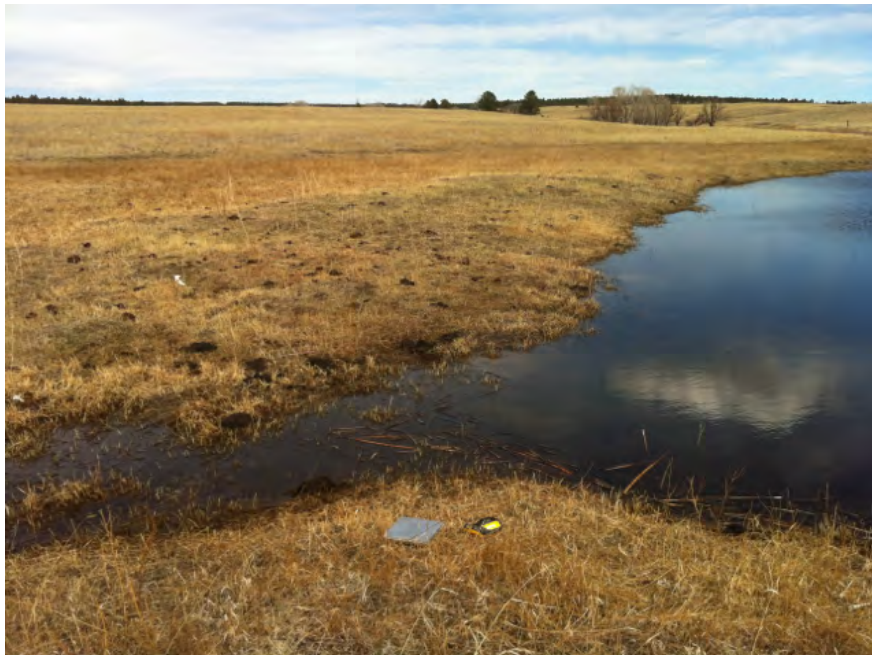
Pond 1 – Looking north from west end of the dam. Water flows out of the pond on this southwest corner and there is also a culvert in the dam center that drains south into the main channel of Sand Creek. The distant cottonwoods are growing along Sand Creek just north of the Project Area. 3/22/15

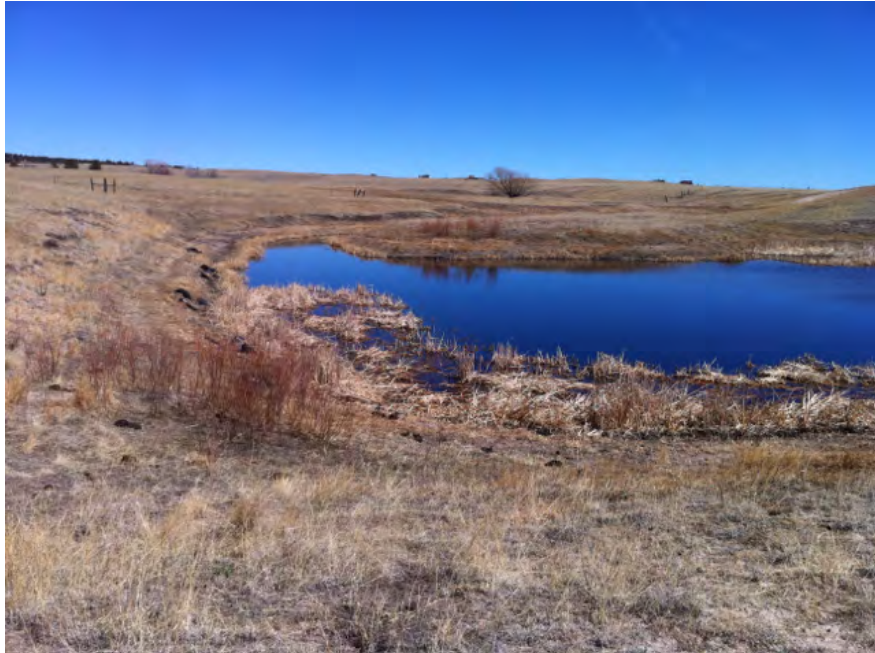
Pond 2 – Looking north from dam. Sand Creek enters the pond on left side of the photo. Pond has well-developed fringe of emergent vegetation. 3/16/15

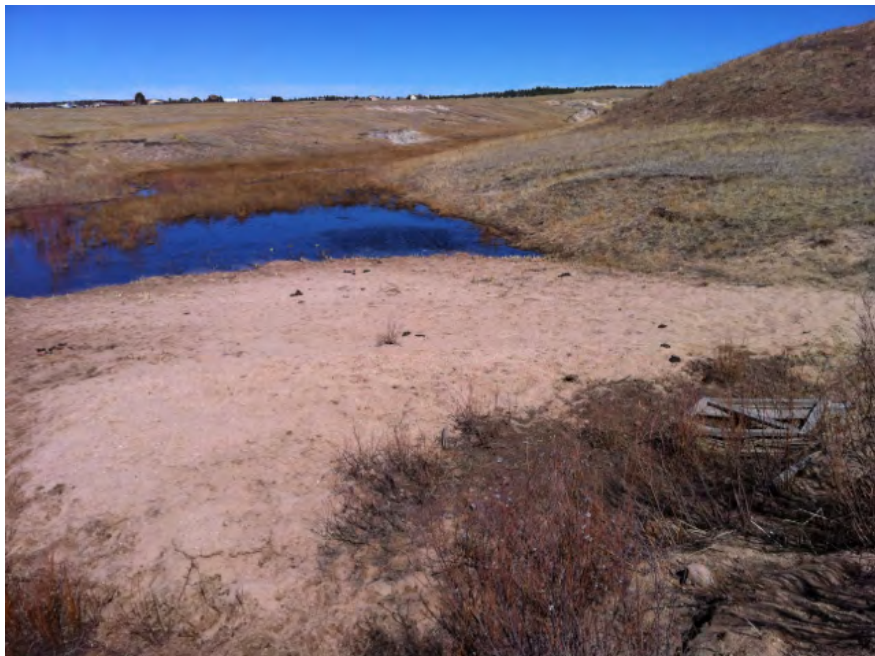
Pond 3 – Looking north from the road, across a shallow ponded area and up Sand Creek (Wetland 7). Water from the adjacent uplands flows into this area via a sandy channel partially visible on the right (east) side of the photo. 3/16/15

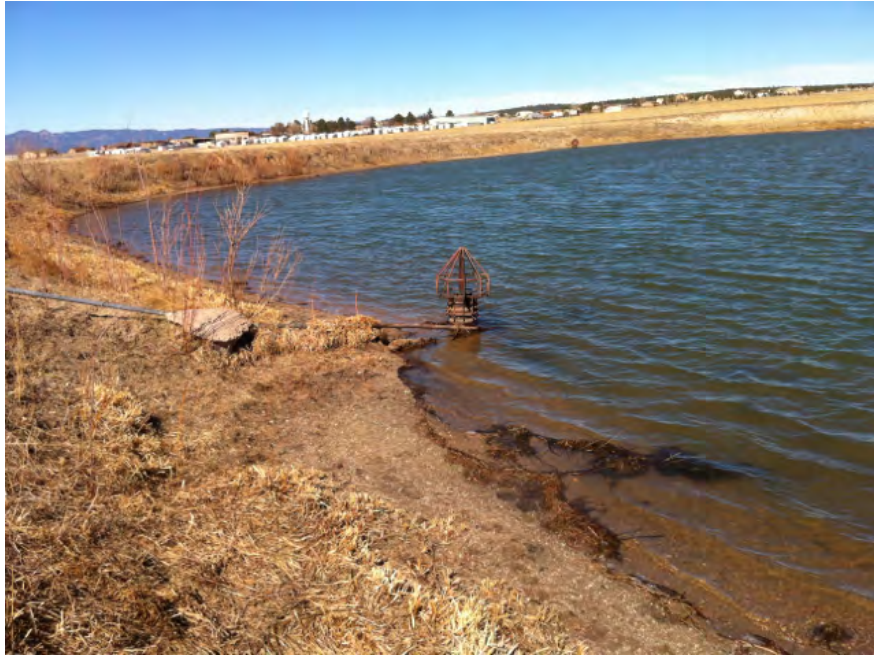
Pond 4 – Looking northwest from dam. This deep pond has a sparse, narrow wetland fringe. The pond drains via the standpipe, to a culvert under the dam, and into Pond 5. Pond 5 is a small open water area (~6' diameter). 3/16/15

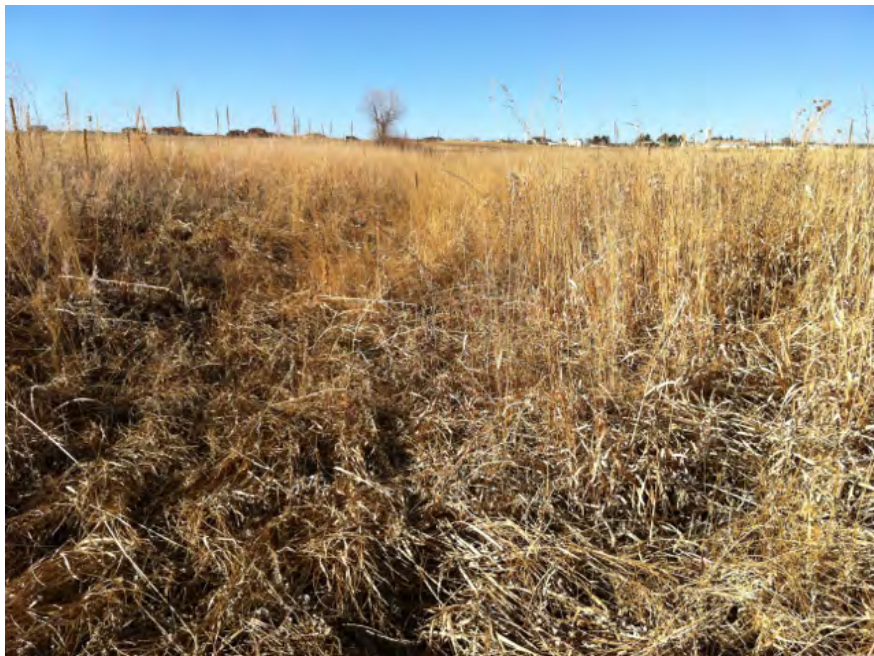
Western Tributary, Wetland 2 – Southern half of the western tributary to Sand Creek, facing north along the poorly defined channel with a narrow band of wetland vegetation. 3/10/15
