# **THOMPSON THRIFT WETLAND DELINEATION AND PROTECTED SPECIES REVIEW**

**Thompson Thrift**

**July 2024**

**Olsson Project No. 024-00437**

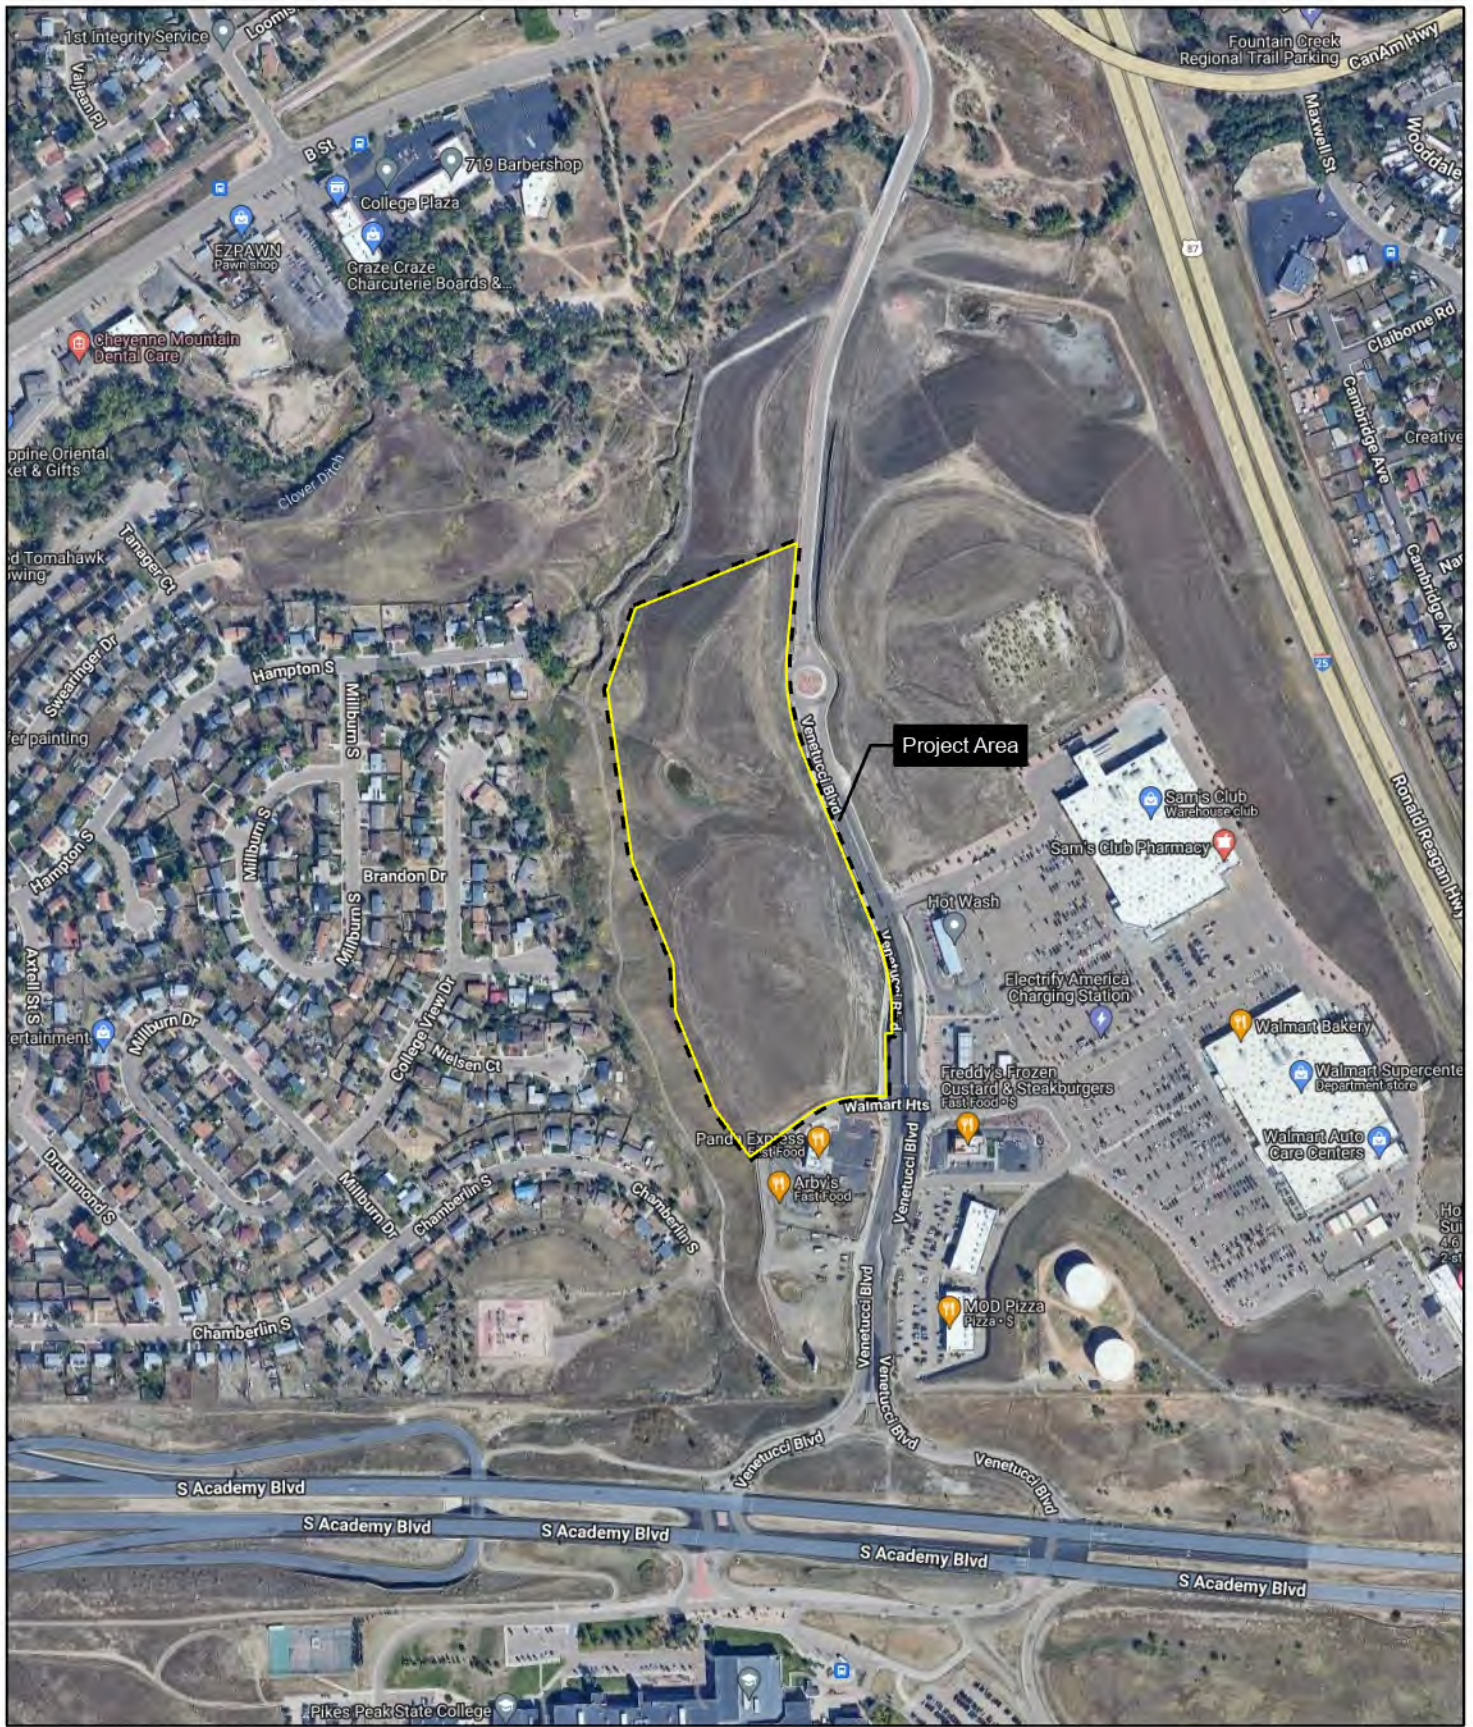
**Thompson Thrift**  
Wetland Delineation and  
Protected Species Report  
024-00437  
El Paso County, Colorado  
**Site Map**  
Figure 2

The Aerial Site Map (**Figure 2, Appendix A**) shows the Project area encompassing a broad grassed field which continues north, beyond the Project boundary. The western portion is

bounded by an unpaved two-track road adjacent to a stream channel. A densely populated residential area is located immediately west of the channel. Venetucci Boulevard bounds the eastern portion of the Project area. The area beyond Venetucci Boulevard is occupied by a number of commercial developments which continue to the southern extent of the site. A depression showing signs of saturation was identified in the north-central portion of the Project area.

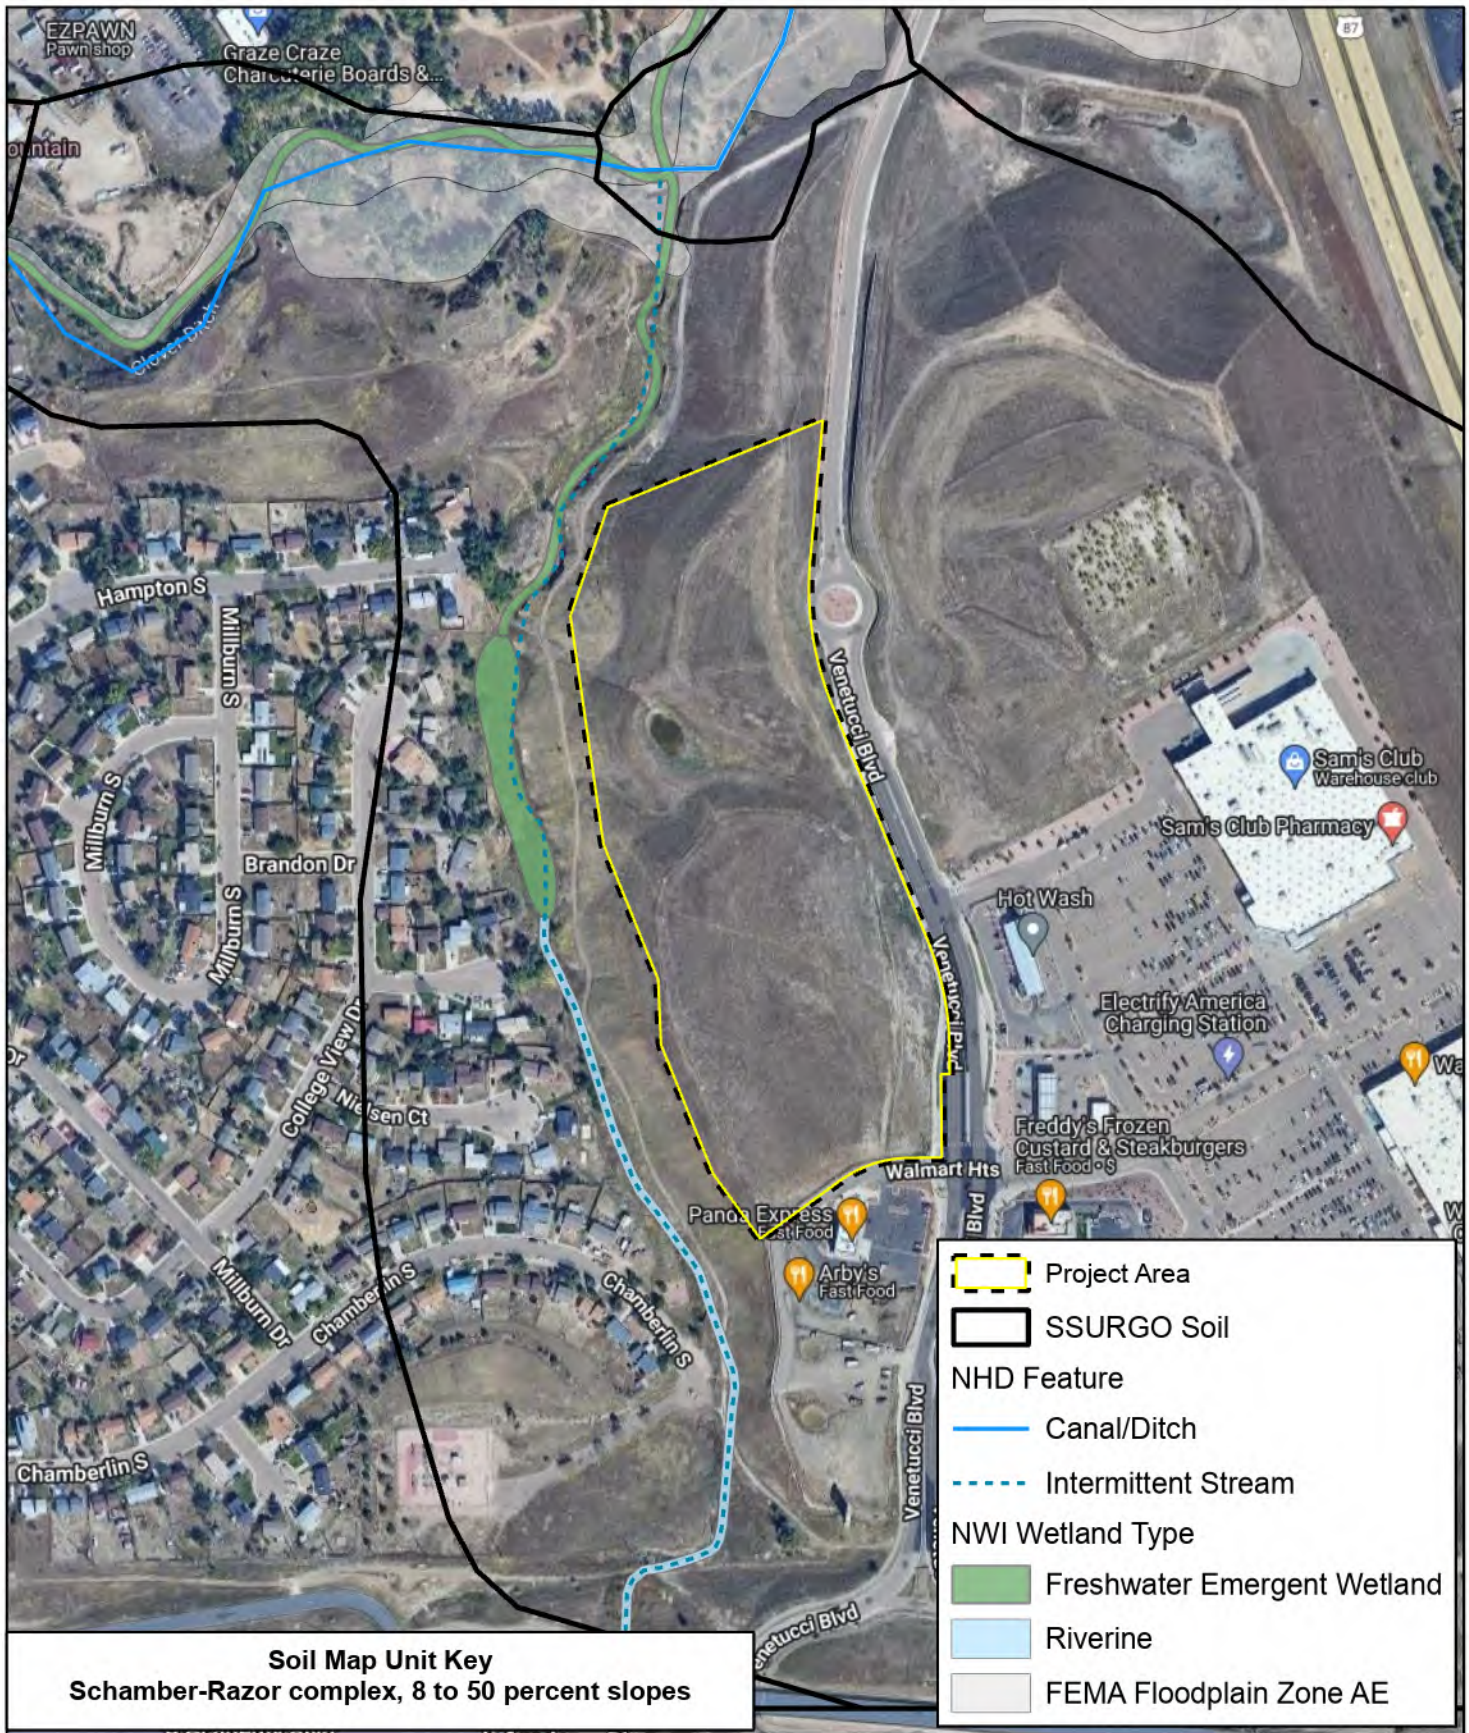
On the Natural Resources Map (**Figure 3, Appendix A**), the NHD depicts one unnamed intermittent stream channel meandering outside of the western boundary of the Project area. The water feature confluences with Clover Ditch, approximately 500 feet north of the site. The NWI indicates that no mapped wetland features occur within the boundaries of the Project area. One R4SBC Riverine habitat feature, and two emergent wetland habitats (PEM1B and PEM1C) associated with the unnamed water feature occur beyond the western boundary of Project area.

The Natural Resources Map (**Figure 3, Appendix A**) identified the following SSURGO soil map unit within the Project area:

- Schamber-Razor complex, 8 to 50 percent slopes, 1 percent hydric rating

The hydric percentage indicates what percentage of the soil map unit meets the criteria for hydric soils, which may indicate wetland conditions. The one percent hydric rating indicates that the soils within the Project area are not likely to support wetland characteristics.

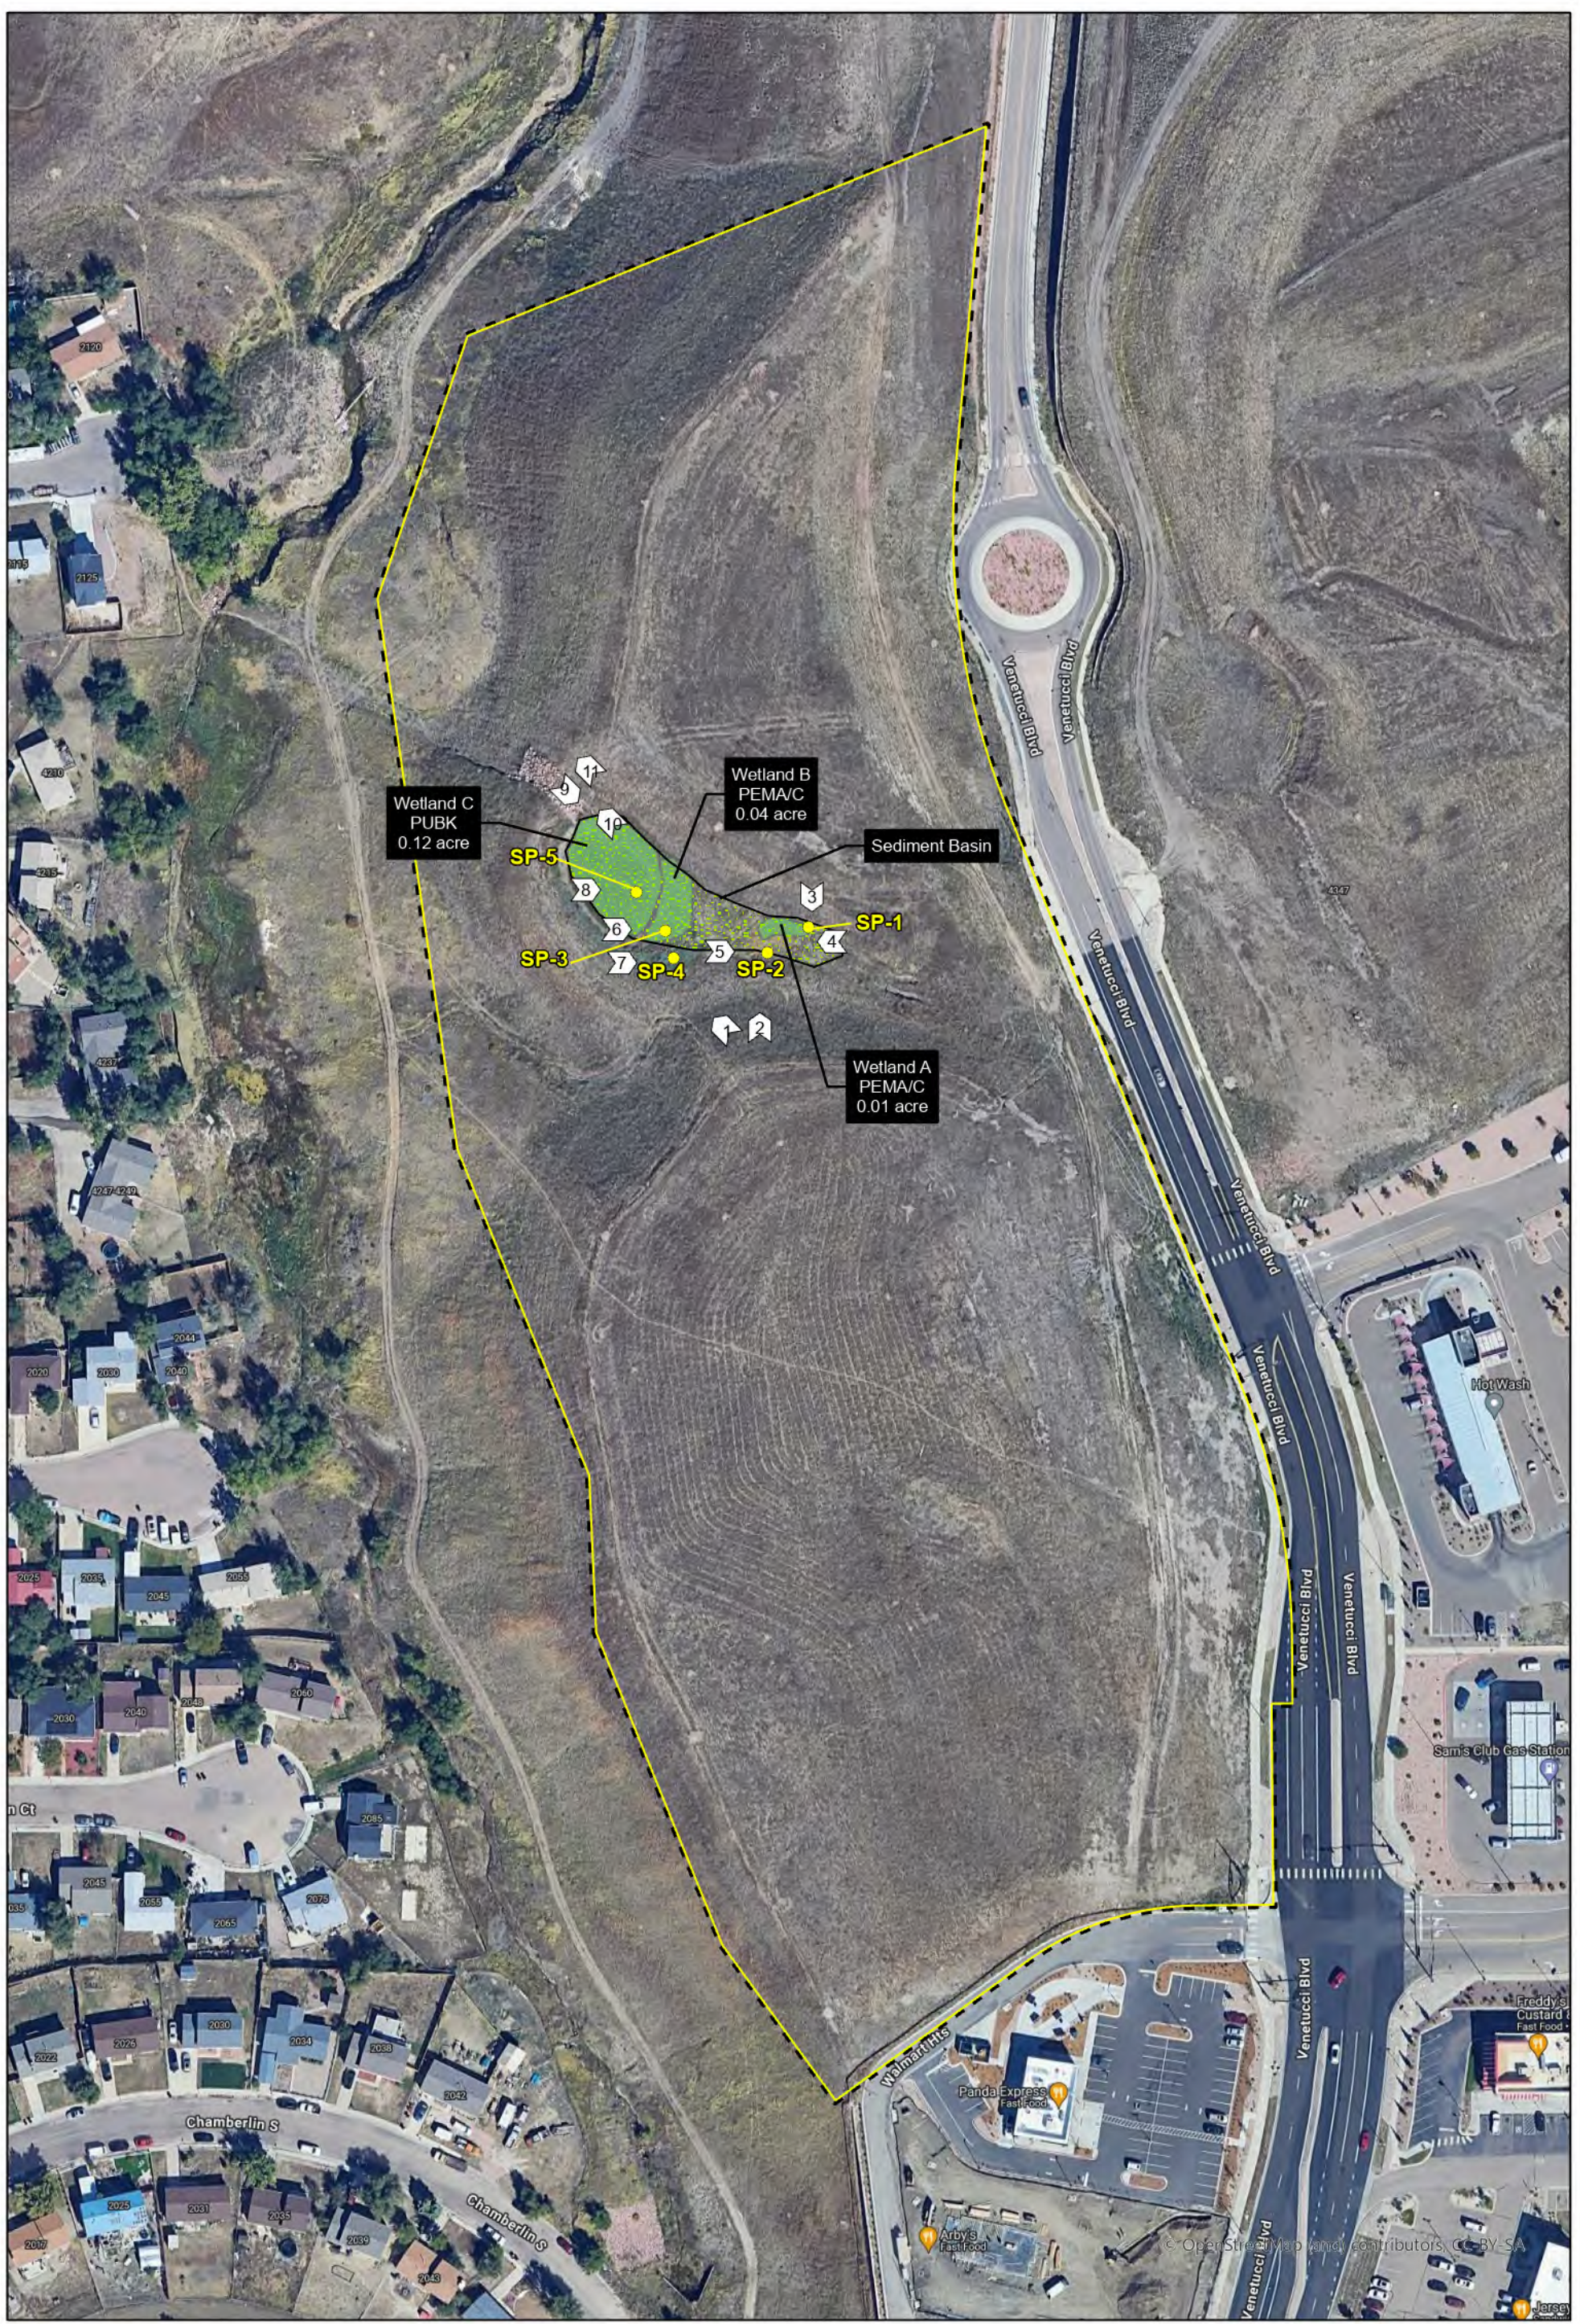
**Thompson Thrift**  
 Wetland Delineation and  
 Protected Species Report  
 024-00437  
 El Paso County, Colorado  
**Wetland Map**  
 Figure 4

Olsson staff visited the Project area on April 24, 2024, to complete the wetland delineation field investigation. The wetland delineation followed methodology described in the *U.S. Army Corps of Engineers Wetland Delineation Manual* (USACE 1987) and the *Regional Supplement to the Corps of Engineers Wetland Delineation Manual: Western Mountains, Valleys, and Coast* (USACE 2010). All conditions described represent conditions at the time of the field investigation. U.S. Army Corps of Engineers Wetland Determination Data Forms are included in Appendix B. Photographs were taken during the visit and are shown in Appendix C. Sample point locations, photo locations, and delineated water features are shown on Figure 4, Appendix A.

The Project area features a broad, terraced, upland landscape that slopes lower in elevation to the west-northwest. A total of three areas that met the criteria of wetlands were delineated within the Project area (**Figure 4, Appendix A**). These areas are all located in a man-made sediment basin constructed when the site was previously graded. Two Palustrine Emergent Temporarily Flooded / Seasonally Flooded (PEMA / C) wetlands occur within the sediment basin which widens at its northwestern extent. The northwestern extent of the sediment basin is occupied by a Palustrine Unconsolidated Bottom / Artificially Flooded open water feature (PUBK.) These features are not represented in the NWI database and although they meet the criteria of wetlands, they are not natural features and are only present due to the construction of the sediment basin.

Feature ID	Sample Point(s)	Cowardin Classification*	Photograph(s)	Figure	Size (Acres)
Wetland A	1 and 2	PEMA / C	2, 3, 4, and 14	4	0.01
Wetland B	3 and 4	PEMA / C	1, 7, and 8	4	0.04
Wetland C	4 and 5	PUBK	1, 9, and 10	4	0.12
<b>TOTAL (ac)</b>					<b>0.17</b>

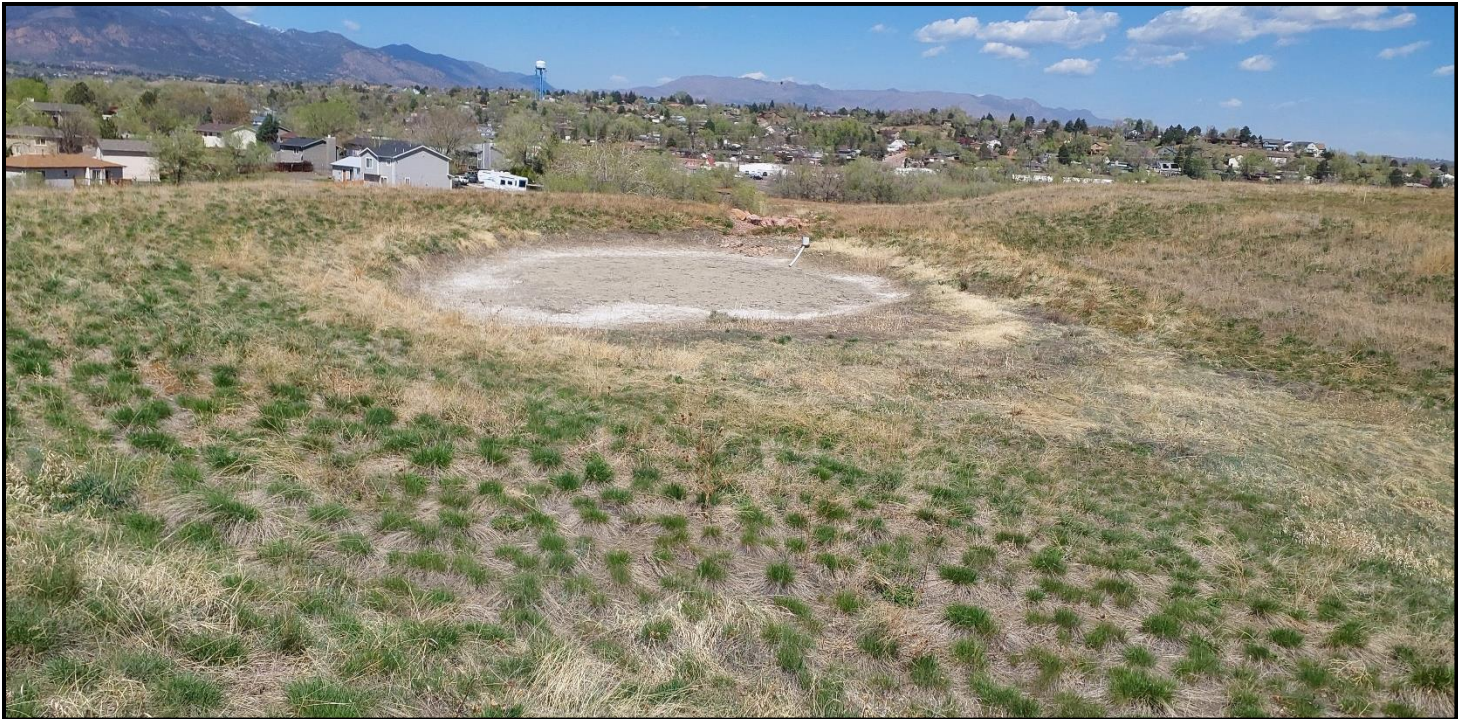
Photo No: 1	Direction Photo Taken: Northwest	Figure No: 4
Description: Overview of Wetlands B and C. Wetland B is a Palustrine Emergent Temporarily/Seasonally Flooded (PEMA/C) wetland and Wetland C is a Palustrine Unconsolidated Bottom Artificially Flooded (PUBK) open water feature.

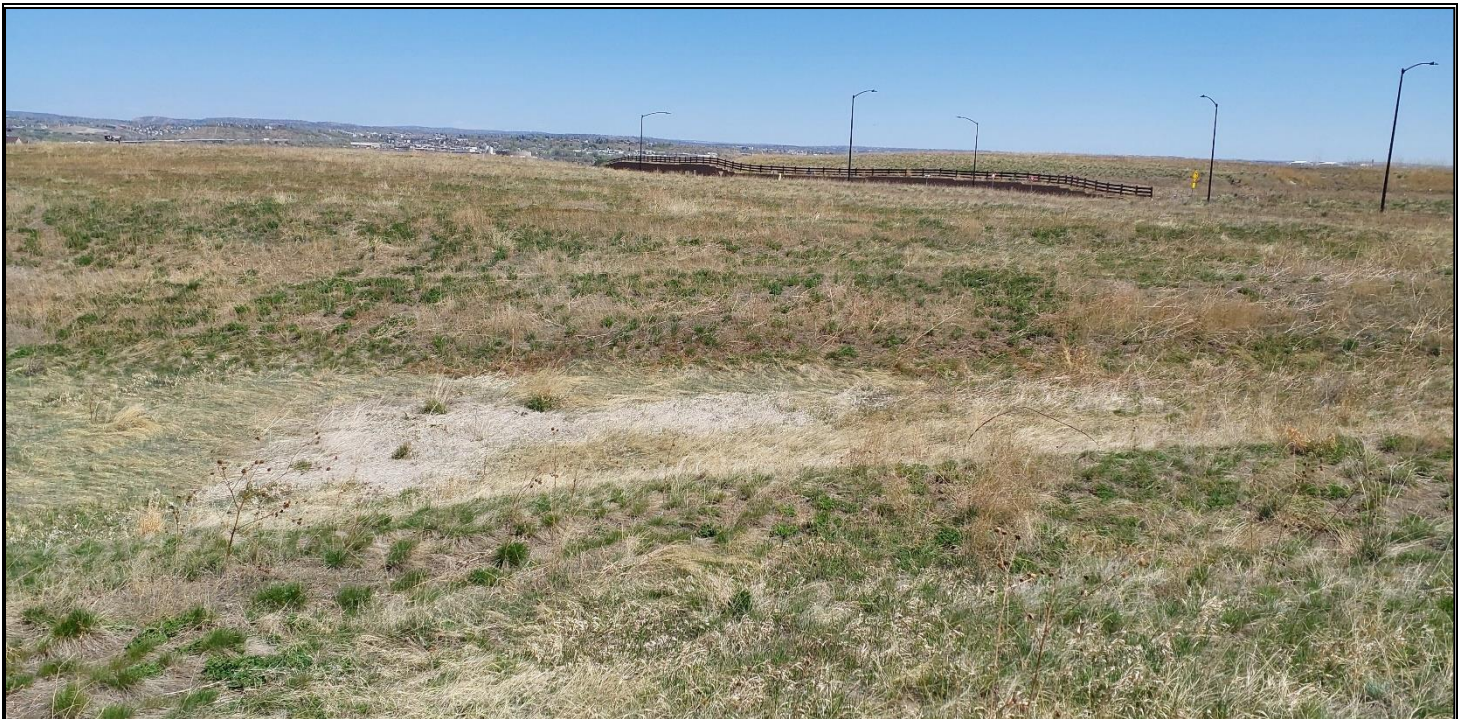
Photo No: 2	Direction Photo Taken: North	Figure No: 4
Description: Overview of Wetland A, a PEMA/C wetland located in a narrow depression between upland hillslopes.

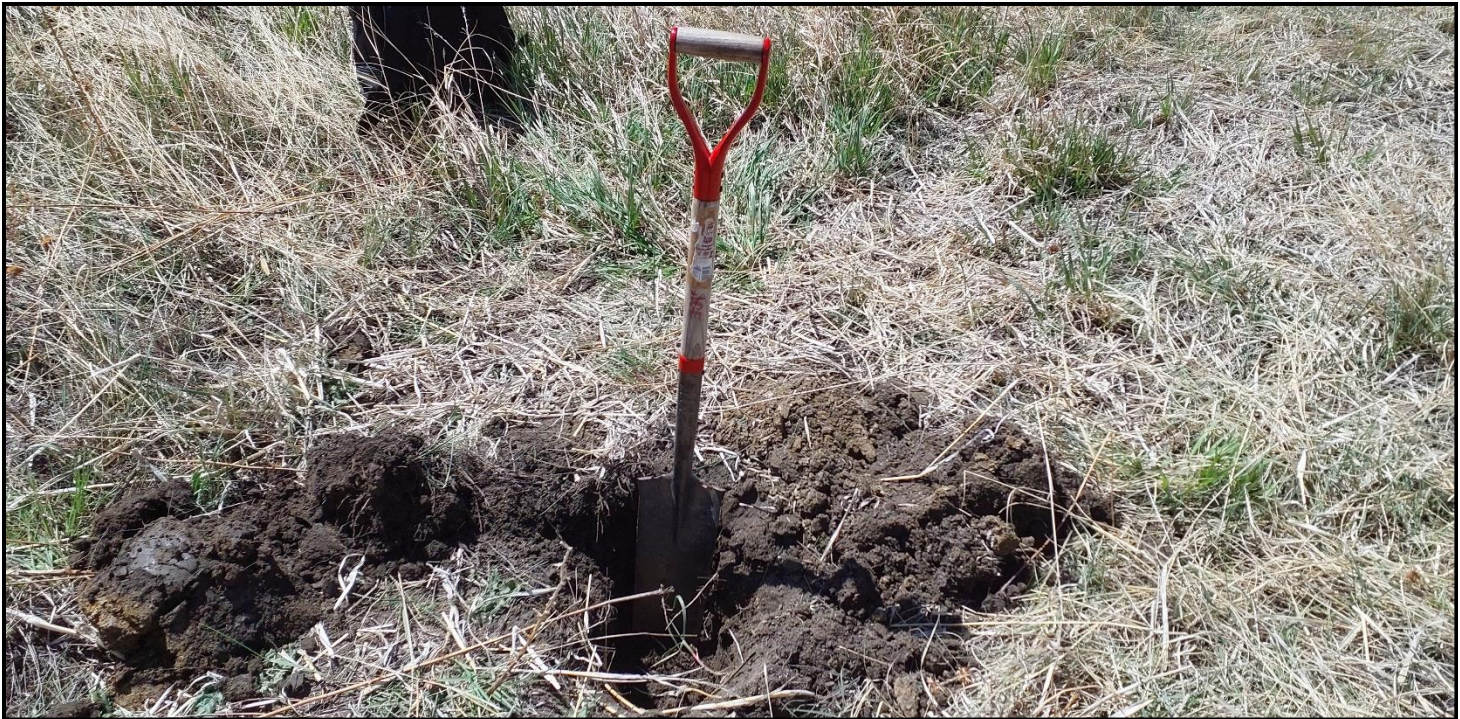
Photo No: 3	Direction Photo Taken: South	Figure No: 4
Description: Sample point 1, the in point for PEMA/C Wetland A, located in a narrow depression.

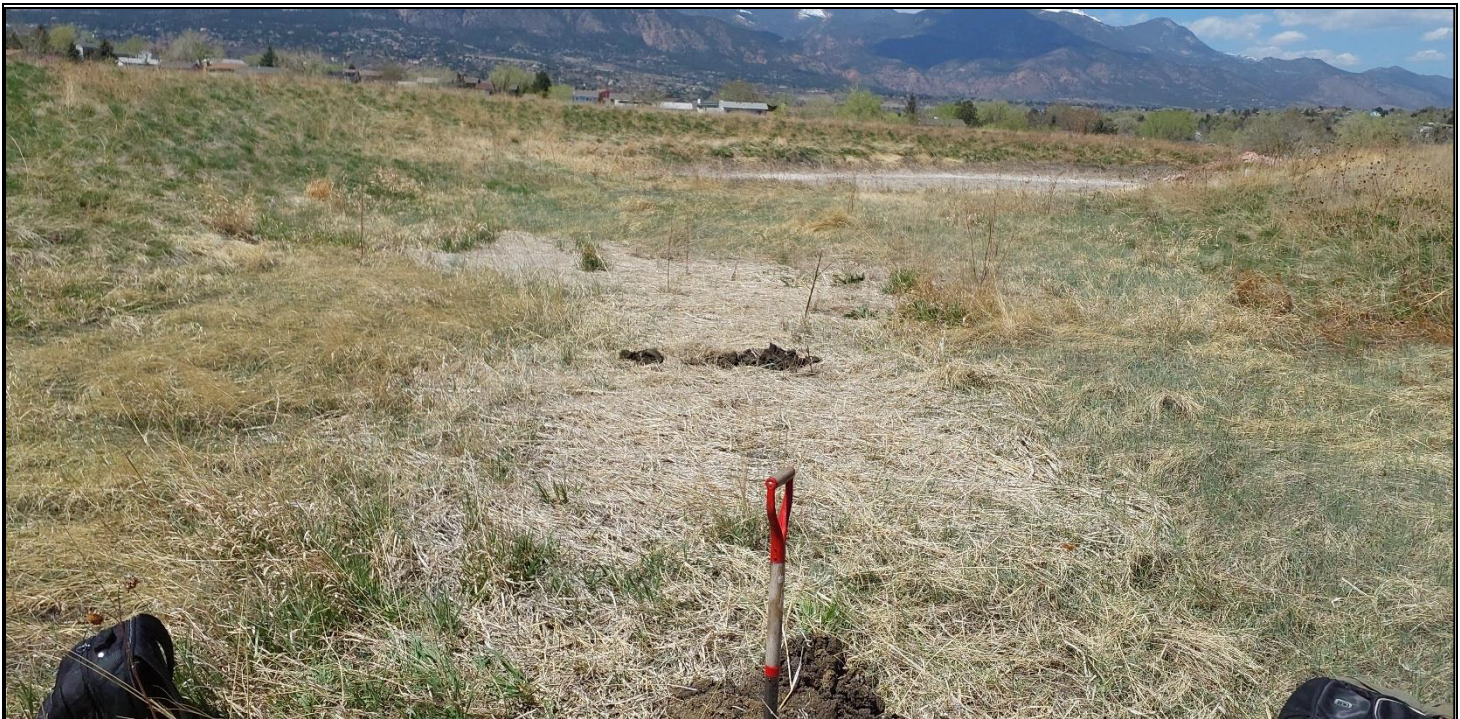
Photo No: 4	Direction Photo Taken: West	Figure No: 4
Description: Overview of Wetland A with sample point 1 in the foreground.

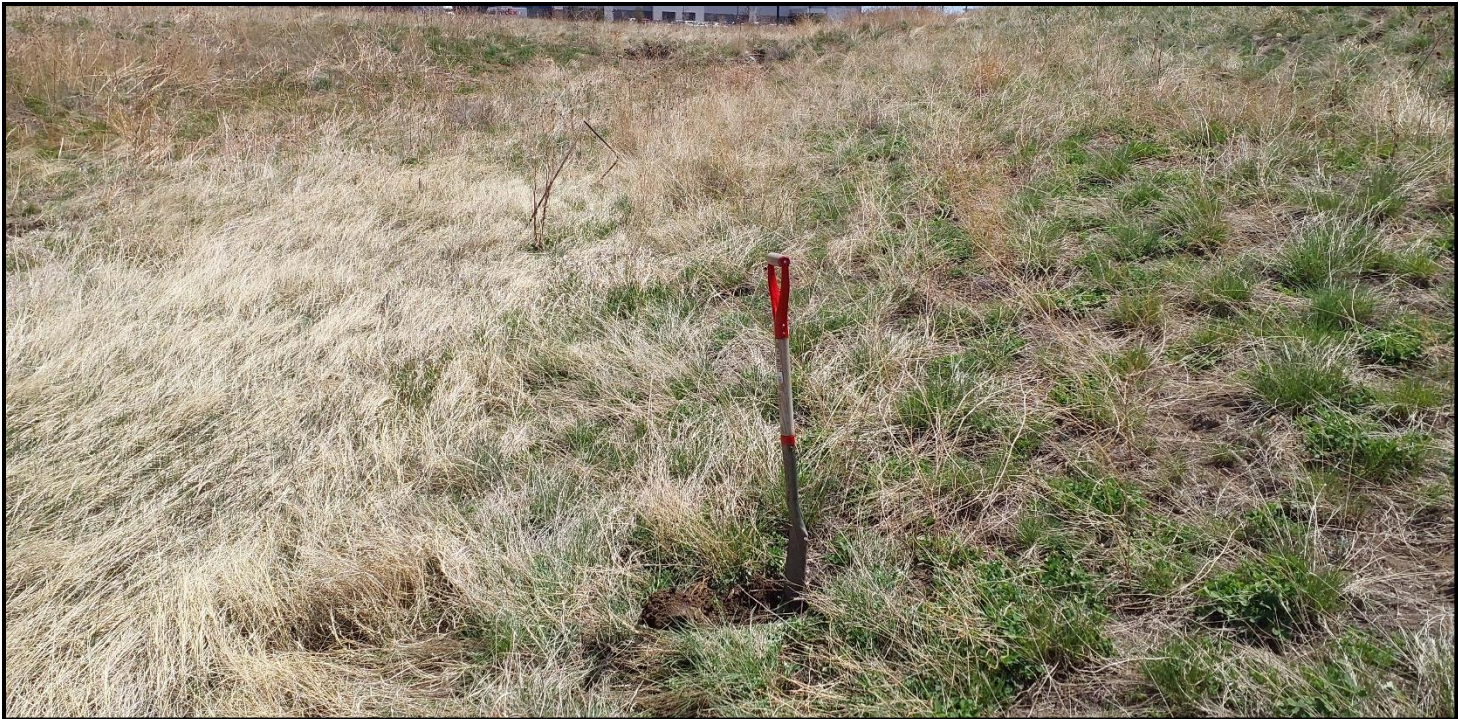
Photo No: 5	Direction Photo Taken: East	Figure No: 4
Description: Sample point 2 located on an upland hillslope, out point for Wetland A.

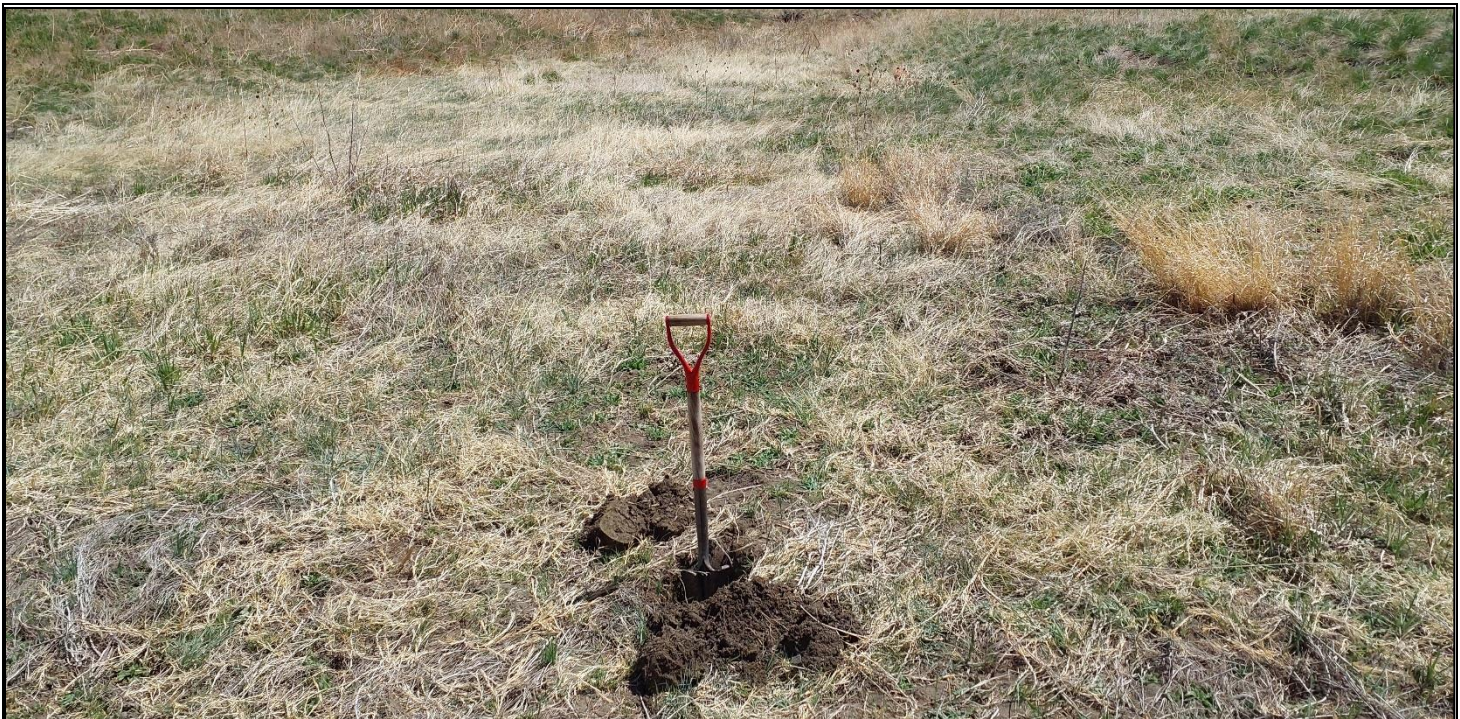
Photo No: 6	Direction Photo Taken: East	Figure No: 4
Description: Sample point 4, in point for PEMA/C Wetland B, located adjacent to a sediment basin associated with Wetland C.

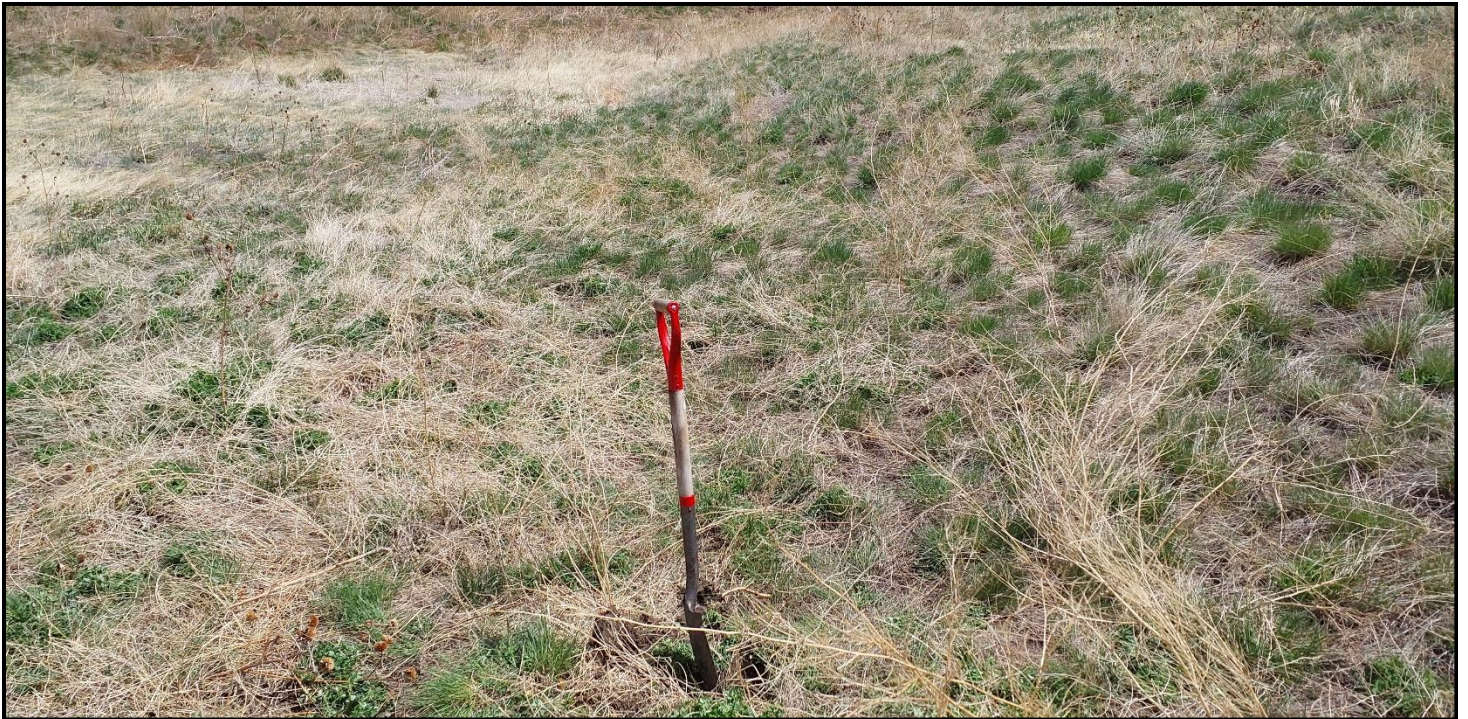
Photo No: 7	Direction Photo Taken: East	Figure No: 4
Description: Sample point 4 located on an upland hillslope above Wetland B, this is the out point for sample points 4 and 5.

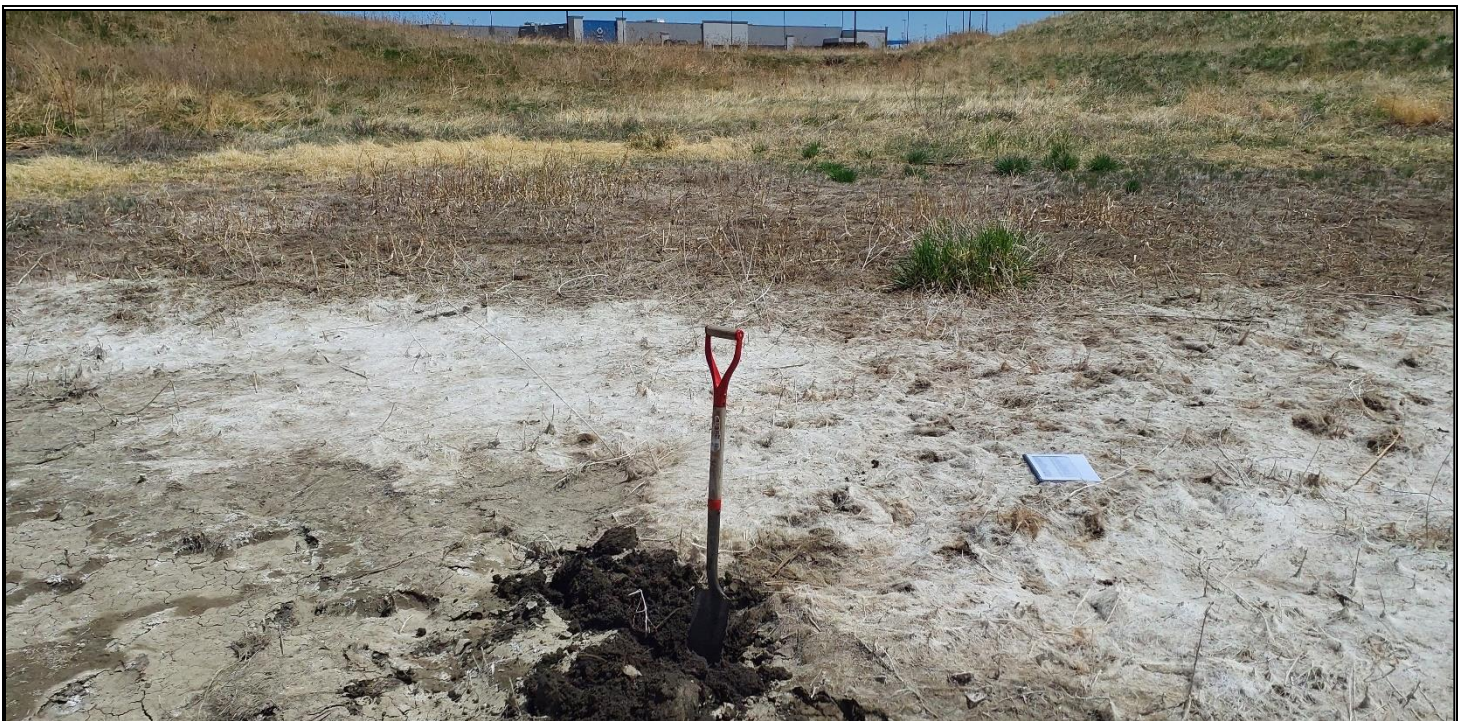
Photo No: 8	Direction Photo Taken: East	Figure No: 4
Description: Sample point 5, in point for PUBK Wetland C, located in a dry sediment basin. Aerial imagery indicates that the basin is periodically inundated.

Historic aerial imagery indicates that the sediment basin is periodically inundated but also goes through periods where no water is present, which likely does not provide optimal conditions for vegetation growth. Beyond the western portion of the sediment pond, the elevation abruptly drops approximately 40 feet to a vegetated area containing an unpaved two-track road adjacent to the unnamed intermittent stream channel. The northwestern portion of the sediment basin contains a cobble riprap drainage swale which may function as a way to slow overflow from the pond and prevent additional sediment from entering the channel west of the Project area.

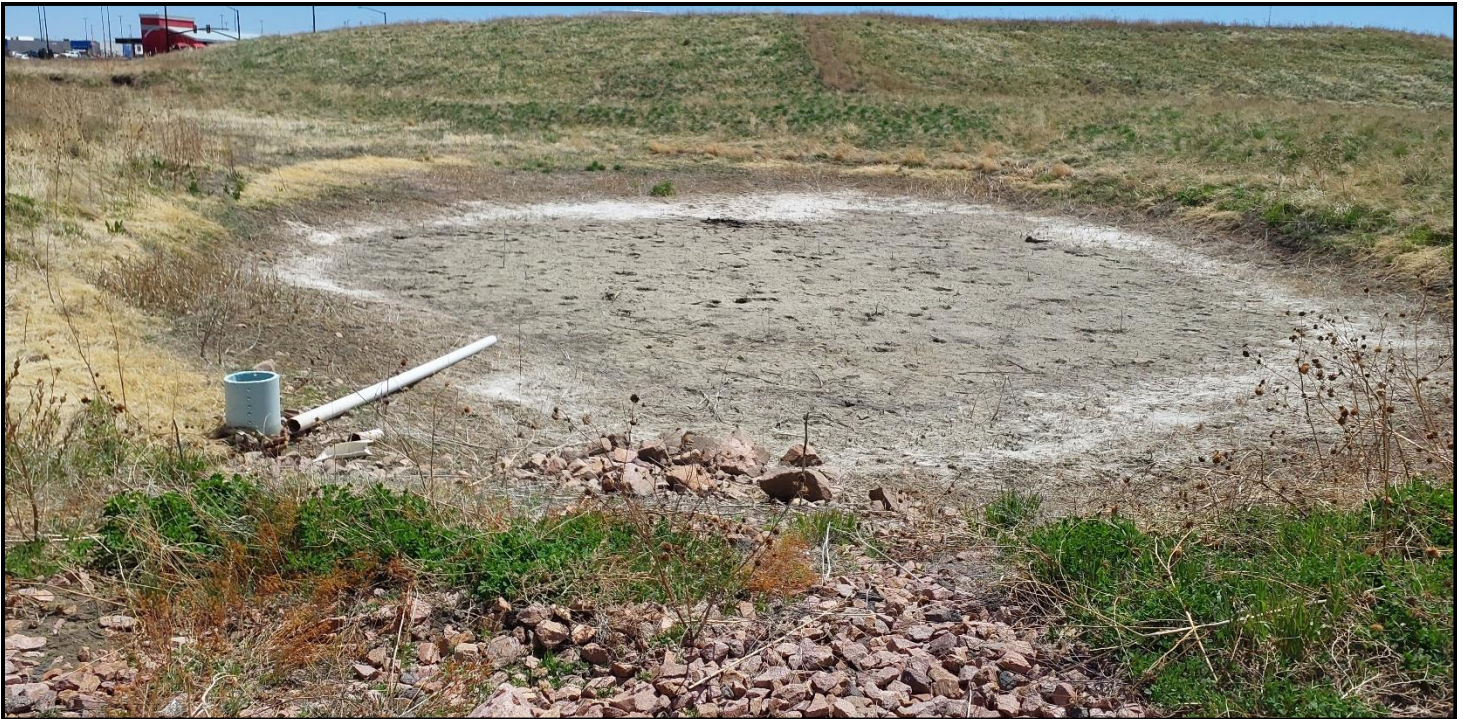
Photo No: 9	Direction Photo Taken: Southeast	Figure No: 4
Description: Overview of Wetland C, located in a dry sediment basin. A cobble riprap drainage swale in the foreground.

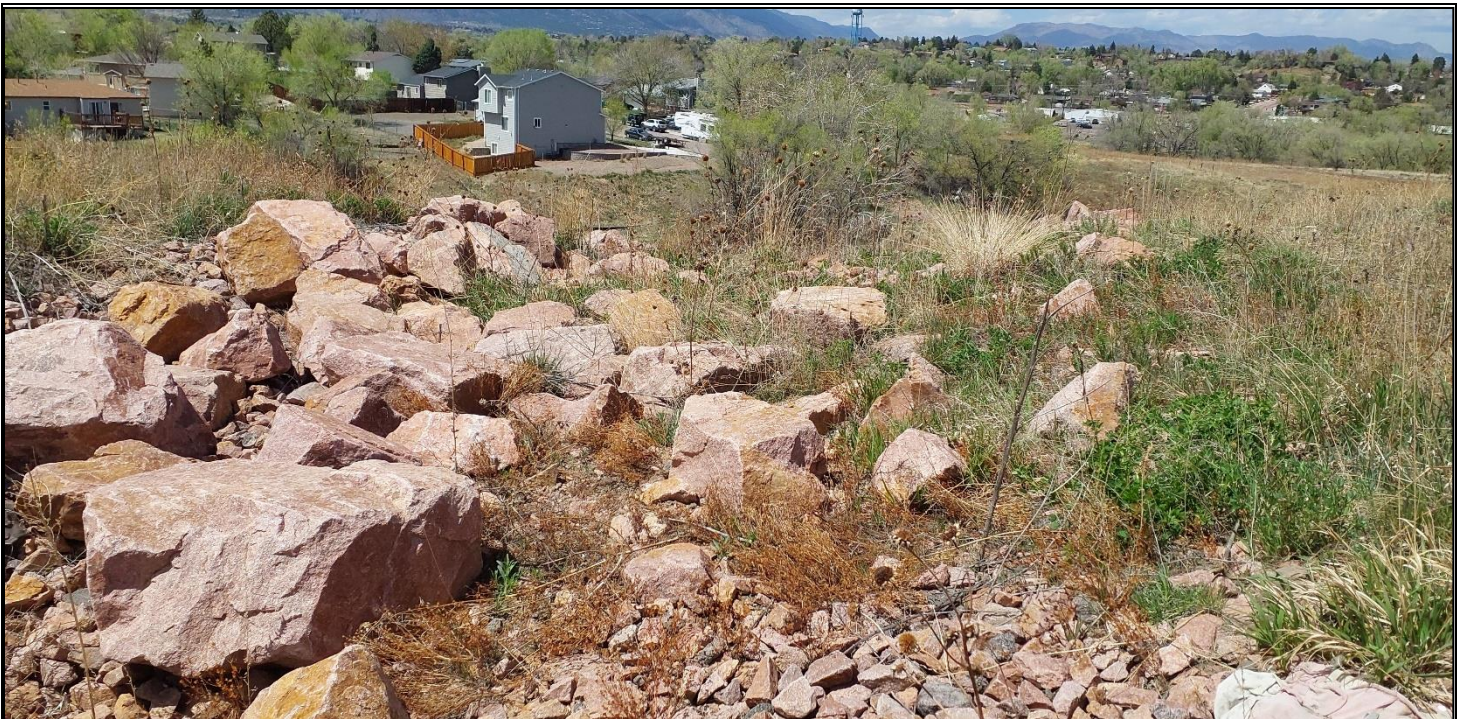
Photo No: 10	Direction Photo Taken: Northwest	Figure No: 4
Description: A cobble riprap line drainage swale located at the northwestern portion of the sediment basin.
