WETLAND DELINEATION REPORT

***Falcon Ranchettes Filing No. 1A
El Paso County, Colorado***

Bristlecone Ecology, LLC
2023 W. Scott Place
Denver, CO 80211
Contact: Dan Maynard
dmaynard@bristleconeecology.com

February 16, 2024

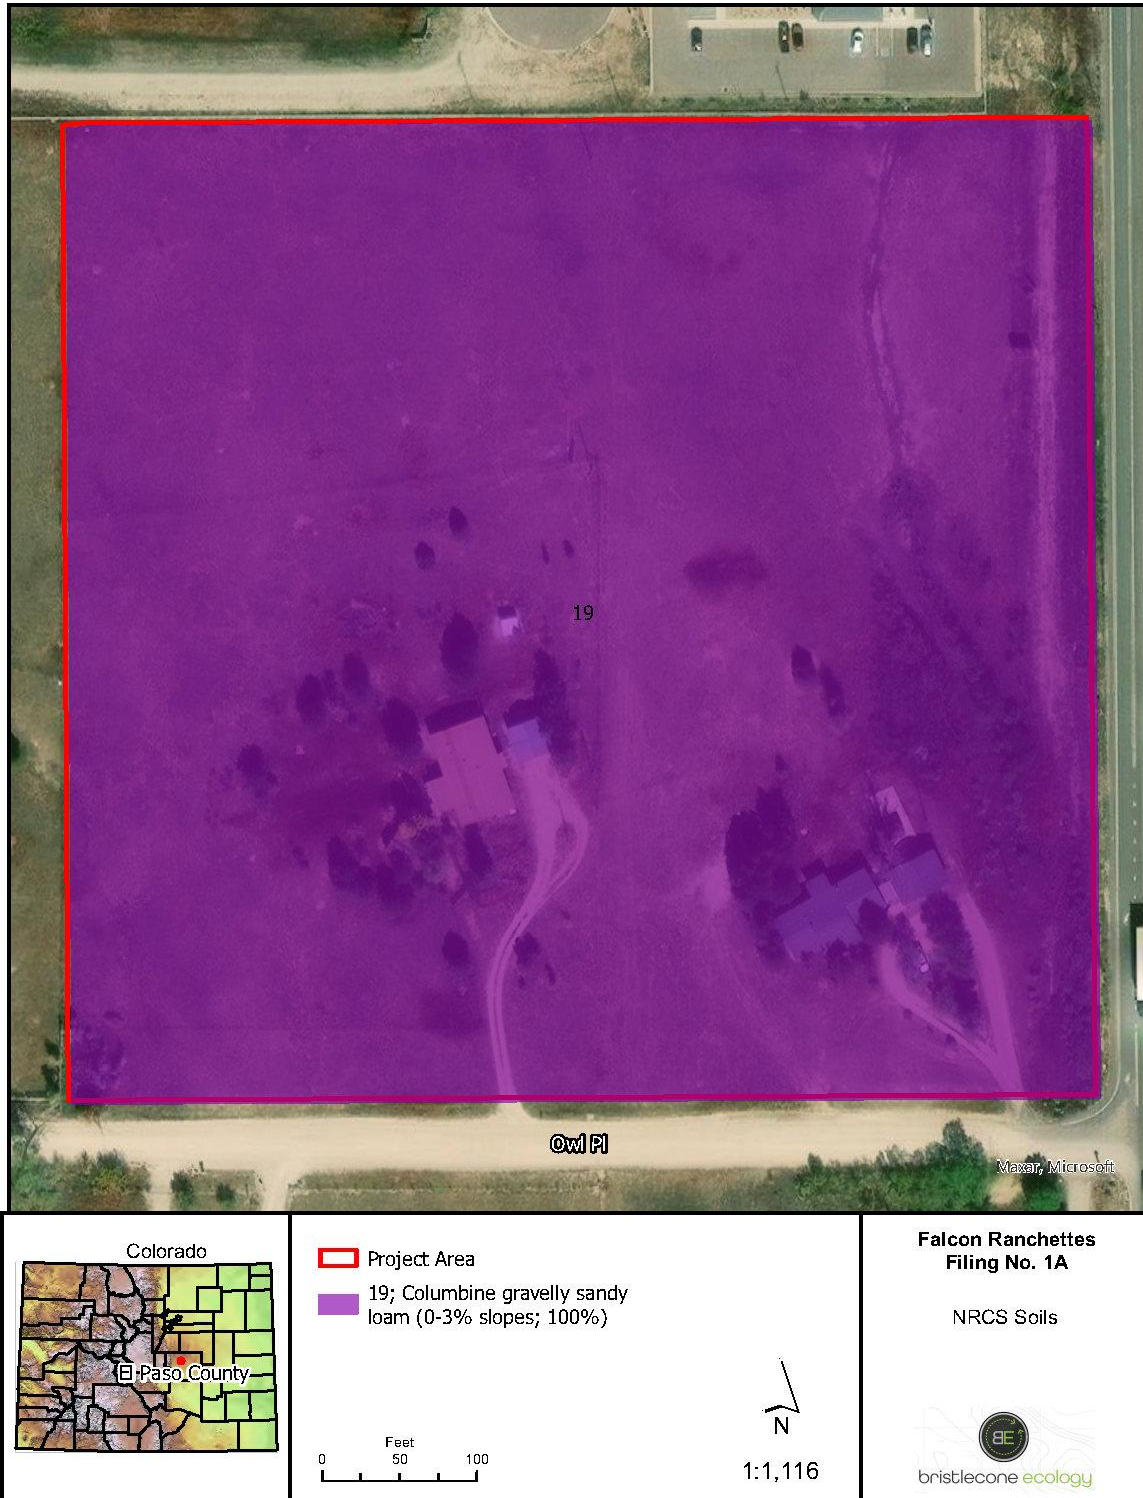
Figure 3: NRCS Soils

County soil survey data indicate that the site is composed entirely of Columbine gravelly sandy loam, 0 to 3 percent slopes (**Figure 3: NRCS Soils**). The Columbine soil series is a consociation, so other, minor soil series may be present within it (NRCS 2023). The primary minor series that forms the remainder of the consociation is the Pleasant series, which is typically found in depressions and is rated as hydric in El Paso County (NRCS 2023).

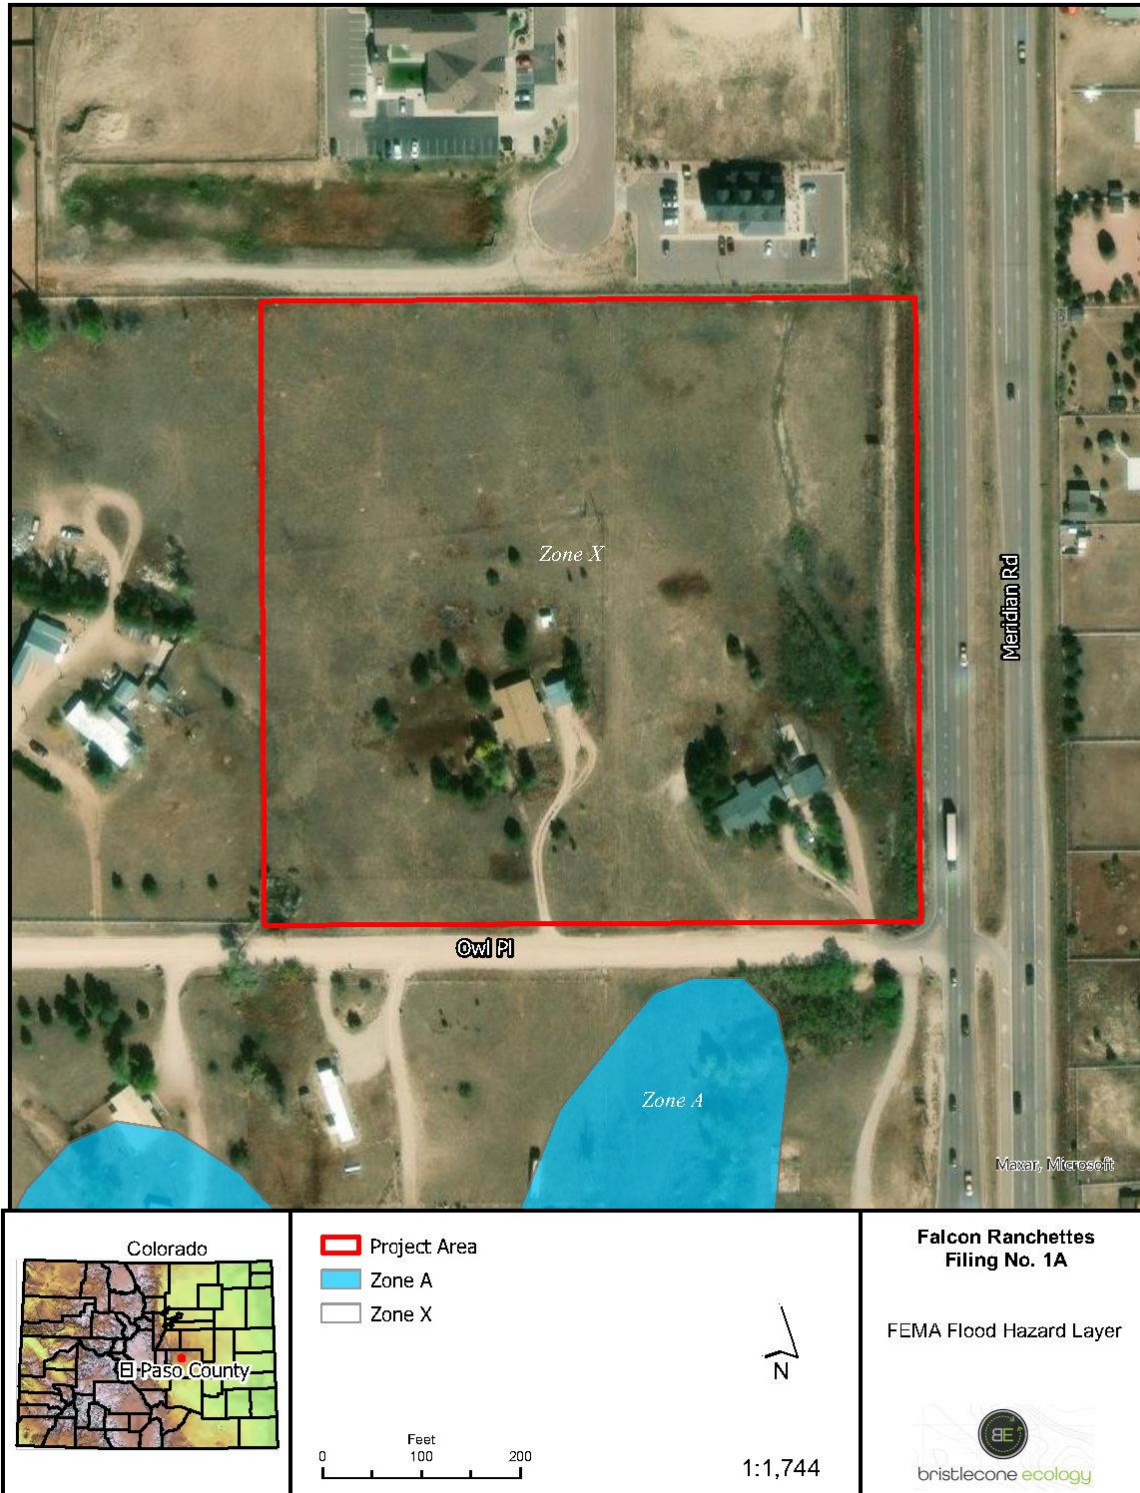
Figure 4: FEMA Flood Hazard Layer

A review of the National FEMA flood hazard layer (2023) indicated that the entirety of the Project Area is in Zone X and is thus in an area of minimal flood hazard and higher than the elevation of the 0.2-percent-annual-chance flood (**Figure 4: FEMA Flood Hazard Layer; FEMA 2023**).

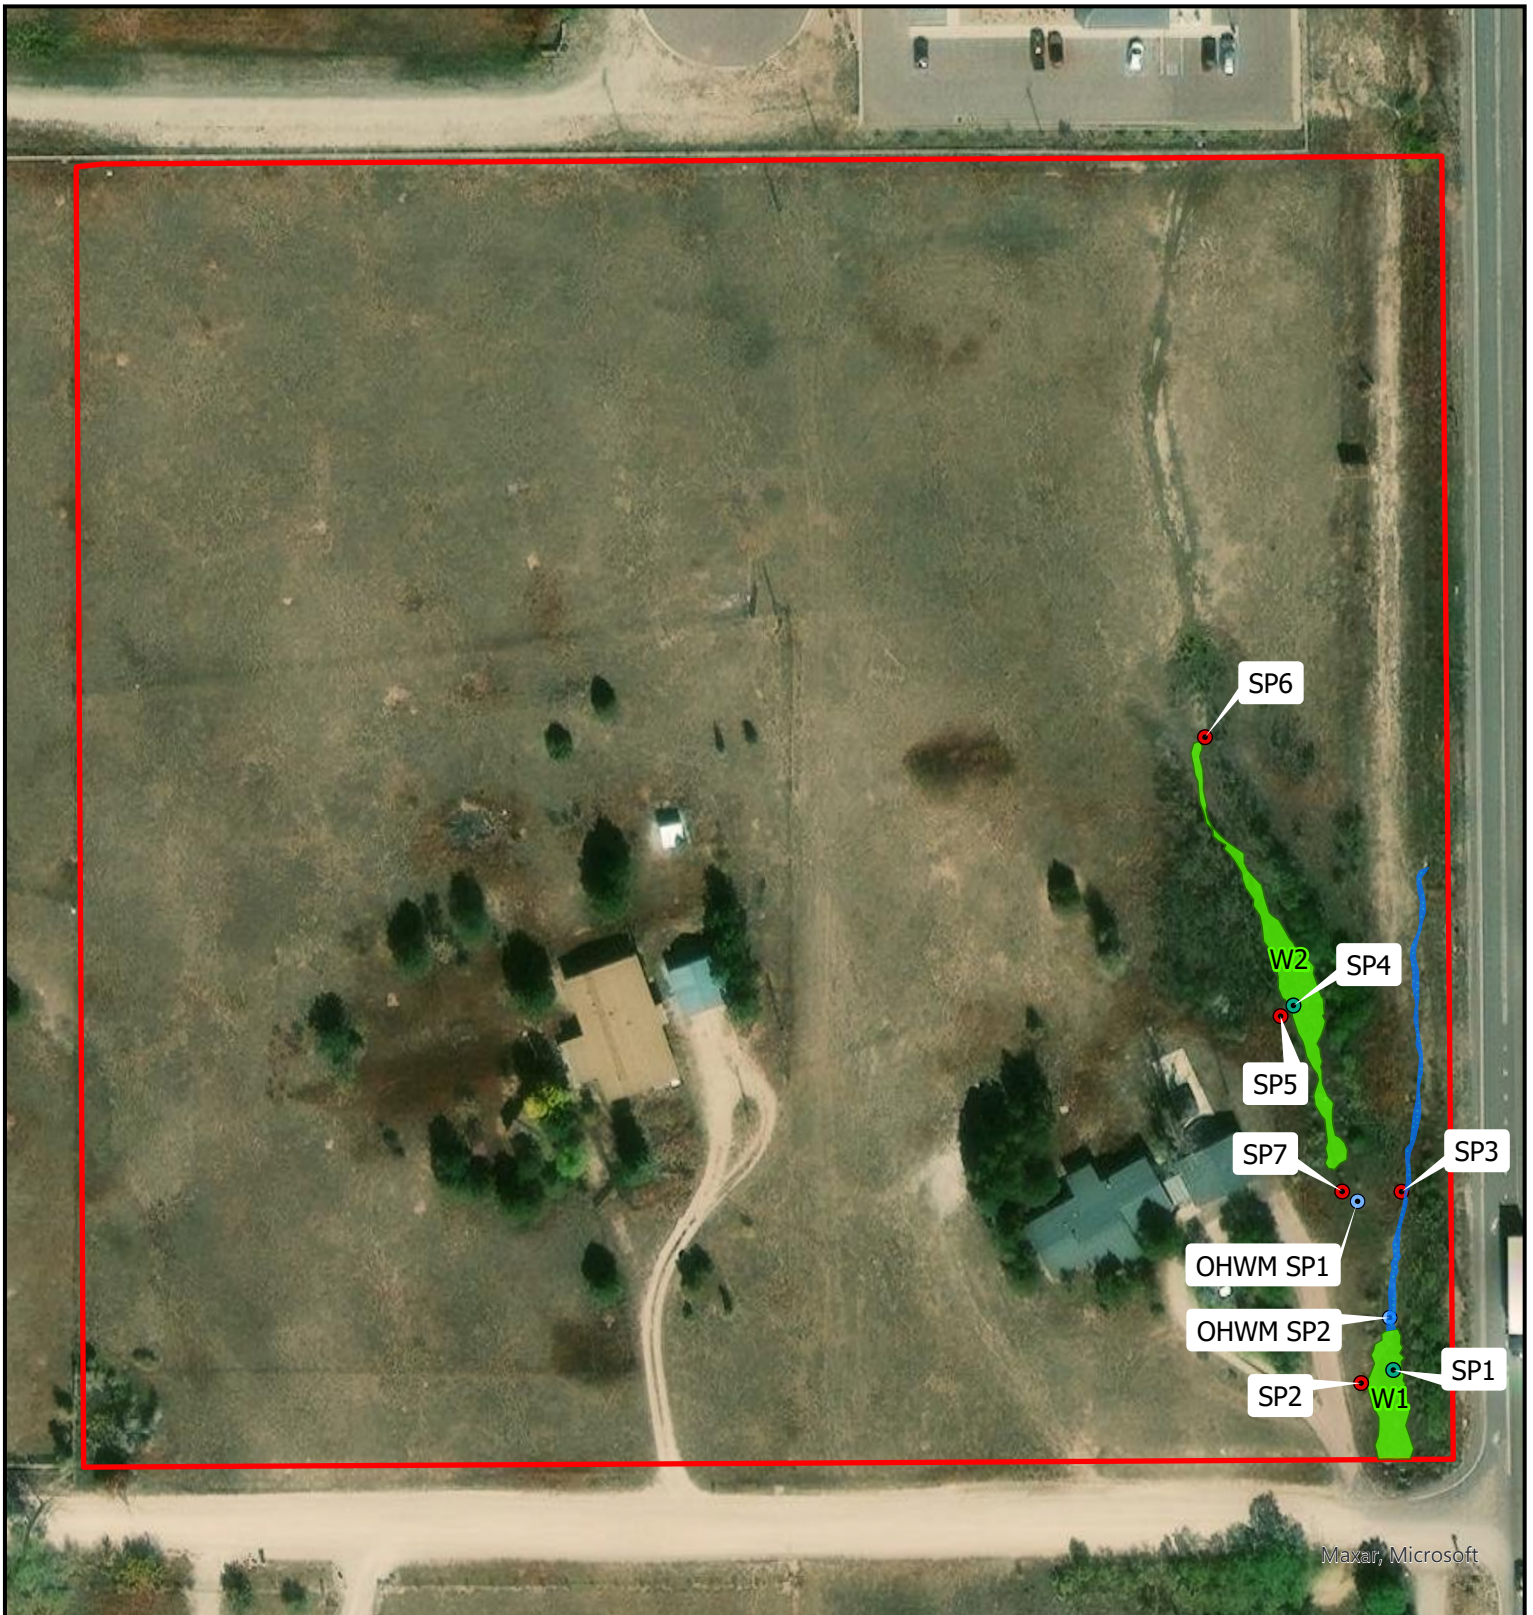
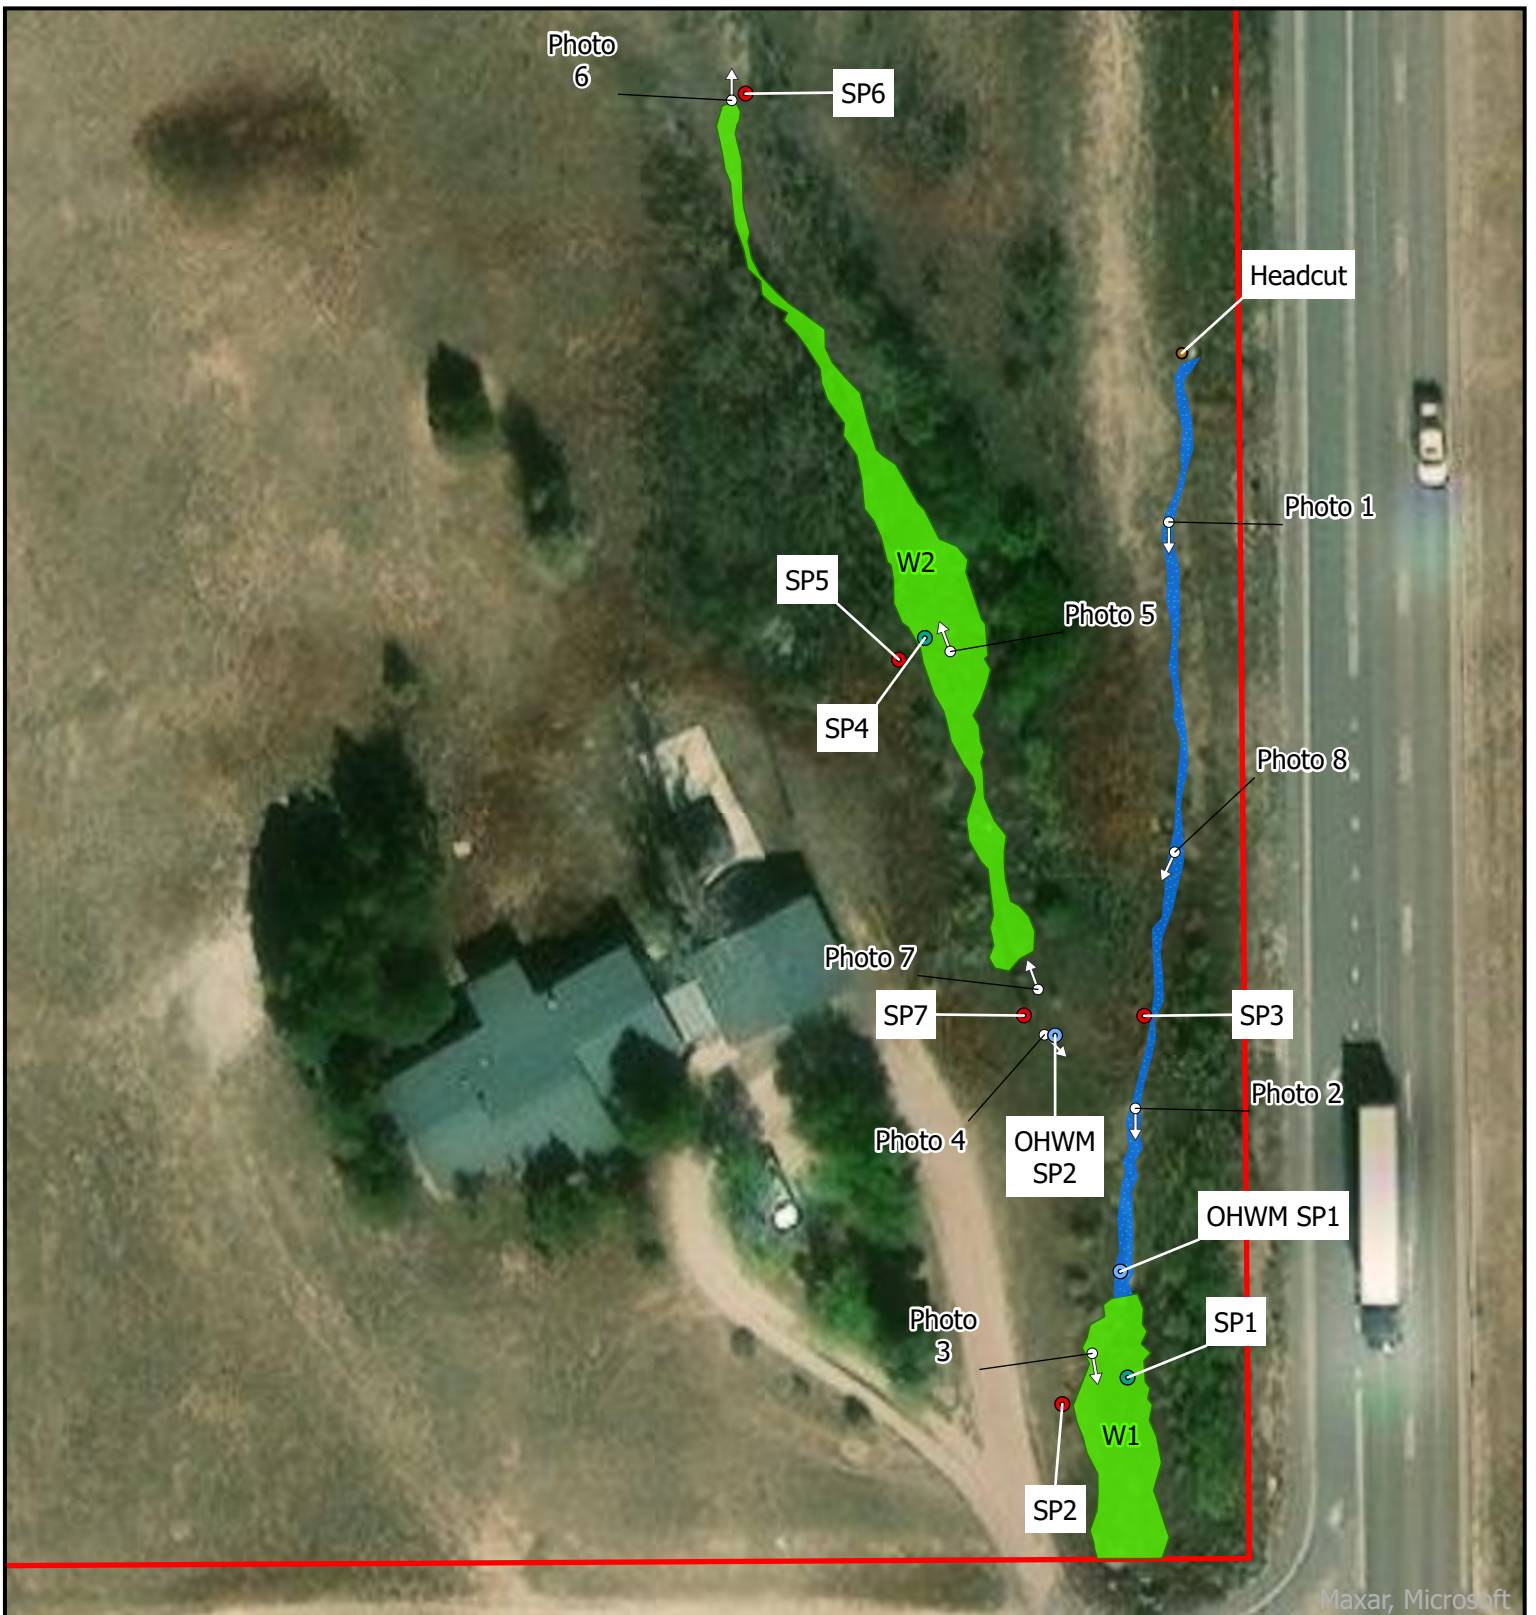
**Falcon Ranchettes
Filing No. 1A**
Wetland Location Overview

In summary, two Palustrine emergent wetlands (W1 and W2) were delineated within the Project Area. The two wetlands were separated by an upland swale and were not connected hydrologically, as there was no evidence of an OHWM in the swale between them, nor were they abutting. There was an OHWM present north of W1 that began at a distinct headcut along the eastern border of the site where channelization began and a defined streambed and banks formed. The OHWM was present in a constructed ditch which connected to the northern extent of W1.

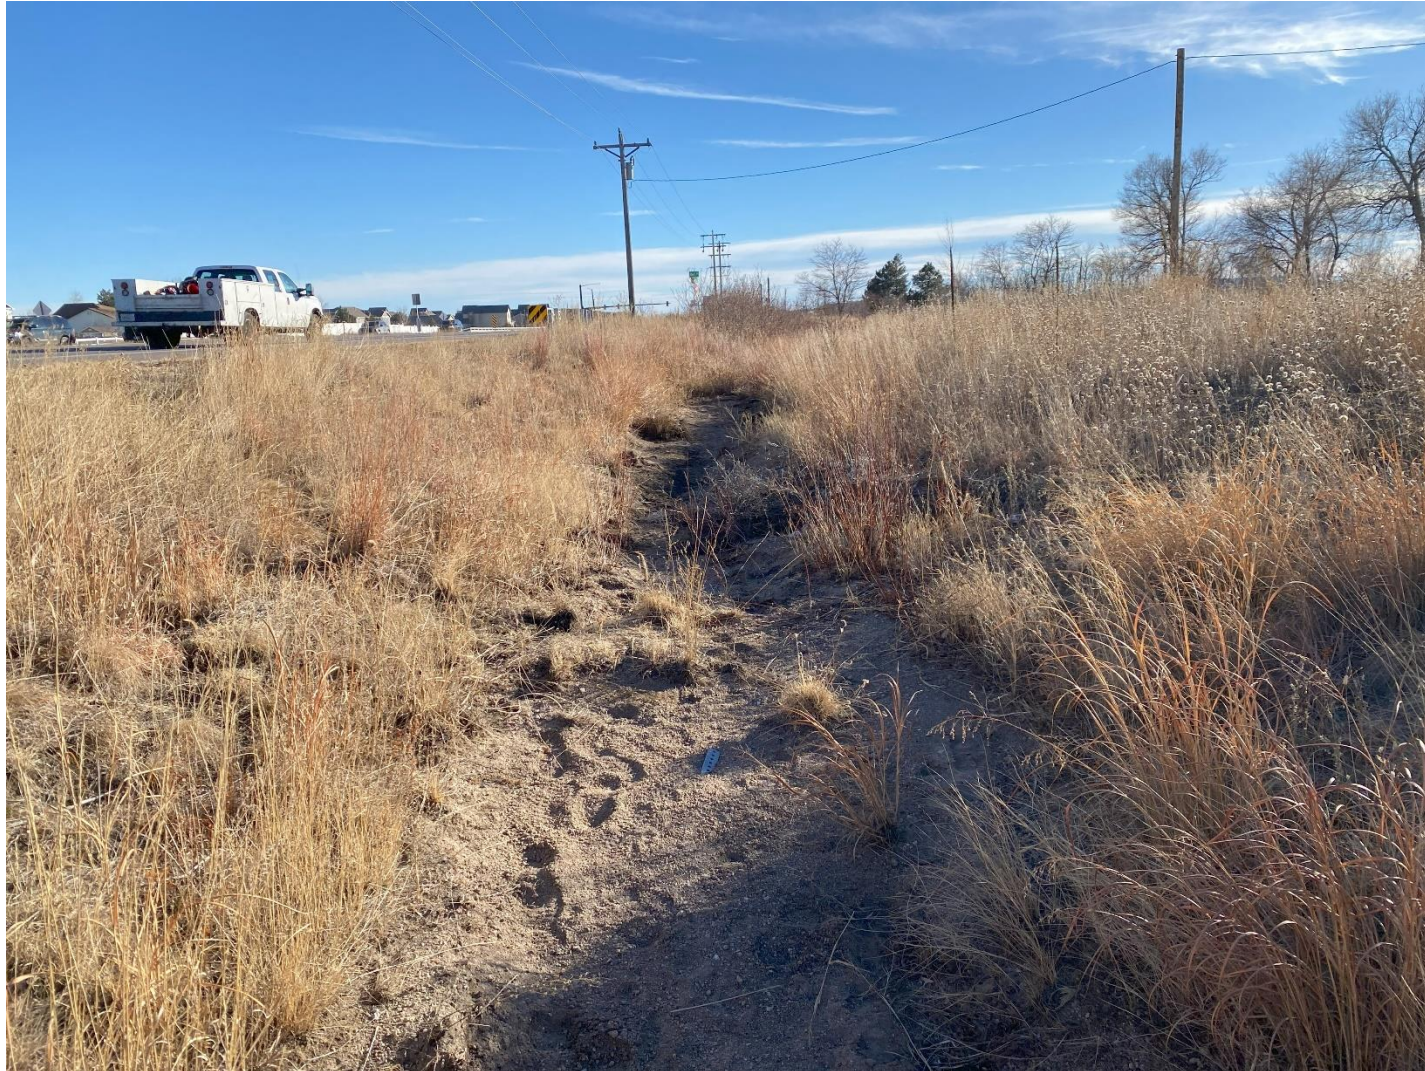
Photo 1 – View facing south of the constructed ditch showing the topographic, sediment, and vegetation changes of an OHWM; the ditch eventually connects with Wetland 1 to the south.

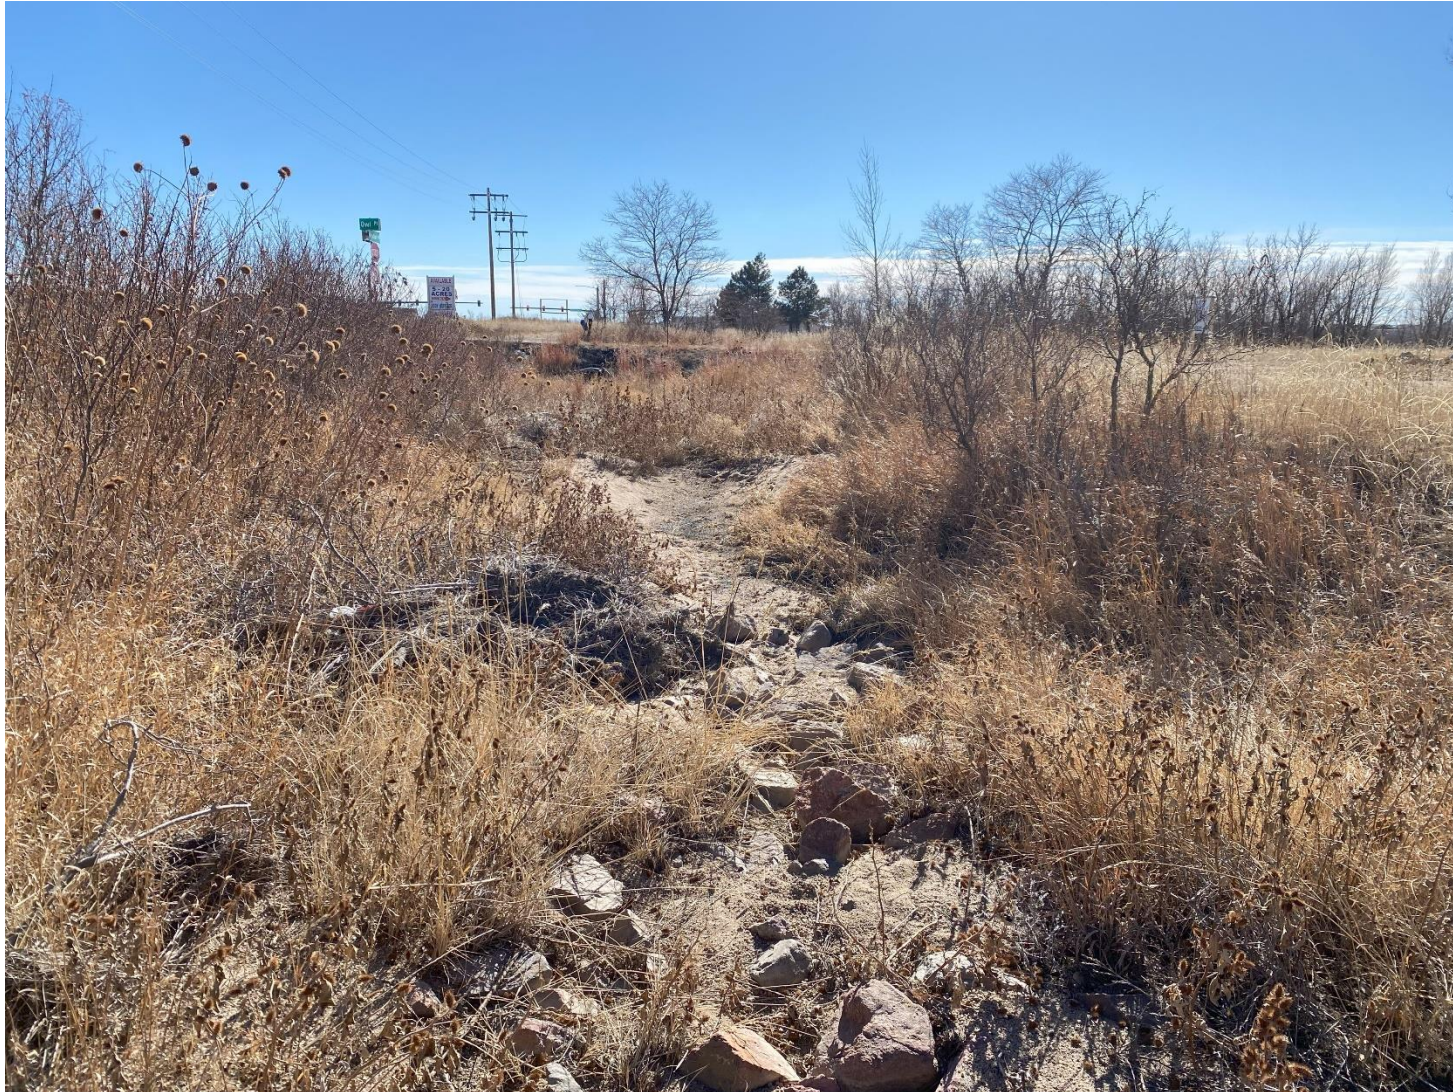
Photo 2 – Another view facing south of the constructed ditch and OHWM, just north of OHWM SP1. The confluence between the ditch and W1 can be seen in the top half of the photo. Rock riprap has been installed in this section of the ditch and can be seen in the photo.

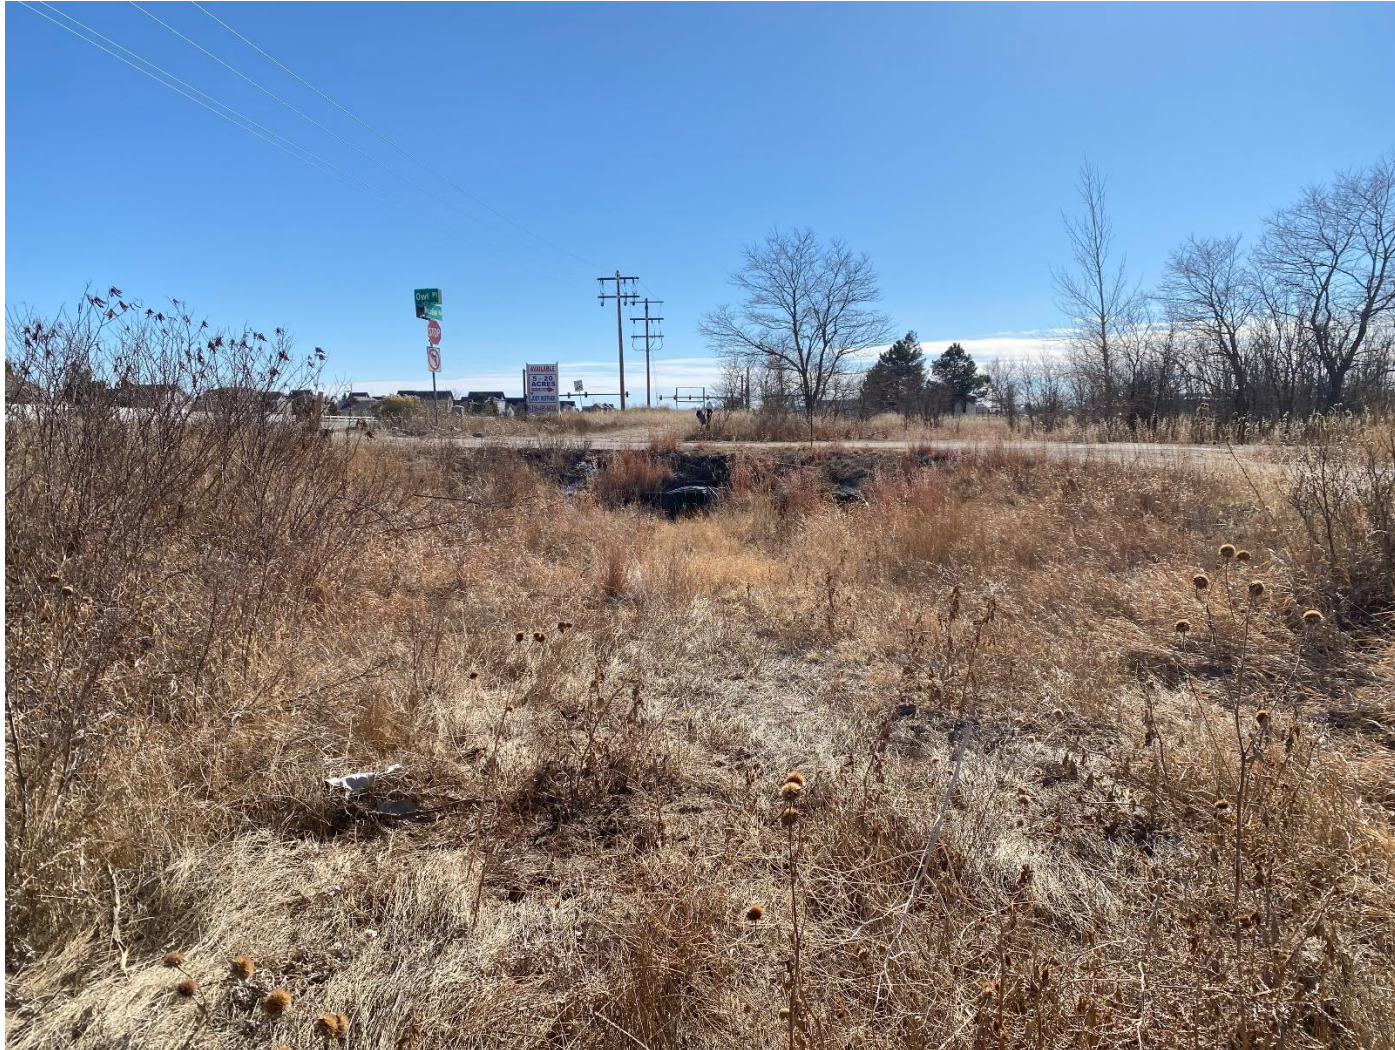
Photo 3 – View facing south-southeast, looking at W1 and the culvert under Owl Place, taken near SP1, SP2, and OHWM SP1. Baltic rush dominates the wetland and the transition to uplands is marked by the presence of smooth brome, common sunflower, and New Mexico locust. The wetland ends at the culvert under Owl Place that can be seen under the roadway.

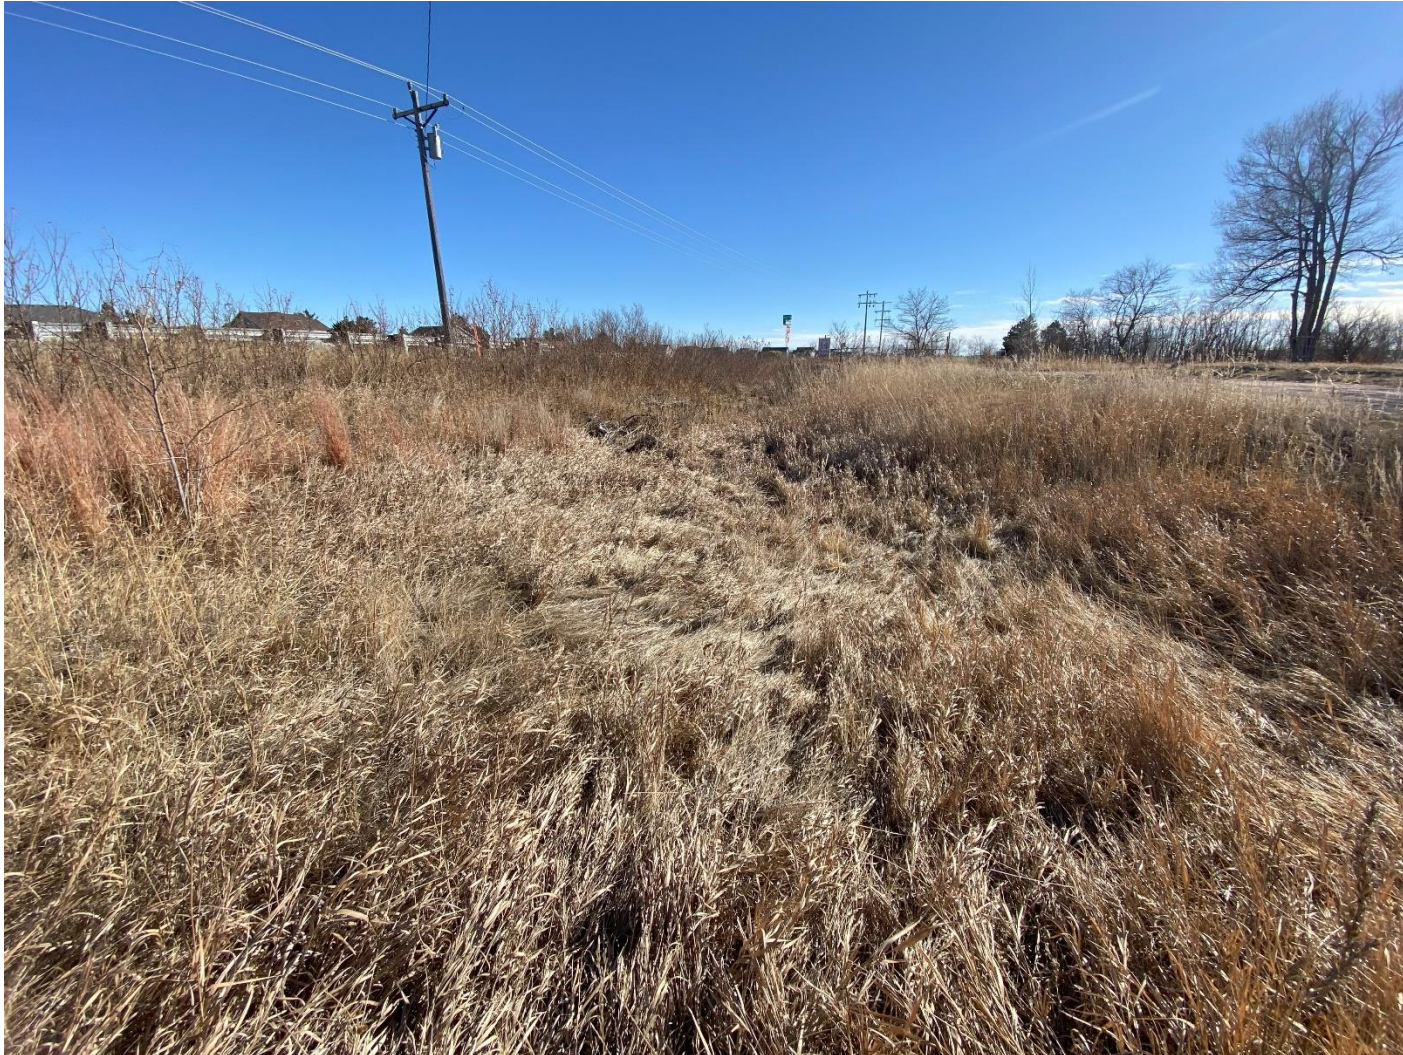
Photo 4 – Photo taken at SP7 and OHWM SP2, looking southeast at the vegetated swale between W1 and W2. Sampling confirmed that no wetlands or OHWM are present in the connecting swale. The area is a transition from the depression containing W2, and is dominated by smooth brome, little bluestem, and switchgrass.

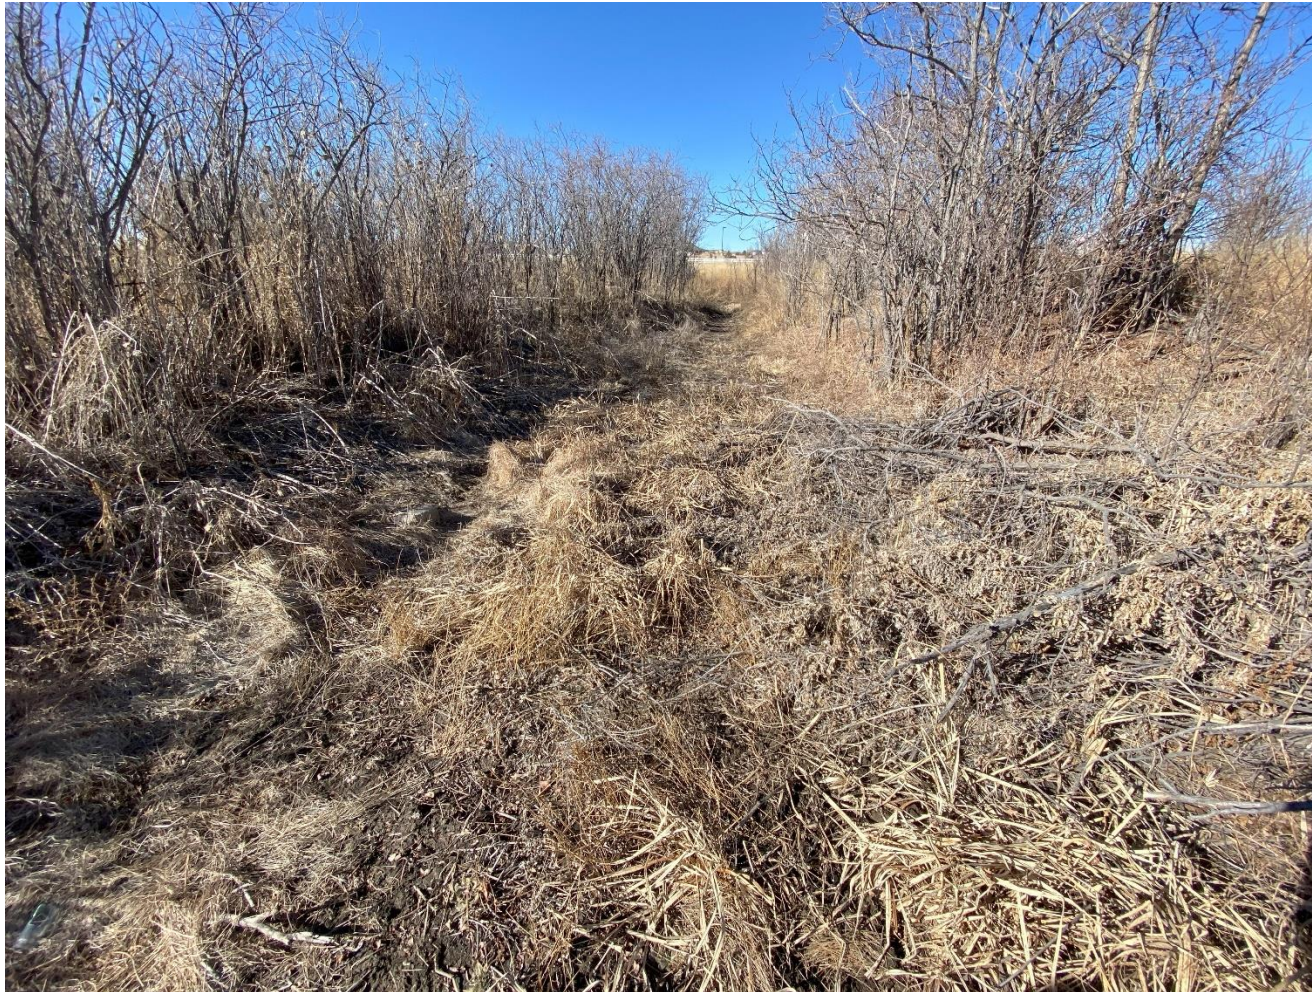
Photo 5 – View facing north-northwest of W2, taken near SP4. W2 is a depressional wetland within a swale that does not contain surface connection to W1 downstream. This wetland is dominated by Baltic rush and Nebraska sedge (both visible in the photo) and is surrounded by smooth brome, switch grass, and New Mexico locust at the edges of the depression. Noxious weeds including common mullein and Canada thistle are also present in the transition area from wetland to upland in W2.

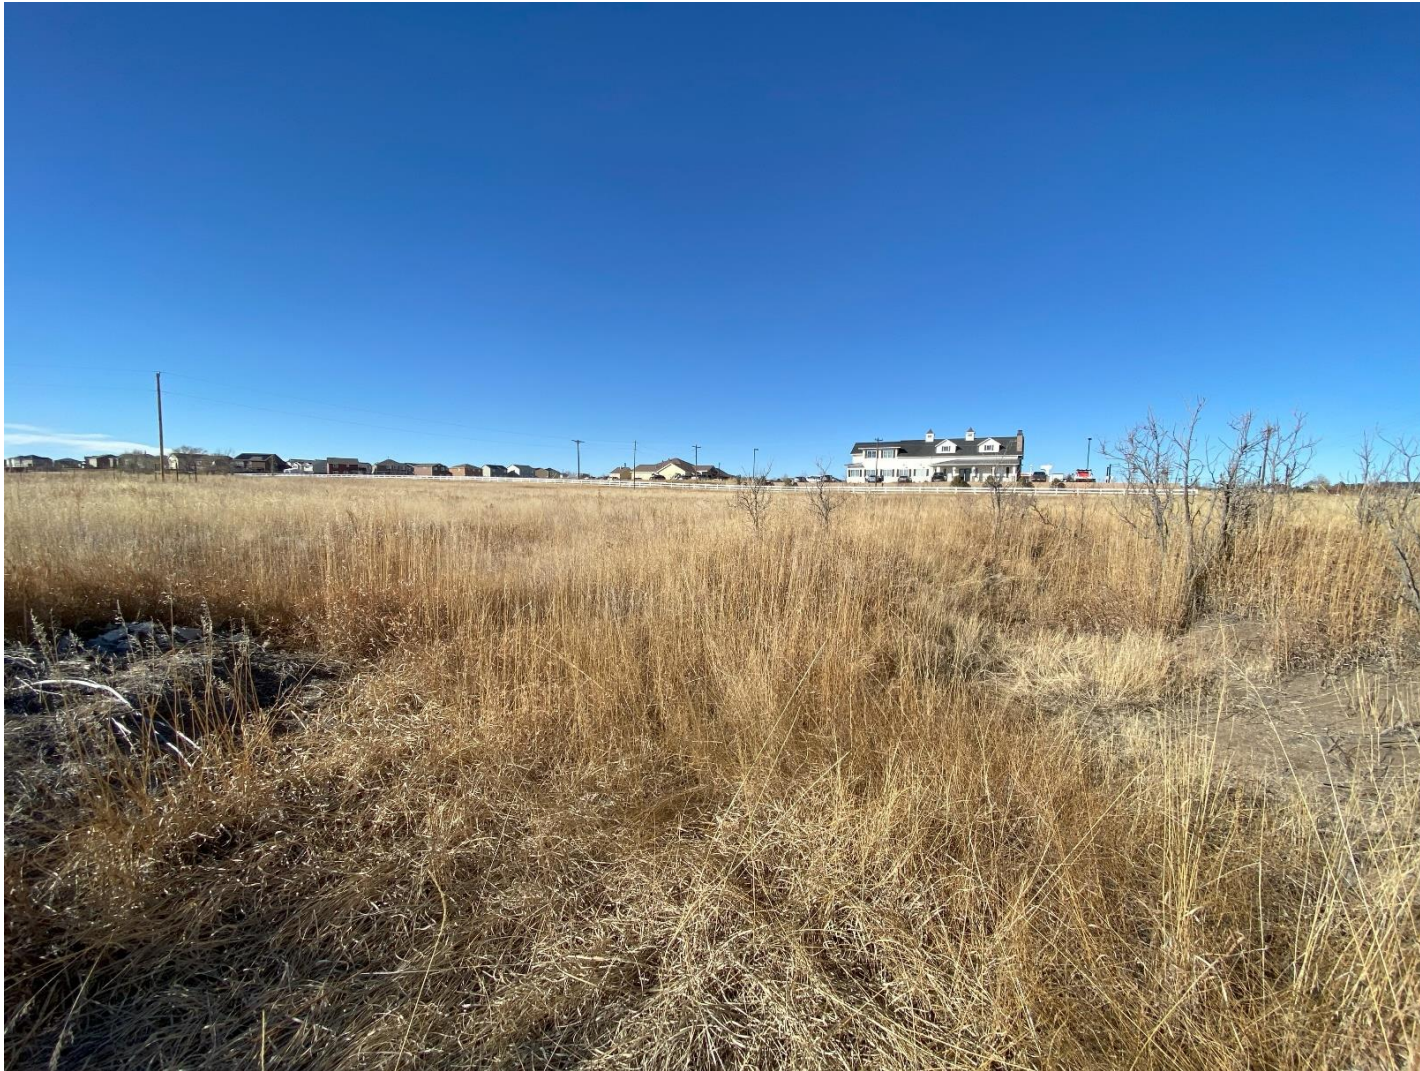
Phot 6 – View facing north of the northernmost limit of W2, taken near SP6, where vegetation transitions to upland grass dominated by smooth brome, little bluestem, and blue grama.

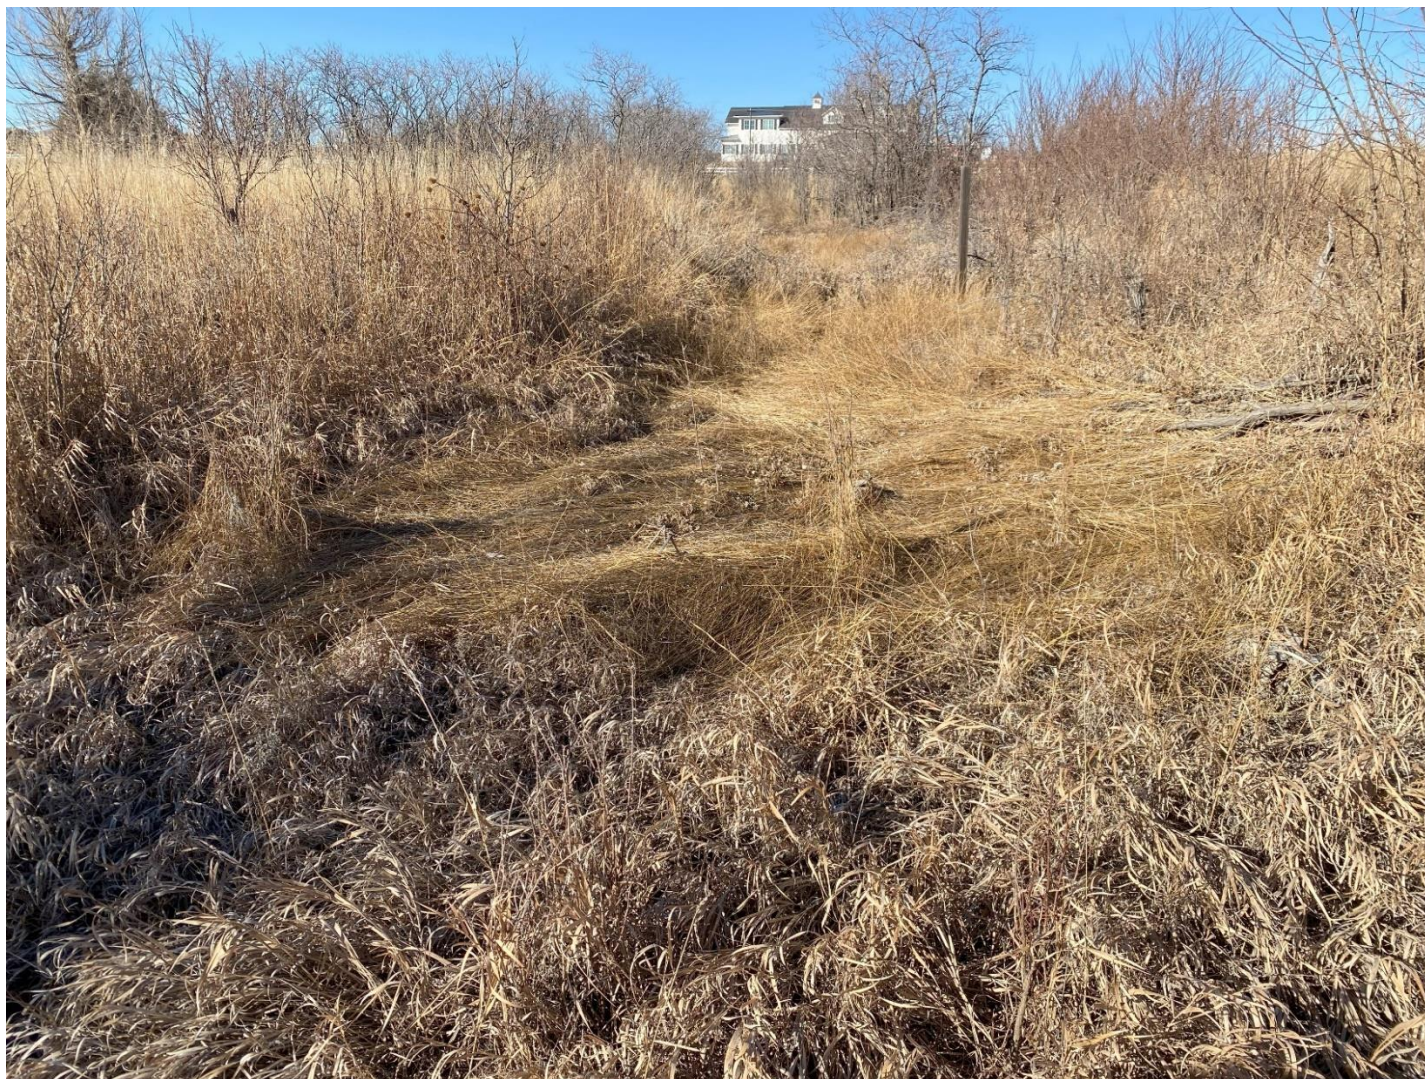
Photo 7 – View facing north-northwest of the transition area between W2 and the upland swale south of the wetland behind the viewer. The abrupt vegetative transition from Baltic rush to smooth brome is clear in the foreground.

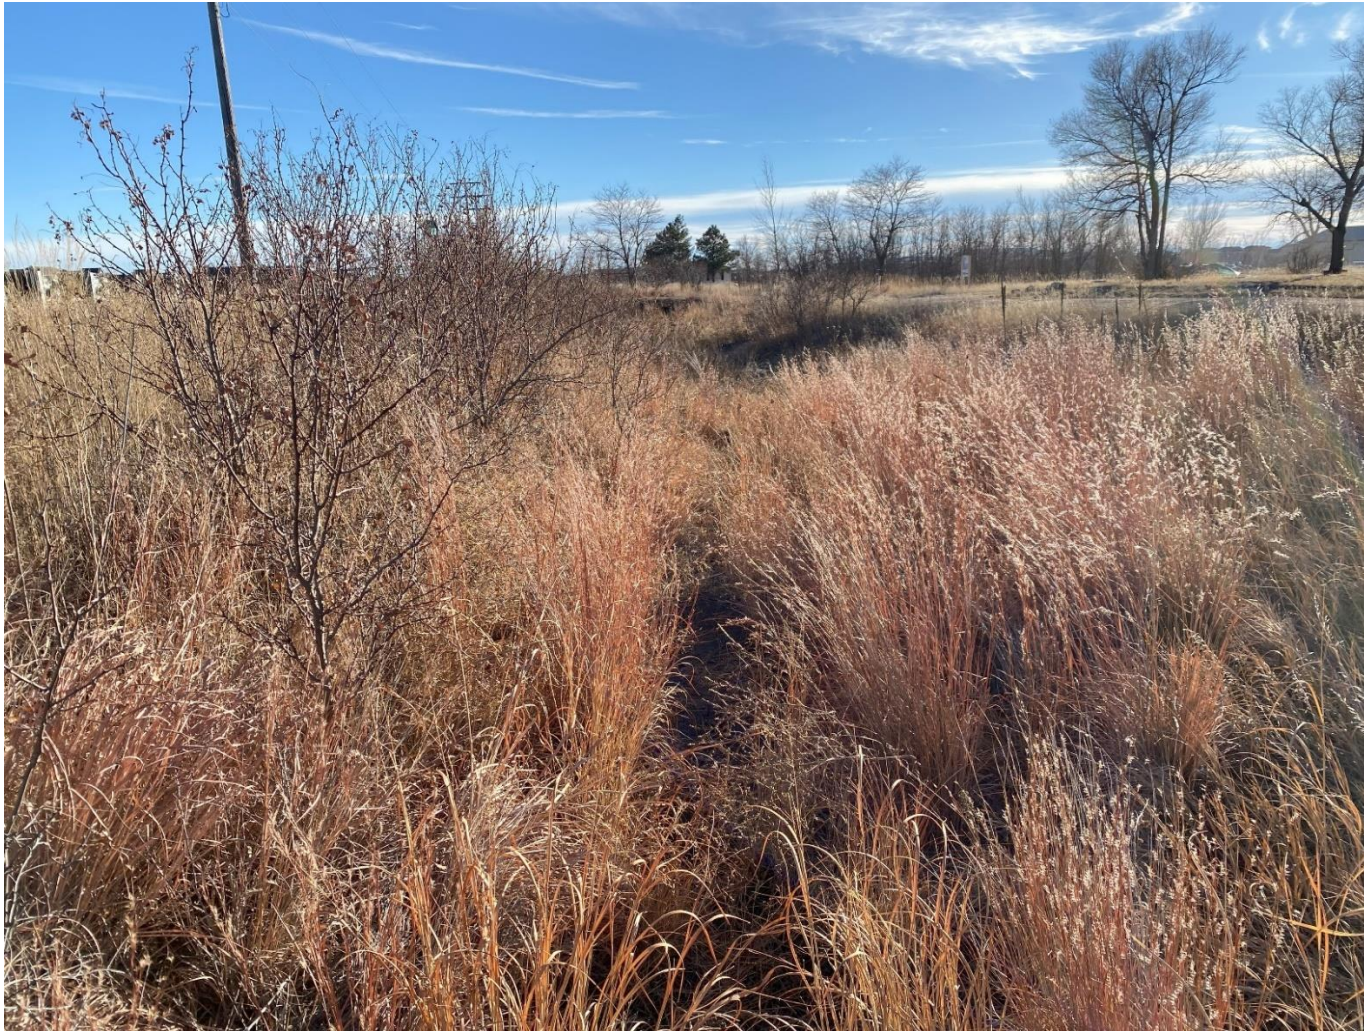
Photo 8 – View facing south-southwest of the heavily vegetated area along the constructed ditch, north of W1. This area is dominated by little bluestem and switchgrass and contains a very faint OHWM, marked primarily by sediment deposits along the bottom of the ditch and subtle topographic changes along the side slopes of the ditch on both sides.
