Natural Resources Assessment Woodmoor Lake Pump Station No. 2 and Pipeline Northeast of Woodmoor Drive and Lake Woodmoor Drive El Paso County, Colorado

ERO Resources Corporation
1842 Clarkson Street
Denver, Colorado 80218
(303) 830-1188
ERO Project #21_047

March 23, 2021

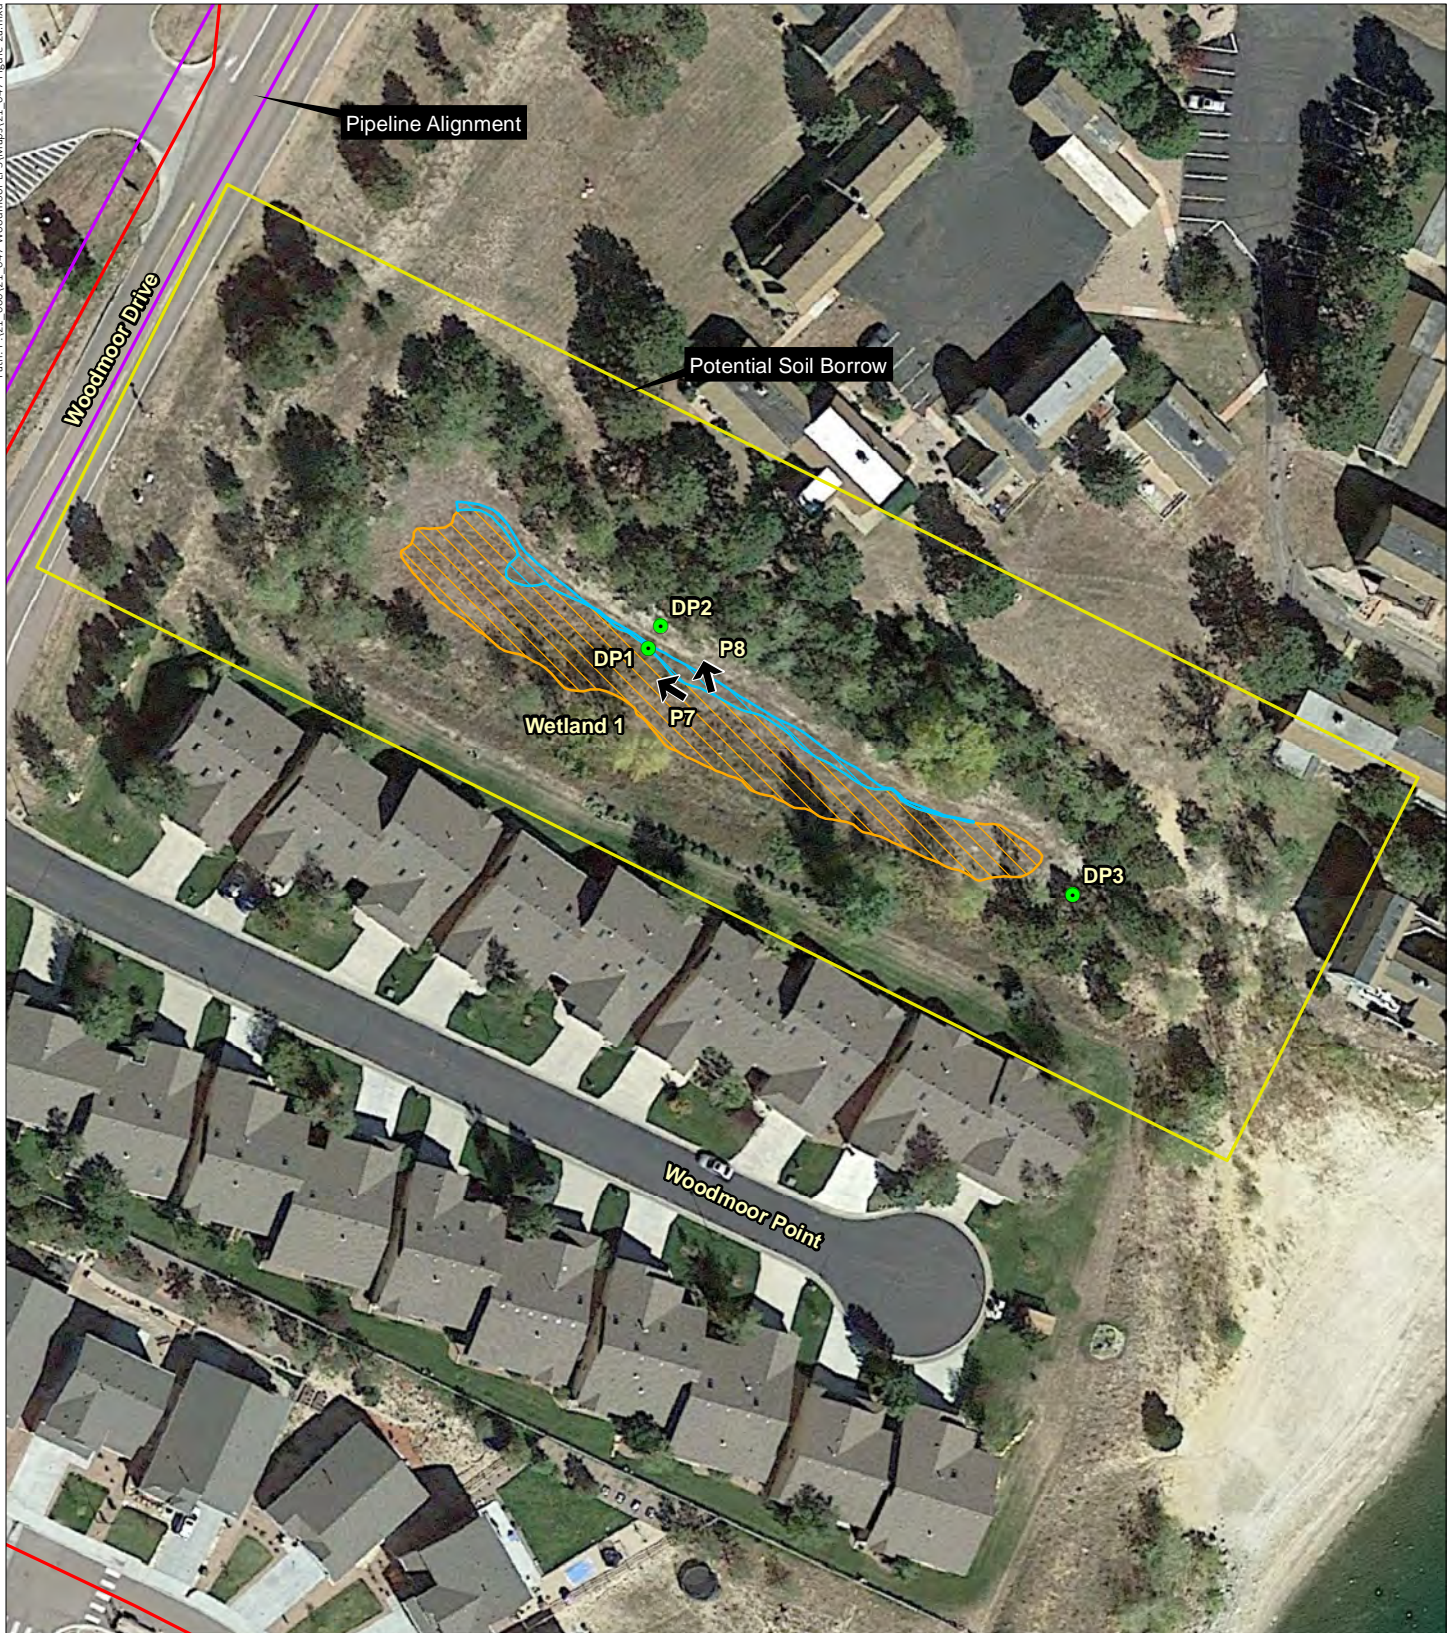
Figure 2a
Existing Conditions

A wetland (Wetland 1) is located within a stormwater detention basin in the western portion of the project area (Photo 7; Figure 2a) and is dominated by broadleaf cattail (*Typha latifolia*), Emory's sedge (*Carex emoryi*), redtop (*Agrostis gigantea*), and sandbar willow. Wetland 1 is bordered by upland vegetation and ponderosa pine trees (Photo 8; Figure 2a).

During the 2021 site visit, one broadleaf cattail-dominated wetland was mapped in the western part of the project area (Wetland 1; Figure 2a). ERO mapped a total of 0.172 acre of wetlands in the project area. Wetland 1 is in a stormwater detention basin between residential buildings. Wetland 1 appears to receive stormwater runoff from residential developments to the north and south and Woodmoor

Wetland 1 would likely be considered nonjurisdictional under current regulations because it does not appear to have a clear surface connection to a known downstream water of the U.S. Woodmoor Lake would most likely be considered jurisdictional because the lake is located along an intermittent stream and has a downstream connection to the Arkansas River, a known water of the U.S. If Wetland 1 or Woodmoor Lake are determined jurisdictional and if work is planned within Wetland 1 or Woodmoor Lake, a Section 404 permit would be required for the placement of dredged or fill material within the wetlands or OHWM. If the impacts are limited to less than 0.5 acre, the project potentially could be authorized under one or more Nationwide Permits. If no work is planned within Wetland 1 or along Woodmoor Lake or if Wetland 1 and the Woodmoor Lake are determined nonjurisdictional, no further action is necessary.

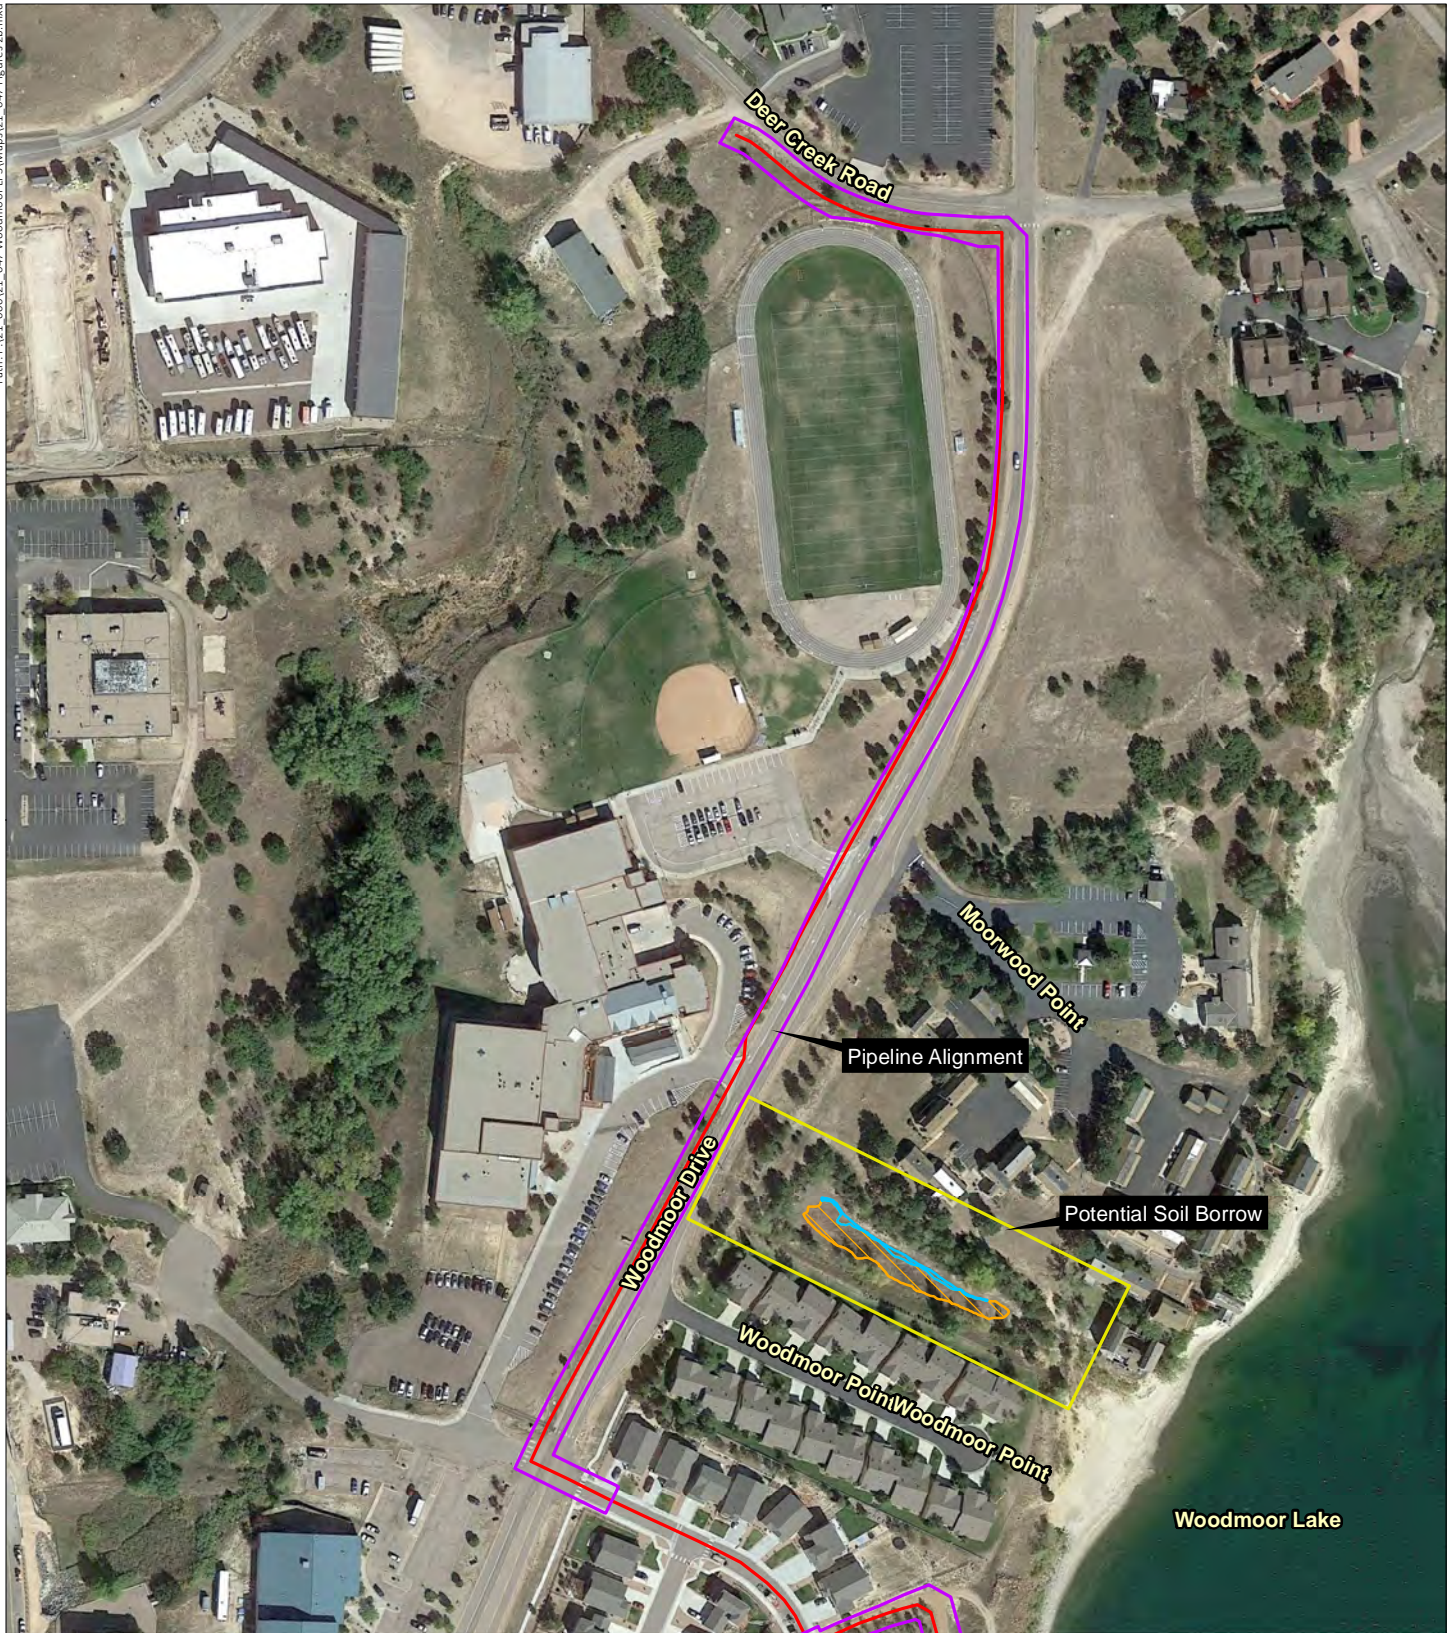
Figure 2b Existing Conditions

Woodmoor Lake is within portions of the project area and is shown on the National Hydrography Dataset (NHD) as a perennial lake that is fed by an unnamed intermittent stream and has a downstream connection to the Arkansas River, a known water of the U.S. During the 2021 site visit, ERO mapped a total of 2.20 acres of ordinary high water mark in the project area.

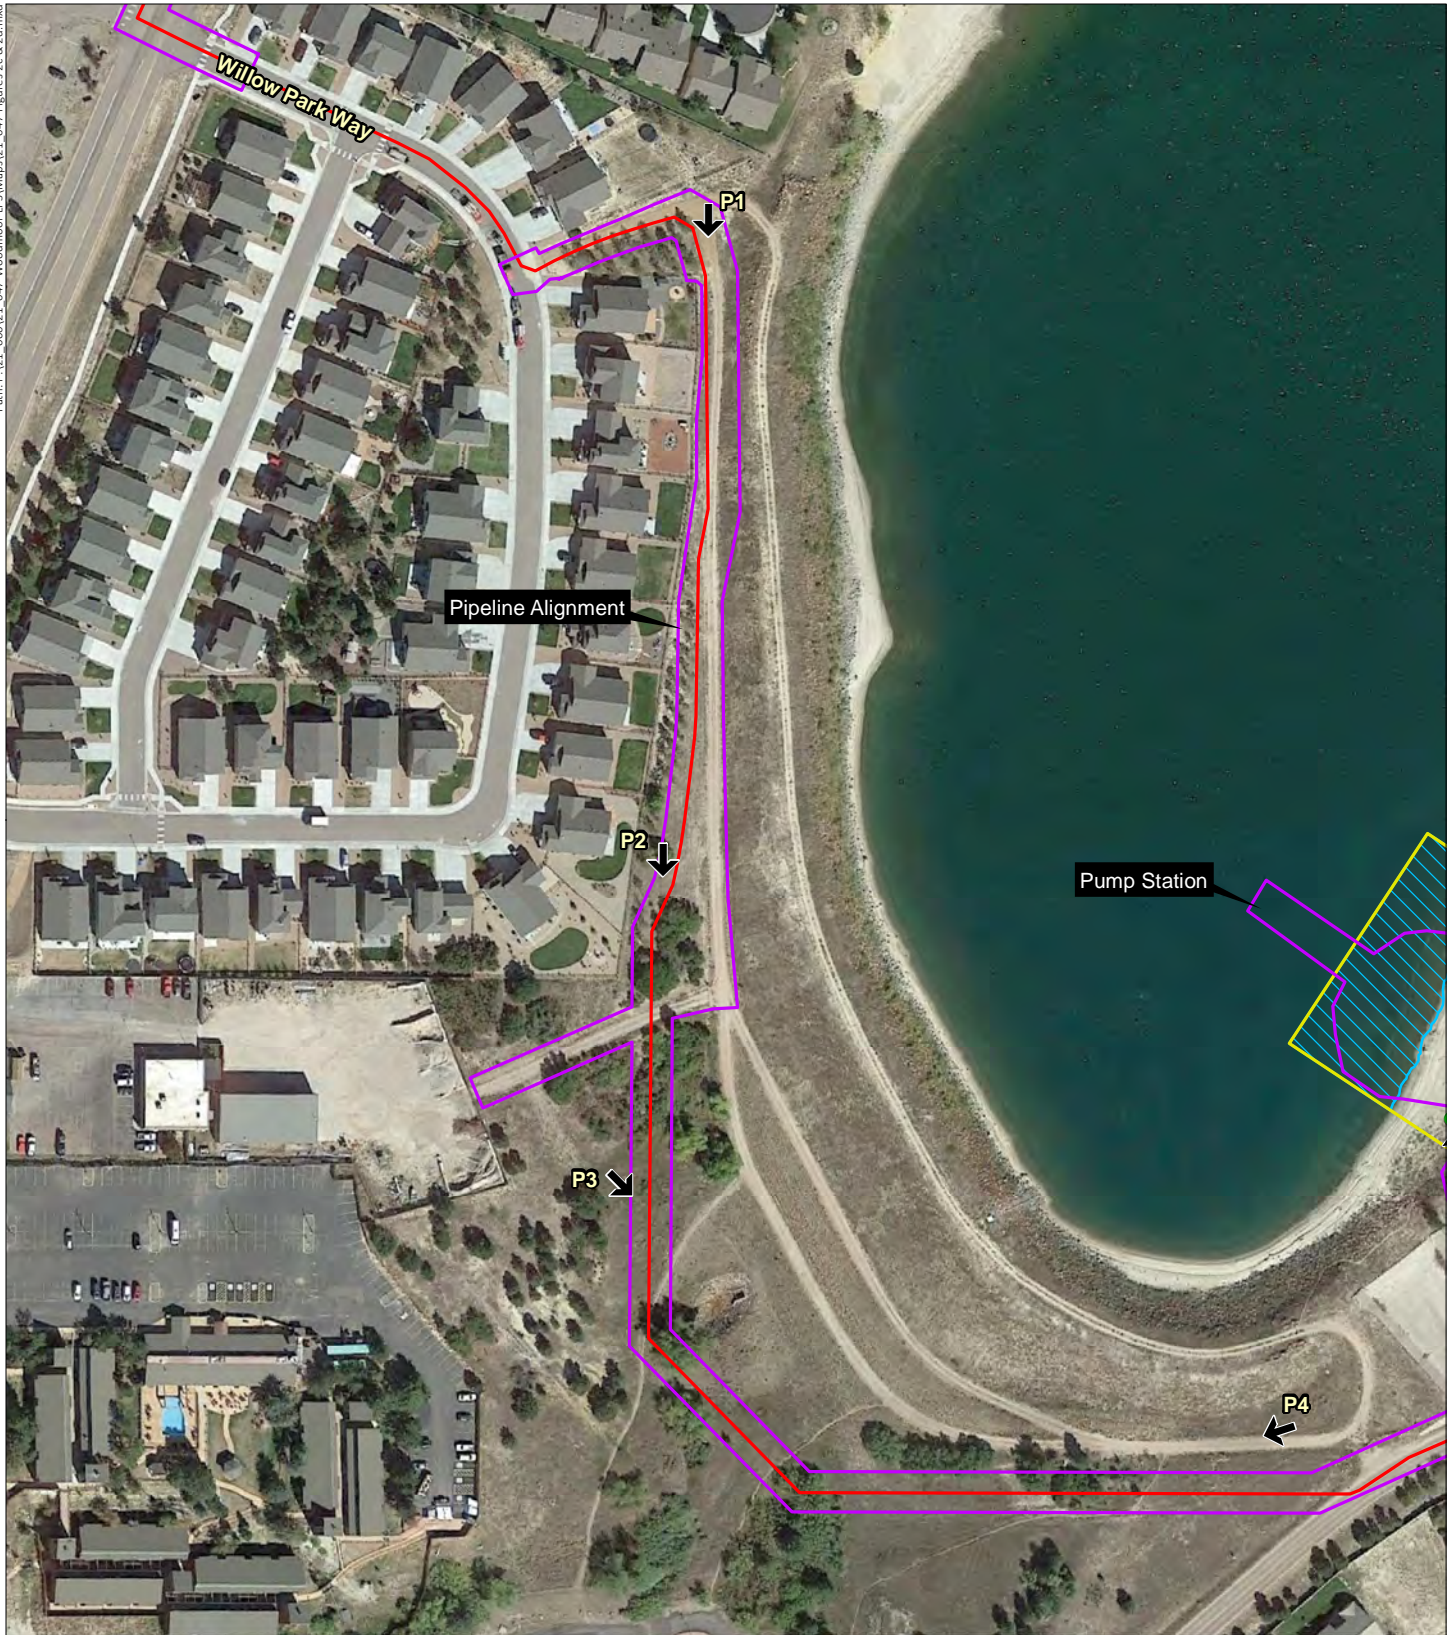
- ➔ Photo Point
- Data Point
- Pipeline Alignment
- Limit of Work
- Ordinary High Water Mark (2.200 ac)
- Wetland (0.172 ac)
- Project Area Boundary

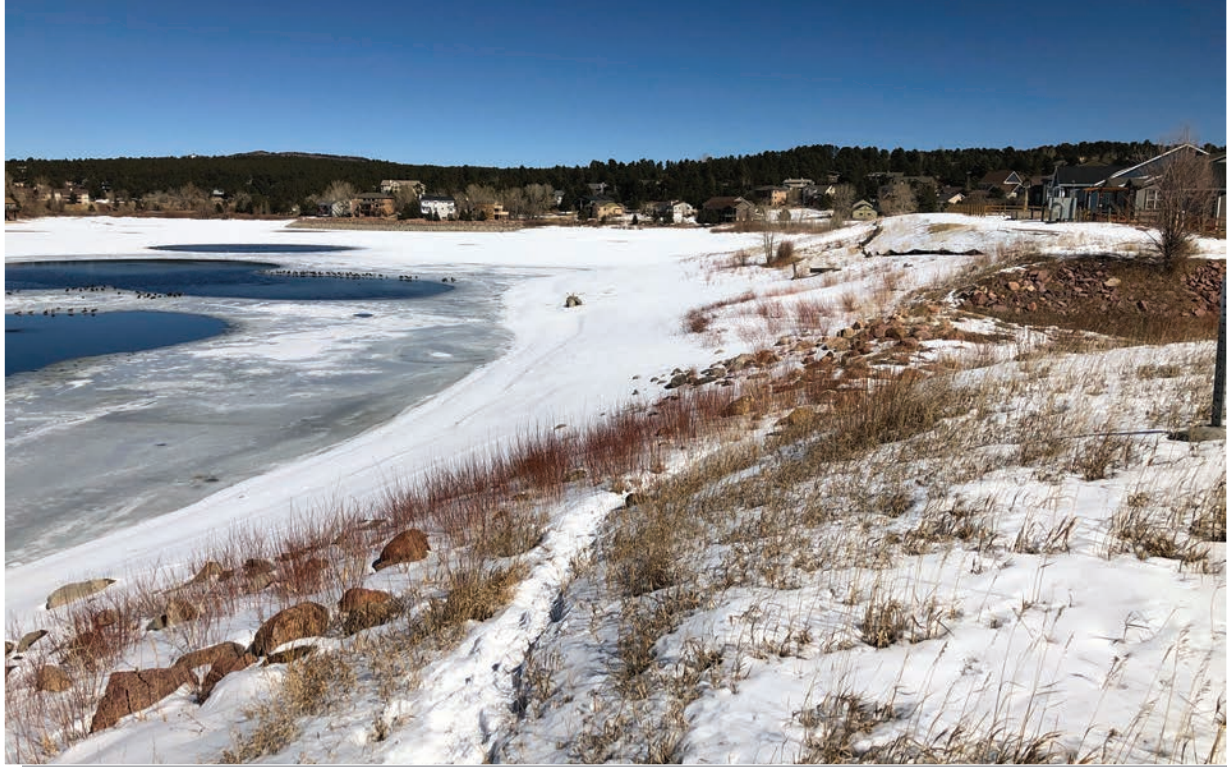
Photo 5 - Overview of riparian habitat in the eastern part of the project area. View is to the northwest.

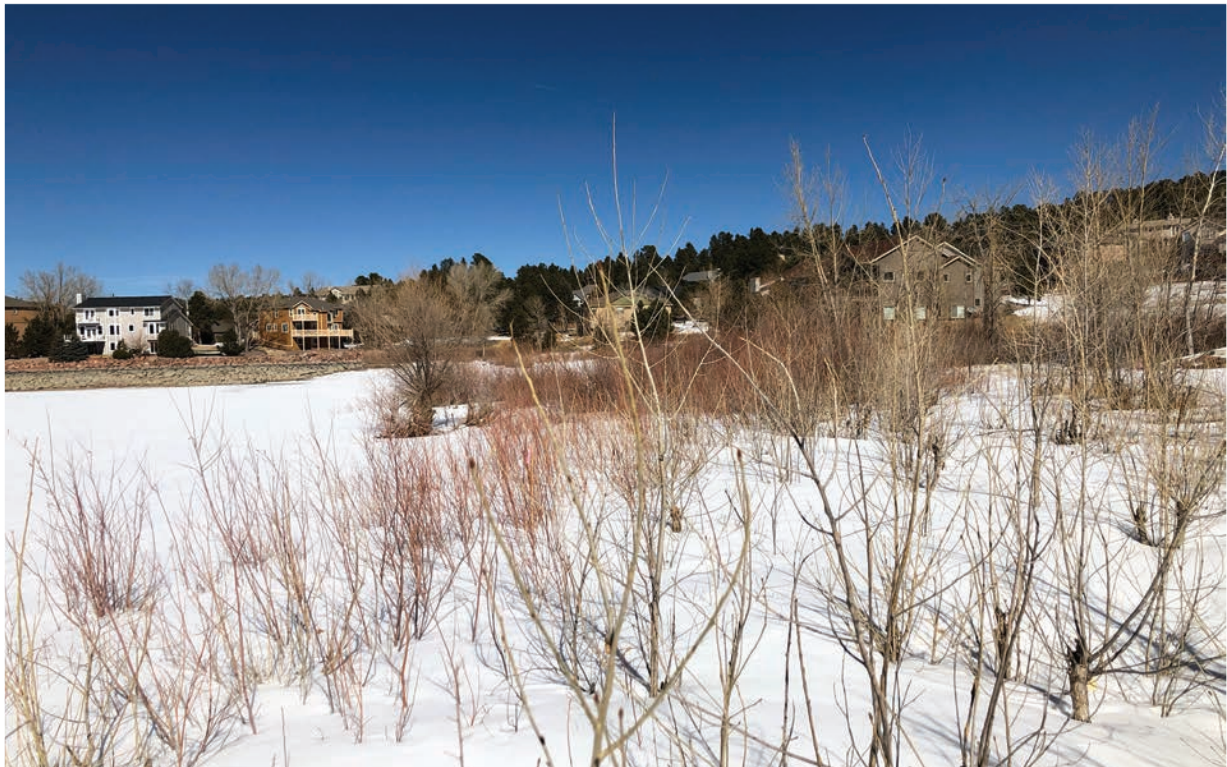
Photo 6 - Overview of riparian habitat in the eastern part of the project area. View is to the northeast.

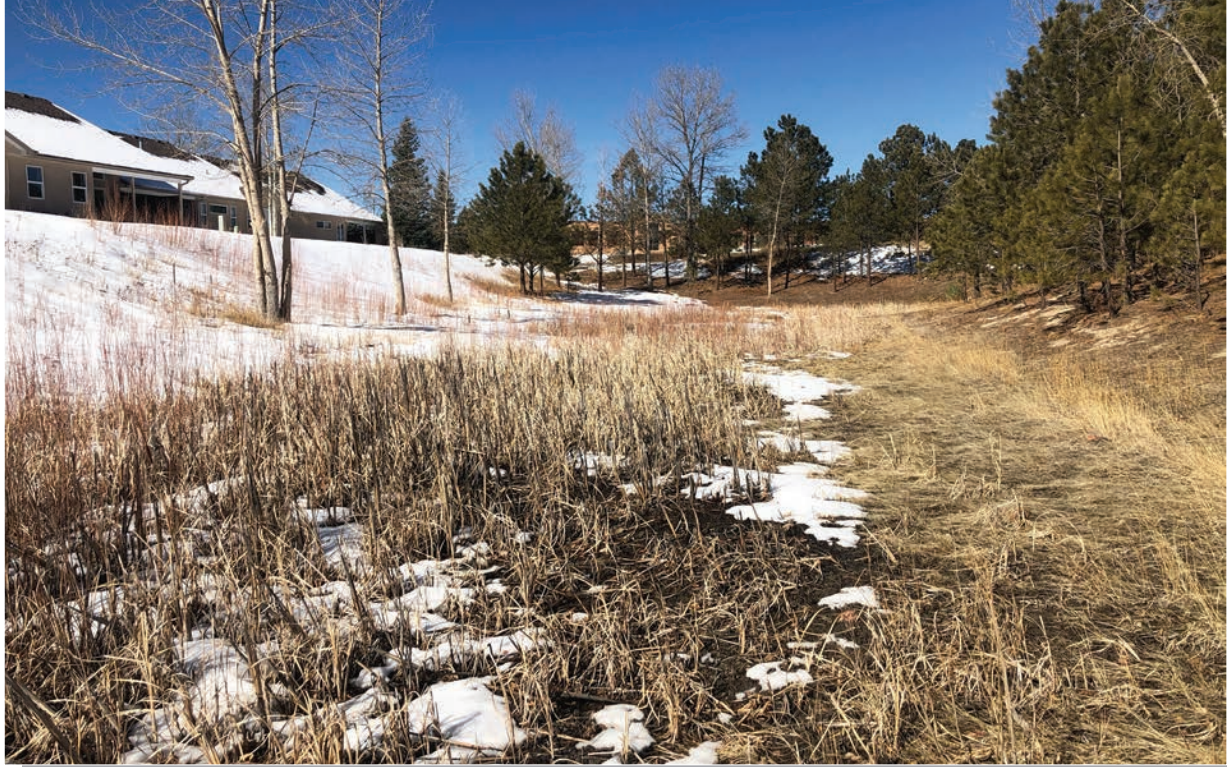
ERO mapped one wetland (Wetland 1) dominated by broadleaf cattail (Obligate), Emory's sedge (Obligate), and reedtop (Facultative Wetland) in the project area during the 2021 site visit (Figure 2a). The vegetation at DP1 met the dominance test for hydrophytic vegetation. The vegetation at DP2, DP3, DP4, and DP5 did not meet any of the hydrophytic vegetation indicators.

Photo 7 - Overview of wetland vegetation in Wetland 1 in the western part of the project area.
View is to the northwest.

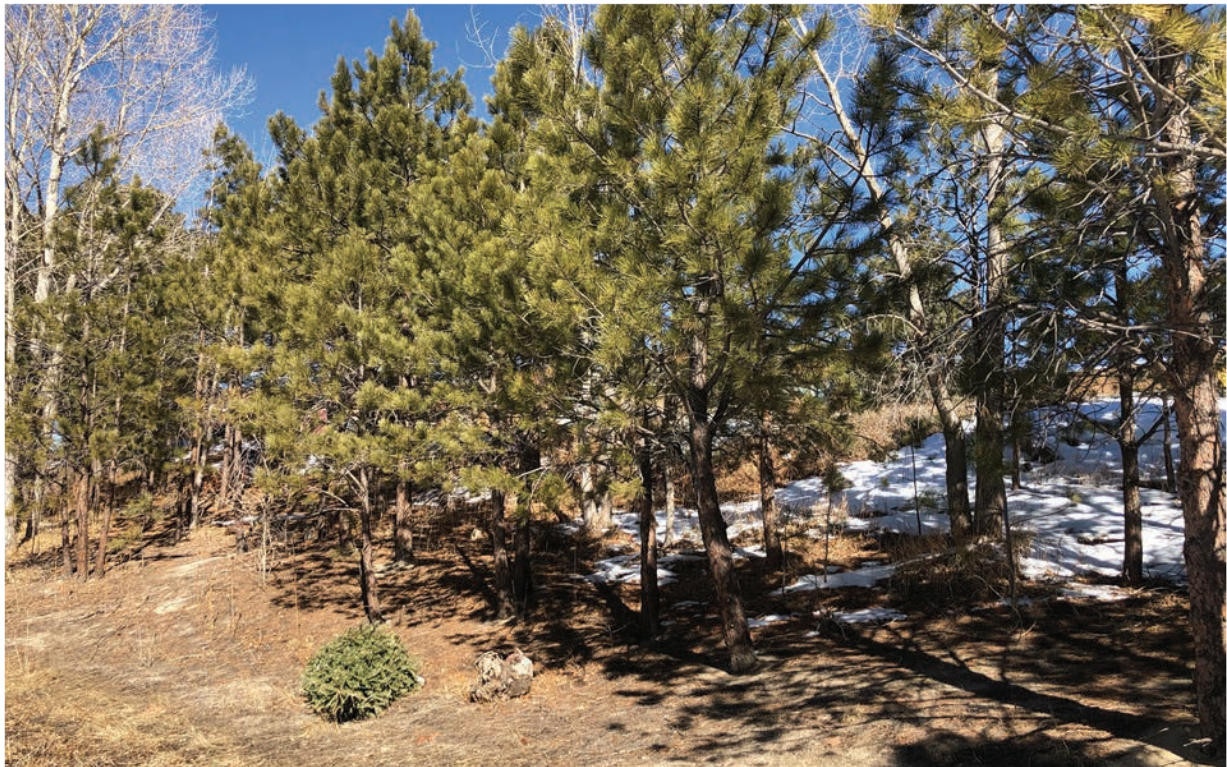
Photo 8 - Overview of upland vegetation and ponderosa pine trees in the western part of the project area.
View is to the northwest.
