NATURAL FEATURES AND WETLANDS REPORT

***Falcon Field
El Paso County, CO***

December 2020

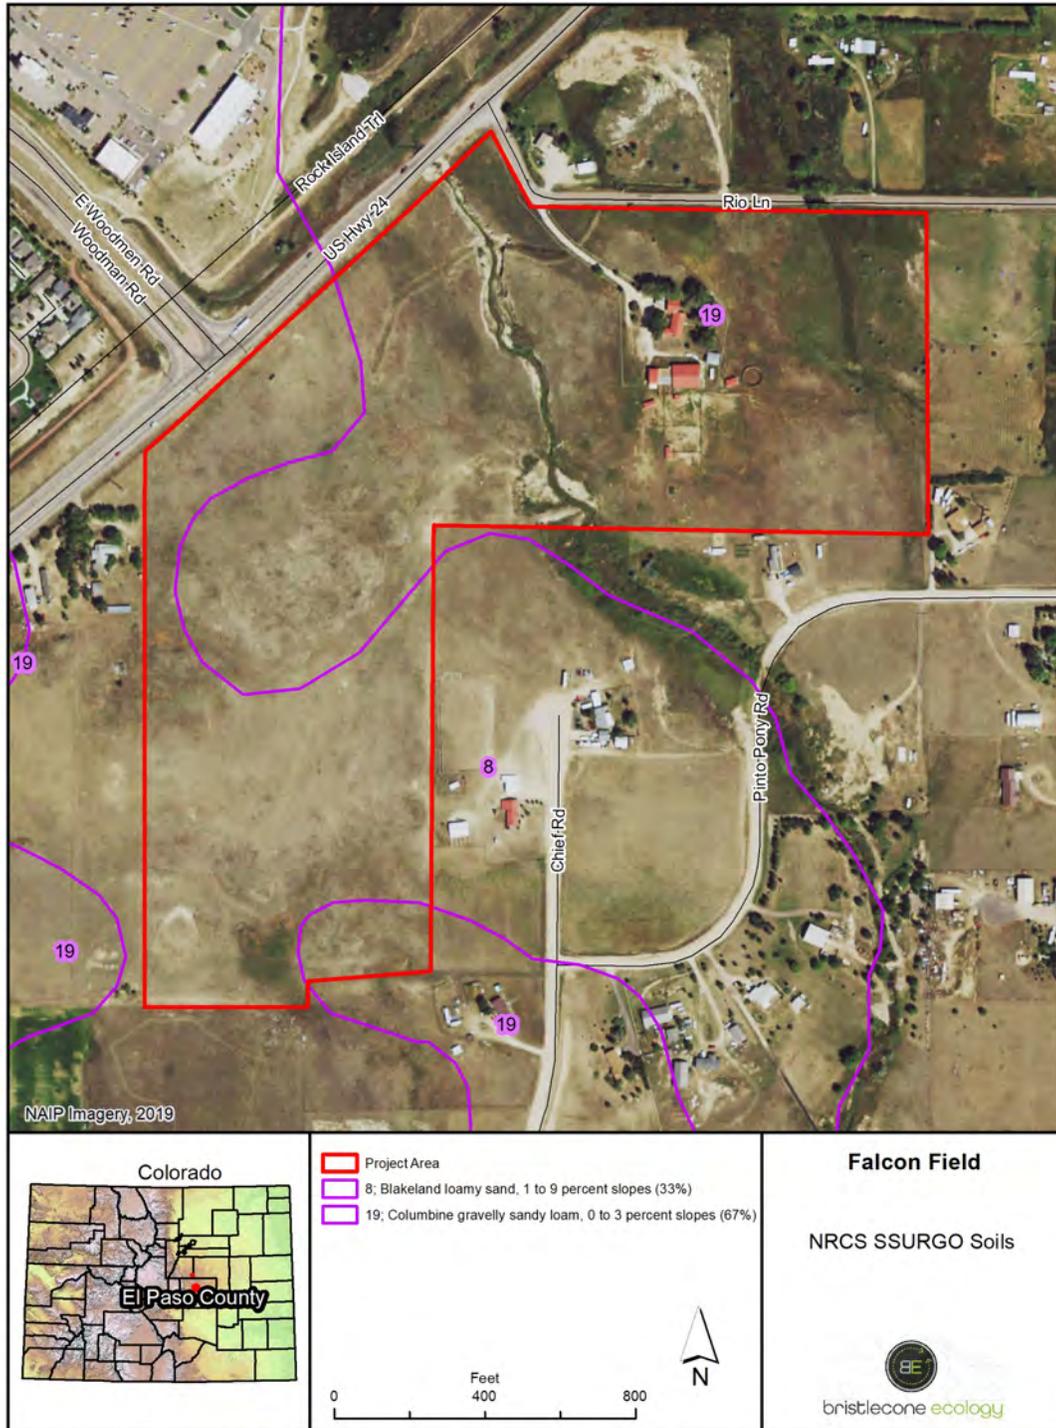
Figure 2: NRCS SSURGO Soils Map

B.E. reviewed the hydric soil ratings for all soil components present on the Project site to aid in the identification of wetland habitats during the site reconnaissance (NRCS 2020b). Hydric soils are those that form under conditions of saturation, flooding, or ponding long enough during the growing season to develop anaerobic conditions, and their formation is required in order for wetlands to become established. The NRCS hydric rating indicates the percentage of each map unit that meets the criteria for hydric soils. The map unit hydric rating is 2 for the Columbine map unit and it not rated as hydric. Two minor components of the Columbine map unit are rated as hydric in El Paso County. The Pleasant series (1%) is typically found in depressions where ponding can occur. Fluvaquentic Haplaquolls (1%) typically occur in swales. The Blakeland map unit has a hydric rating of 1, it not rated as hydric, and also includes the hydric Pleasant series as a minor component (1%).

Hydrologic soil groups are based on estimates of runoff potential (NRCS 2020a). Soils are assigned to one of four groups according to the rate of water infiltration. The Columbine and Blakeland series are both in Hydrologic Group A. When thoroughly wet, soils in this group have a high infiltration rate and low runoff potential. These soils have a high rate of water transmission. Group A soils consist mainly of deep, well drained to excessively drained sands or gravelly sands.

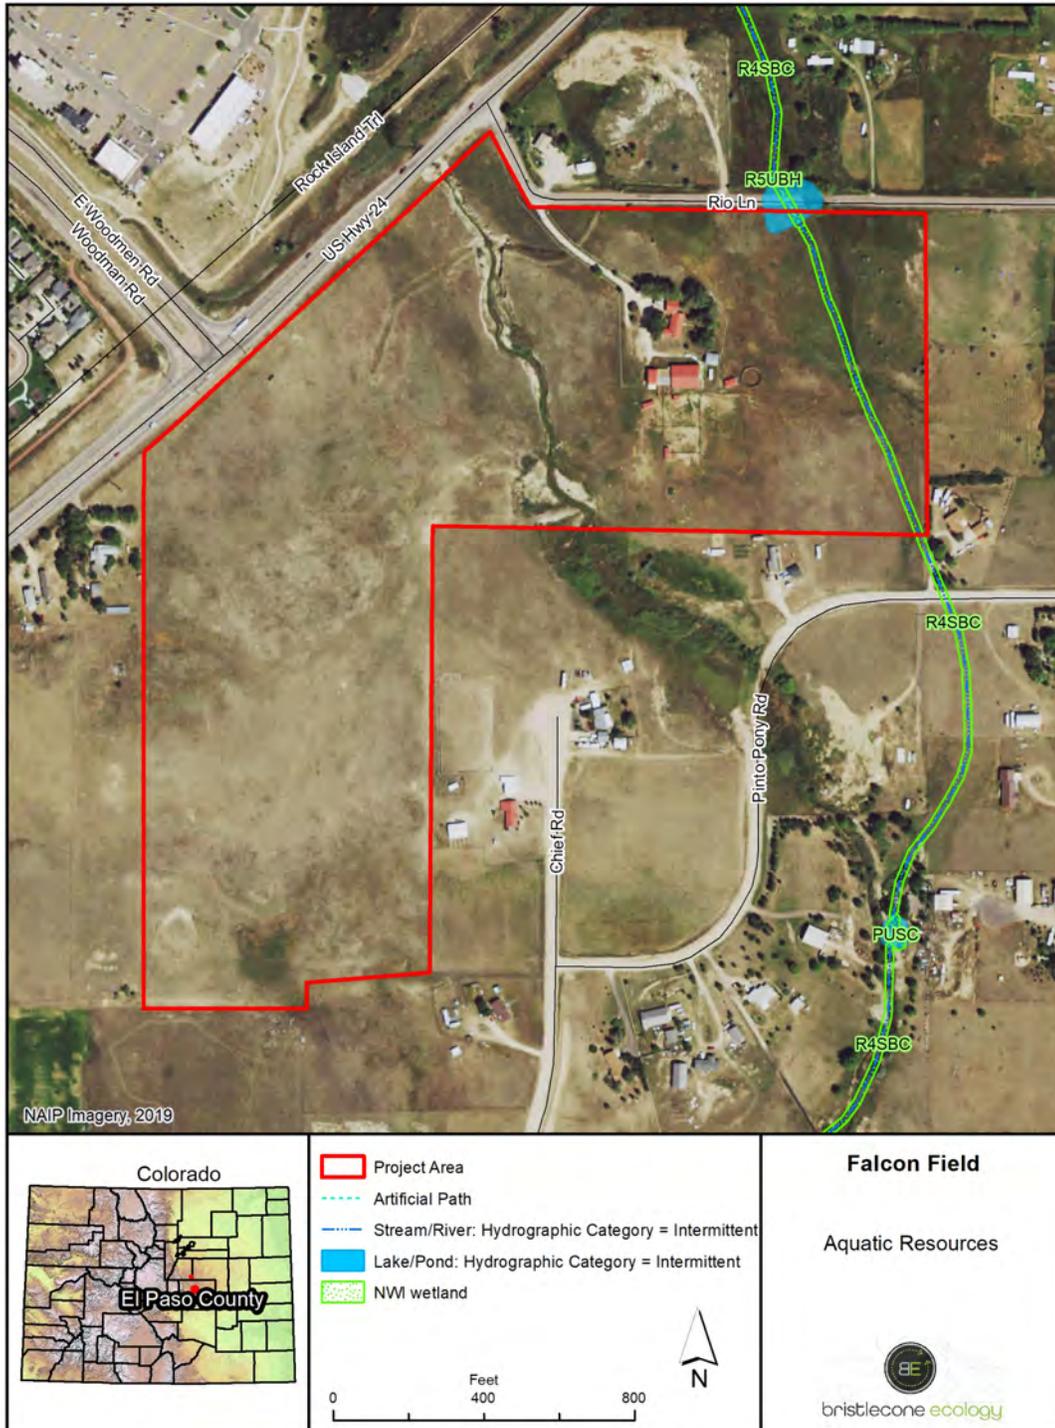
Figure 3: Aquatic Resources Map

Watercourses and other aquatic features identified in the preliminary desktop analysis were inspected in the field to assess their current conditions and jurisdictional potential. This included additional potential wetland areas identified on aerial photographs. Site reconnaissance confirmed that wetlands are more extensive than depicted in the NWI/NHD data with a total wetland area of roughly 7.2 acres. Most of the wetlands are associated with sub-irrigated wet meadows on the east side of the Project Area. During the site reconnaissance, the following features identified in the NWI/NHD data were delineated and classified as follows (Figure 5: *Wetland Delineation Map*):

While only the U.S. Army Corps of Engineers may determine the regulatory status of aquatic features under the Clean Water Act, it is B.E.’s professional opinion that the field-delineated wetlands on the site would not be considered jurisdictional because there is not a continuous surface connection to downstream WOTUS.

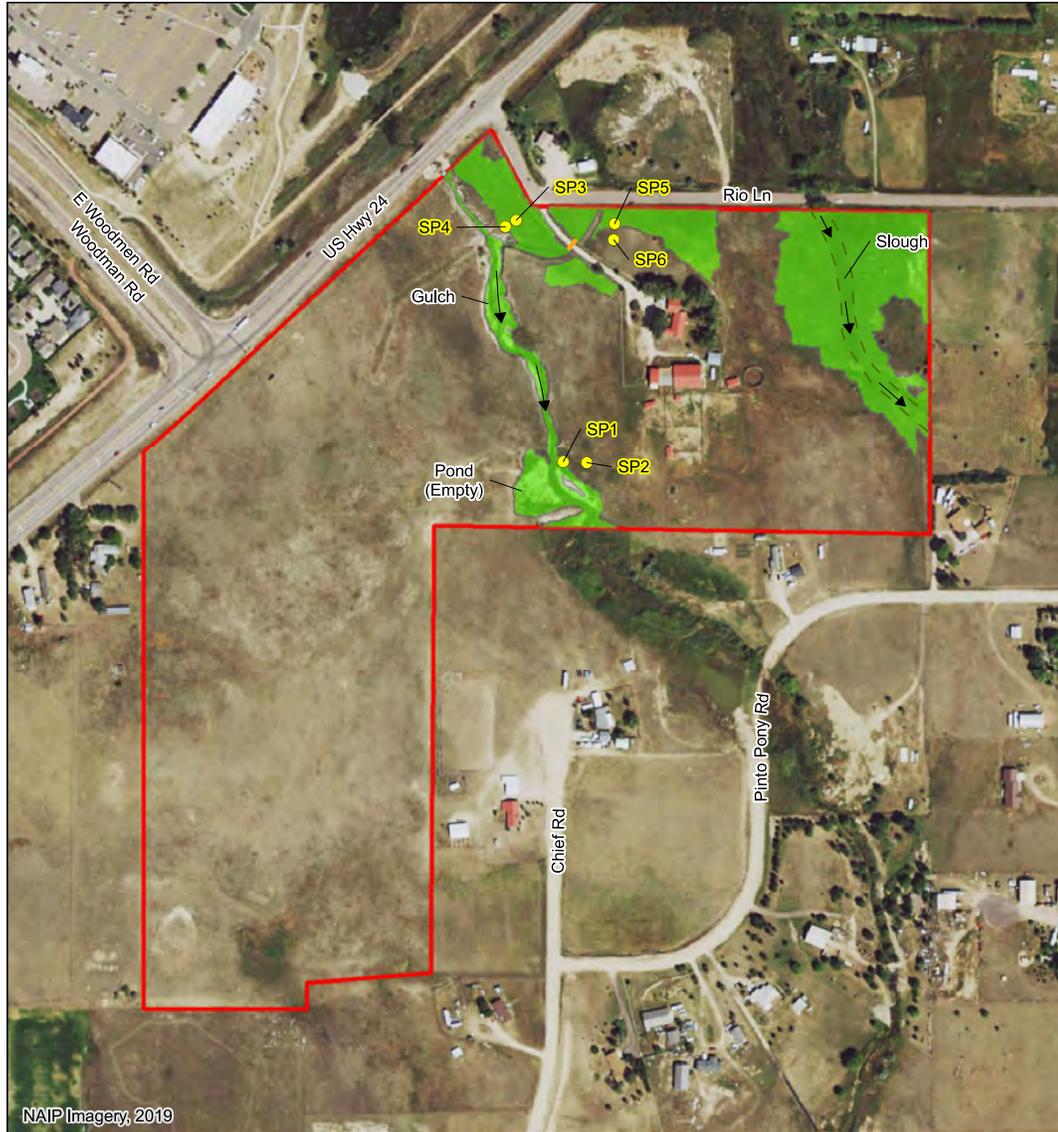
Figure 5: Wetland Delineation Map

- Near the southwest end of the gulch and within the FEMA mapped floodplain, there is an abandoned farm pond. There is sparse palustrine scrub shrub wetland vegetation growing throughout the pond. Groundwater in the pond area appears to be shallow as evidenced by the small springs observed around the perimeter, areas of surface soil saturation, and well-established wetland vegetation. The hydrology of Sample Point 1 (Appendix 1) is representative of the pond edge.

- Wetland vegetation continues south from the pond for another 0.14 mile and then ends at Blaney Road to the east and a large driveway to the south. During the site visit, upland vegetation was growing in both of these areas and no surface water connection to downstream areas via culverts was observed.

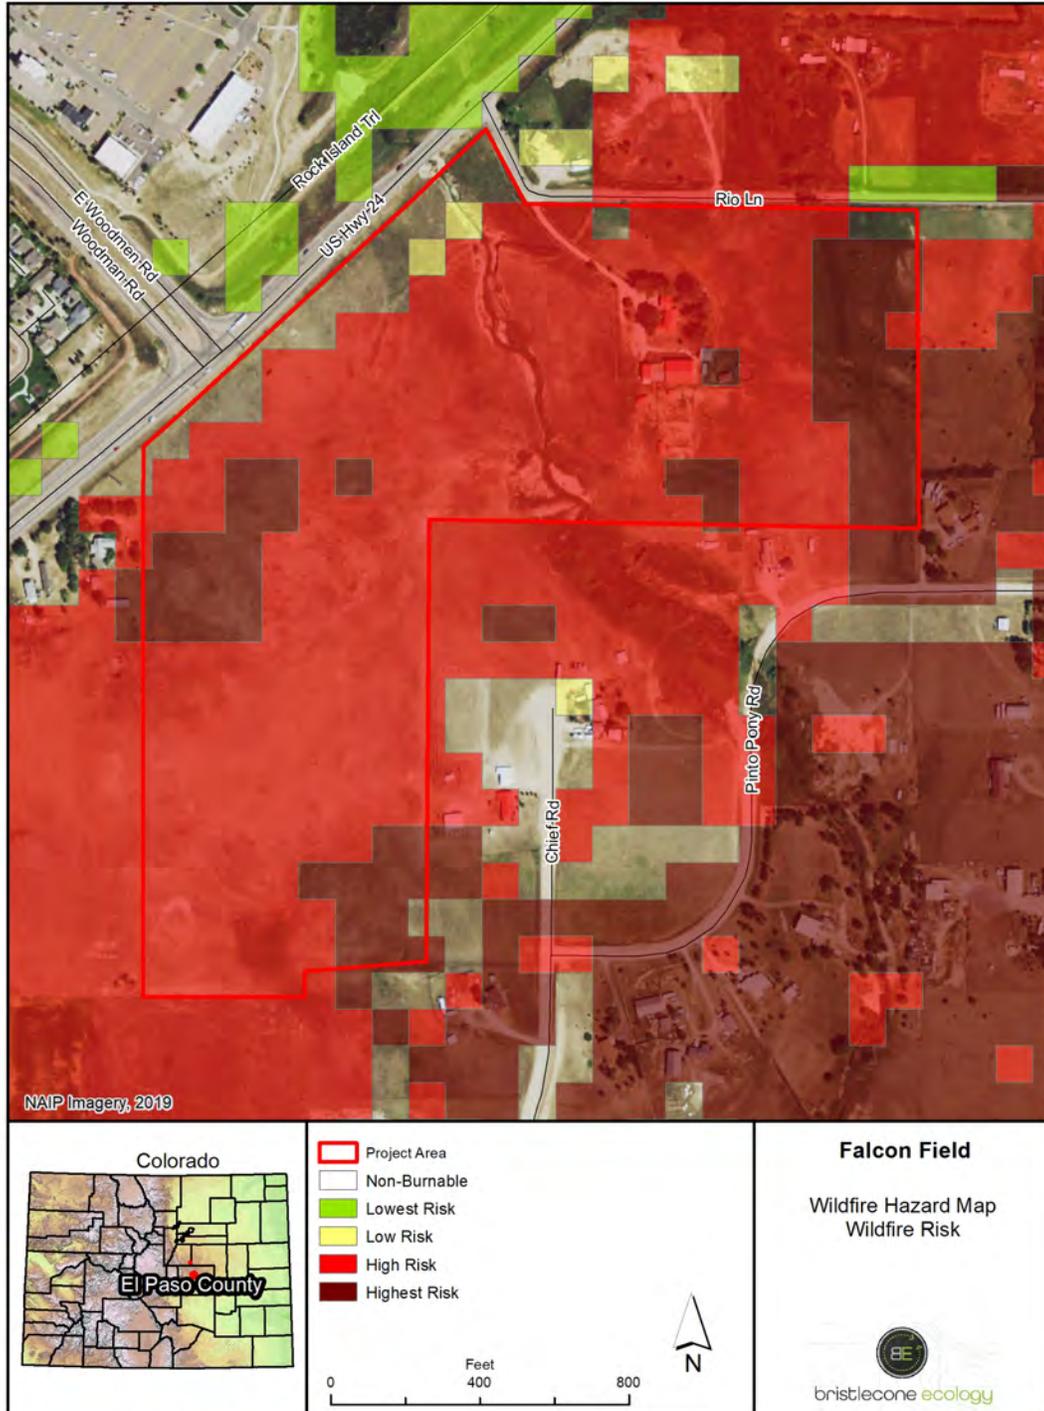
Figure 6: Wildfire Hazard Map – Wildfire Risk

Wildfire hazard for the Project site was evaluated using the Colorado State Forest Service's (CSFS) online Wildfire Risk Assessment Portal (WRAP; CSFS 2020). WRAP allows professionals, planners, and the public to access the best scientific information regarding wildfire risk and establish prevention and mitigation measures accordingly. According to WRAP, the wildfire risk for the majority (~80%) of the Project area is listed as "High Risk," with small areas mapped as "Non-Burnable," "Low Risk," and "Highest Risk" (CSFS 2020; Figure 6: *Wildfire Hazard Map – Wildfire Risk*). "Wildfire Risk" is determined by CSFS by combining the burn probability rating of a site with the values-at-risk rating. The "High Risk" rating is likely based on the presence of multiple homes surrounding the site. The burn probability for the entire site is rated "Moderate-High" (CSFS 2020; Figure 7: *Wildfire Hazard Map – Burn Probability*).

The wildfire risk for the majority of the Site is mapped as “High” and the burn probability is rated as “Moderate-High,” presumably based on the presence of numerous homes and structures surrounded by mostly dry grasslands. Development of the site would increase the values and assets, while simultaneously reducing available wildfire fuels. The Project is expected to reduce the overall wildfire risk index for the Site, especially close to U.S. Highway 24 which would become similar to the commercial areas to the north that are currently mapped as “Lowest Risk” and “Non-Burnable.”

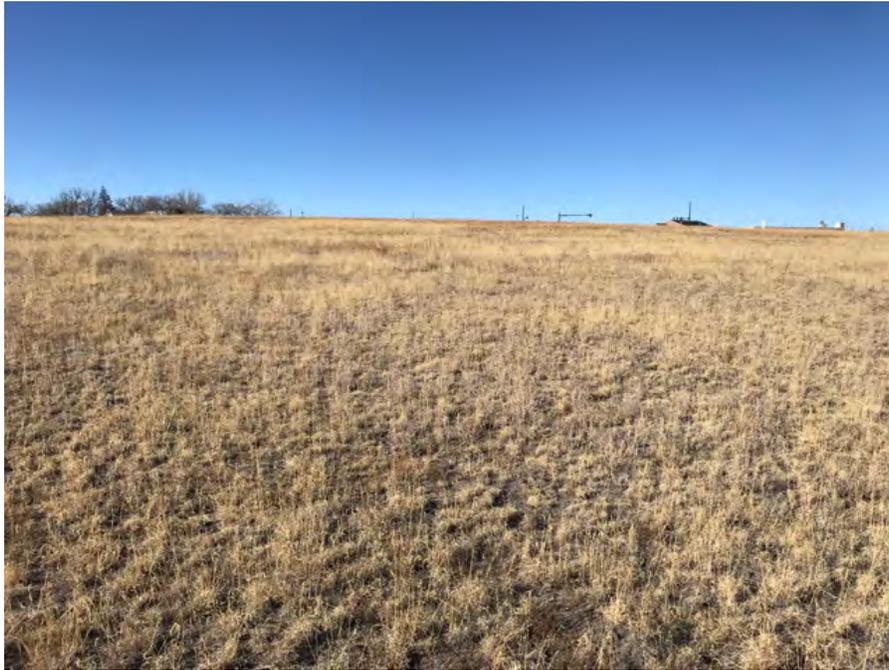
View from the southeast portion of the site facing towards the northwest corner of the site and State Highway 24. Shortgrass prairie dominated by blue grama is the predominant upland vegetation here. Some sparse kochia is visible in the foreground (dark spots) and the reddish colored little bluestem of the mixed-grass prairie is faintly visible along the hilltop.

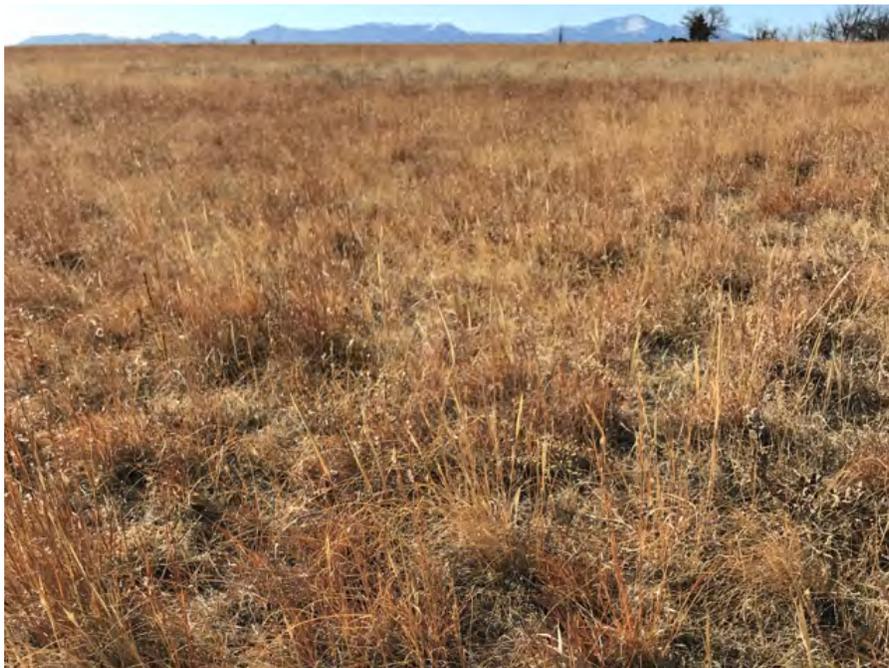
The hill slope on the west side of the site is vegetated with mixed-grass prairie. The dominant plant species are little bluestem, prairie sandreed, and sand dropseed with lesser amounts of blue grama.

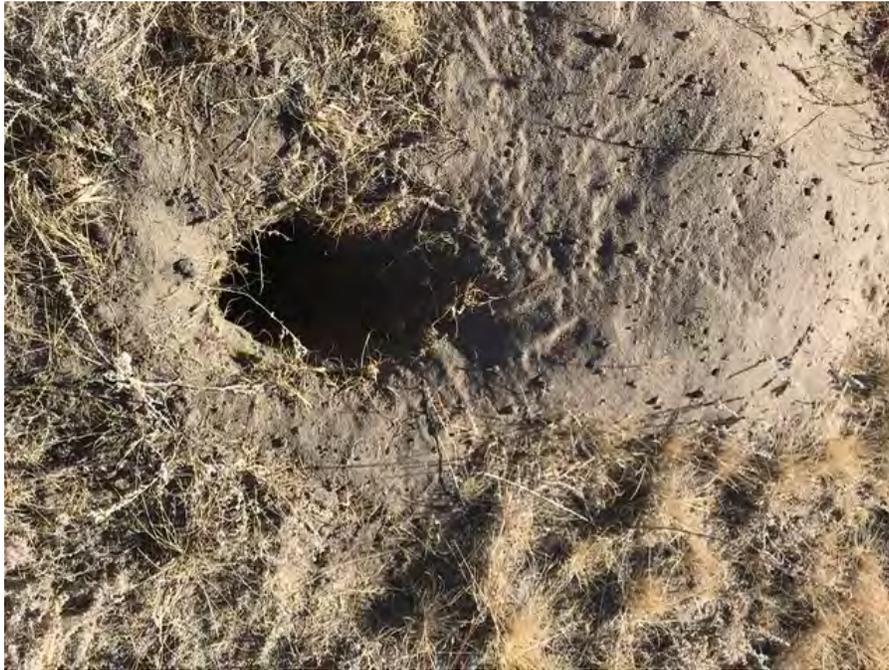
Den entrance located in the southern portion of the site. Multiple medium sized burrows, with entrances of six to ten-inch diameter, were noted. Potential occupants include badger, fox, or skunk.

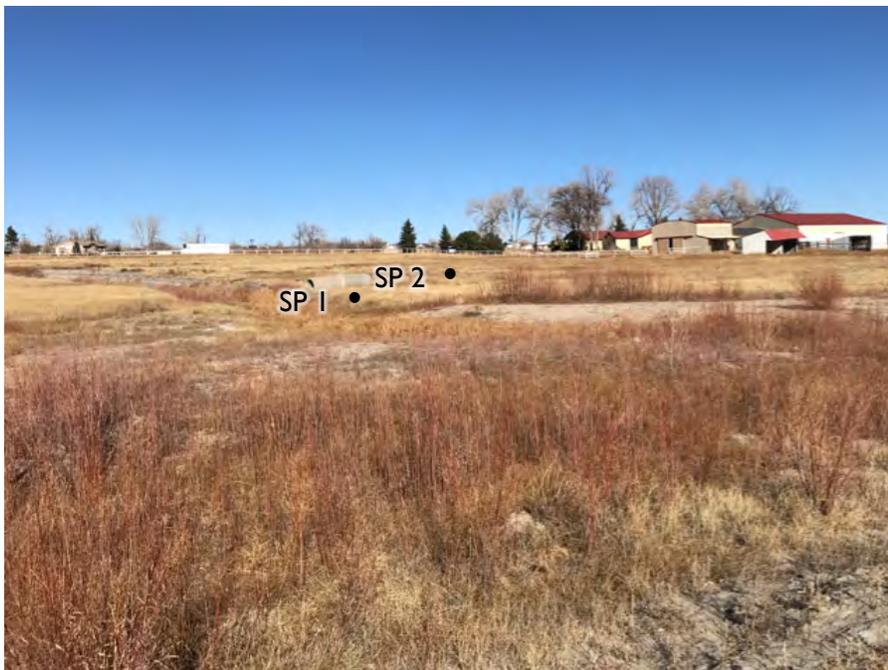
Photo taken from the small dam, facing northeast across shrub-scrub wetlands in the abandoned pond. The gulch is visible to the left of the large concrete culverts and to the right of the culverts it daylight into a wide, marshy channel. Sampling points (SP) 1 and 2 were completed in a low area on the east bank of the channel. The pond has mostly filled in with sand deposits carried by high flows.

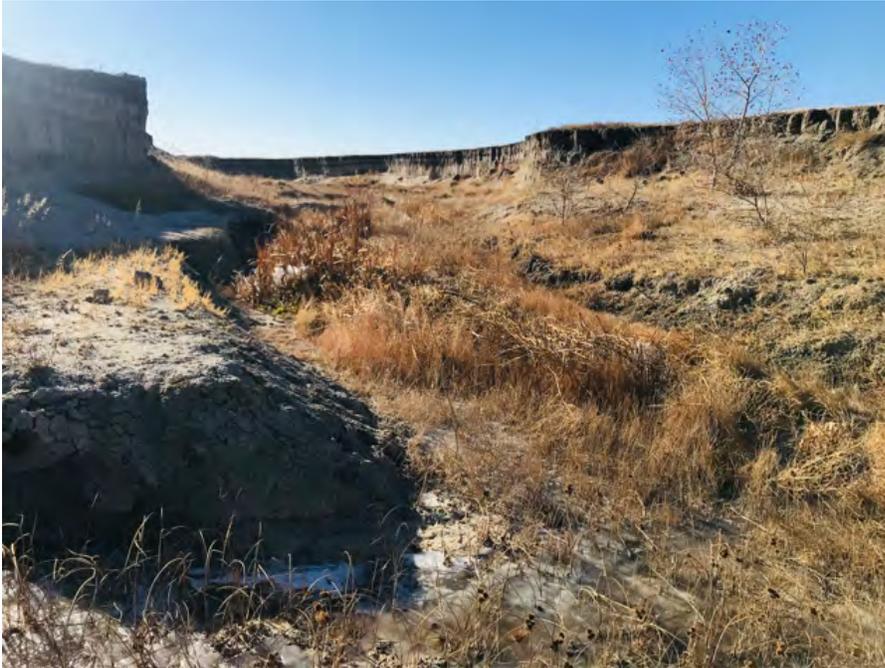
Photo taken in the gulch below SP 4 and facing south (downstream). Water flowing at the gulch bottom is approximately ten feet wide, eight inches deep, and supports dense emergent wetland vegetation. Along the sides of the gulch and above the channel, there are saturated soils associated with small seeps and springs. Saturated soils are eroding in steep areas and support sparse wetland vegetation on flat benches above the channel.

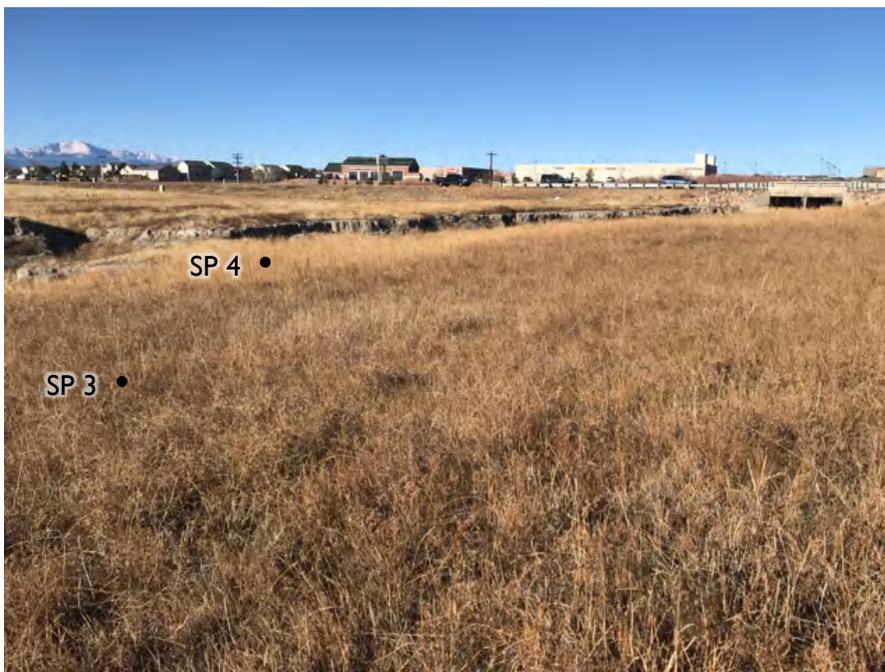
Photo taken from near the north corner of the site facing northwest towards the large box culvert at the north end of the gulch at State Highway 24. In the foreground is a large wet meadow where some areas are saturated at the surface and dominated by three-square rush (SP 3), an obligate wetland species. The drier wetlands (SP 4) are more diverse, with reedtop and switchgrass being two of the most common species, both here and in other wet meadows.

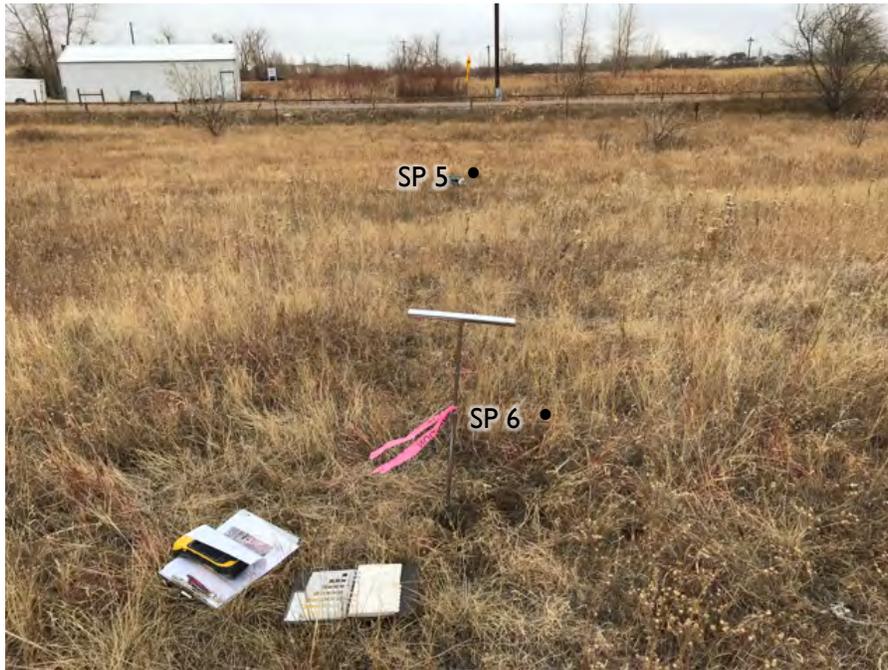
Northwest corner of the site, photo taken from the SP 6 (upland) located slightly above SP 5 (wetland) and facing north towards Rio Lane. The diverse vegetation at these sampling points is typical of upland/wetland transitional areas on most of the site.

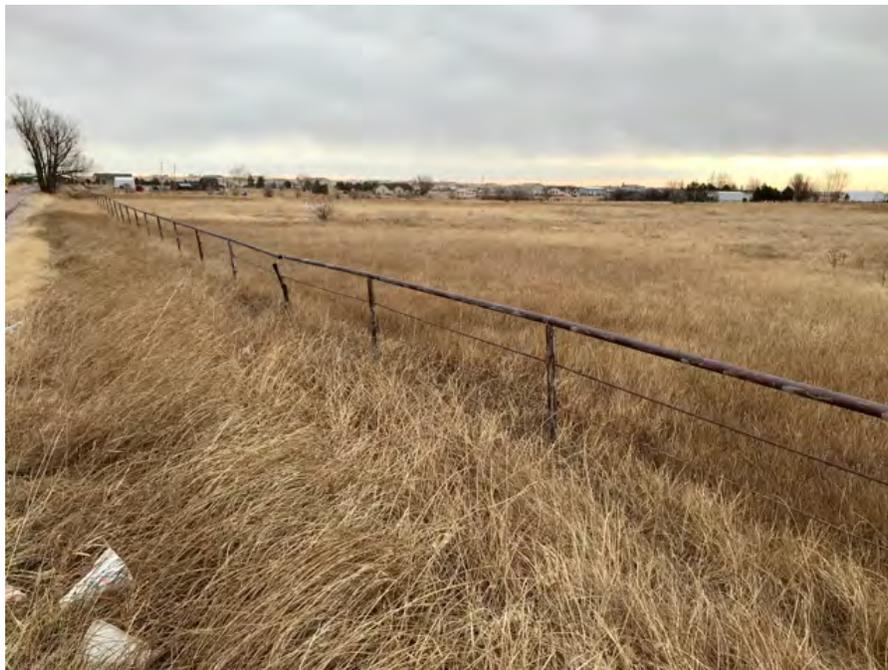
Northeast portion of the site, facing east along Rio Road. Wetland vegetation along the fence is dominated by Nebraska sedge in areas with standing water and three-square in areas without standing water. The patch of large trees growing along the road is at the north end of the slough that drains across the site to the southeast (right).

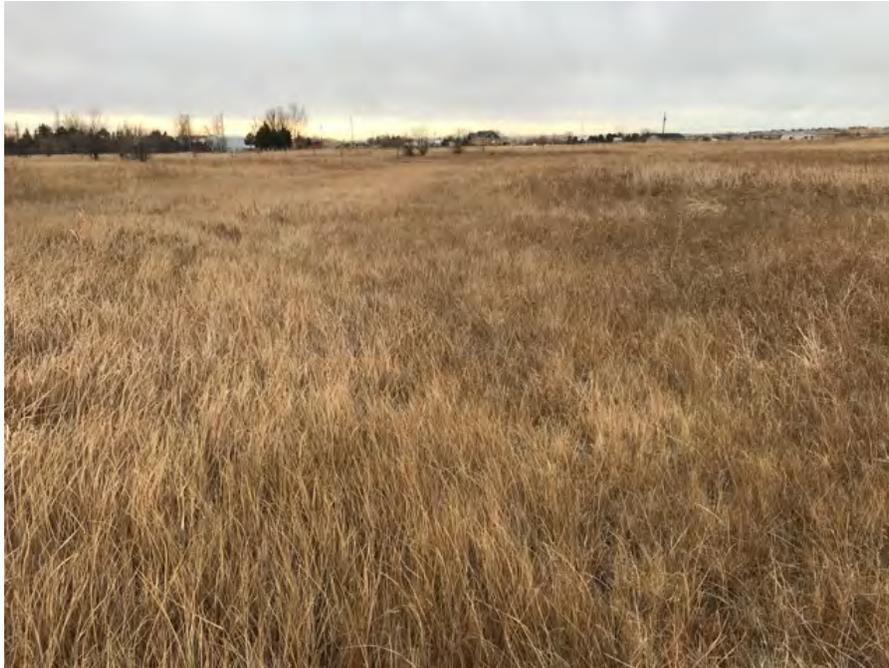
Photo taken from near the north end of the slough, facing southeast (downstream). Wetland vegetation extended several vertical feet above the slough on both sides.

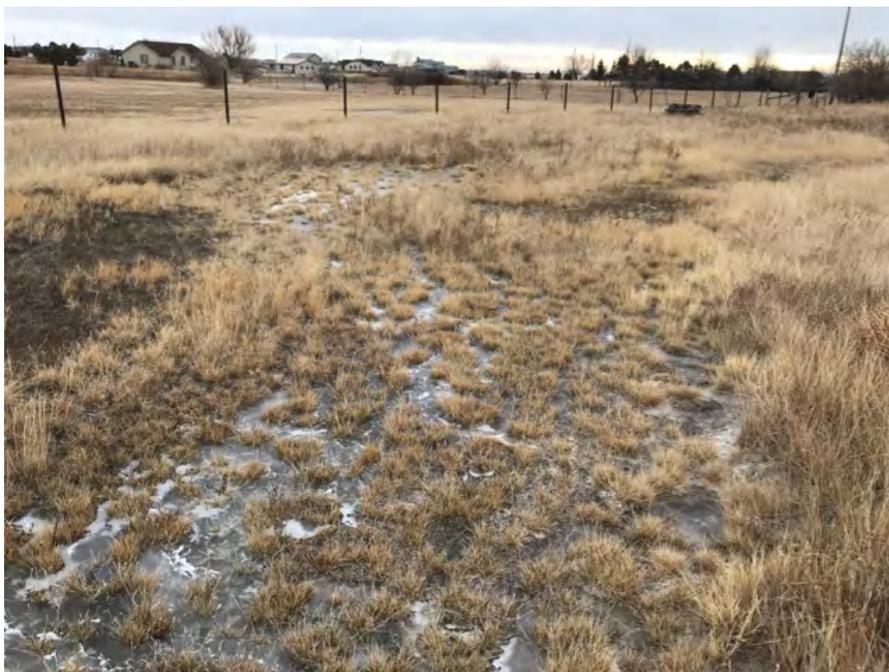
Photo taken from near the southeast corner of the site facing southeast across a flat, saltgrass dominated wet meadow with visible surface saturation (ice). The small tufted grass in the foreground is Nuttall's alkaligrass and the dark vegetation to the left is purple seepweed.
