**Re: Grant Subdivision
Geologic & Soils Report**

This Report is intended to satisfy the Geology and Soils Report requirement for the Grant Subdivision. The address of the Grant Subdivision is 1315 Walsen Road, Colorado Springs, CO 80921, comprising approximately 41 acres, El Paso County Schedule number 6205000029. The proposal is to divide the 41 acres into 11 acres containing the existing residence, and a 30-acre parcel of bare land.

Clive and Karen Grant
Grant Minor Subdivision

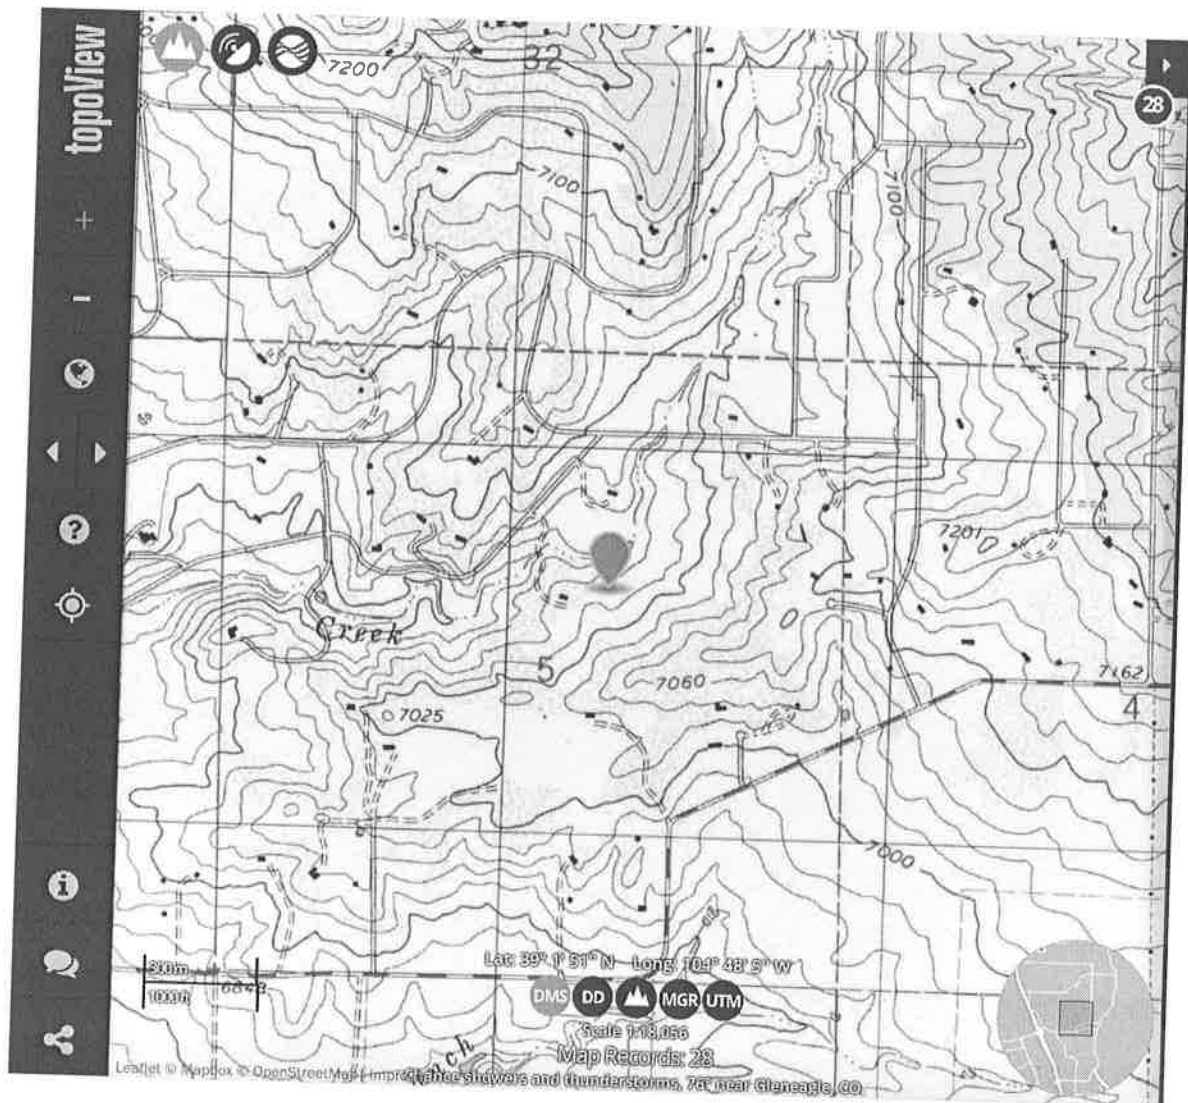
Appendix 2. Topography of the overall Grant Subdivision (Blue pointer in center of the map indicates Grant Subdivision property.)

The topography of the 41-acre property is attached as Appendix 2. Aside from the afore mentioned Smith Creek, there are no topographical concerns as there have been no substantive changes in the 41 acres since the single residence was built in 1978.

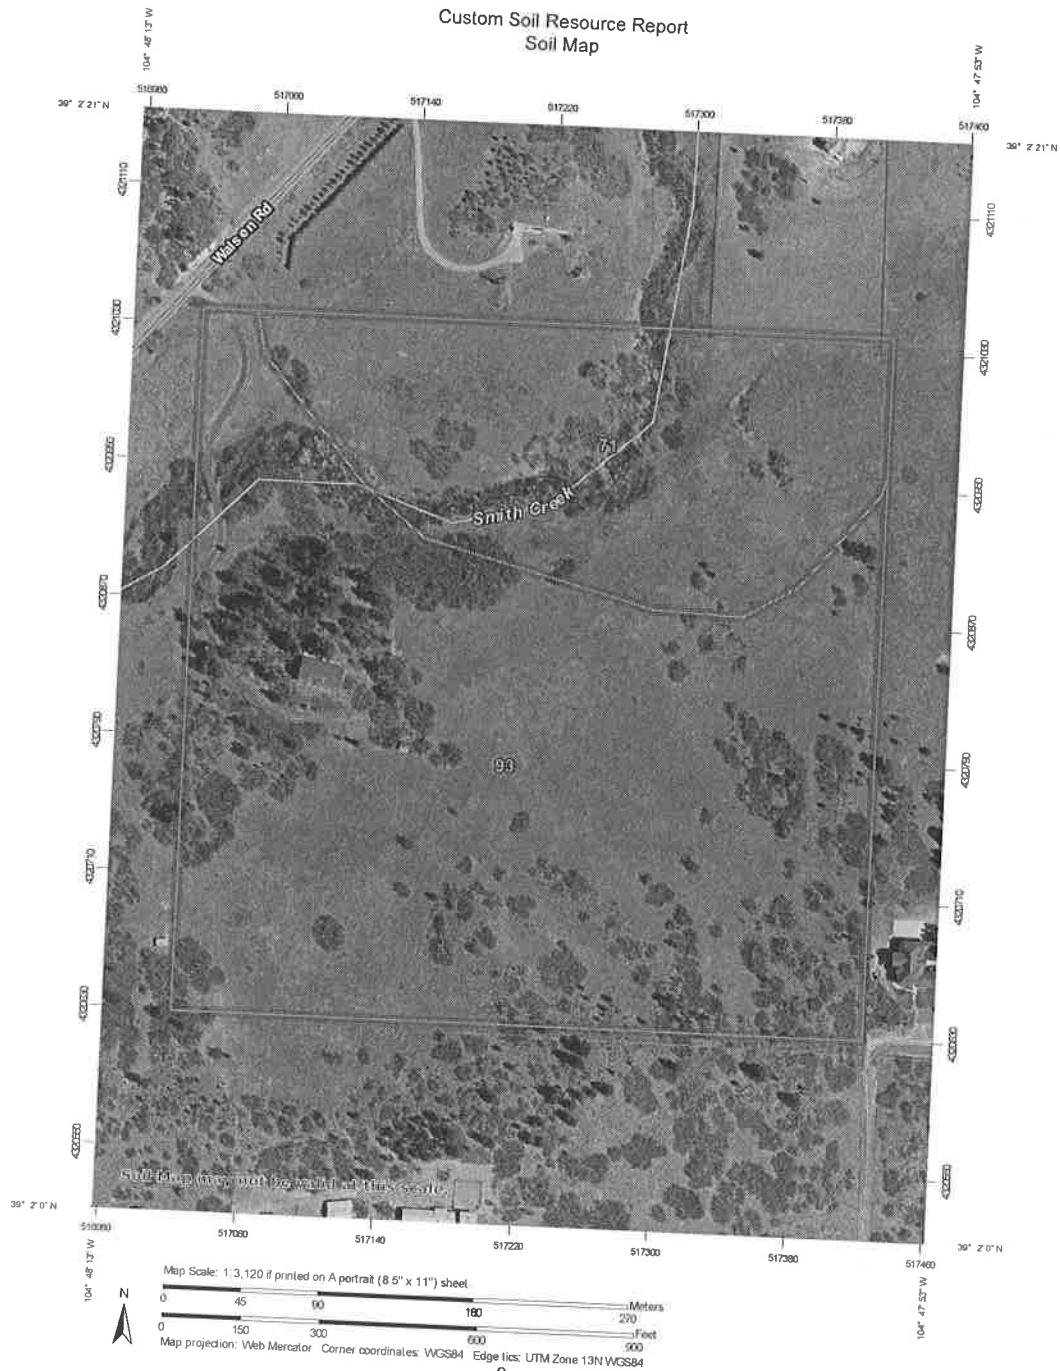
Custom Soil Resource Report Soil Map

71—Pring coarse sandy loam, 3 to 8 percent slopes

93—Tomah-Crowfoot complex, 8 to 15 percent slopes

According to the Soil Survey of El Paso County Area, Colorado by the United States Department of Agriculture, the soil of the site can be summarized as a combination of Tomah-Crowfoot complex (70%) and Pring coarse sandy loam (30%), both of which are part of hydrologic soil group B (map and explanations, Appendix 4). They are both well drained (map and explanation included as Appendix 5) with low-medium runoff, more than 80 inches to the water table, with frequencies of flooding or ponding listed as "none". Regarding suitability for "Dwellings Without Basements", the Pring coarse sandy loam is "not limited", and the Tomah-Crowfoot complex is "somewhat limited" (map and explanations are included as Appendix 6; the ratings are exactly the same with Dwellings With Basements—map and explanation not included). The suitability for "Lawns and Landscaping" for both soil areas is described as somewhat limited, implying that the soils have "features that are moderately favorable for the specified use, and the limitations can be overcome or minimized by special planning, design, or installation (map and explanations included as Appendix 7).

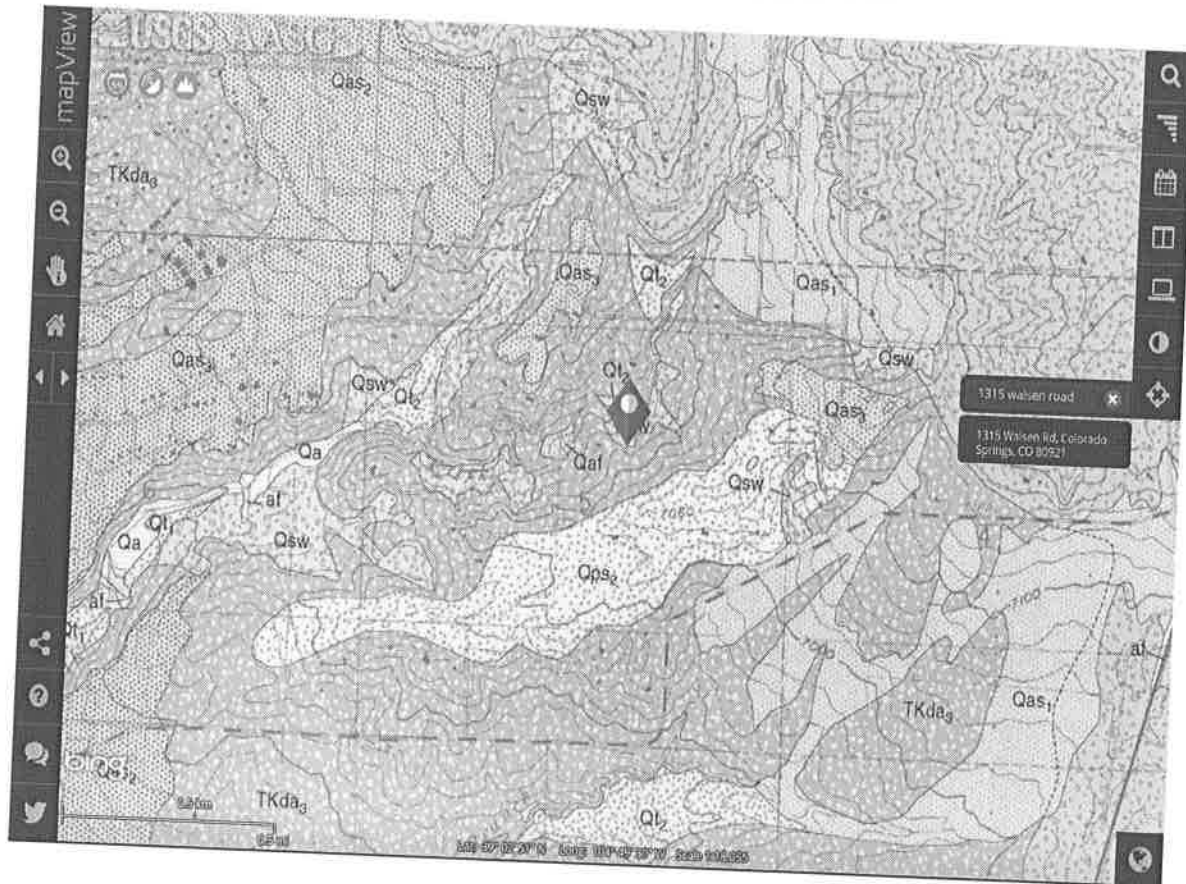
National Geologic Map Database
Geologic Map of the Monument Quadrangle, El Paso County Colorado
Colorado Geological Survey
Specific site of Grant Subdivision indicated by red marker in center.

Geology for the site consists of a major structural feature known as the Rampart Range Fault about 7 miles west of the Grant Subdivision site. The fault is the boundary between the Great Plains Physiographic Province and the Southern Rocky Mountain Province. The bedrock underlying the site consists of the Dawson formation of Tertiary to Cretaceous Age and is typically gently dipping in a northwesterly direction. The geology of the site using site specific mapping of the Map of the Monument Quadrangle, El Paso County, Colorado by Thorson and Madole in 2003 is included as Appendix 8. The base units of TKda3 and Qsw are described by The Colorado Geological Survey Division of Minerals and Geology, Department of Natural Resources:
