Re: Threatened and Endangered Species Habitat Assessment – Falcon
Marketplace, El Paso County, Colorado

PHOTO LOG
FALCON MARKETPLACE
EL PASO COUNTY, COLORADO
JULY 2, 2016

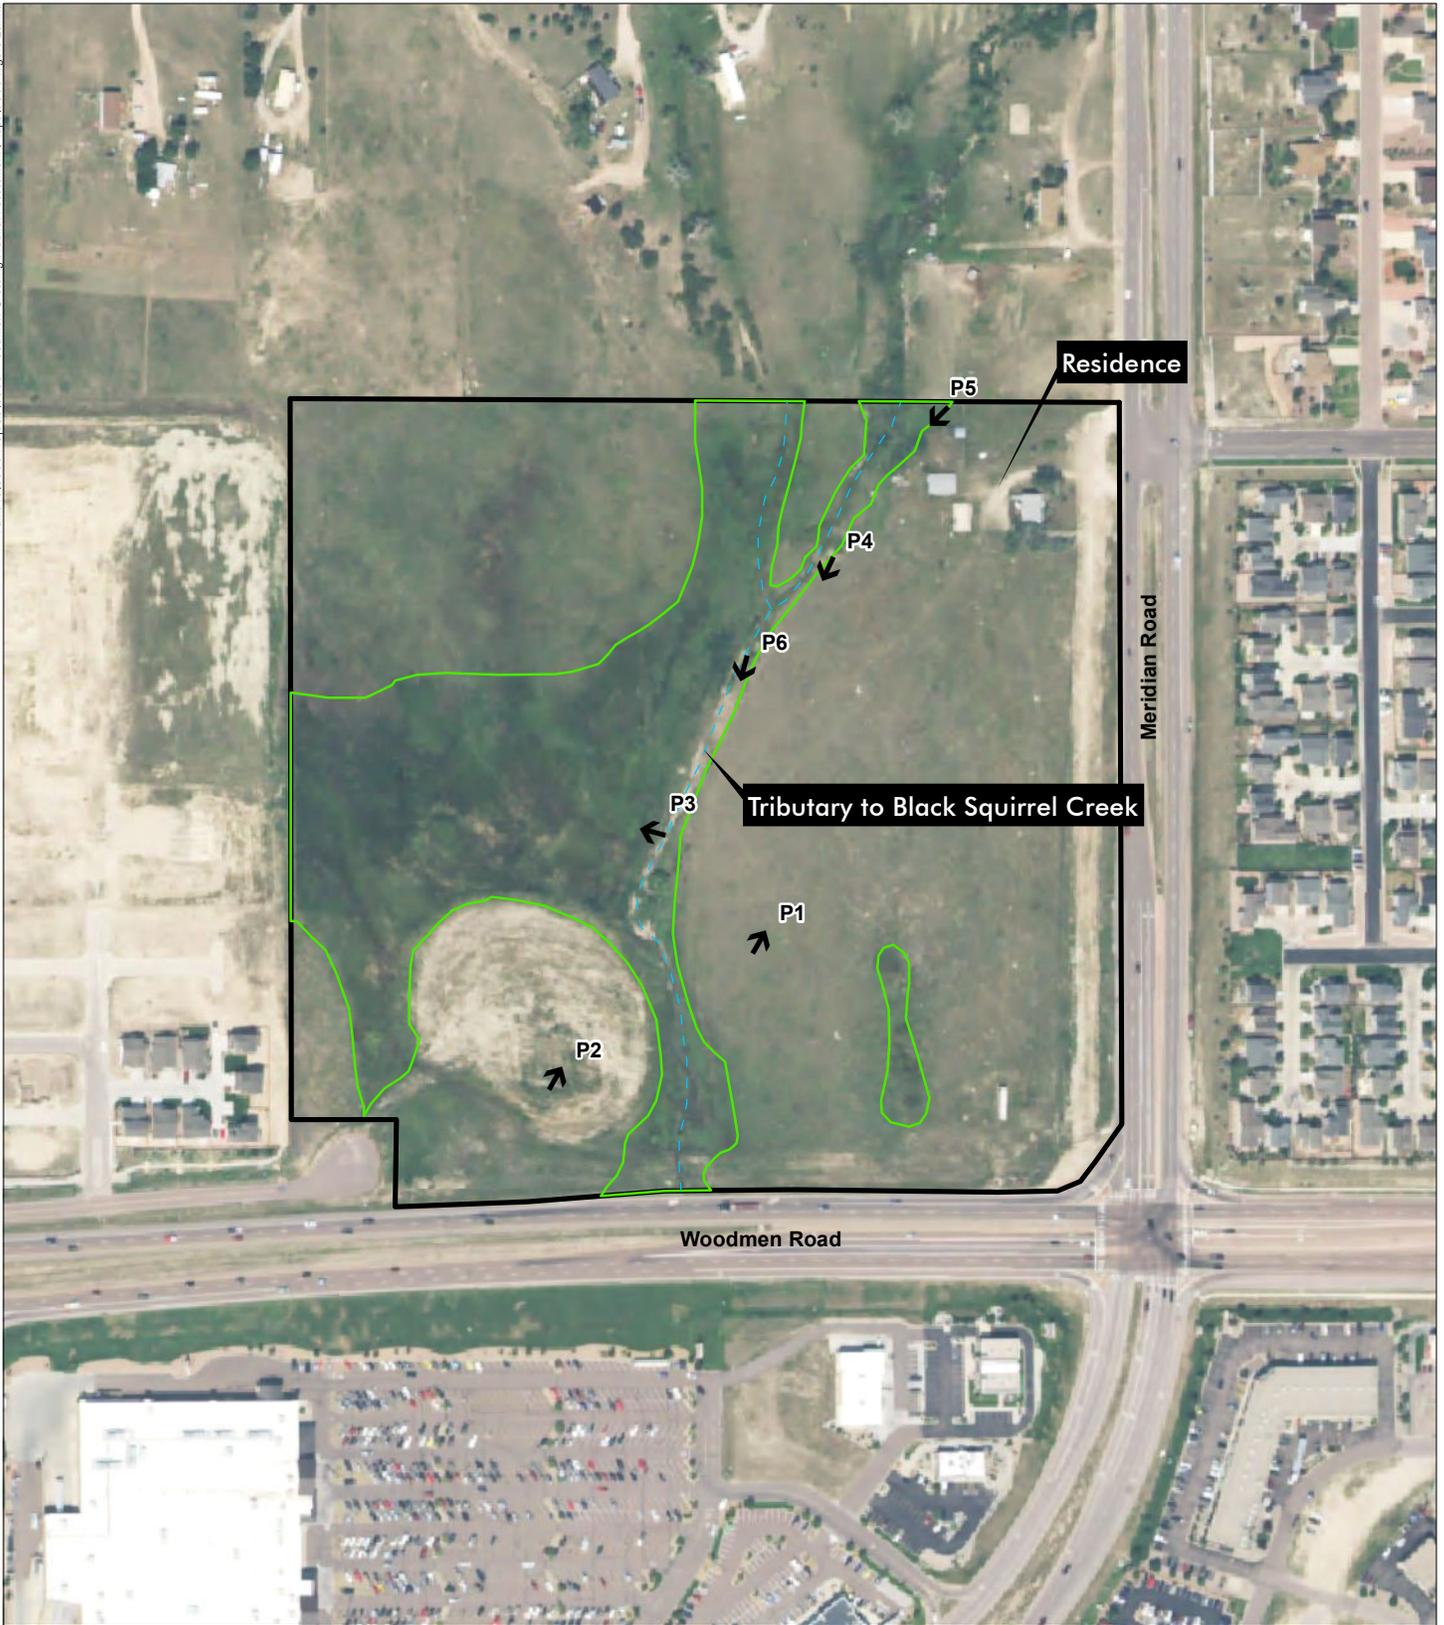
Figure 2 Existing Conditions

Falcon Marketplace is located northwest of the intersection of Woodmen Road and Meridian Road near Falcon in El Paso County, Colorado. Portions of the project area appear to have been previously disturbed. The project area consists of a mixture of uplands and potential wetlands. Uplands were observed within the northwestern and eastern portions of the project area and in an upland inclusion on a small hill near the southwest corner of the project area (Photos 1 and 2). Two drainages associated with an unnamed tributary of Black Squirrel Creek connect in and traverse the project area from north to south. Outside of the tributary, potential wetlands were established within lower elevation areas through the center and western portions of the project area.

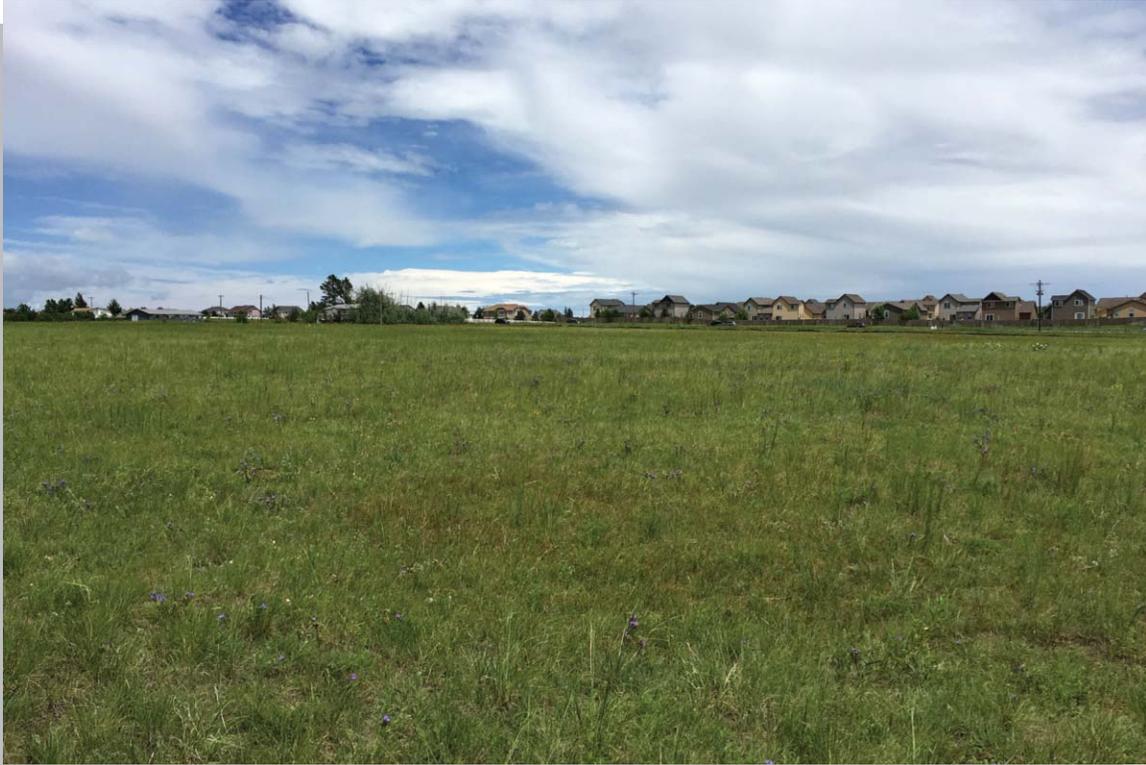
Photo 1 - Overview of the eastern portion of the project area consisting of uplands.
View is to the northeast.

The uplands within the project area consist of a mix of native and nonnative species including smooth brome (*Bromus inermis*), western wheatgrass (*Pascopyrum smithii*), spiderwort (*Tradescantia* sp.), crested wheatgrass (*Agropyron cristatum*), sand dropseed (*Sporobolus cryptandrus*), pricklypear cactus (*Opuntia* spp.), common mullein (*Verbascum thapsus*), cheatgrass (*Bromus tectorum*), and Canada thistle (*Cirsium arvense*) (Photos 1 and 2).

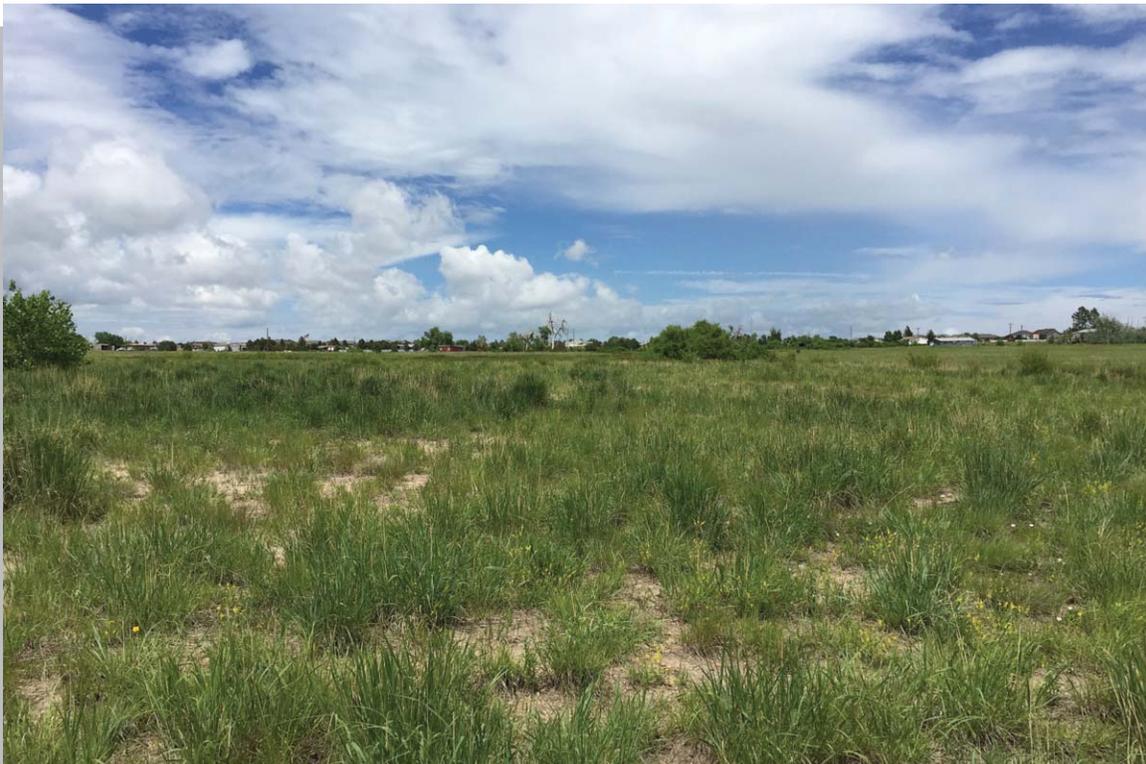
Photo 2 - Upland area on a hill in the southeastern portion of the project area.
View is to the northeast.

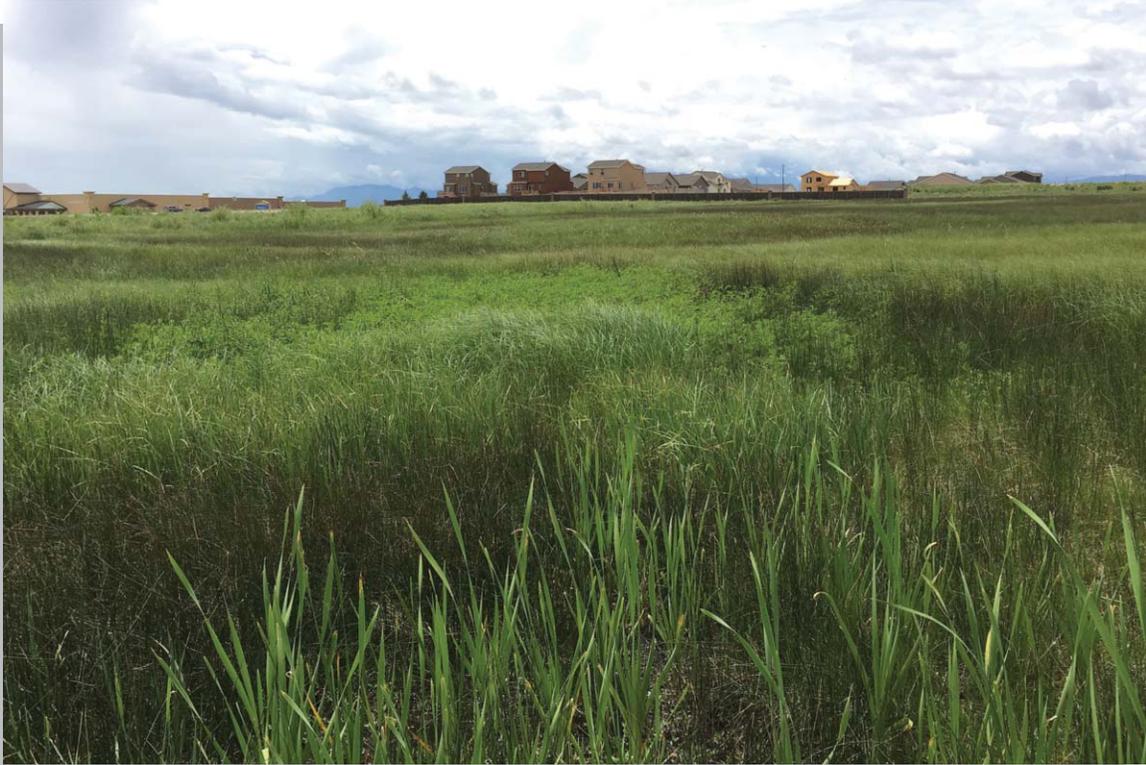
Photo 3 - Potential wetlands within the project area dominated by Baltic rush and several other hydrophytic herbaceous species. View is to the west.

The potential wetlands within the project area are dominated by Baltic rush (*Juncus arcticus*). Other prevalent hydrophytic vegetation includes Emory's sedge (*Carex emoryi*), Nebraska sedge (*Carex nebrascensis*), common spikerush (*Eleocharis palustris*), and broadleaf cattail (*Typha latifolia*) (Photo 3). Along the upstream portions of the drainages, a few patches of sandbar willow sprouts (*Salix exigua*) and New Mexico locust (*Robinia neomexicana*) were observed (Photo 4). In the northern half of the project area, the western branch of the unnamed tributary consisted of a potential wetland dominated by Baltic rush with no defined channel bed or bank. The eastern branch of the unnamed tributary had a 1- to 5-foot-wide channel with very slow flowing water (Photo 5). Downstream of the confluence of the two drainages, the tributary channel dried up and was only observed intermittently (Photo 6).

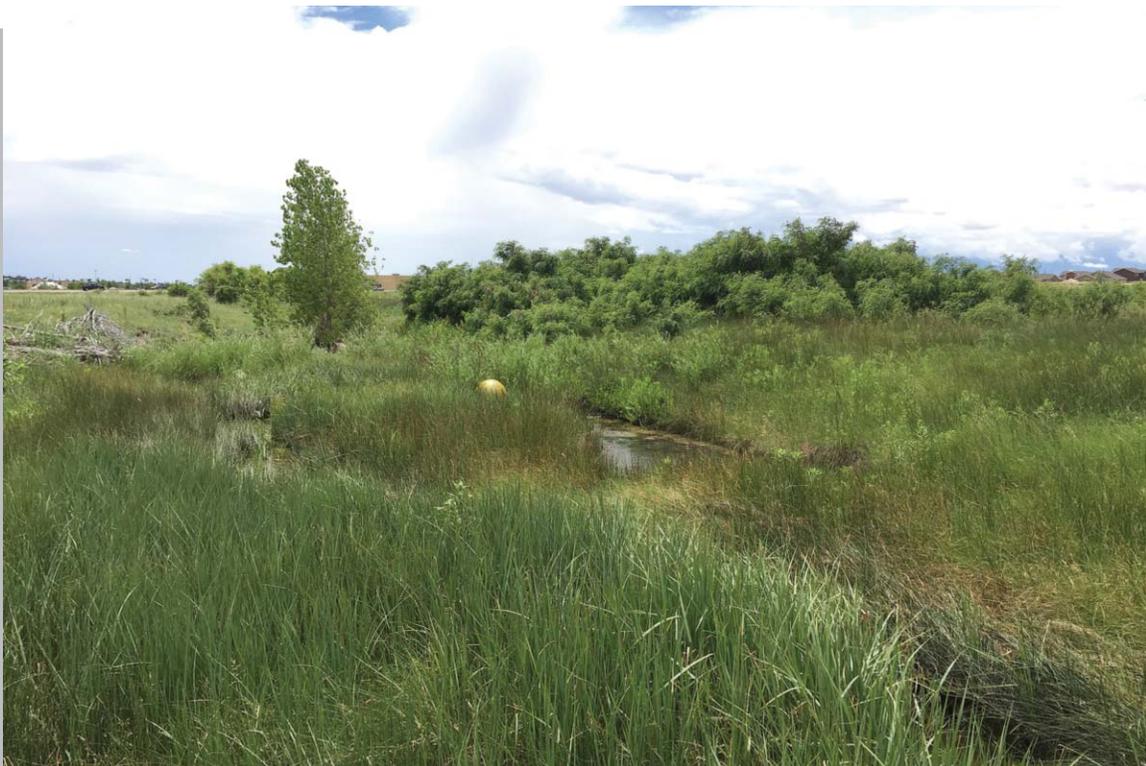
Photo 4 - Patches of willow sprouts and New Mexico locust shrubs observed along the unnamed tributary. View is to the southwest.

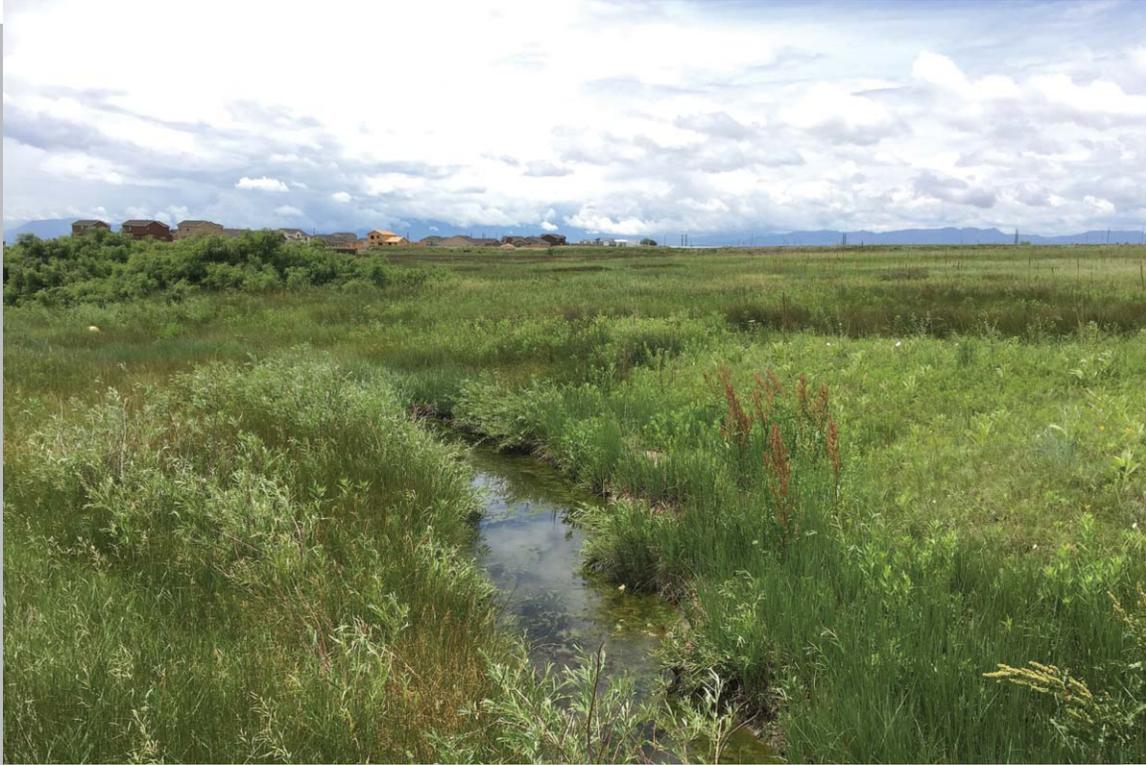
Photo 5 - Overview of the upstream end of the eastern branch of the unnamed tributary. View is to the southwest.

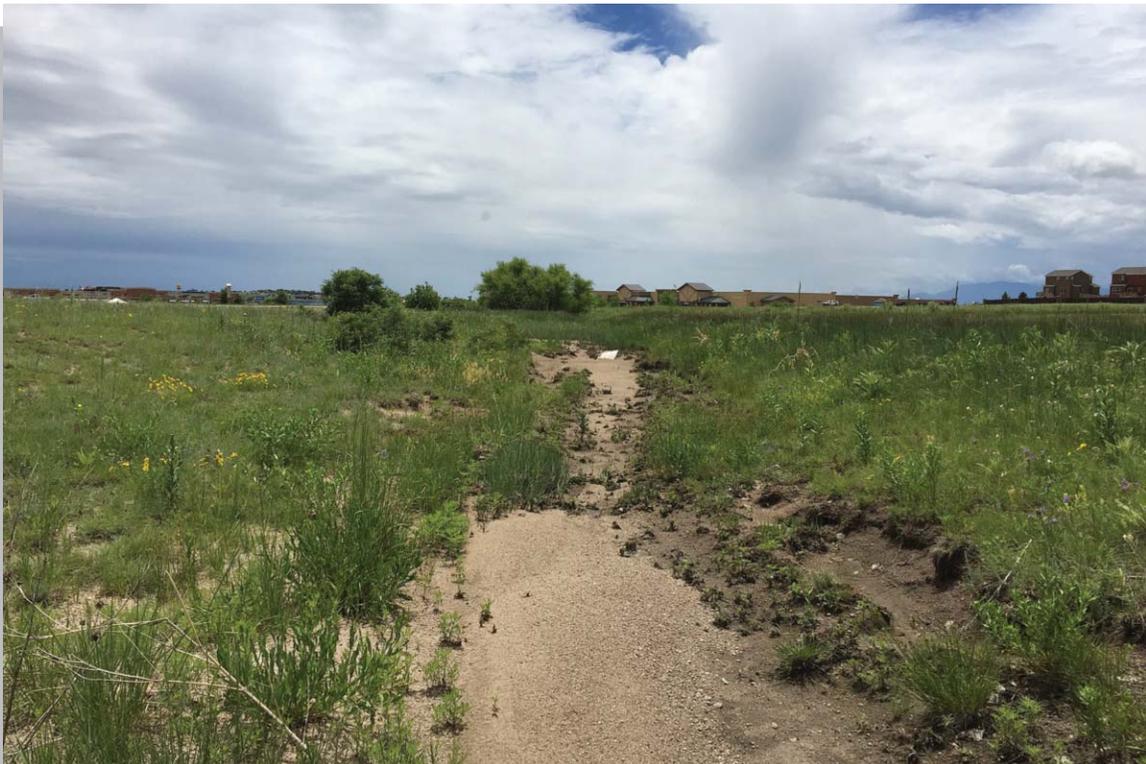
Photo 6 - Overview of the unnamed tributary channel downstream of the confluence of the two drainages in the project area. View is to the southwest.
