**PRIVATE DETENTION BASIN /  
STORMWATER QUALITY BEST MANAGEMENT PRACTICE  
MAINTENANCE AGREEMENT AND EASEMENT**

I. WHEREAS, Developer desires to construct for the subdivision two detention basin/stormwater quality BMP(s) ("detention basin/BMP(s)") as the means for providing adequate drainage and stormwater runoff control and to meet requirements of the County's MS4 Permit, and to provide for operating, cleaning, maintaining and repairing such detention basin/BMP(s); and

## EXTENDED DETENTION BASIN NORTH EASEMENT

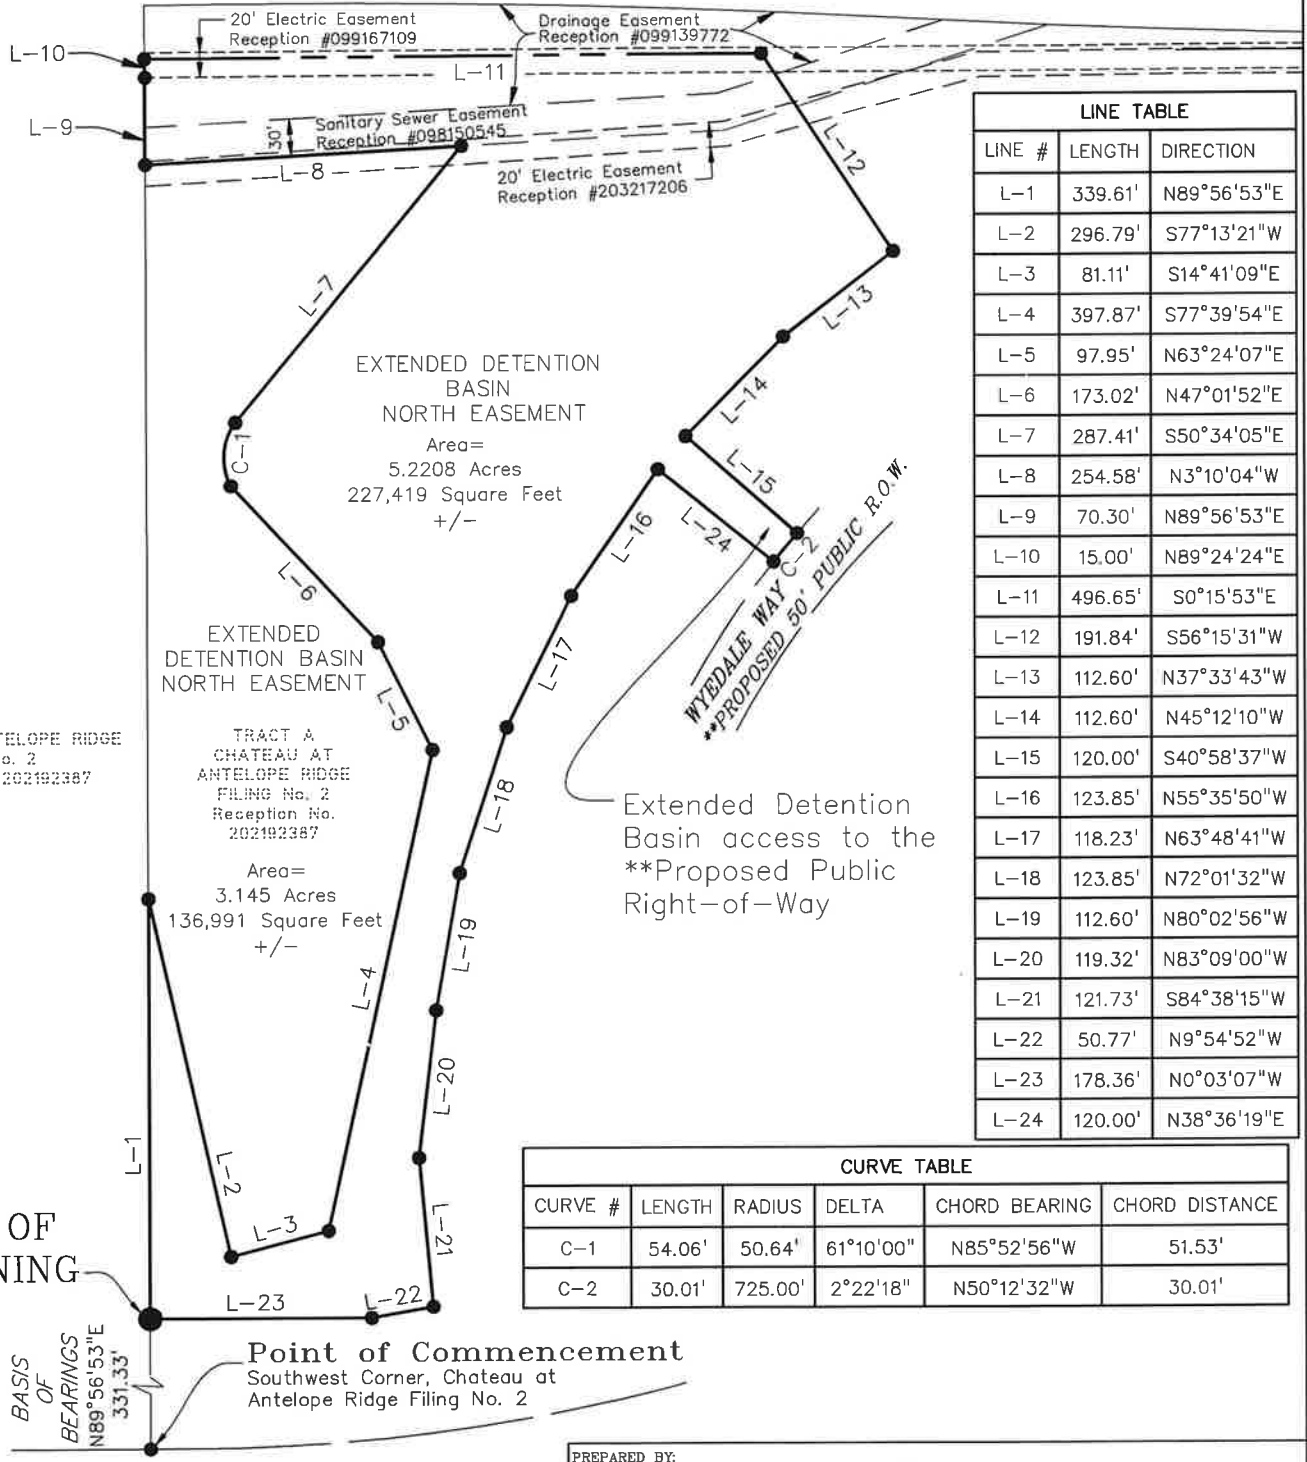
# EXHIBIT E

SCALE: 1"=150'

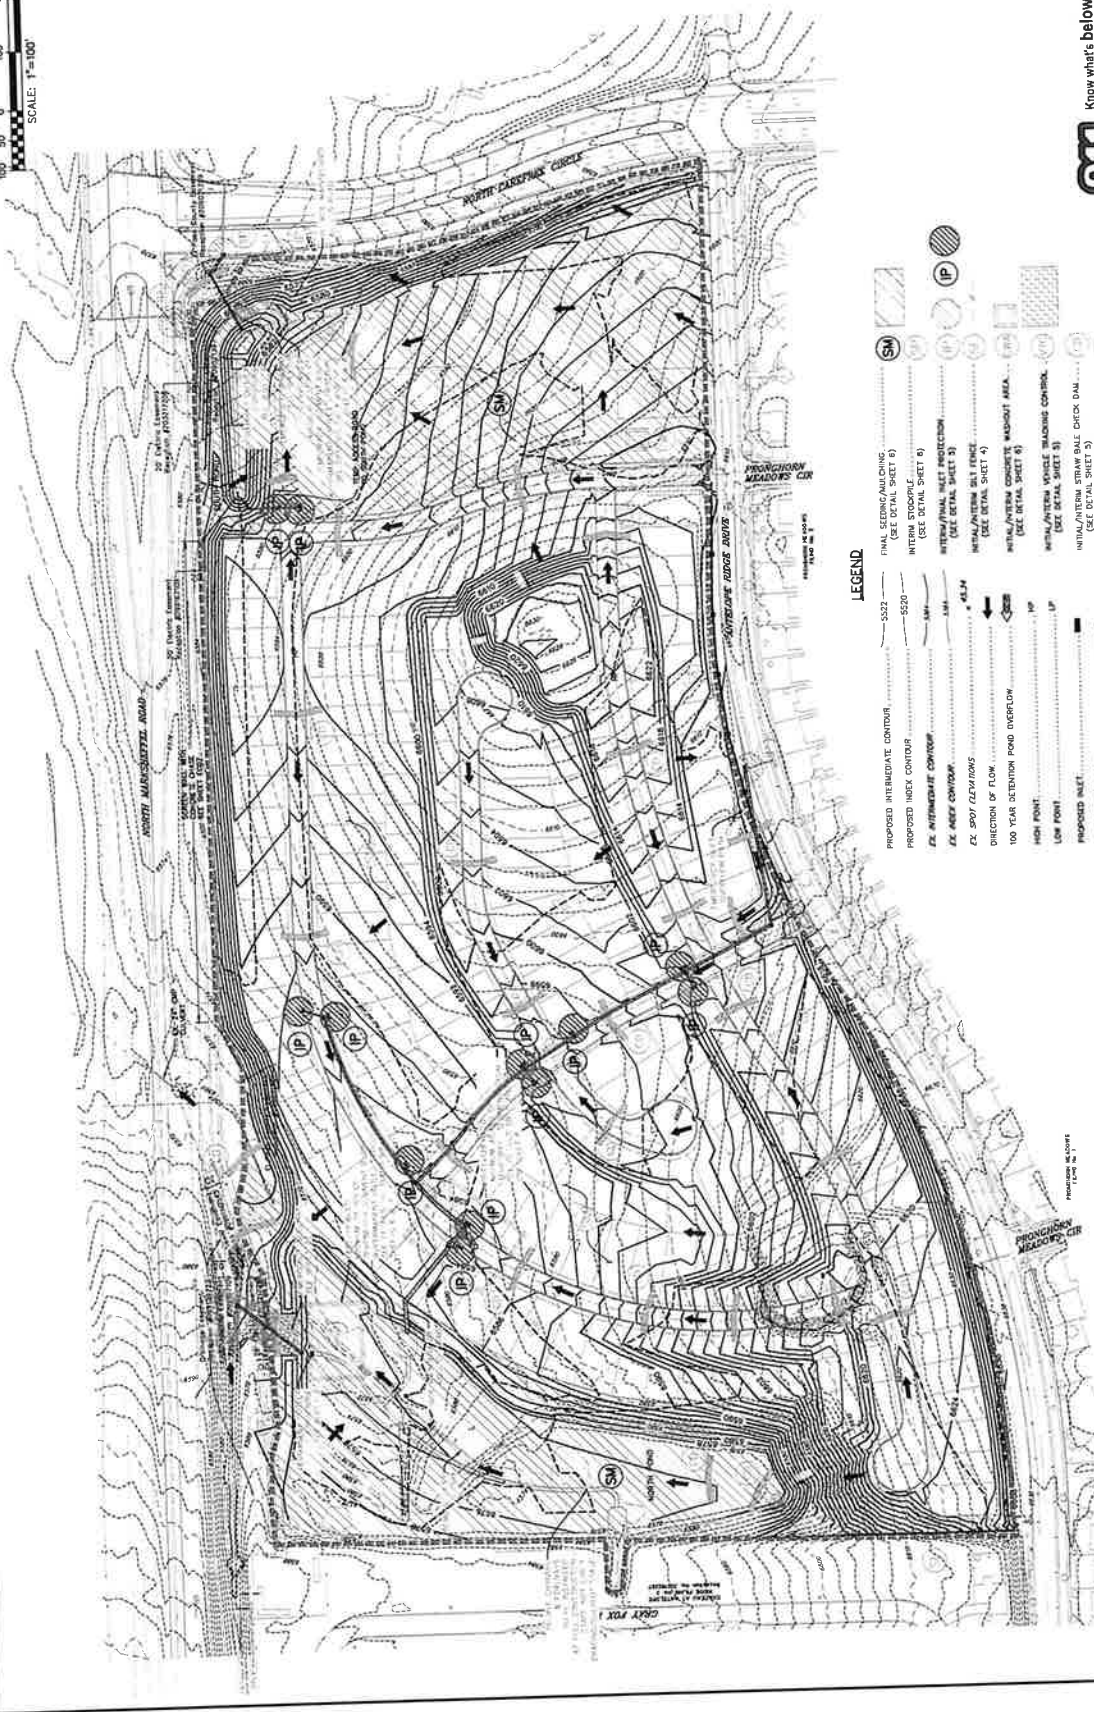
**EC04**  
 SHEET: 4 OF 10  
 COUNTY FILE NO.: SF2126

FINAL EROSION CONTROL PLAN

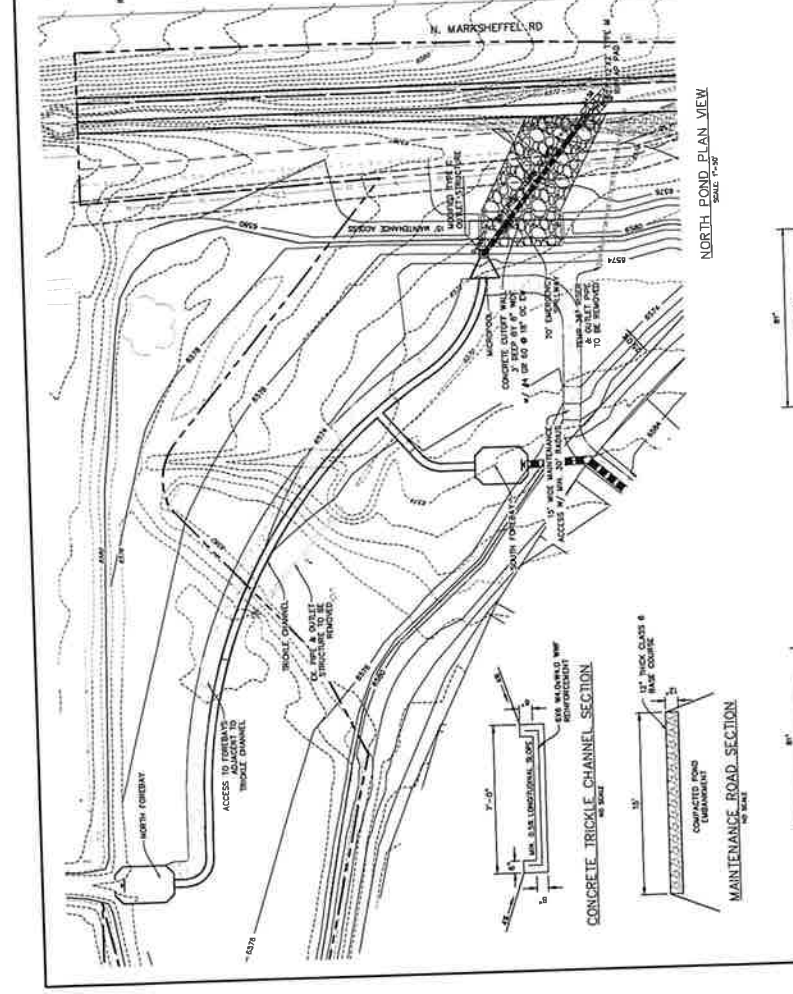
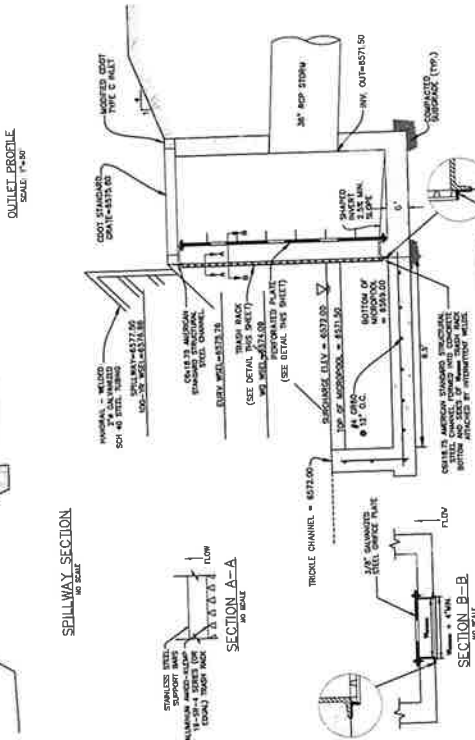
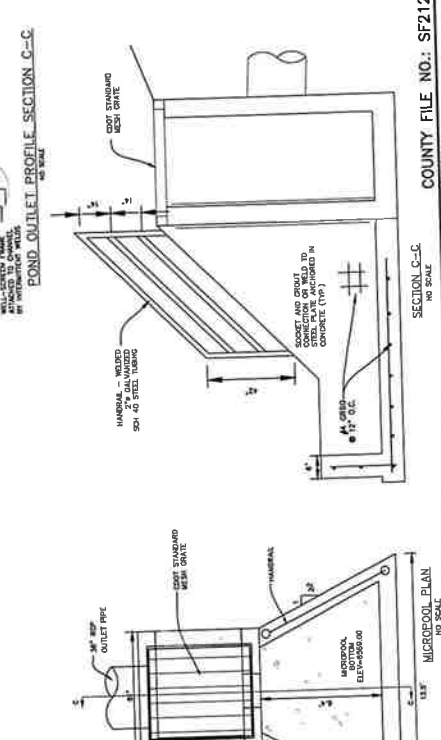
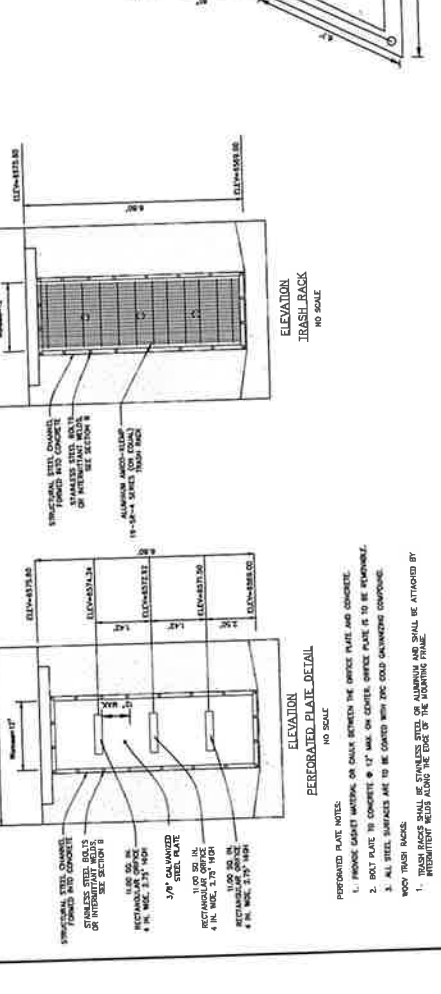
SHEET: 8 OF 10

- PERFORATED PLATE NOTES:
1. PROVIDE GRANITE MATERIAL ON CHANNEL BETWEEN THE SERVICE PLATE AND CONCRETE.
  2. SERVICE PLATE TO CONCRETE IS 1' MAX. OR CONCRETE SERVICE PLATE IS TO BE REMOVED.
  3. ALL STEEL PARTS ARE TO BE COATED WITH ZPC COLD GALVANIZING COMPOSITE.
- WOOD TRASH RACKS:
1. TRASH RACKS SHALL BE STAINLESS STEEL OR ALUMINUM AND SHALL BE ATTACHED BY BRACKETING HELD TO THE END OF THE WASTEWATER PIPE.
- GENERAL NOTES:
1. ALL EXPOSED STEEL SHALL BE EITHER STAINLESS OR HOT-DIPPED GALVANIZED.

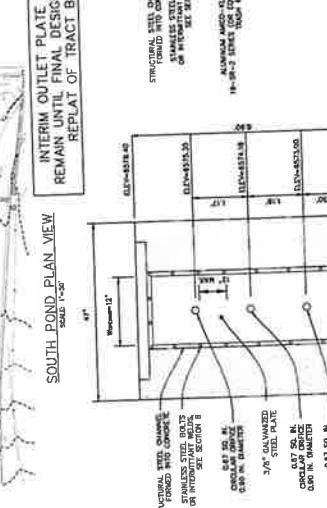
DRAWING NO. PD-2  
 SHEET: 9 OF 10

FORWARDED PLATE NOTES:  
 1. PERFORATED PLATE MATERIAL OR GAUGE BETWEEN THE GRITZES PLATE AND CONCRETE.  
 2. GRIZES PLATE TO CONCRETE 1/4\"/>

GENERAL NOTES:  
 1. TRASH RACKS SHALL BE ATTACHED BY  
 2. ALL OUTLET STEEL SHALL BE EITHER GALVANIZED OR HOT DIPPED GALVANIZED
