**PRIVATE DETENTION BASIN /  
STORMWATER QUALITY BEST MANAGEMENT PRACTICE  
MAINTENANCE AGREEMENT AND EASEMENT**

C. WHEREAS, Developer desires to plat and develop on the Property a subdivision to be known as Windermere Filing No. 1; and

I. WHEREAS, Developer desires to construct for the subdivision two detention basin/stormwater quality BMP(s) ("detention basin/BMP(s)") as the means for providing adequate drainage and stormwater runoff control and to meet requirements of the County's MS4 Permit, and to provide for operating, cleaning, maintaining and repairing such detention basin/BMP(s); and

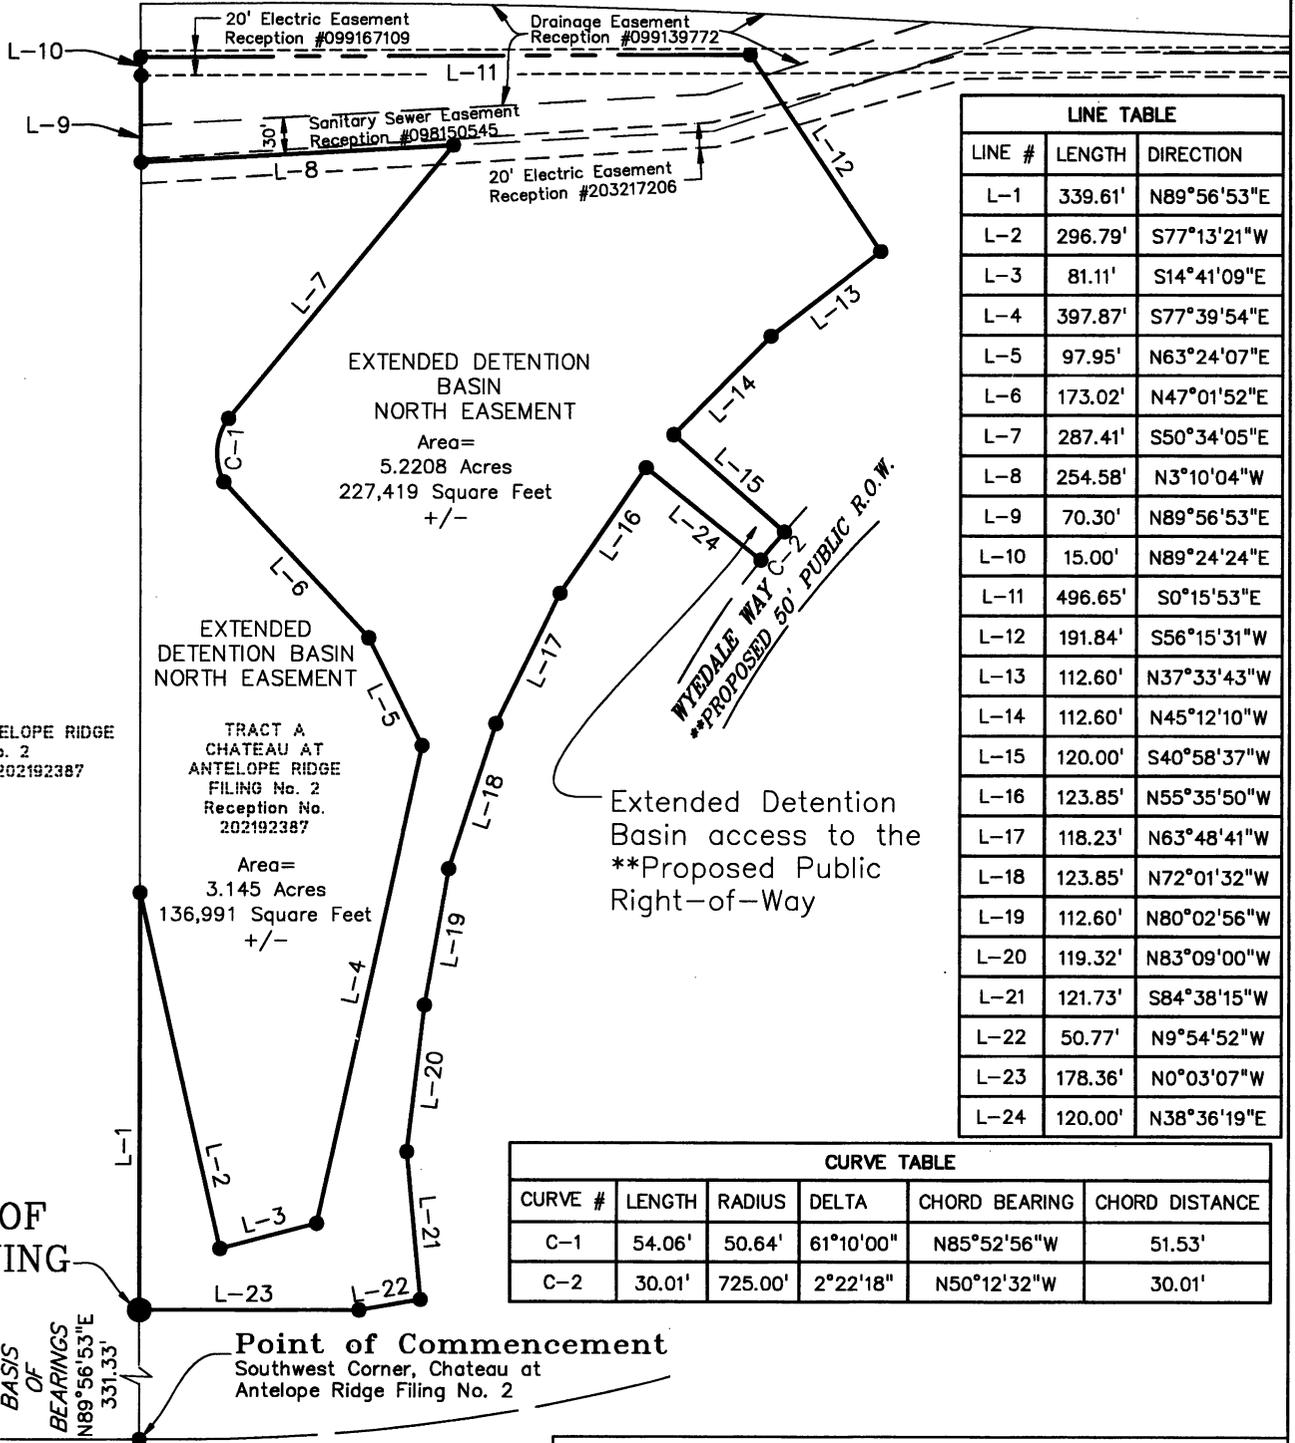
## EXTENDED DETENTION BASIN NORTH EASEMENT

# EXHIBIT E

SCALE: 1"=150'

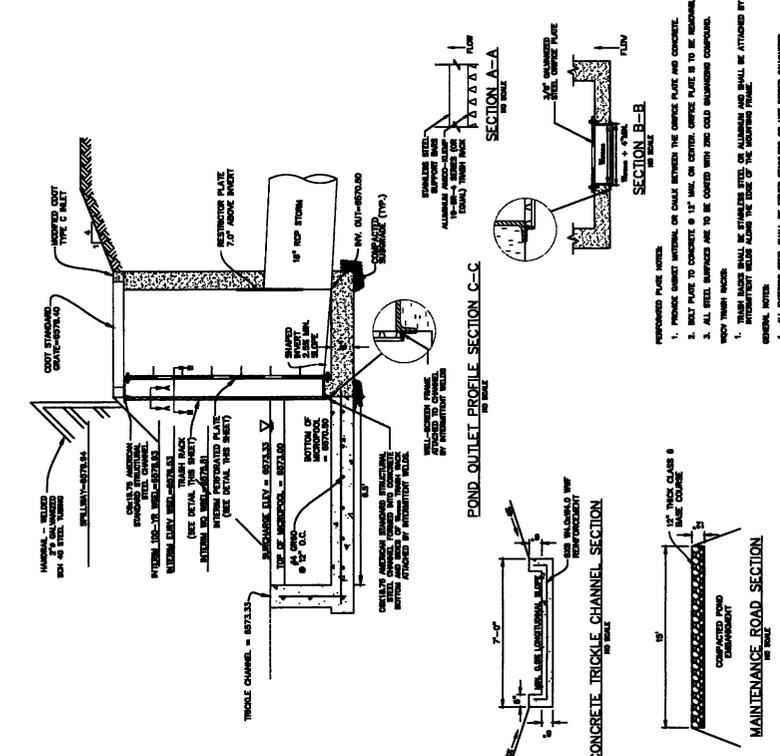
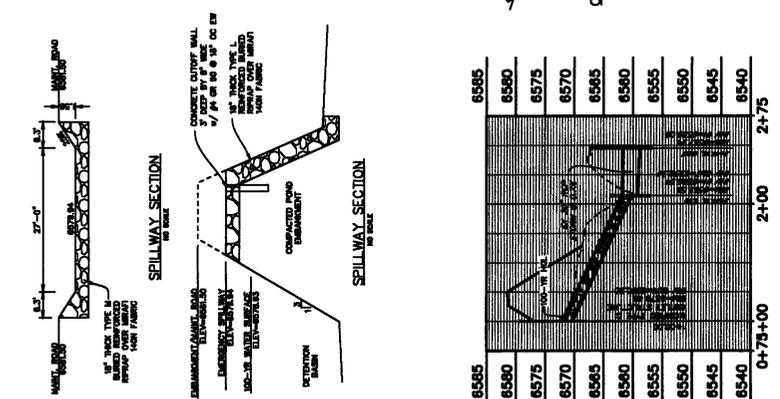
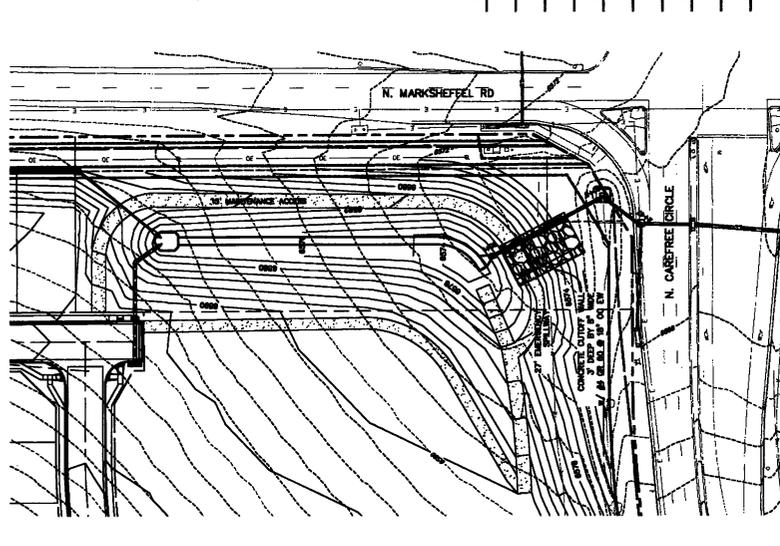
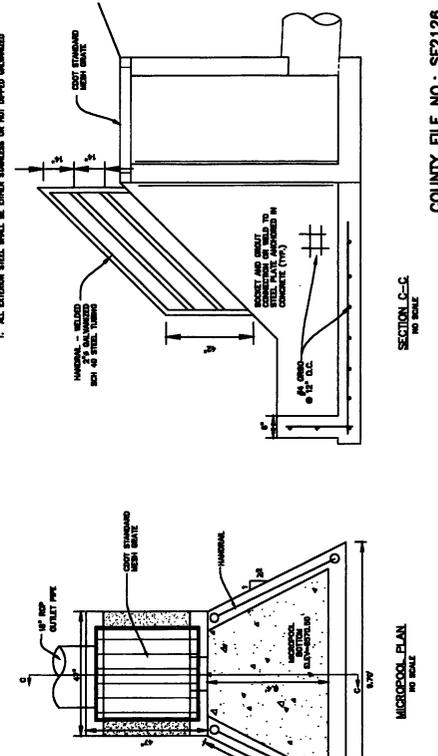
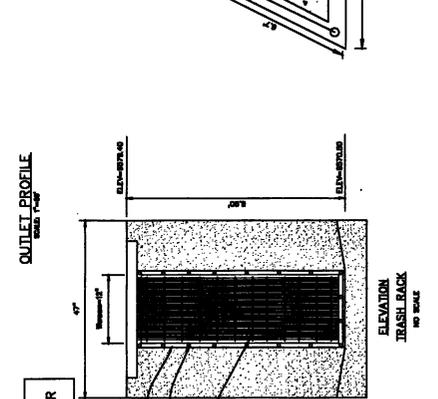
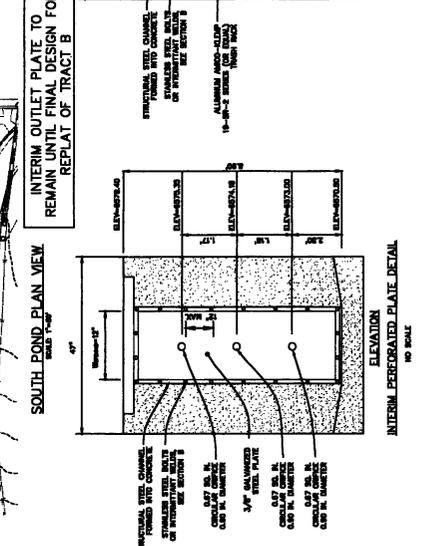
**PD-2**  
 SHEET: 9 OF 10

SCALE: N/A  
 HORIZONTAL: N/A  
 VERTICAL: N/A  
**SOUTH POND INTERIM OUTLET DETAILS**
