Job No. 198281

Re: Wastewater Study
Antlers Range
NE Corner of N Meridian Rd and Ayer Rd
El Paso County, Colorado

SITE VICINITY MAP

TEST PIT
LOCATION PLAN

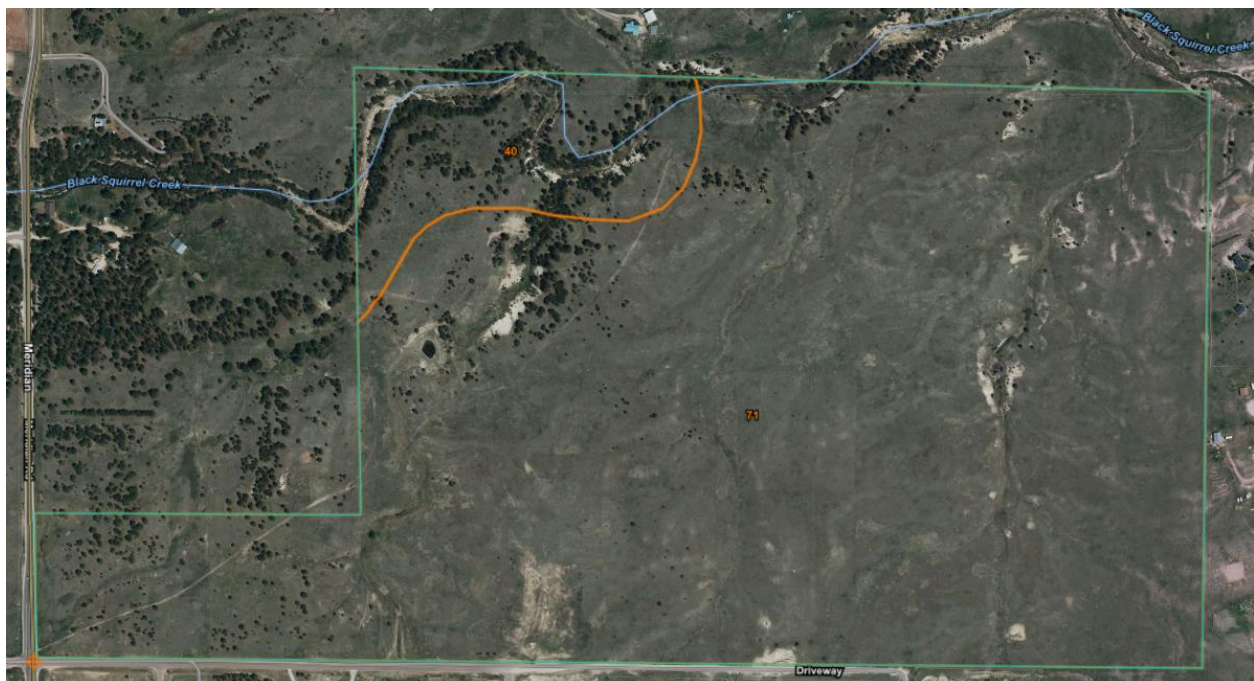
The U.S. Soil Conservation Service along with USDA has identified the soils on the property as:

- 41 – Kettle gravelly loamy sand, 8 to 40 percent slopes. The Kettle gravelly loamy sand was mapped by the USDA to be located near the northwest portion of the property. The Properties of the Kettle gravelly loamy sand include, somewhat excessively drained soil, depth of the water table is anticipated to be greater than 6.5 feet, runoff is anticipated to be medium, frequency of flooding and ponding is none, and landforms are depressions.
- 71 – Pring coarse sandy loam, 3 to 8 percent slopes. The Pring coarse sandy loam encompasses the majority of the property. Properties of the Pring coarse sandy loam include, well-drained soil, depth of the water table is anticipated to be more than 80 inches, runoff is anticipated to be low, frequency of flooding is none and ponding is none. Landforms include hills.

The USDA Soil Survey Map is presented below.

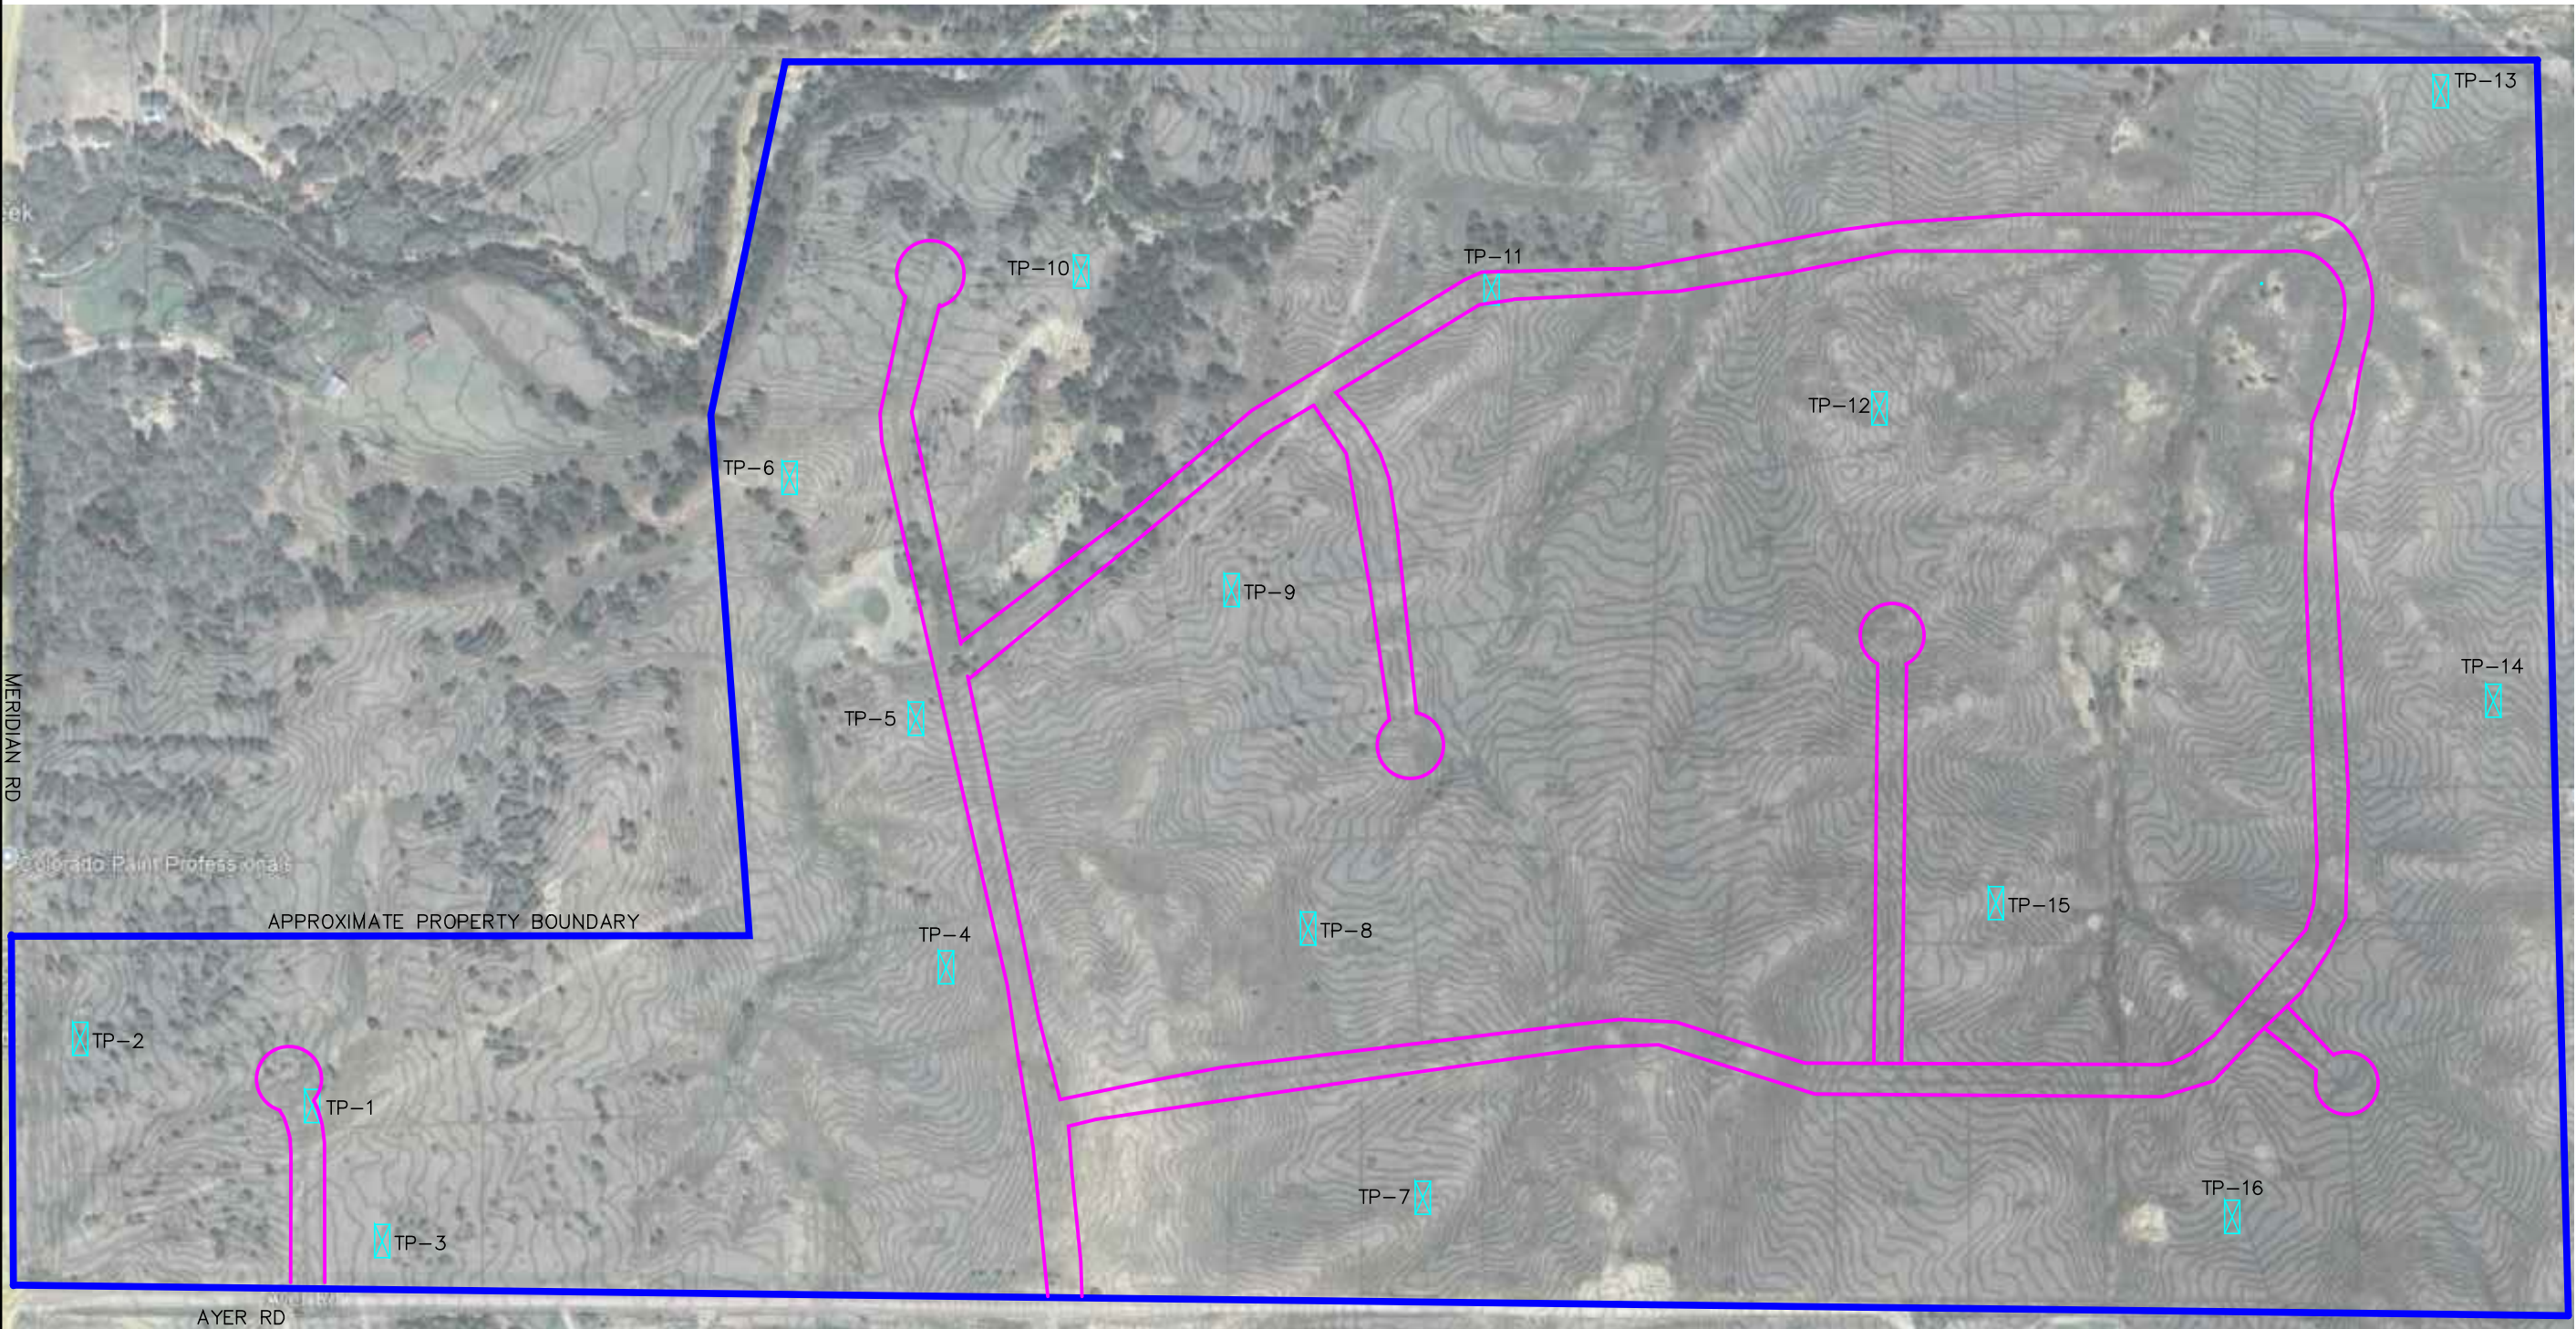
FIG-3

DENOTES APPROXIMATE LOCATION OF TEST PITS

Personnel of RMG performed a reconnaissance visit on December 23, 2024. The purpose of the reconnaissance visit was to evaluate the site surface characteristics including landscape position, topography, vegetation, natural and cultural features, and current and historic land uses. Seventeen (17) 3.5 to 8-foot deep test pits were performed across the entire site, during our reconnaissance visit. A Test Pit Location Plan is presented in Figure 3.

Personnel of RMG performed soil evaluations in 17 test pits ranging in depths between 3.5 and 8 feet on December 23, 2024, utilizing the visual and tactile method for the evaluation of the site soils. The test pits were excavated in areas that appeared most likely to be problematic areas for future OWTS. The Explanation of Test Pit Logs and the Test Pit Logs are presented in Figures 3-13. A Septic Suitability map is presented in Figure 14.
