SUBSURFACE SOIL INVESTIGATION

**Lots 1-178
Bent Grass Residential, Filing No. 2
El Paso County, Colorado**

JOB NO. 173093

January 21, 2020

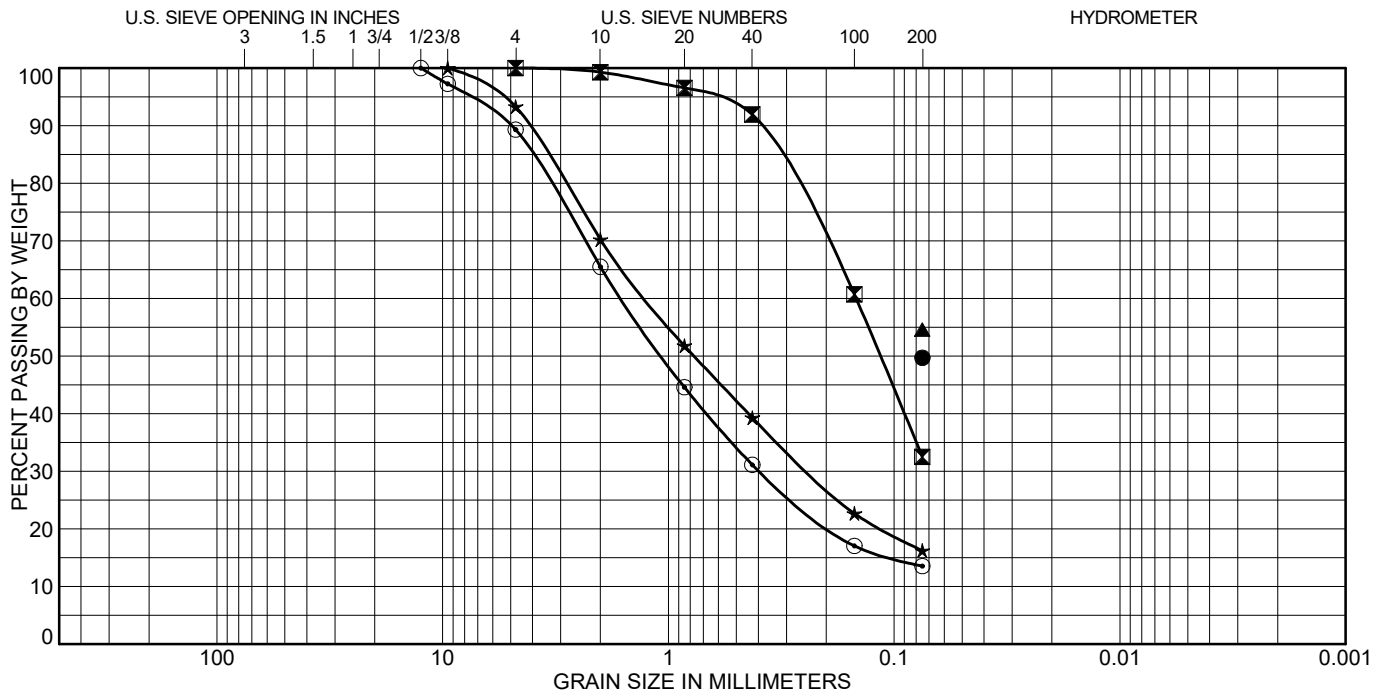
Test Boring	Depth (ft)	Classification	LL	PL	PI
● 7	9.0	CLAYEY SAND(SC)	34	14	20
⊠ 8	14.0	SILTY SAND(SM)	NP	NP	NP
▲ 9	9.0	SANDY LEAN CLAY(CL)	40	14	26
★ 10	2.0	SILTY SAND(SM)	NP	NP	NP
⊙ 11	4.0	SILTY SAND(SM)	NP	NP	NP
Test Boring	Depth (ft)	%Gravel	%Sand	%Silt	%Clay
● 7	9.0			49.7	
⊠ 8	14.0	0.0	67.5	32.5	
▲ 9	9.0			54.6	
★ 10	2.0	6.7	77.1	16.2	
⊙ 11	4.0	10.7	75.8	13.5

The moisture content for the recovered samples was obtained in the laboratory. Grain-size analysis, Atterberg Limits, and Denver Swell/Consolidation tests were performed on selected samples for purposes of classification and to develop pertinent engineering properties. A Summary of Laboratory Test Results is presented in Figure 88. Soil Classification Data are presented in Figures 89 through 121. Swell/Consolidation Test Results are presented in Figures 122 through 140.

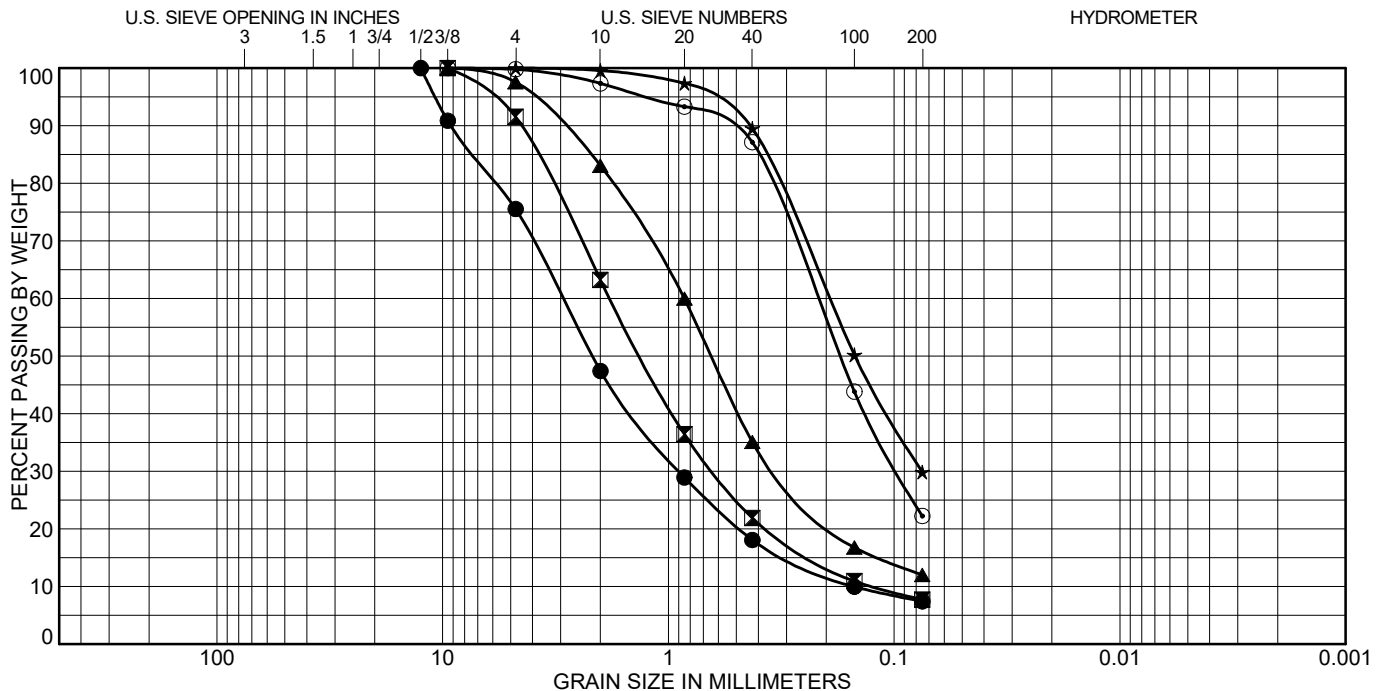
Test Boring	Depth (ft)	Classification	LL	PL	PI
● 16	9.0	WELL-GRADED SAND with SILT and GRAVEL(SW-SM)	NP	NP	NP
⊠ 17	4.0	WELL-GRADED SAND with SILT(SW-SM)	NP	NP	NP
▲ 18	4.0	WELL-GRADED SAND with SILT(SW-SM)	NP	NP	NP
★ 19	9.0	SILTY SAND(SM)	NP	NP	NP
⊙ 20	9.0	SILTY SAND(SM)	NP	NP	NP
Test Boring	Depth (ft)	%Gravel	%Sand	%Silt	%Clay
● 16	9.0	24.5	68.1	7.4	
⊠ 17	4.0	8.4	83.8	7.7	
▲ 18	4.0	2.4	85.6	12.0	
★ 19	9.0	0.0	70.1	29.9	
⊙ 20	9.0	0.2	77.6	22.2

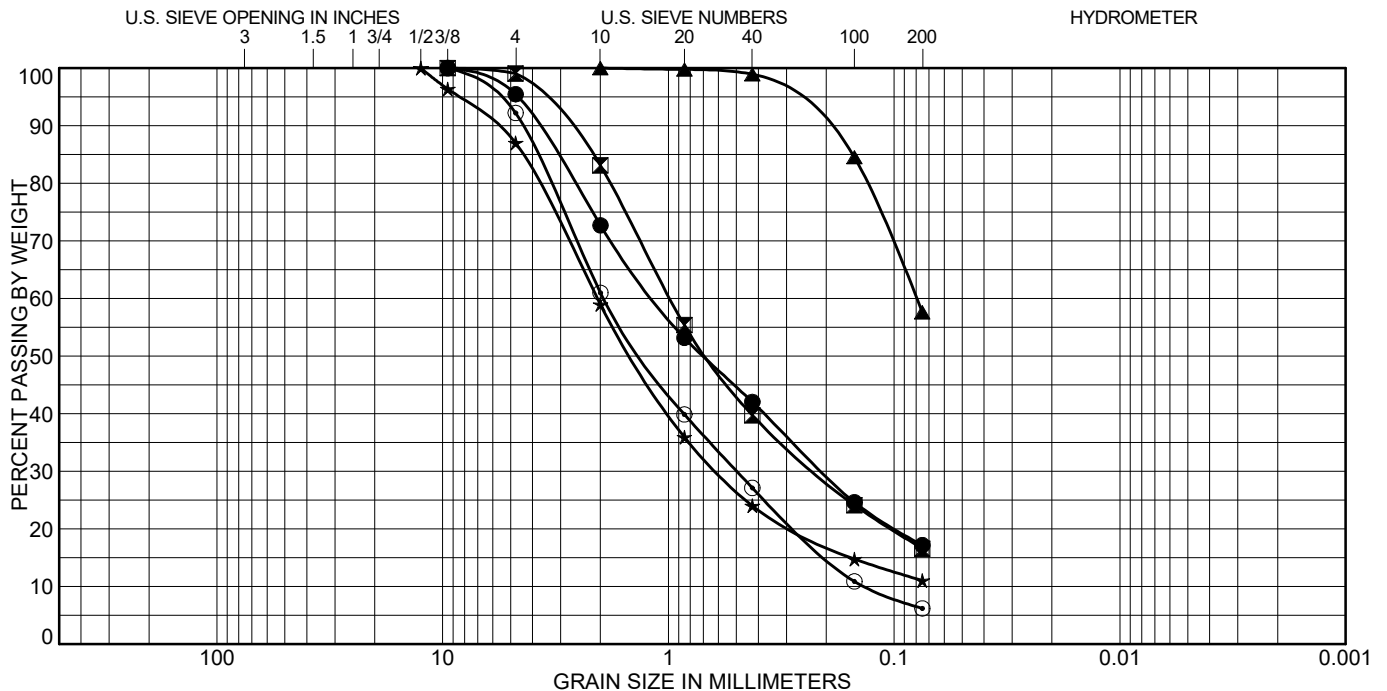
Test Boring	Depth (ft)	Classification	LL	PL	PI
● 21	4.0	SILTY SAND(SM)	NP	NP	NP
⊠ 22	4.0	SILTY SAND(SM)	NP	NP	NP
▲ 23	9.0	SANDY LEAN CLAY(CL)	34	17	17
★ 24	9.0	WELL-GRADED SAND with SILT(SW-SM)	NP	NP	NP
⊙ 25	4.0	POORLY GRADED SAND with SILT(SP-SM)	NP	NP	NP

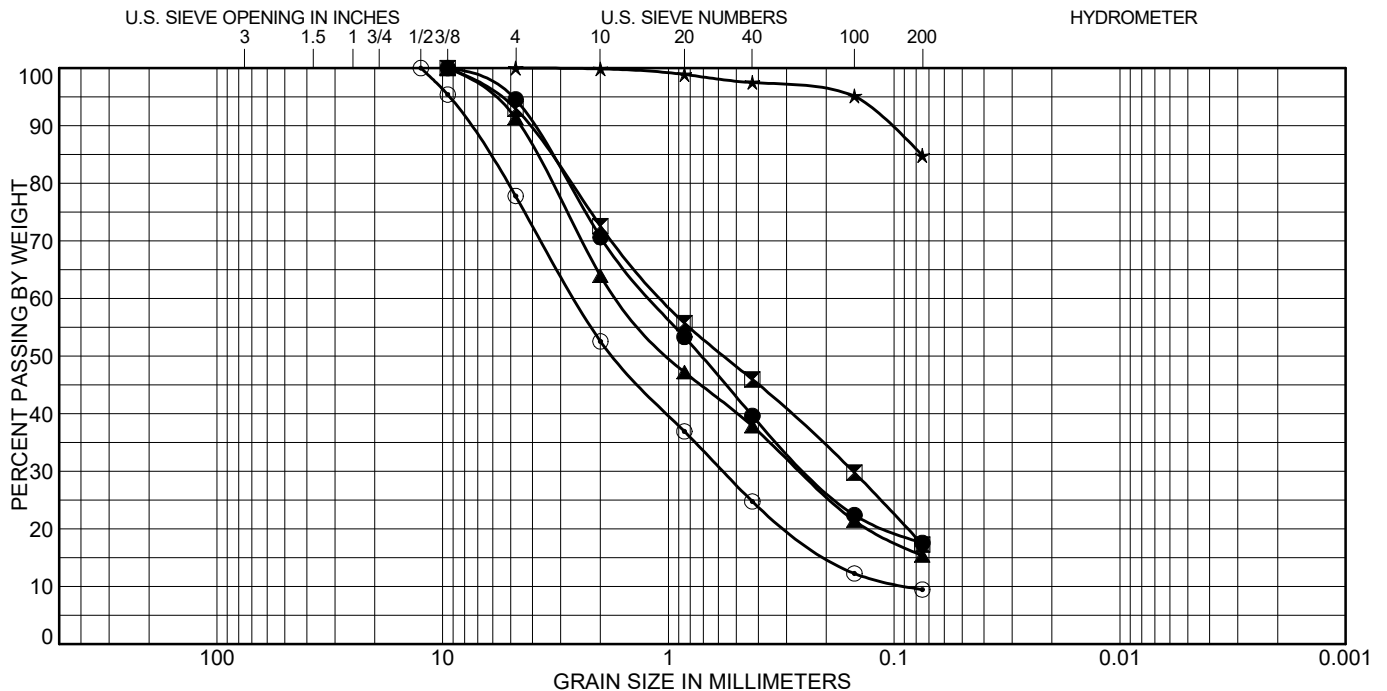
Test Boring	Depth (ft)	Classification	LL	PL	PI
● 54	9.0	SILTY SAND(SM)	NP	NP	NP
⊠ 56	4.0	SILTY SAND(SM)	NP	NP	NP
▲ 57	14.0	SILTY SAND(SM)	NP	NP	NP
★ 58	4.0	LEAN CLAY with SAND(CL)	37	18	19
⊙ 59	9.0	WELL-GRADED SAND with SILT and GRAVEL(SW-SM)	NP	NP	NP
Test Boring	Depth (ft)	%Gravel	%Sand	%Silt	%Clay
● 54	9.0	5.4	77.0	17.6	
⊠ 56	4.0	7.0	75.7	17.3	
▲ 57	14.0	8.7	76.0	15.4	
★ 58	4.0	0.0	15.2	84.8	
⊙ 59	9.0	22.2	68.3	9.5

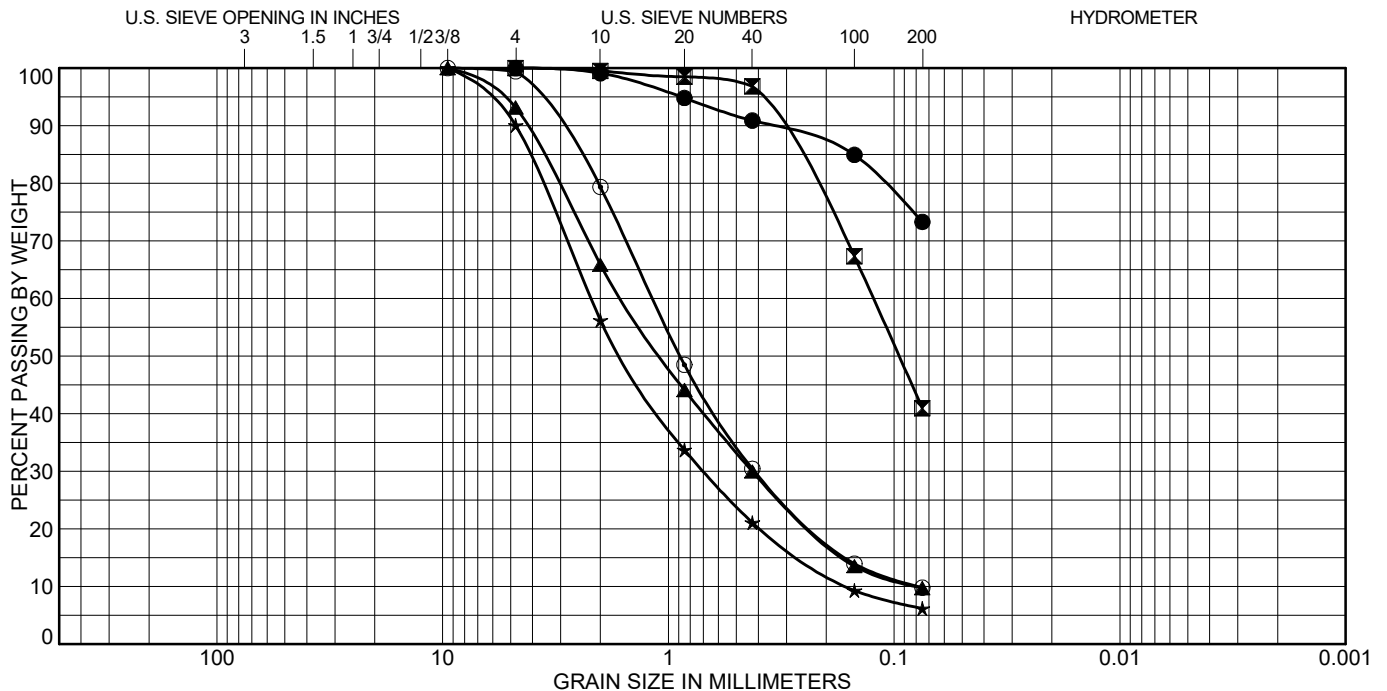
Test Boring	Depth (ft)	Classification	LL	PL	PI
● 97	14.0	LEAN CLAY with SAND(CL)	29	13	16
⊠ 98	4.0	CLAYEY SAND(SC)	33	12	21
▲ 99	9.0	WELL-GRADED SAND with SILT(SW-SM)	NP	NP	NP
★ 100	4.0				
⊙ 102	4.0	WELL-GRADED SAND with SILT(SW-SM)	NP	NP	NP

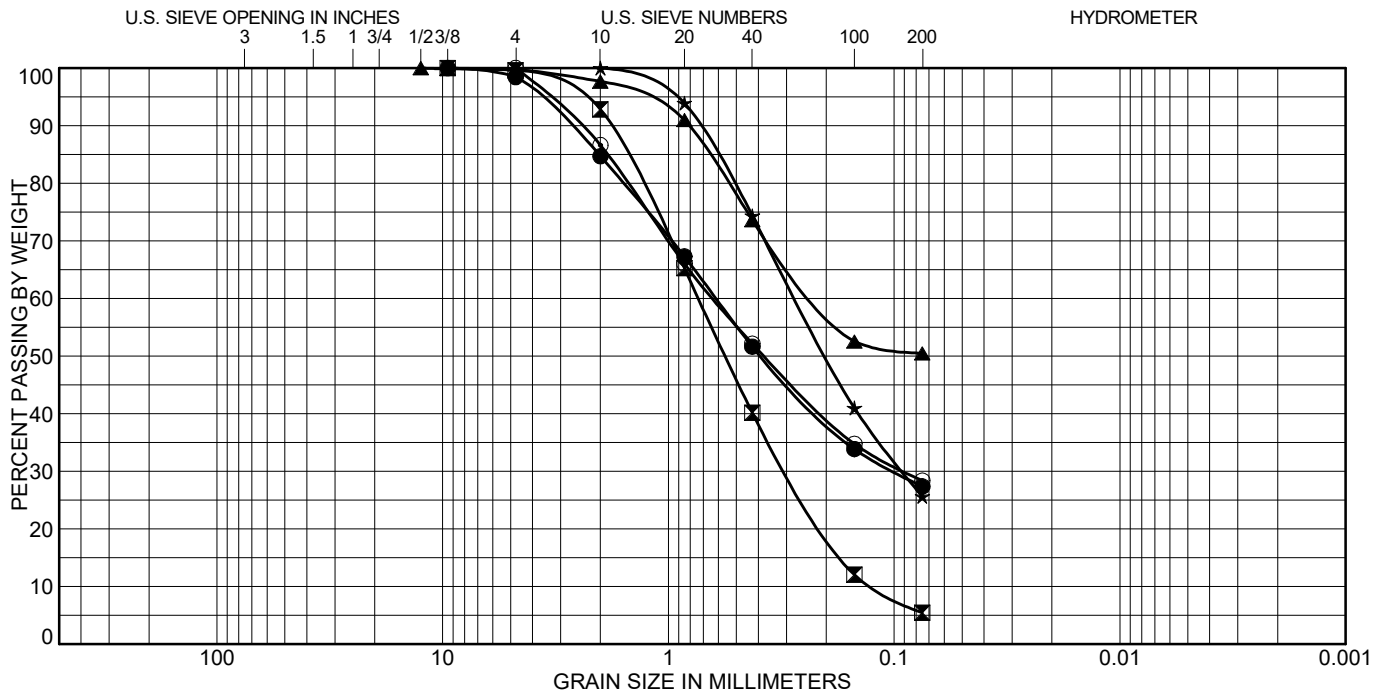
Test Boring	Depth (ft)	Classification	LL	PL	PI
● 125	14.0				
⊠ 127	4.0				
▲ 128	9.0				
★ 129	14.0	CLAYEY SAND(SC)	30	16	14
⊙ 130	9.0	CLAYEY SAND(SC)	35	15	20
Test Boring	Depth (ft)	%Gravel	%Sand	%Silt	%Clay
● 125	14.0	1.6	71.1	27.4	
⊠ 127	4.0	0.4	94.2	5.4	
▲ 128	9.0	0.3	49.2	50.5	
★ 129	14.0	0.0	74.4	25.6	
⊙ 130	9.0	0.0	71.6	28.4

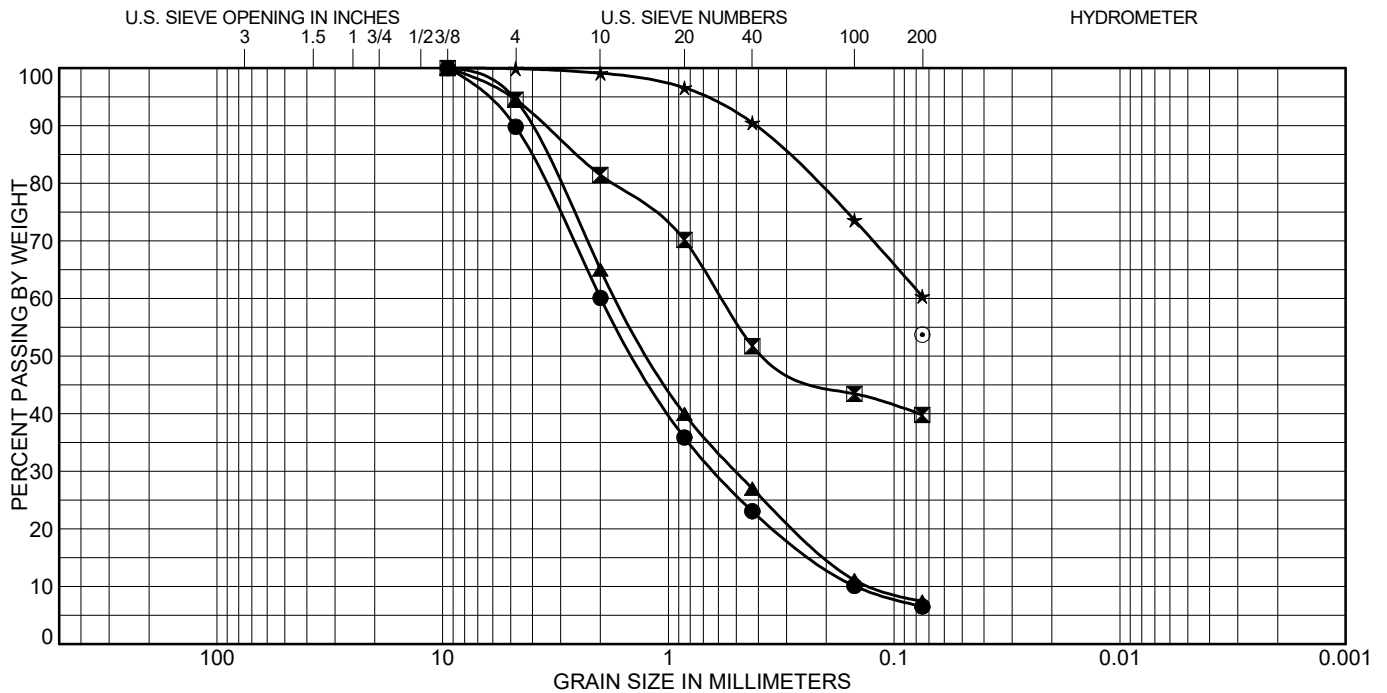
Test Boring	Depth (ft)	Classification				LL	PL	PI
● 147	2.0							
⊠ 148	9.0							
▲ 149	4.0							
★ 150	9.0							
⊙ 151	9.0	SANDY LEAN CLAY (CL)				31	12	19
Test Boring	Depth (ft)	%Gravel	%Sand	%Silt	%Clay			
● 147	2.0	10.2	83.3	6.5				
⊠ 148	9.0	5.5	54.7	39.8				
▲ 149	4.0	5.5	87.1	7.4				
★ 150	9.0	0.1	39.5	60.4				
⊙ 151	9.0			53.7

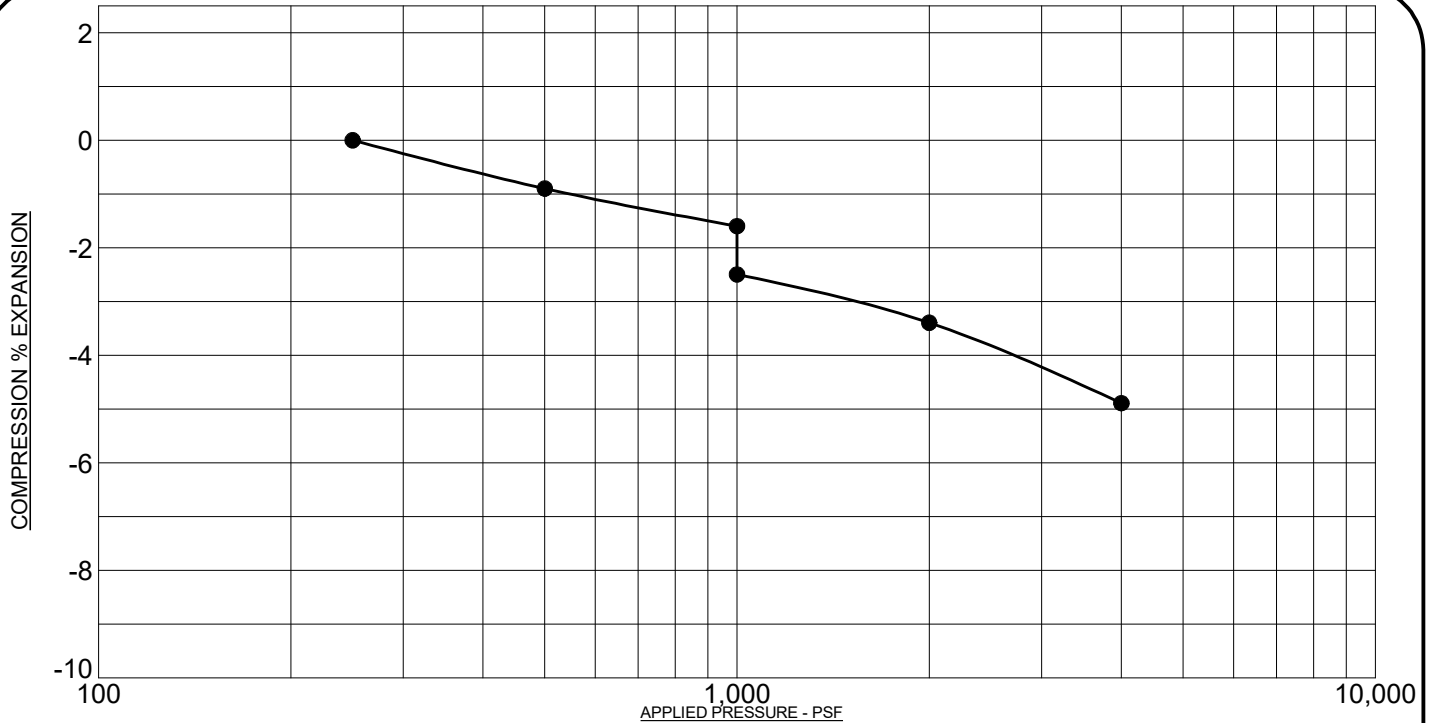
PROJECT: **Bent Grass Residential, Filing No. 2, El Paso County, Colorado**
 SAMPLE DESCRIPTION: **CLAYSTONE, SANDY**
 NOTE: **SAMPLE WAS INUNDATED WITH WATER AT 1,000 PSF**

SAMPLE LOCATION: **7 @ 9 FT**
 NATURAL DRY UNIT WEIGHT: **118.7 PCF**
 NATURAL MOISTURE CONTENT: **13.9%**
 PERCENT SWELL/COMPRESSION: **- 0.9**

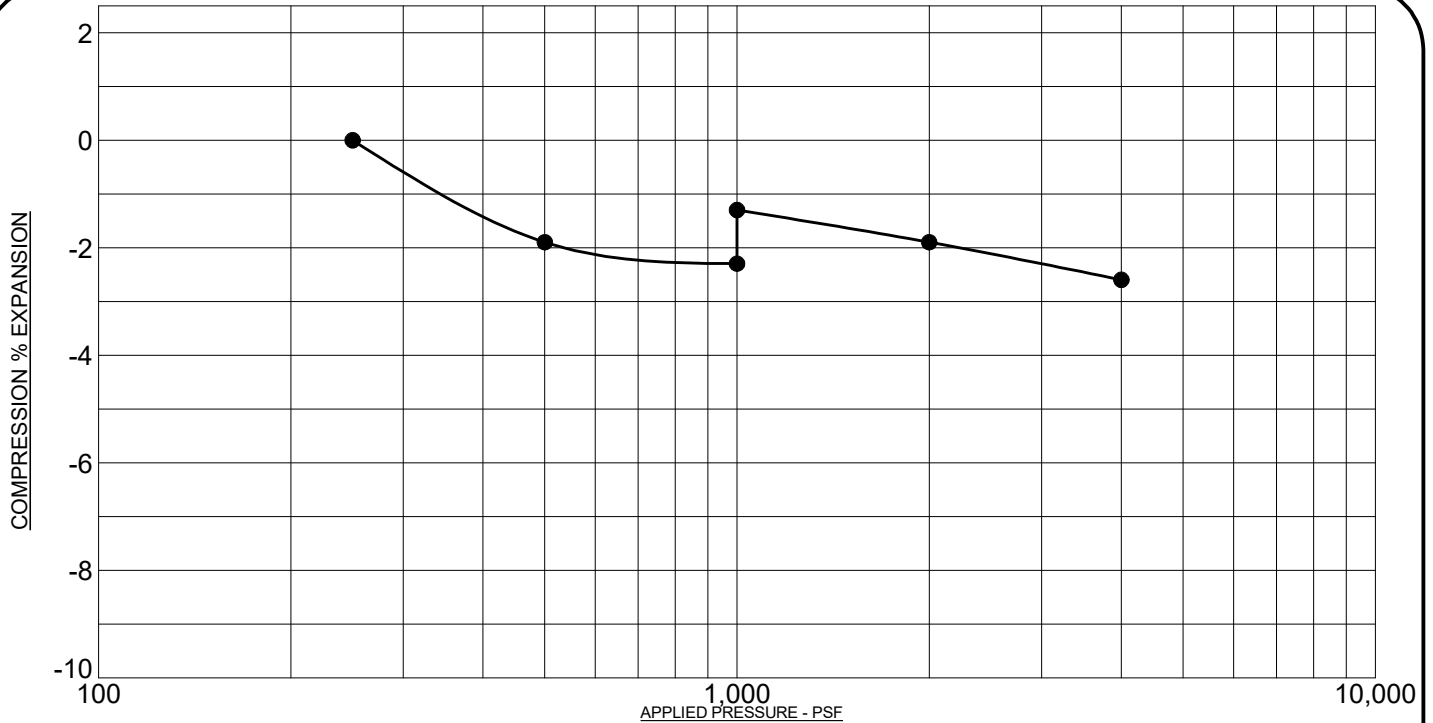
PROJECT: **Bent Grass Residential, Filing No. 2, El Paso County, Colorado**
 SAMPLE DESCRIPTION: **CLAYSTONE, SANDY**
 NOTE: **SAMPLE WAS INUNDATED WITH WATER AT 1,000 PSF**

SAMPLE LOCATION: **9 @ 9 FT**
 NATURAL DRY UNIT WEIGHT: **113.9 PCF**
 NATURAL MOISTURE CONTENT: **15.9%**
 PERCENT SWELL/COMPRESSION: **1.0**

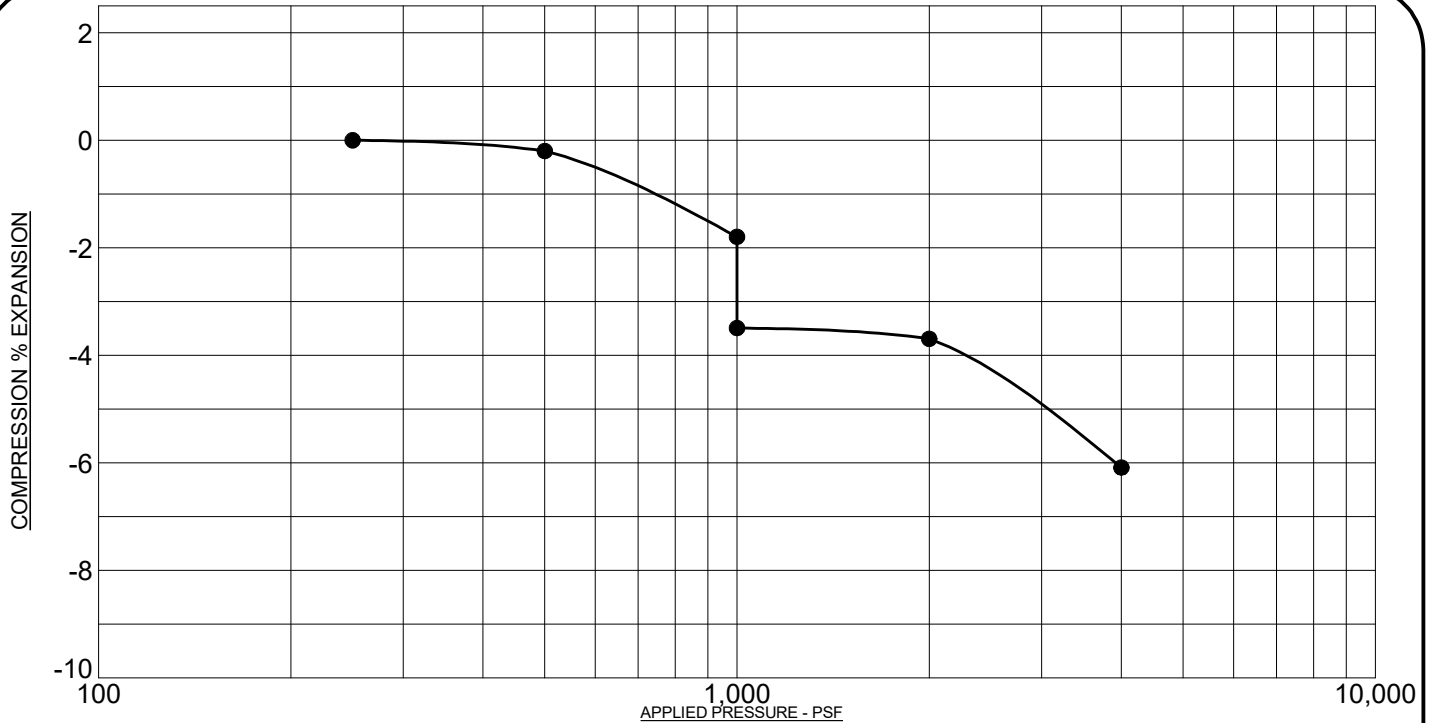
PROJECT: **Bent Grass Residential, Filing No. 2, El Paso County, Colorado**
 SAMPLE DESCRIPTION: **CLAYSTONE, SANDY**
 NOTE: **SAMPLE WAS INUNDATED WITH WATER AT 1,000 PSF**

SAMPLE LOCATION: **13 @ 14 FT**
 NATURAL DRY UNIT WEIGHT: **112.1 PCF**
 NATURAL MOISTURE CONTENT: **11.4%**
 PERCENT SWELL/COMPRESSION: **- 1.7**

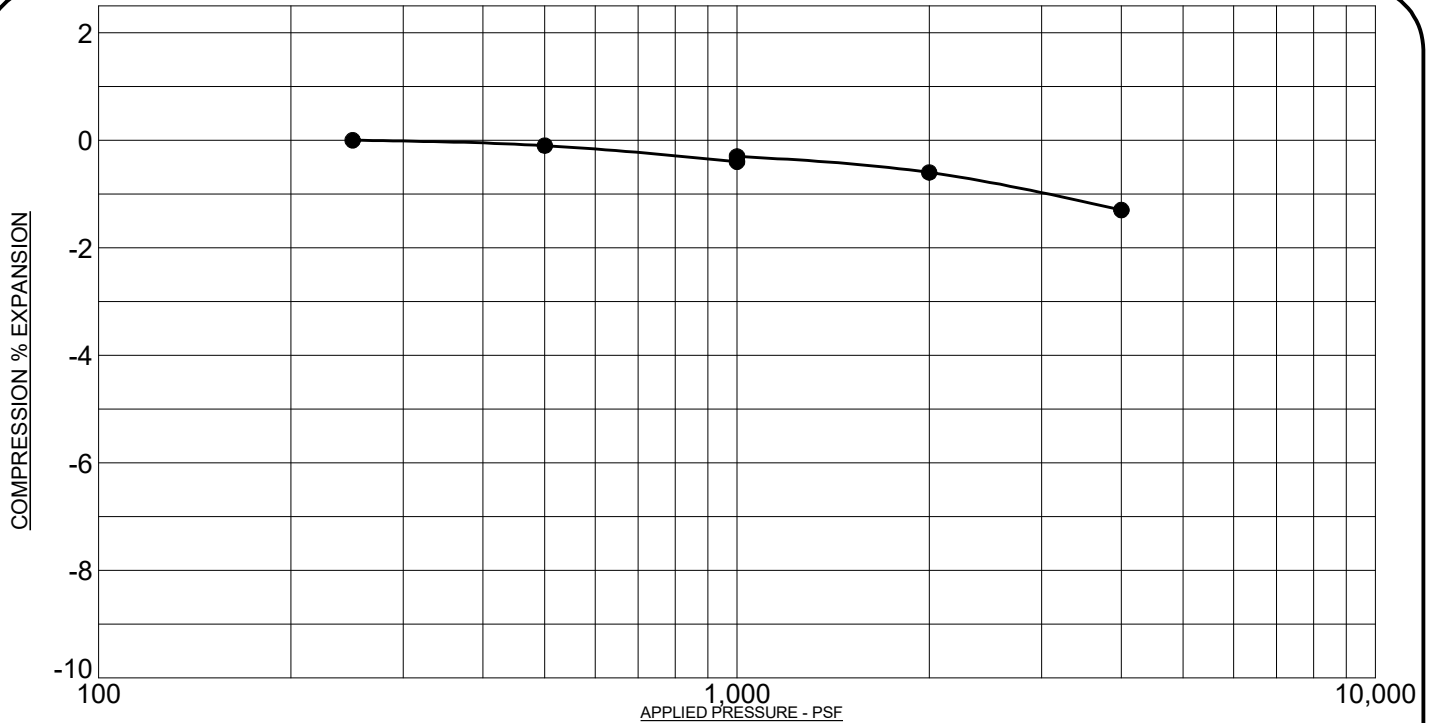
PROJECT: **Bent Grass Residential, Filing No. 2, El Paso County, Colorado**
 SAMPLE DESCRIPTION: **CLAYSTONE, SANDY**
 NOTE: **SAMPLE WAS INUNDATED WITH WATER AT 1,000 PSF**

SAMPLE LOCATION: **23 @ 9 FT**
 NATURAL DRY UNIT WEIGHT: **PCF**
 NATURAL MOISTURE CONTENT: **%**
 PERCENT SWELL/COMPRESSION: **0.1**

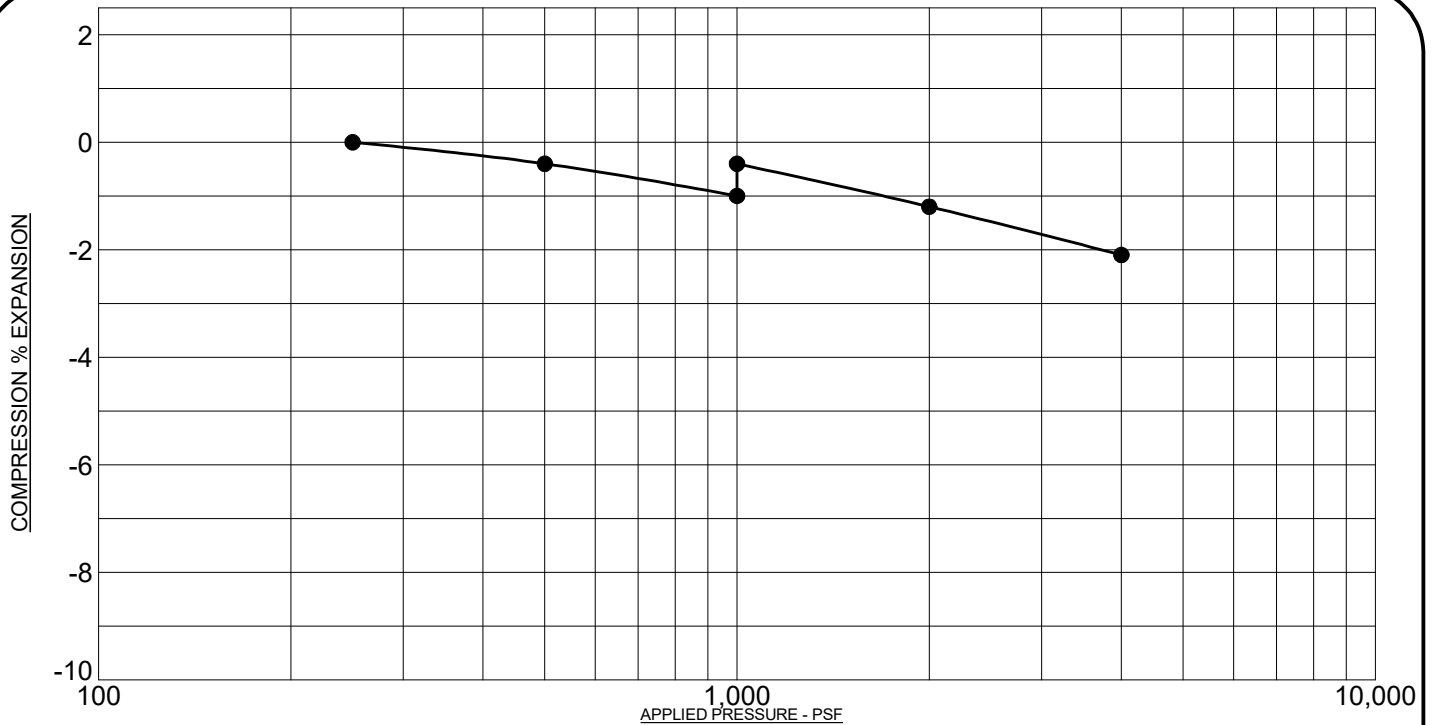
PROJECT: Bent Grass Residential, Filing No. 2, El Paso County, Colorado
 SAMPLE DESCRIPTION: CLAY, SANDY
 NOTE: SAMPLE WAS INUNDATED WITH WATER AT 1,000 PSF

SAMPLE LOCATION: 33 @ 4 FT
 NATURAL DRY UNIT WEIGHT: 114.0 PCF
 NATURAL MOISTURE CONTENT: 17.8%
 PERCENT SWELL/COMPRESSION: 0.6

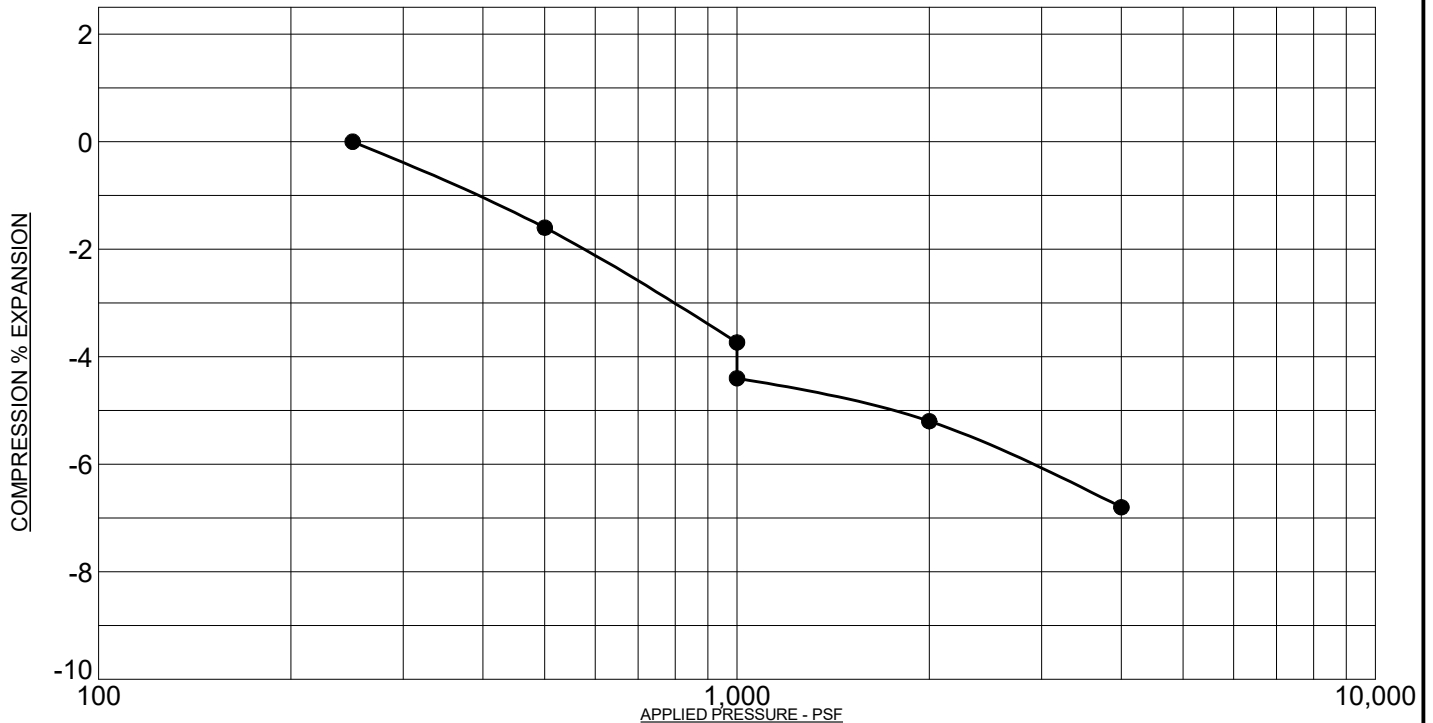
PROJECT: **Bent Grass Residential, Filing No. 2, El Paso County, Colorado**
 SAMPLE DESCRIPTION: **CLAYSTONE, SANDY**
 NOTE: **SAMPLE WAS INUNDATED WITH WATER AT 1,000 PSF**

SAMPLE LOCATION: **91 @ 9 FT**
 NATURAL DRY UNIT WEIGHT: **111.6 PCF**
 NATURAL MOISTURE CONTENT: **13.6%**
 PERCENT SWELL/COMPRESSION: **1.2**
