AMERICAN  
GEOSERVICES

**PROJECT NO: 0224-CS19**

Reference: Summary Letter, Initial Wildlife/Biological Assessment for Mouse Habitat & Initial Wetlands Assessment, Proposed residential development, Bentgrass Meadows St, Falcon, CO

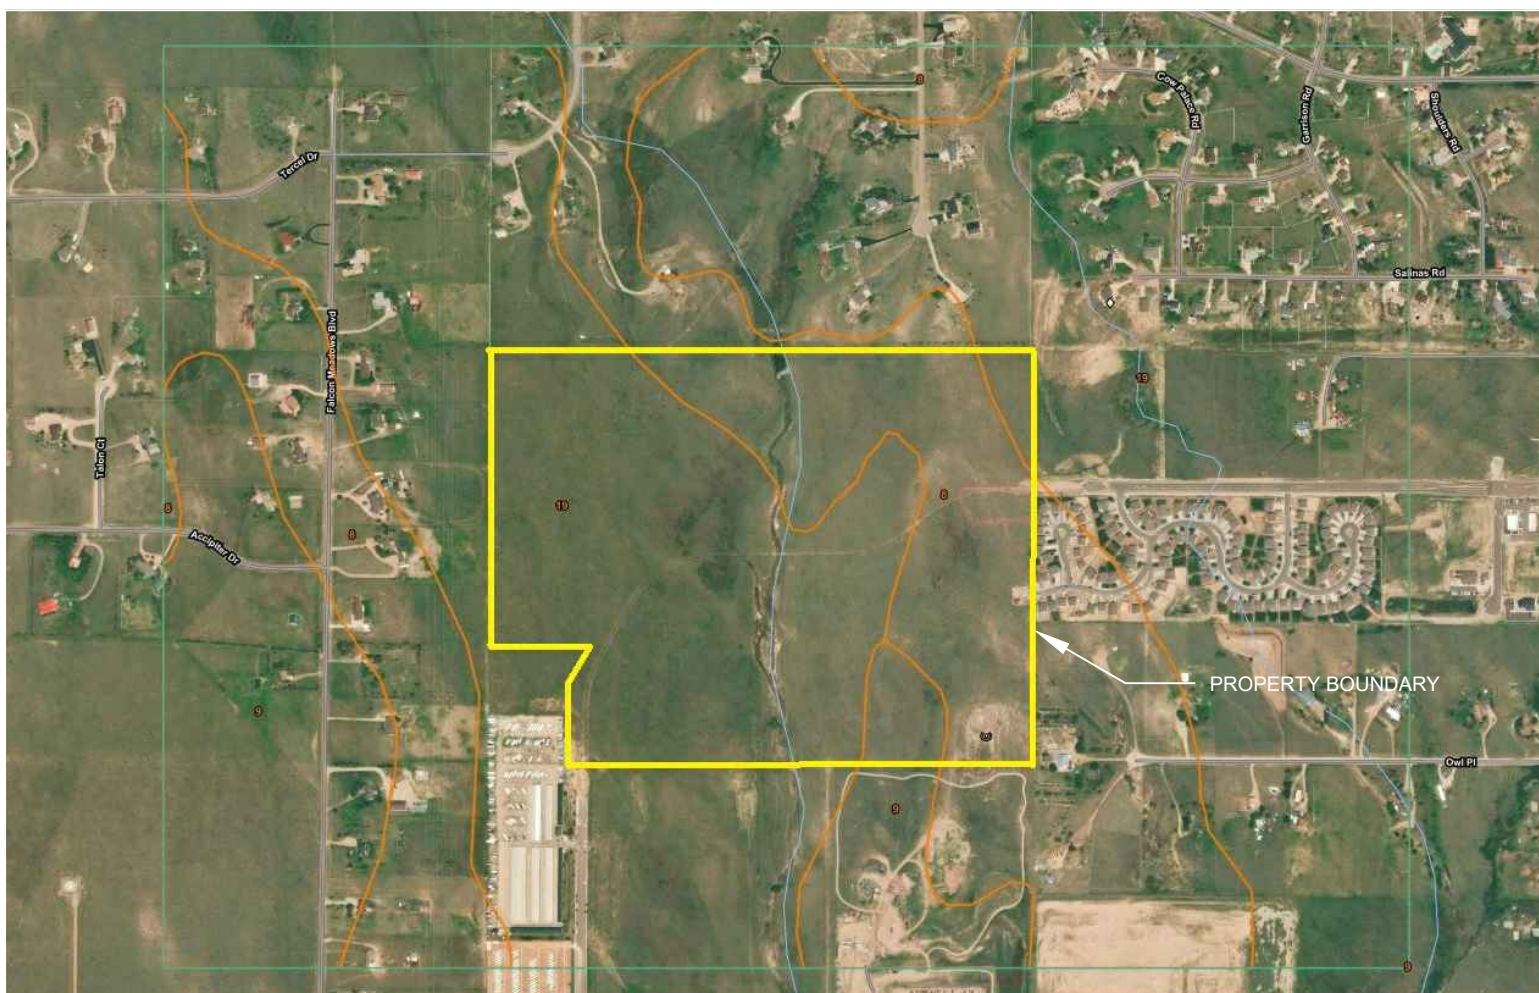
FIGURE 4: SOIL SURVEY MAP

**Soil Survey Maps:** The El Paso County Soil Survey indicates the project area traverses three soil associations including Blackland loamy sand (1 to 9 percent slopes), Blackland-Fluvaquentic Haplaquolls, and Columbine gravelly sandy loam (Figure 4). None of these soils are classified as a hydric soil in El Paso County by the Natural Resources Conservation Service (NRCS).

| El Paso County Area, Colorado (C0625) | | | |
|---|--|---|---|
| 8 | Blakeland loamy sand, 1 to 9 percent slopes | 157.2 | 25.2% |
| 9 | Blakeland-Fluvaquentic Haplaquolls | 77.1 | 12.3% |
| 19 | Columbine gravelly sandy loam, 0 to 3 percent slopes | 390.3 | 62.5% |

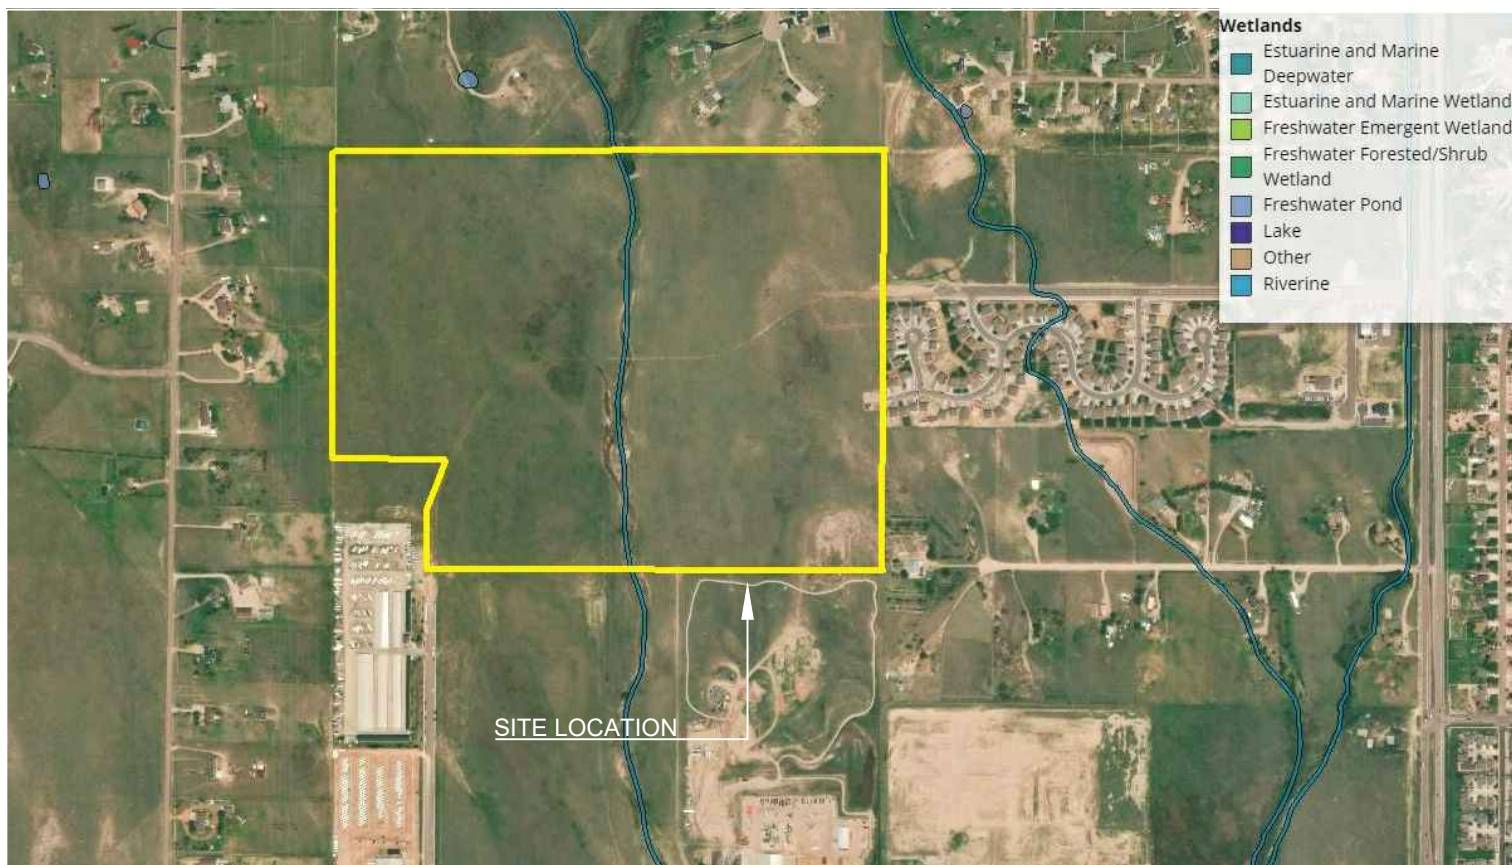
**FIGURE 5:  
NATIONAL WETLANDS INVENTORY  
MAP**

**National Wetlands Inventory Maps:** A review of NWI maps (USFWS) was conducted to determine the potential presence, location, size, and type of wetlands located within the Project boundaries. The USFWS generates NWI maps through aerial photograph interpretation. NWI maps may not accurately depict the extent or existence of wetland systems in a specific area, nor do maps consistently and accurately identify wetland type. As such, the maps were utilized for preliminary analysis only. Field reconnaissance was conducted to determine the true extent and type of wetlands located within the Project, and to verify the information gathered through NWI data review. NWI data did not depict any wetlands within the project boundaries (Figure 5).

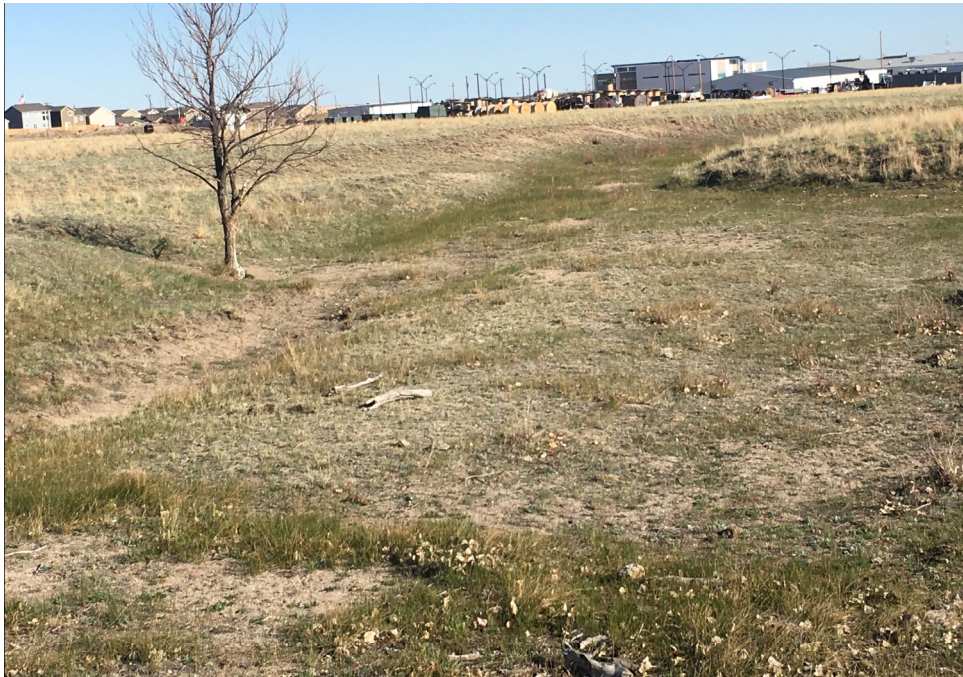
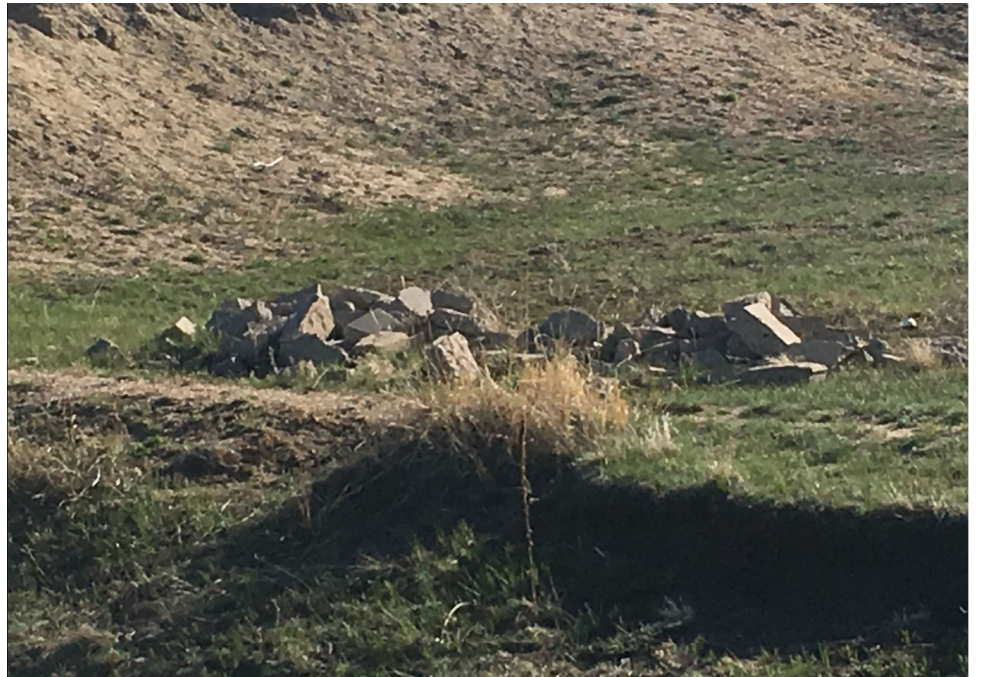
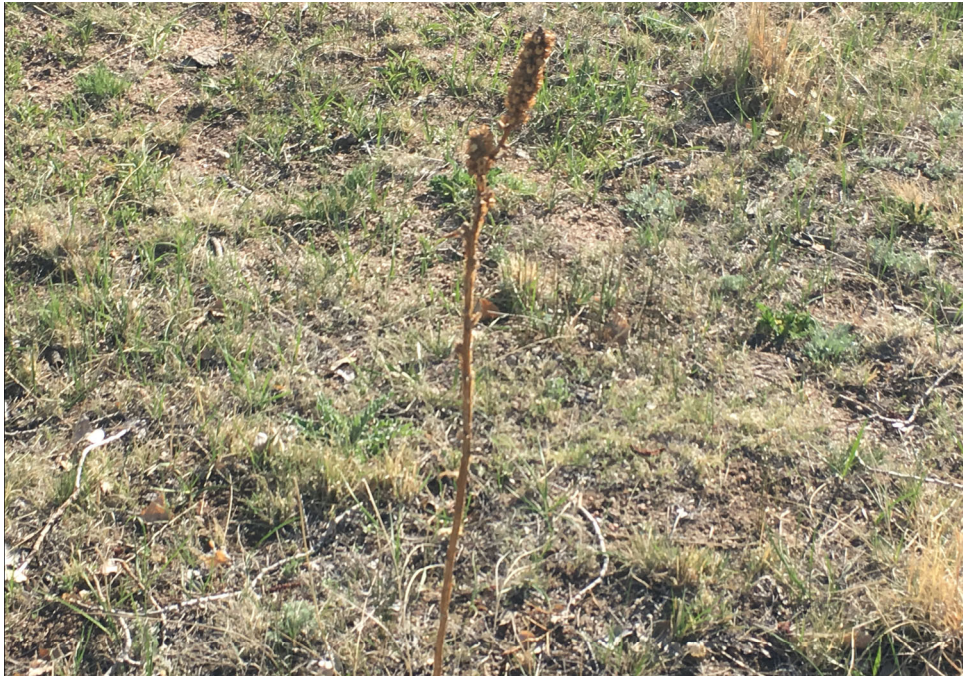
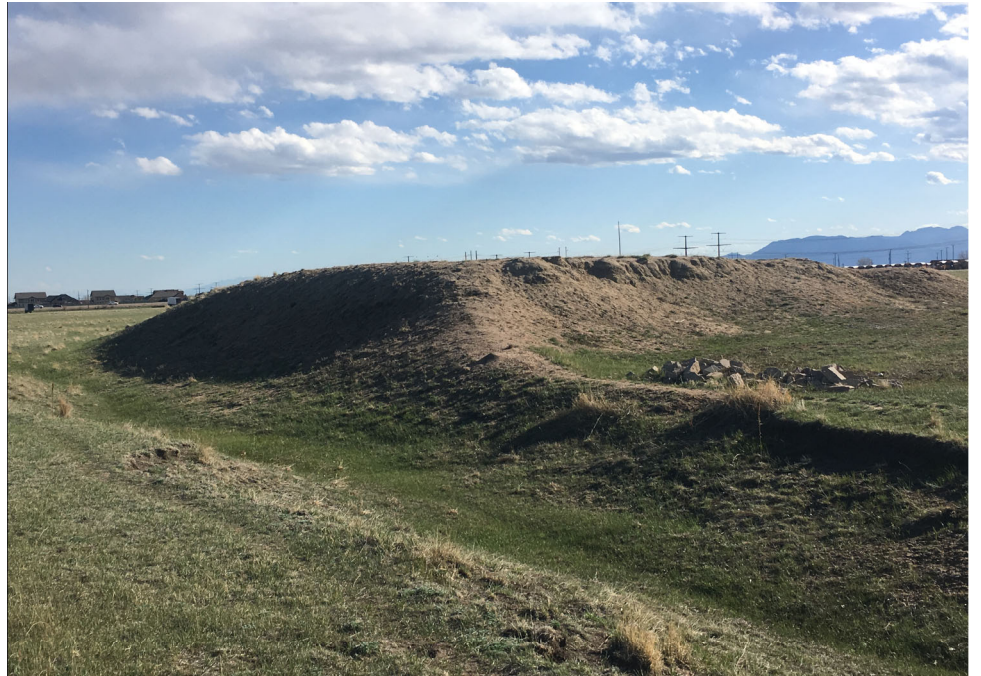
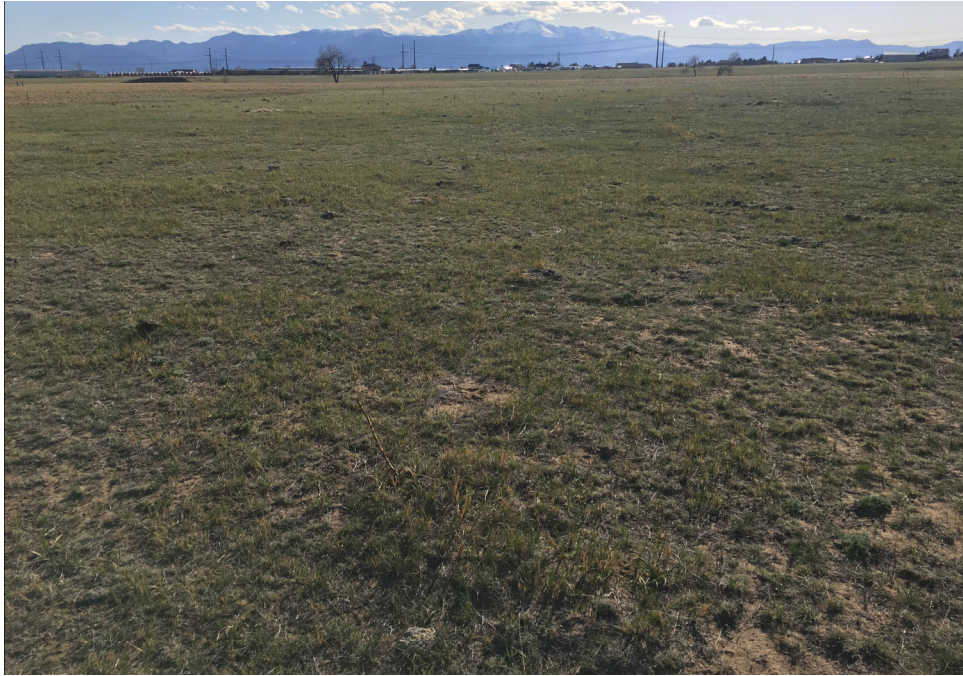
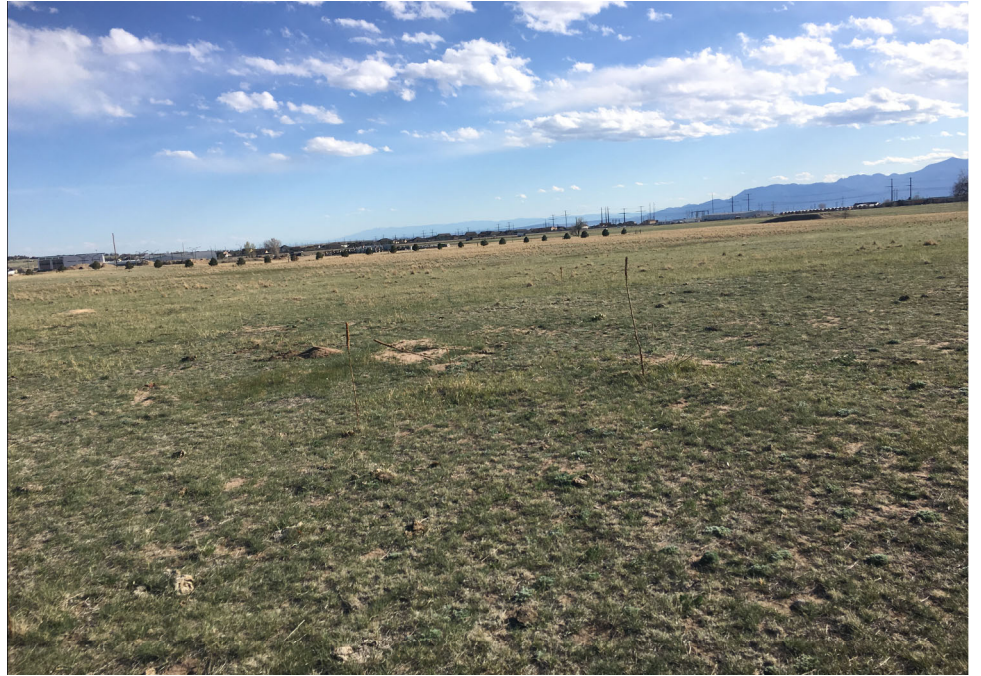
there is no way to know where these photos are in relation to the development. Are the ponds staying? where are they on the overall site map. is there areas that should be mitigated or avoided?
