Final Drainage Letter

**Pike's Peak
Christian Church
Phase III Addition
Storage Facility**

Project Number 61181

PCD File No. PPR-22-042

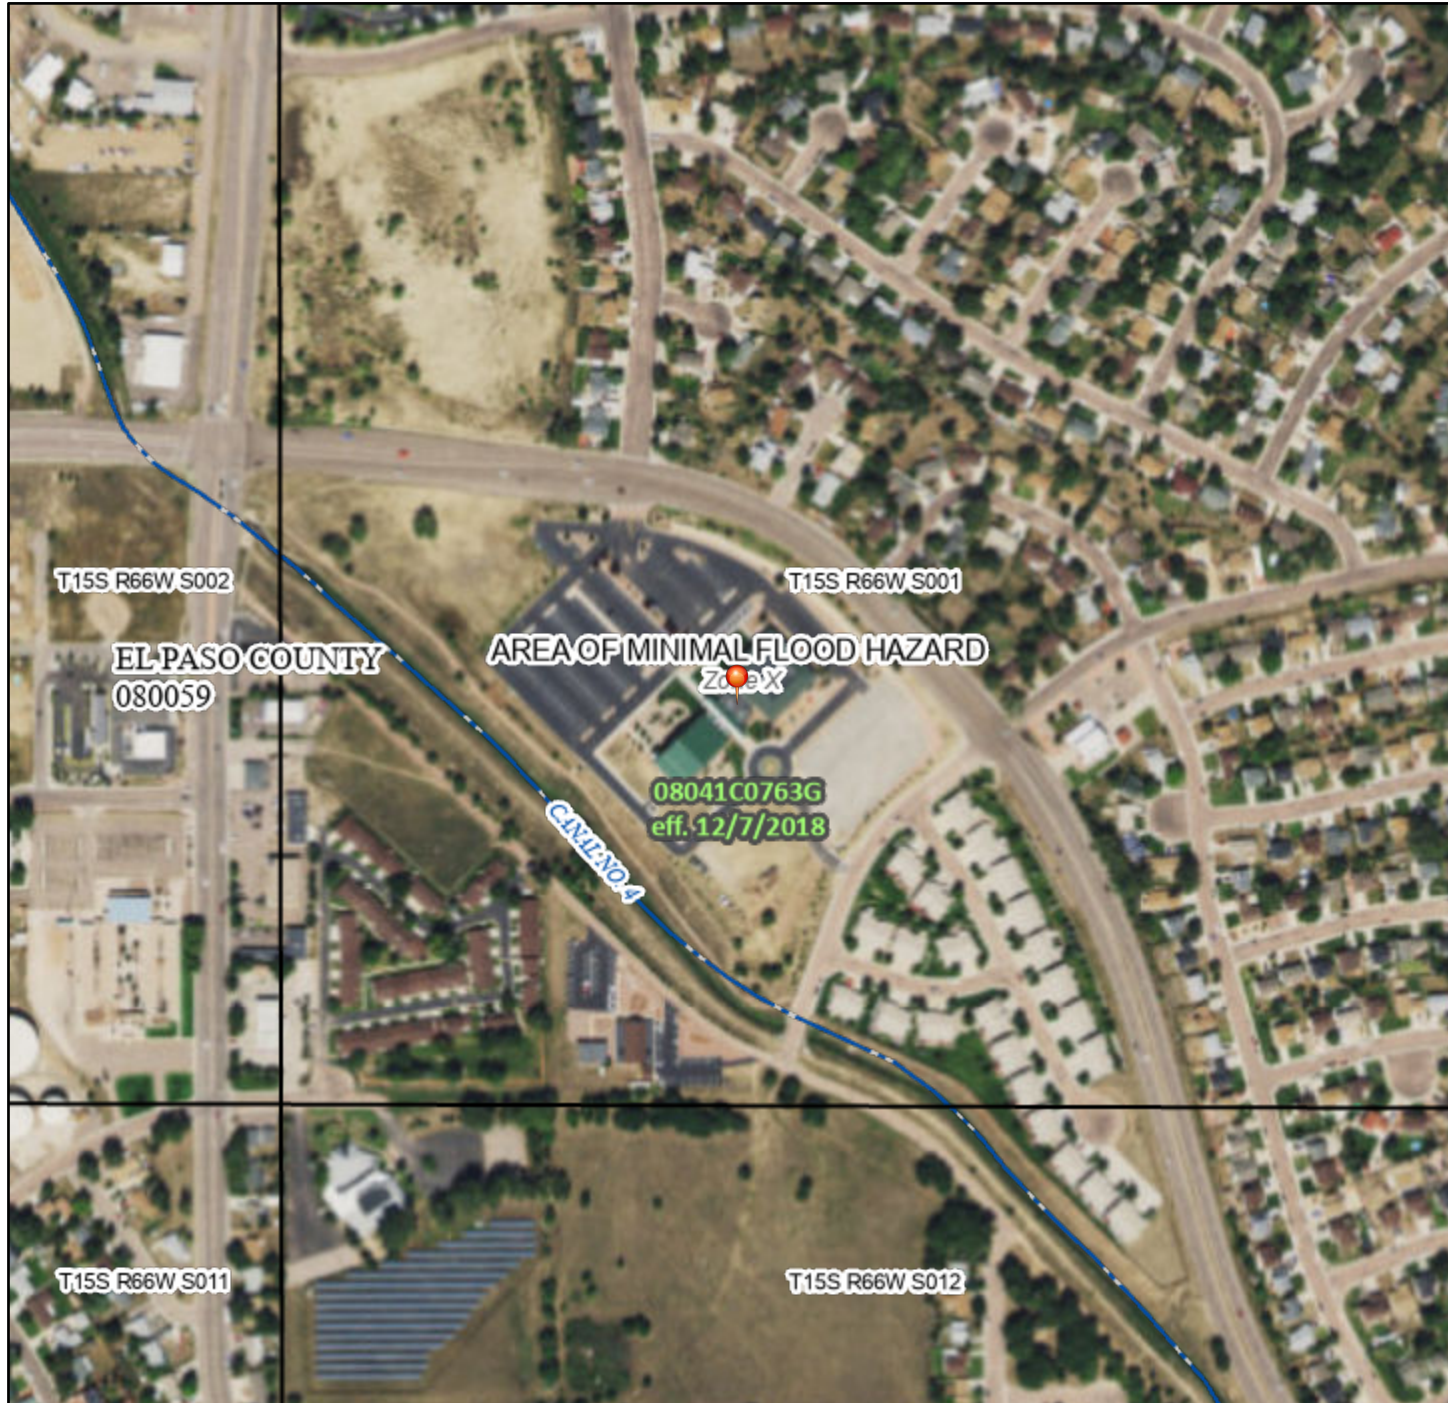
National Flood Hazard Layer FIRMMette

The flood hazard information is derived directly from the authoritative NFHL web services provided by FEMA. This map was exported on **8/31/2022 at 5:59 PM** and does not reflect changes or amendments subsequent to this date and time. The NFHL and effective information may change or become superseded by new data over time.
