**SOIL, GEOLOGY, GEOLOGIC HAZARD,
AND WASTEWATER STUDY,
SADDLEHORN RANCH SUBDIVISION
EL PASO COUNTY, COLORADO**

William Guman and Associates, LTD
731 North Weber Street, Suite 100
Colorado Springs, Colorado 80903

April 29, 2019

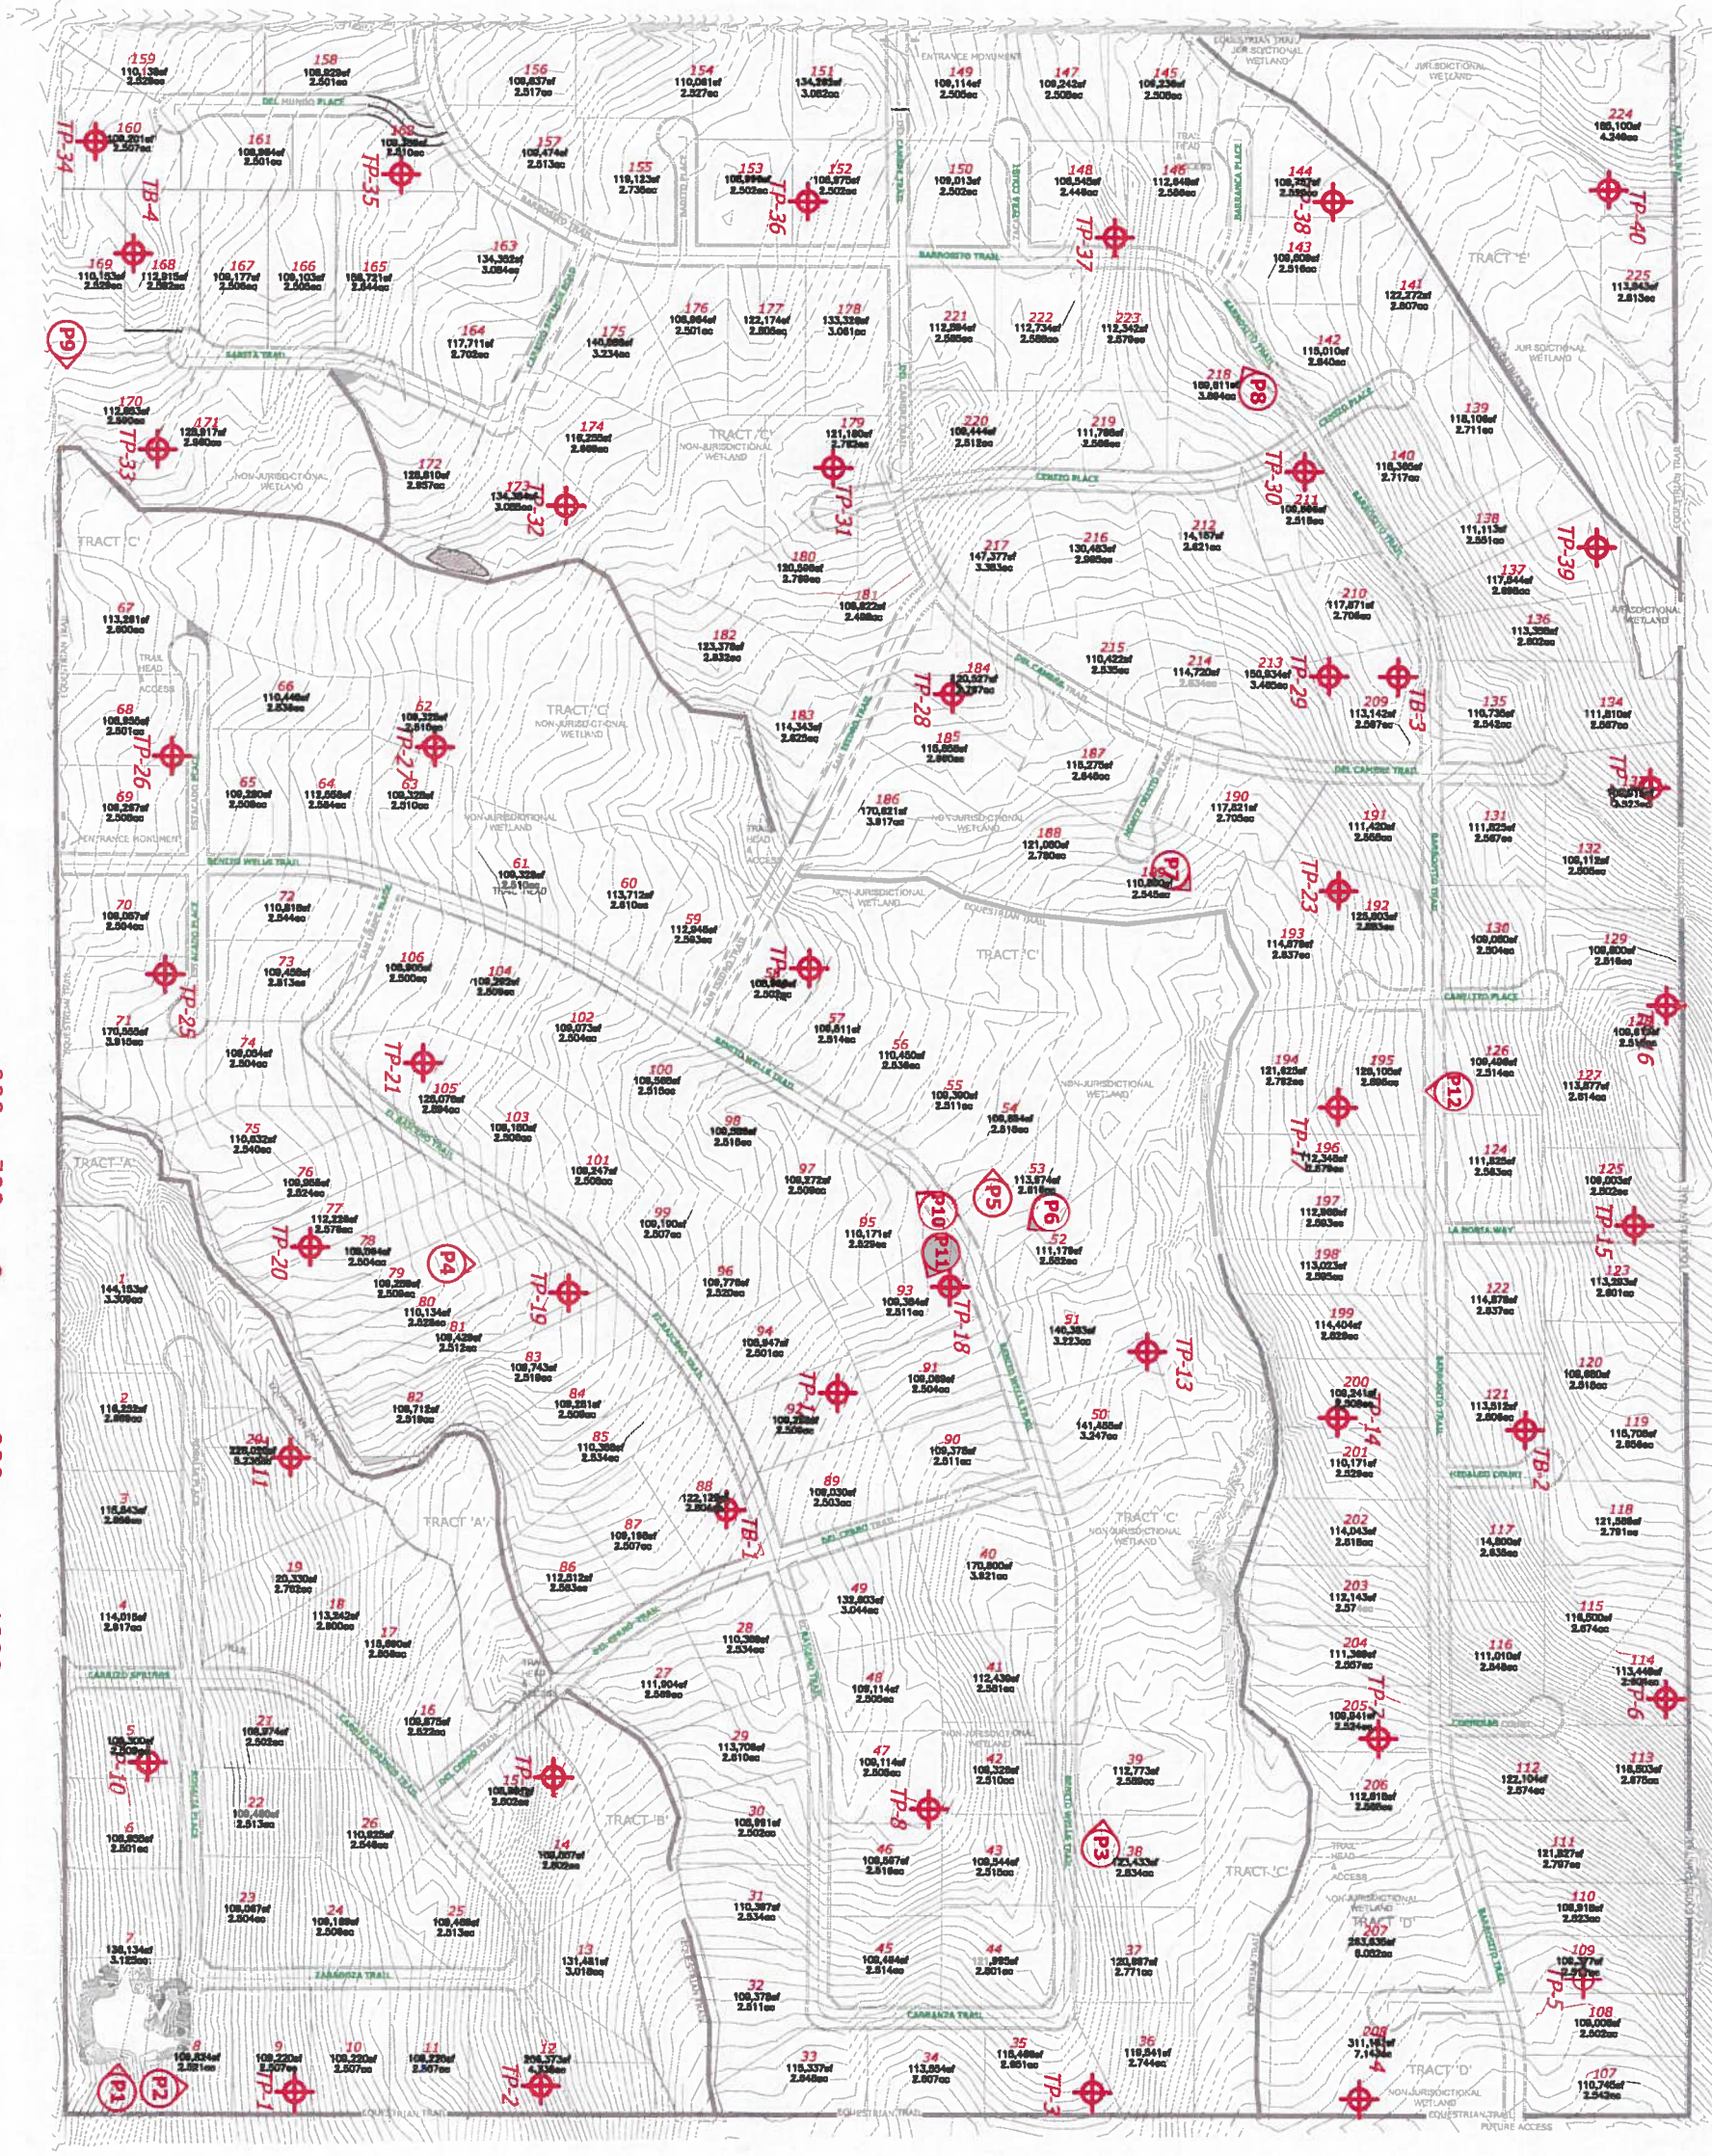
SITE PLAN/TEST BORING LOCATION MAP
SADDLEHORN RANCH SUBDIVISION
CURTIS ROAD AND JUDGE ORR ROAD
EL PASO COUNTY, CO.
FOR: WILLIAM GUMAN AND ASSOCIATES, LTD

Four (4) test borings, and forty (40) tactile test pits were performed on the site to verify general soil conditions and the suitability of the site for the use of on-site wastewater treatment systems. The locations of the test borings, and test pits are indicated on the Site Plan/Testing Location Map, Figure 3. The Test Boring and Test Pit Logs are presented in Appendix B. Results of this testing will be discussed later in this report.

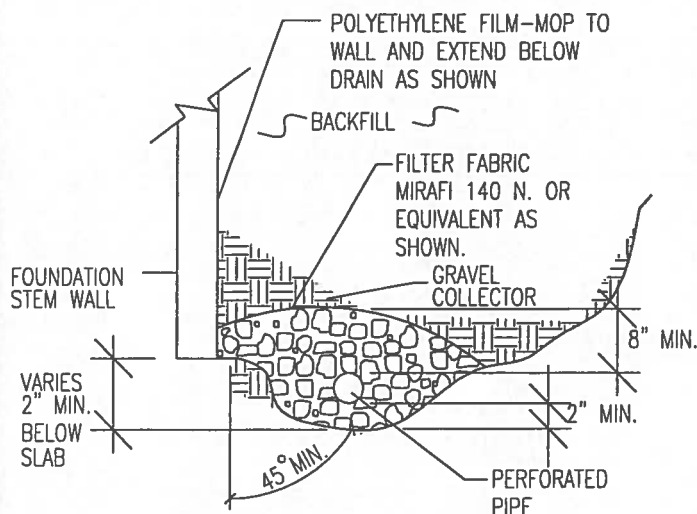
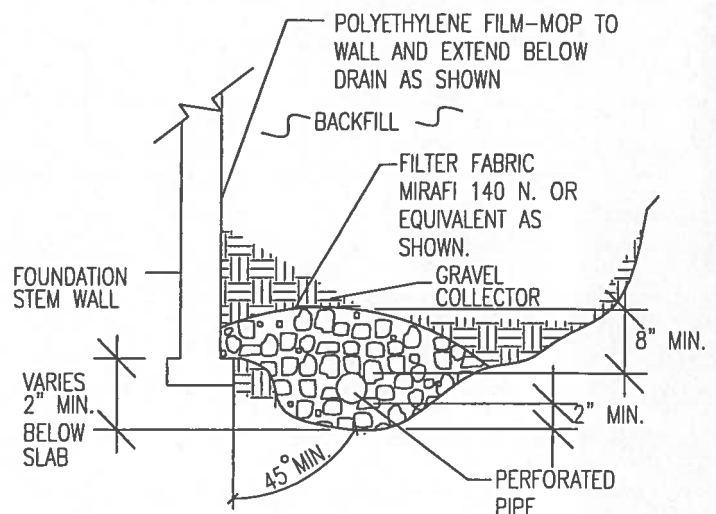
8

-GRAVEL SIZE IS RELATED TO DIAMETER OF PIPE PERFORATIONS-85% GRAVEL GREATER THAN 2x PERFORATION DIAMETER.

Mitigation: In these locations, foundations are subject to severe frost heave and should penetrate to a sufficient depths so as to prevent the formation of ice lenses beneath foundations. At this location and elevation, a foundation depth for frost protection of 30-inches is recommended. In areas where high subsurface moisture conditions are anticipated periodically, a subsurface perimeter drain will be necessary to help prevent the seepage of water into areas below grade. A typical perimeter drain detail is presented in Figure 8. Any grading in these areas should be done in a manner that directs surface flow around construction to avoid areas of ponded water. Areas of organic material will require removal prior to any fill placement. Unstable soil conditions should be expected in areas of shallow groundwater. Where foundations approach the groundwater level, stabilization of the excavations utilizing shot rock may be necessary. Underslab drains or capillary breaks, and interceptor drains may be necessary to prevent intrusion of water into areas below grade. Typical drain details are presented in Figures 9 and 10.

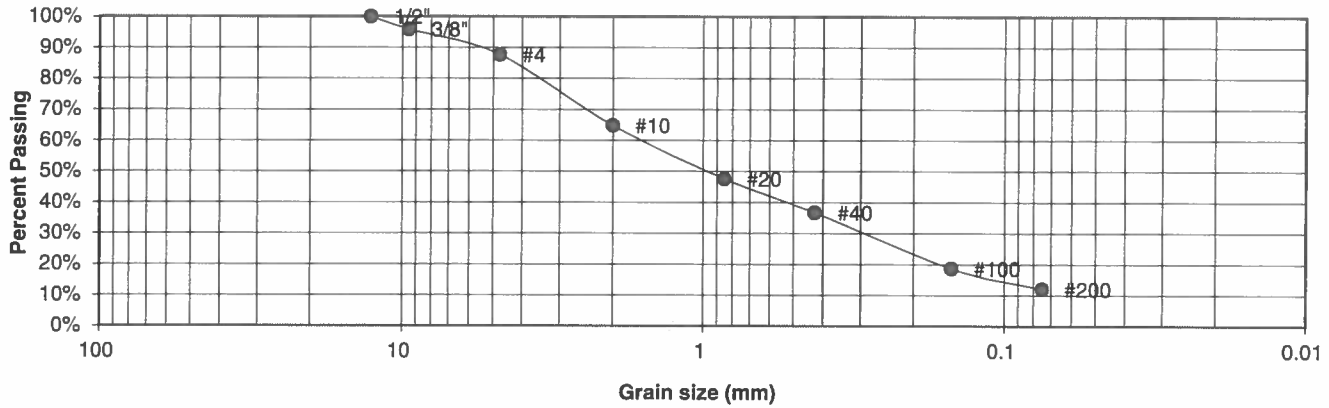
C-1

<u>U.S. Sieve #</u>	<u>Percent Finer</u>
3"	
1 1/2"	
3/4"	
1/2"	100.0%
3/8"	95.8%
4	87.7%
10	64.8%
20	47.7%
40	36.7%
100	18.7%
200	12.0%

Laboratory testing was also performed on some of the soils to classify and determine the soils engineering characteristics. Laboratory tests included grain-size analysis, ASTM D-422, and Atterberg Limits, ASTM D-4318 for classification purposes. Volume change testing was performed on selected samples using the FHA Swell Test and Swell/Consolidation Test, ASTM D-4546, in order to evaluate the expansion/consolidation potential of the soils. Soluble sulfate testing was performed on selected samples to determine the corrosive characteristics of the soils on concrete placed below ground. Results of the laboratory testing are included in Appendix C. The Laboratory Test Results are summarized in Tables 1 and 2.

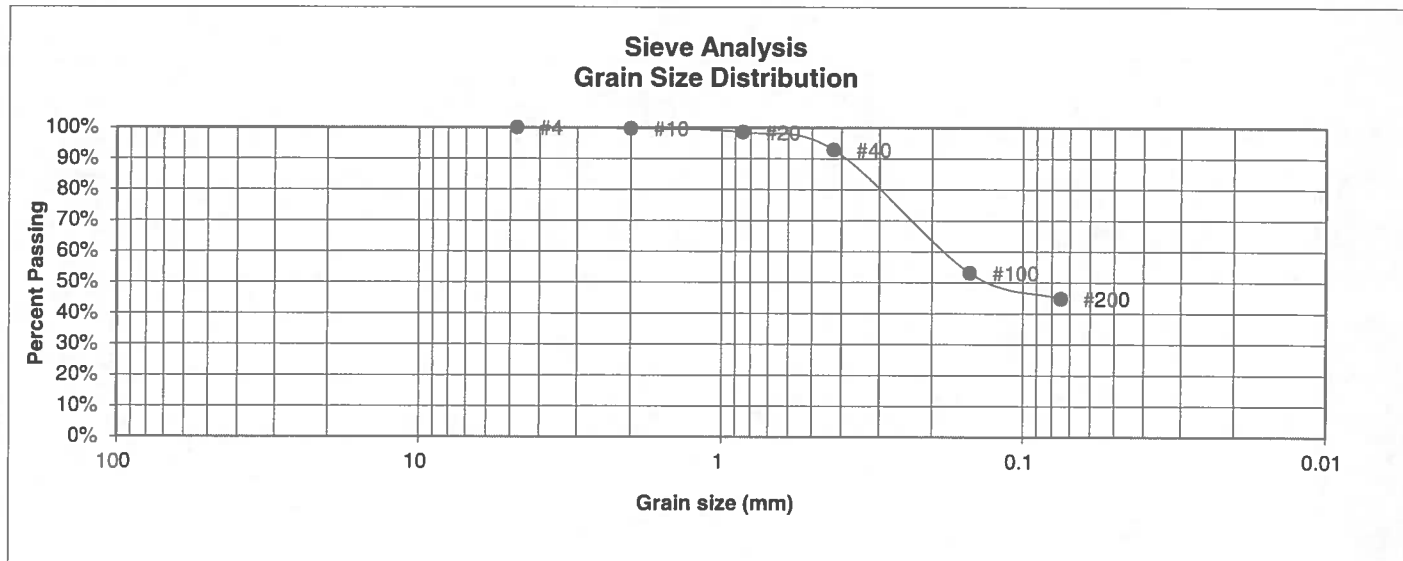
C-24

<u>UNIFIED CLASSIFICATION</u>	SC	<u>CLIENT</u>	GUMAN AND ASSOCIATES
<u>SOIL TYPE #</u>	3	<u>PROJECT</u>	CURTIS RD AND JUGRE ORR RD
<u>TEST PIT #</u>	8	<u>JOB NO.</u>	181823
<u>DEPTH (FT)</u>	4-5	<u>TEST BY</u>	BL

<u>U.S. Sieve #</u>	<u>Percent Finer</u>
3"	
1 1/2"	
3/4"	
1/2"	
3/8"	
4	100.0%
10	99.7%
20	98.5%
40	92.9%
100	53.2%
200	44.8%

<u>Atterberg Limits</u>	
Plastic Limit	16
Liquid Limit	29
Plastic Index	13
