# Natural Features and Wildlife Habitat Assessment High Forest Estates Subdivision Colorado Springs, El Paso County, Colorado

ERO Resources Corporation  
1842 Clarkson Street  
Denver, Colorado 80218  
(303) 830-1188  
ERO Project #22-325

March 20, 2023

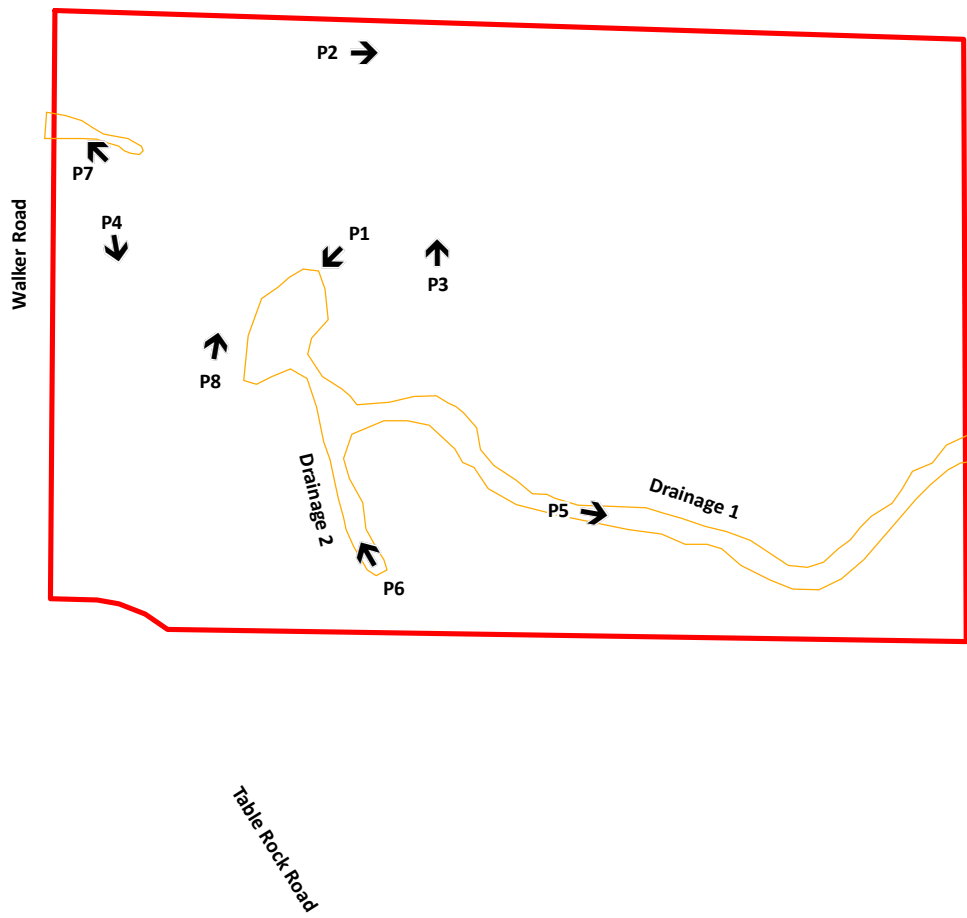
### Figure 2 Existing Conditions

The topography of the project area generally slopes from southeast to northwest, with an intermittent stream running diagonally through the property. The project area consists of a mixture of native and nonnative grasslands with a few scattered trees. One large depressional wetland is present near the center of the project area (Photo 1), with two drainage corridors, which are described in detail in the *Vegetation Communities and Wildlife Habitat* section of this report. A list of plants observed during the 2023 site visit and their foremost associated vegetation community types can be found in Appendix A, Appendix B lists wildlife species observed or potentially found in the project area, and a photo log is provided in Appendix C.

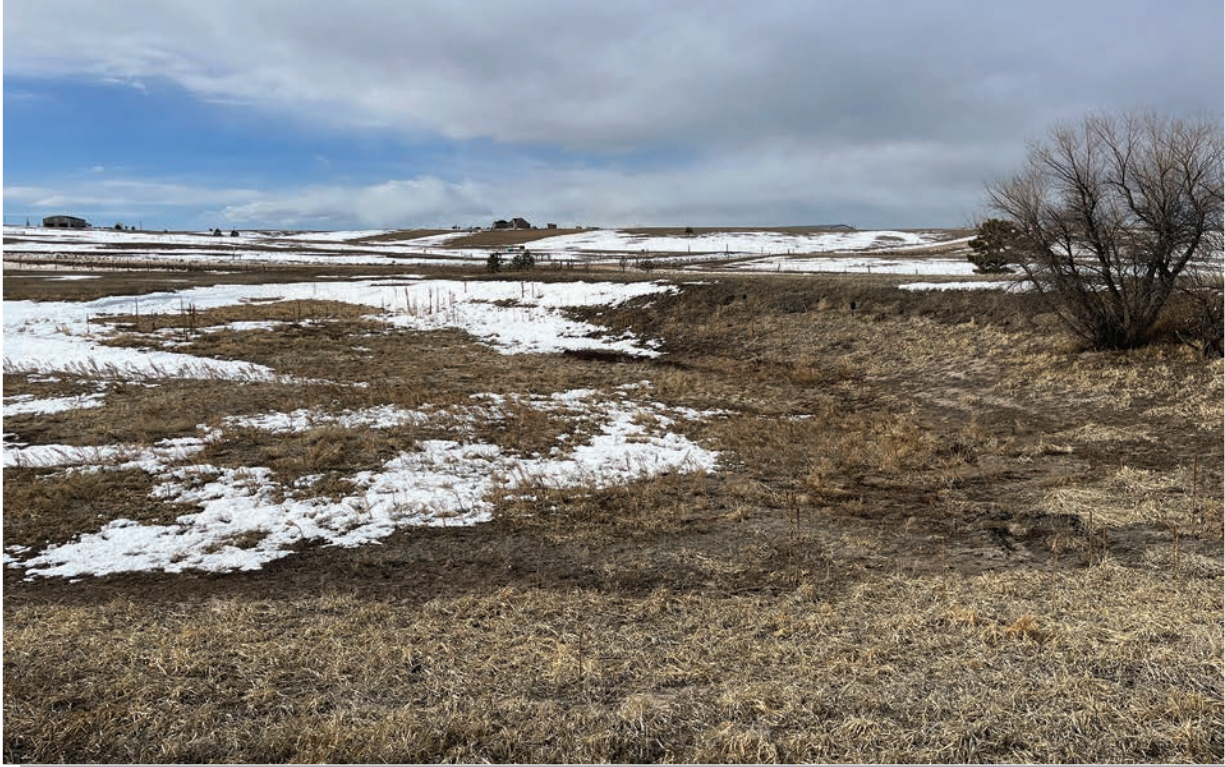
**Photo 1** - Overview of the depressional wetland area. View is to the west.

ERO recommends that the proposed project avoid development within the drainages and their associated wetland vegetation. If any work would be performed in the drainages or wetland areas, a jurisdictional determination should be requested from the Corps. If Drainage 1 or 2 is considered jurisdictional and work is planned in either of these areas, a Section 404 permit would be required for the placement of dredged or fill material below the ordinary high water mark. If either of the drainages is determined nonjurisdictional or if no work is planned in either of these areas, no action would be necessary.

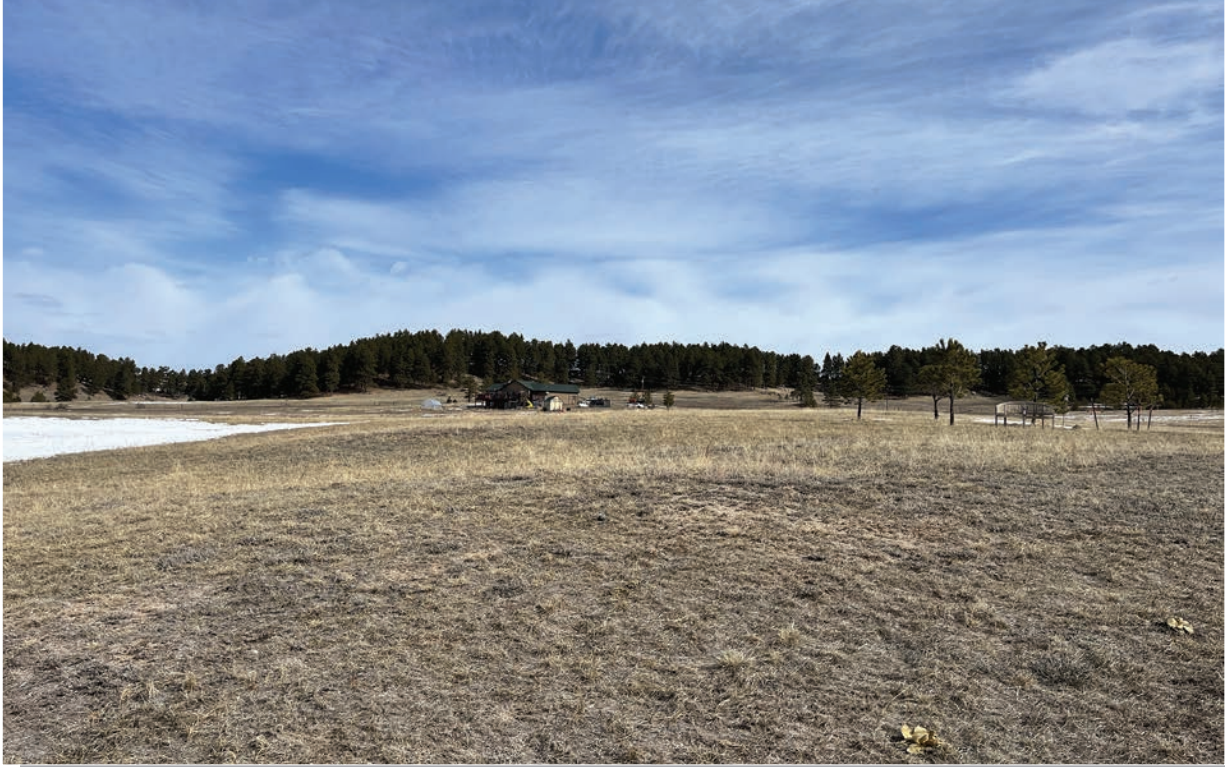
**Photo 3** - Uplands dominated by native species in the project area. View is to the north.

To maintain grassland communities and associated wildlife, native seed should be planted in areas temporarily disturbed by construction. ERO recommends preserving areas of native vegetation to the greatest extent feasible to maintain habitat for the species associated with these community types.

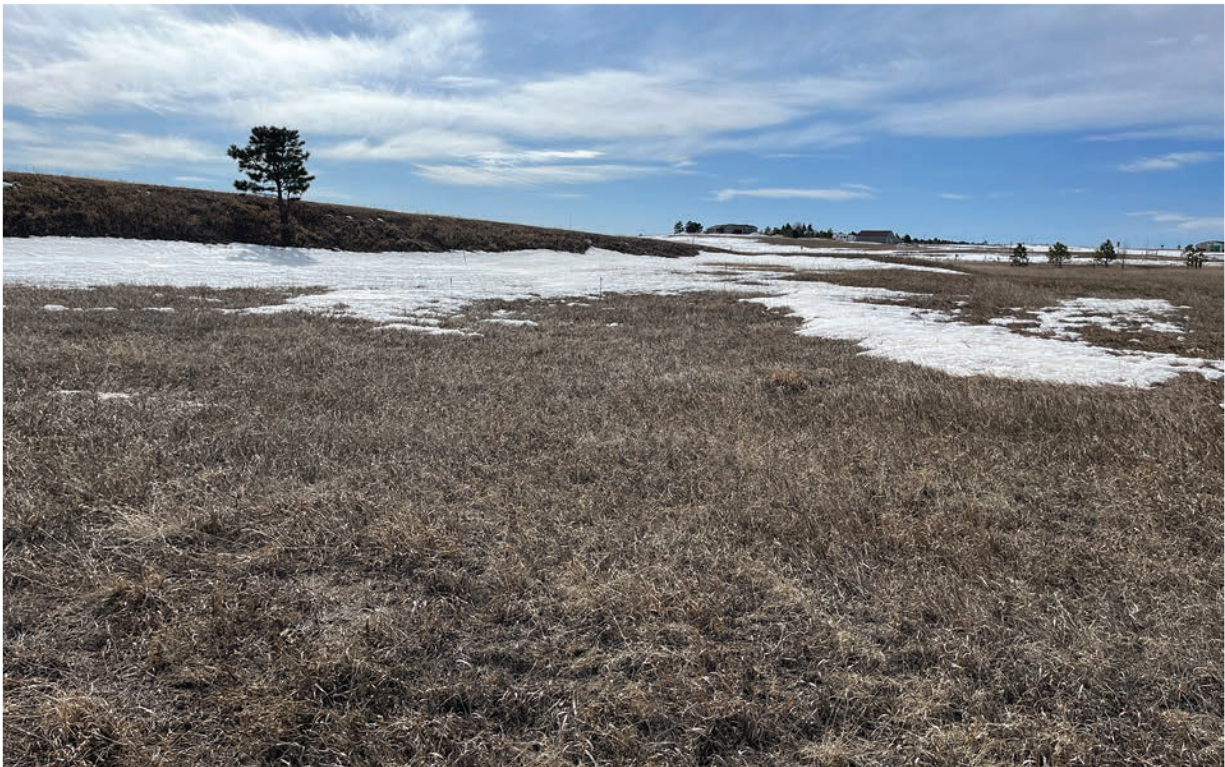
**Photo 4** - Uplands dominated by nonnative species in the project area. View is to the southeast.

- Where feasible, leave mature trees in place to provide continued nesting habitat for avian species.
- Develop and implement a noxious weed plan and management recommendations to control weeds on-site and maintain foraging habitat for big game and other wildlife. Prevalent noxious weed species include musk thistle, common mullein, Canada thistle (*Cirsium arvense*), and yellow toadflax (*Linaria vulgaris*).

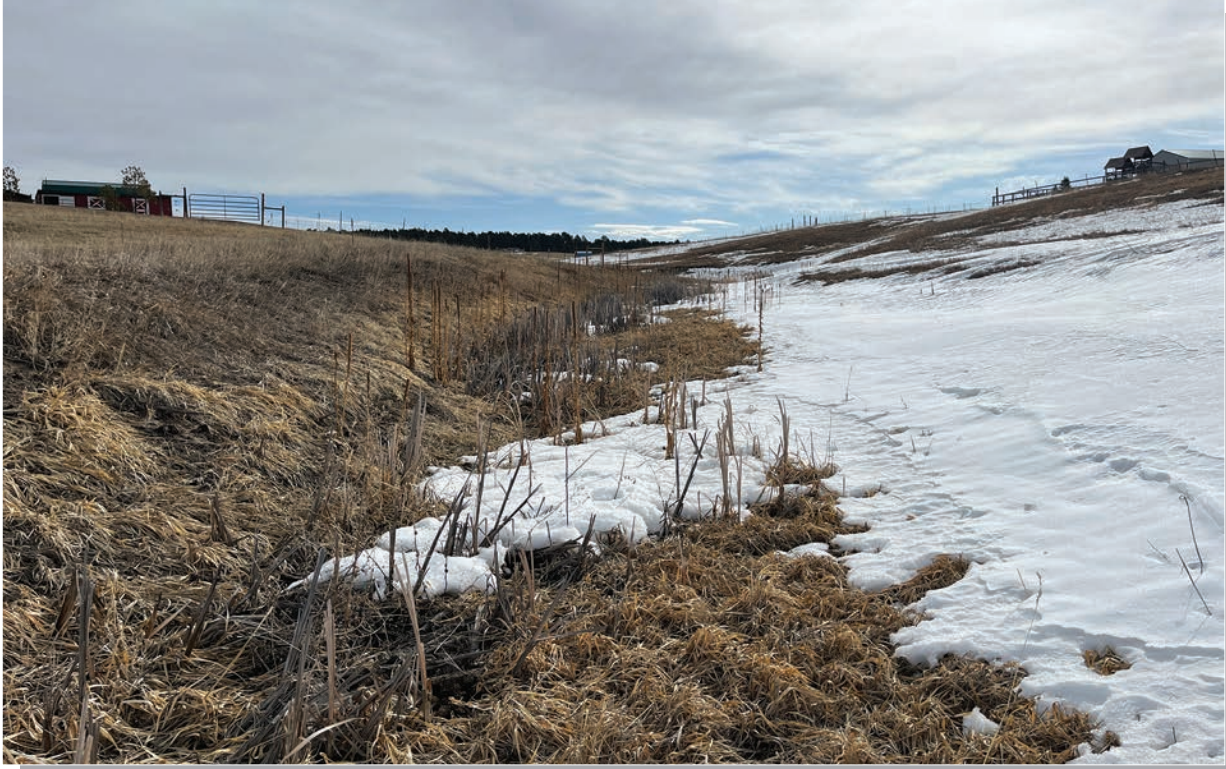
**Photo 5** - Drainage 1 in the project area. View is to the east.

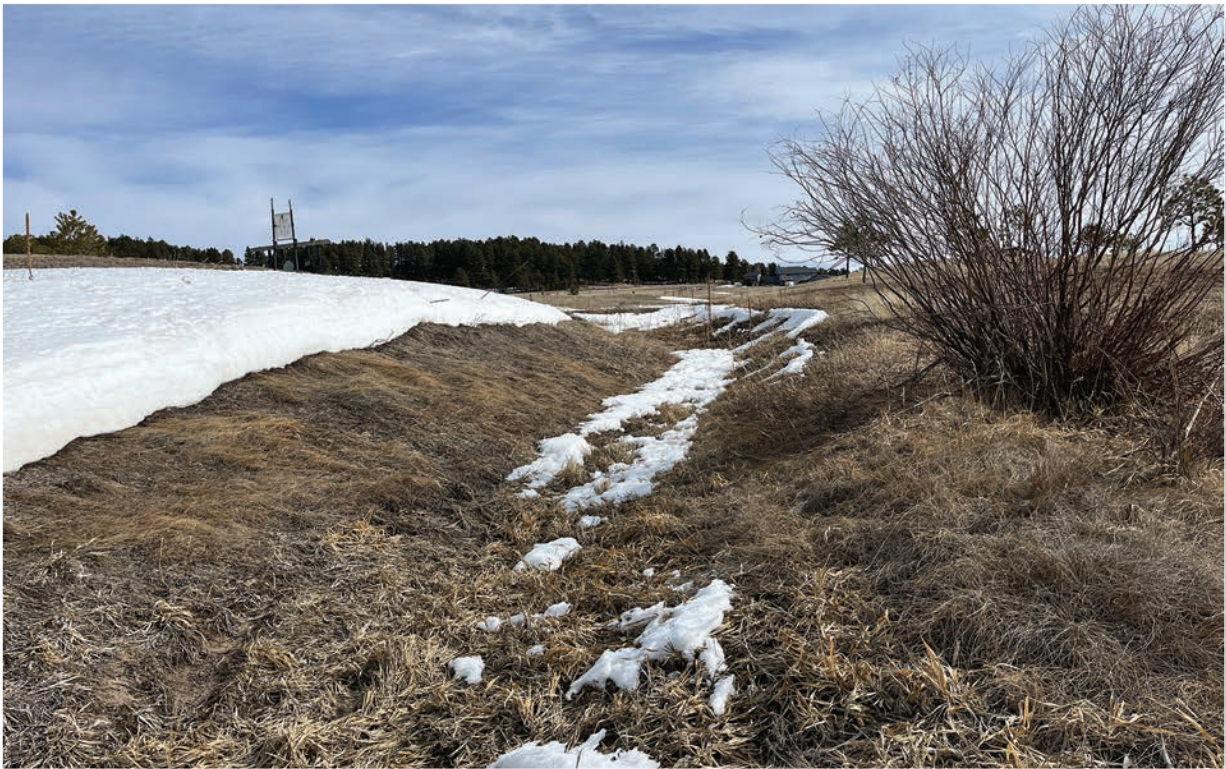
Drainage 2 is in the southwest section of the project area and consists of an ephemeral swale with both wetland and upland species present. The portion of Drainage 2 directly connecting to the depressional wetland contains wetland vegetation. (Photo 6), while the portion toward the southern edge of the project area contains uplands. Drainage 2 mostly lacks a defined bed and bank, and water is only seasonally present. Wetland vegetation along Drainage 2 is dominated by broadleaf cattail, reed canarygrass, and common rush. The overstory in the drainages is sparse with a few crack willow (*Salix fragilis*) occurring in the project area.

**Photo 6** - Drainage 2 in the project area. View is to the northwest.

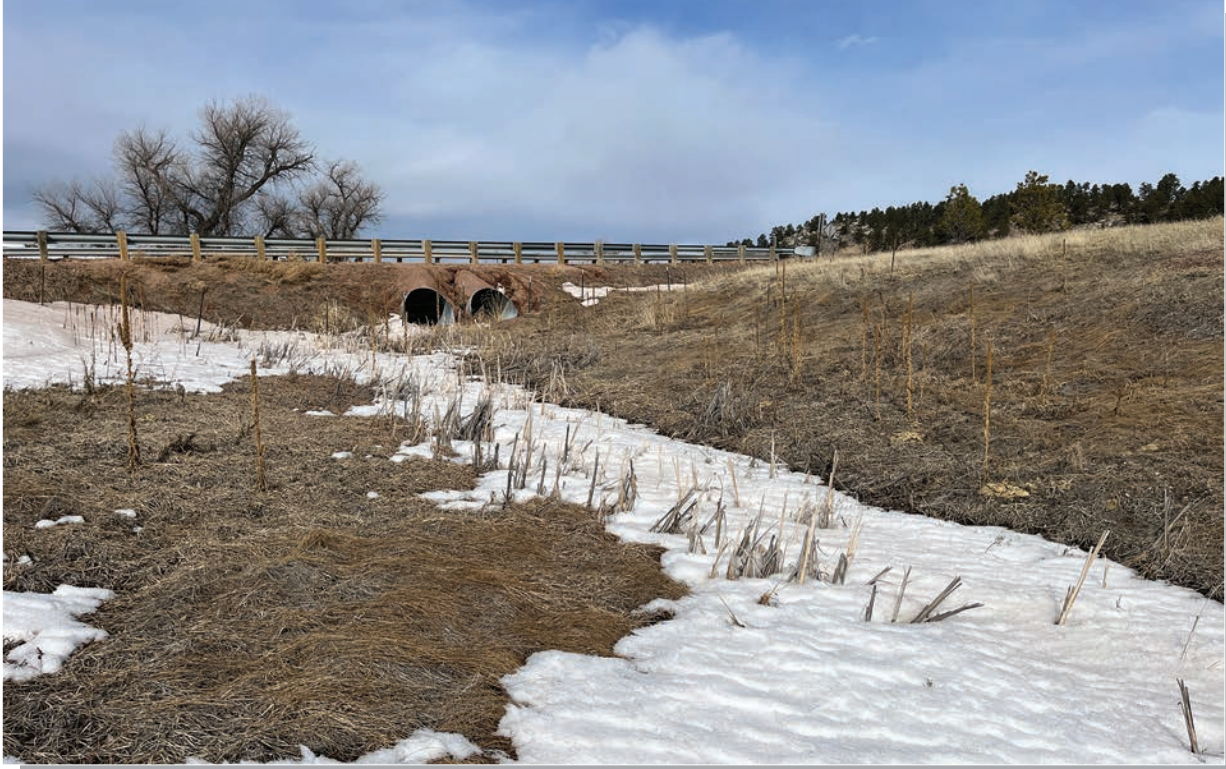
**Photo 7** - Another section of drainage 1 in the project area. View is to the northwest.

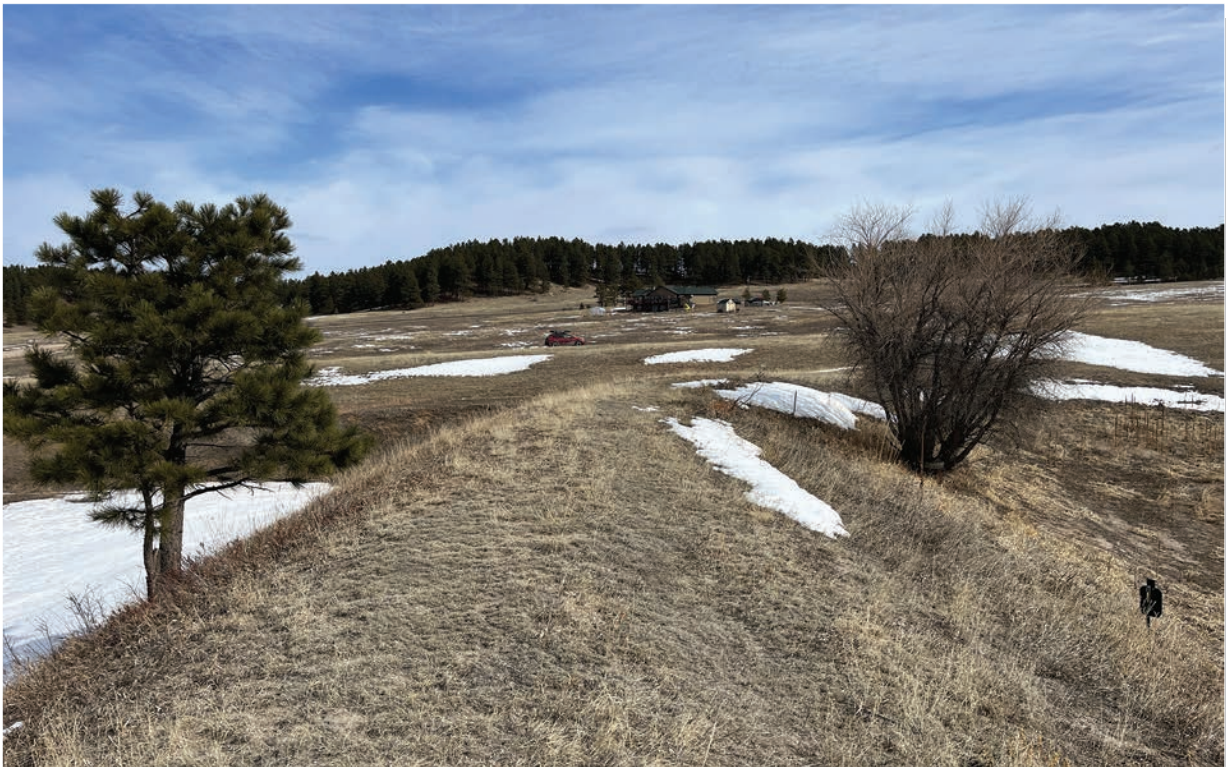
**Photo 8** - Upland berm running through the project area. View is to northeast.
