GWI
GroundWater Investigations LLC · 11590 Black Forest Rd. 614 N Suite 15 · Colorado Springs, CO 80908 · (719) 338-1805

RE: OnSite Waste Treatment System, Circle A Subdivision

PROJECT DESCRIPTION

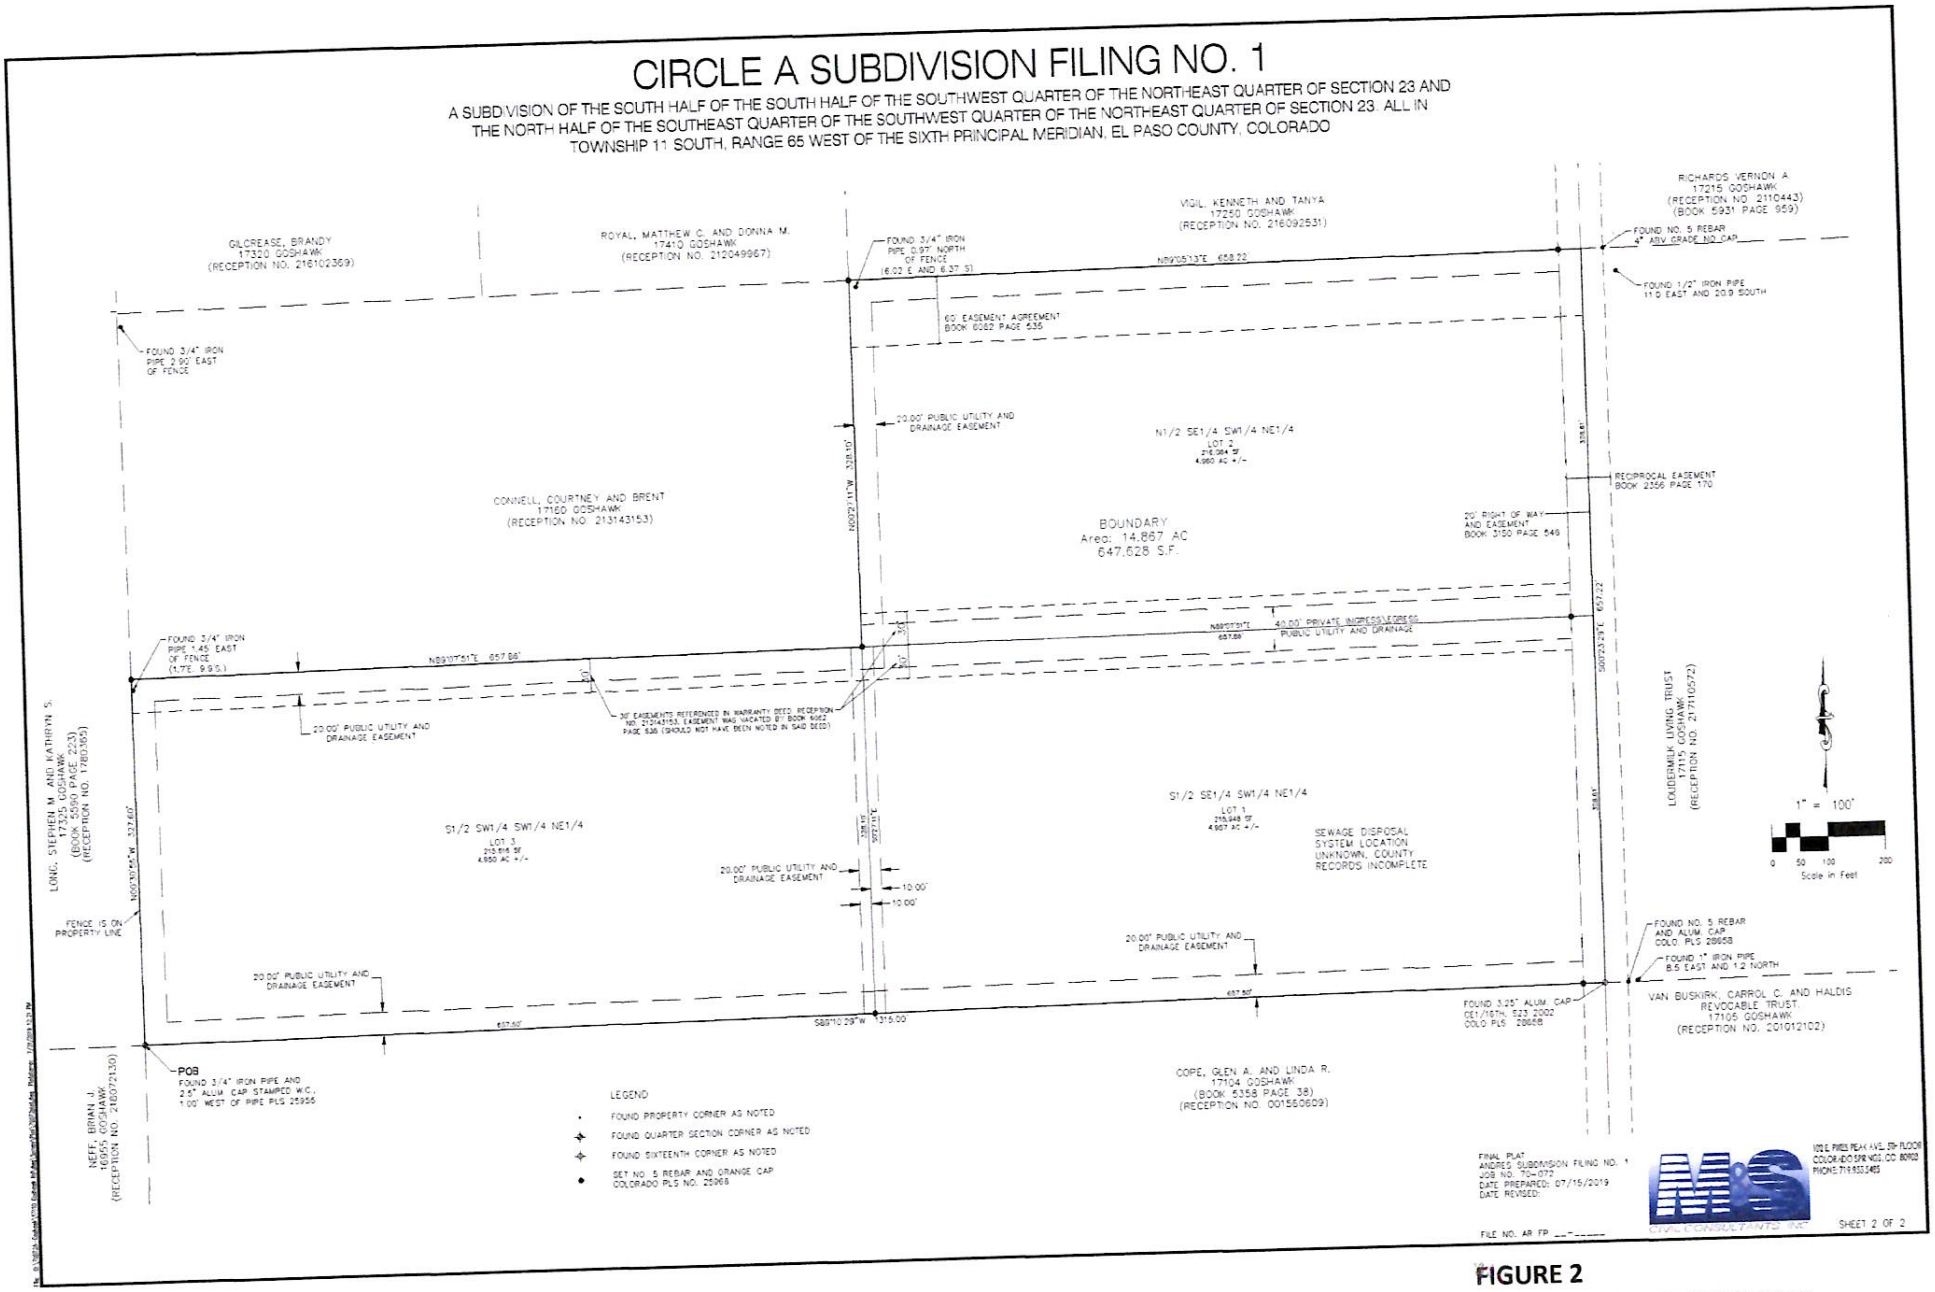
FIGURE 2
CIRCLE A SUBDIVISION LOTS

The Project Site is 14.9 acres of land to be subdivided into 3 single- family residential RR-5 lots (Figure 2). Lot 1 is comprised of 4.957 acres, Lot 2 is 4.96 ACRES and Lot 3 will be 4.95 acres. There is an existing home on Lot 1 with an existing well and individual non-evaporative septic system. The soils at vacant Lots 2 and 3 are addressed herein with regard to soil investigations as it applies to proposed residential structures and septic system suitability. The water supply for lots 2 and 3 will be from individual wells, and wastewater will be treated by individual non-evaporative septic systems.

Please review LDC Sec. 8.4.8(C) and (E)(2)(d) and ensure that this report meets the requirements. Two sites appropriate for OWTS are required to be shown for ALL lots, including developed lot. You can show the existing, but you will also need to show an alternate location on the developed lot.

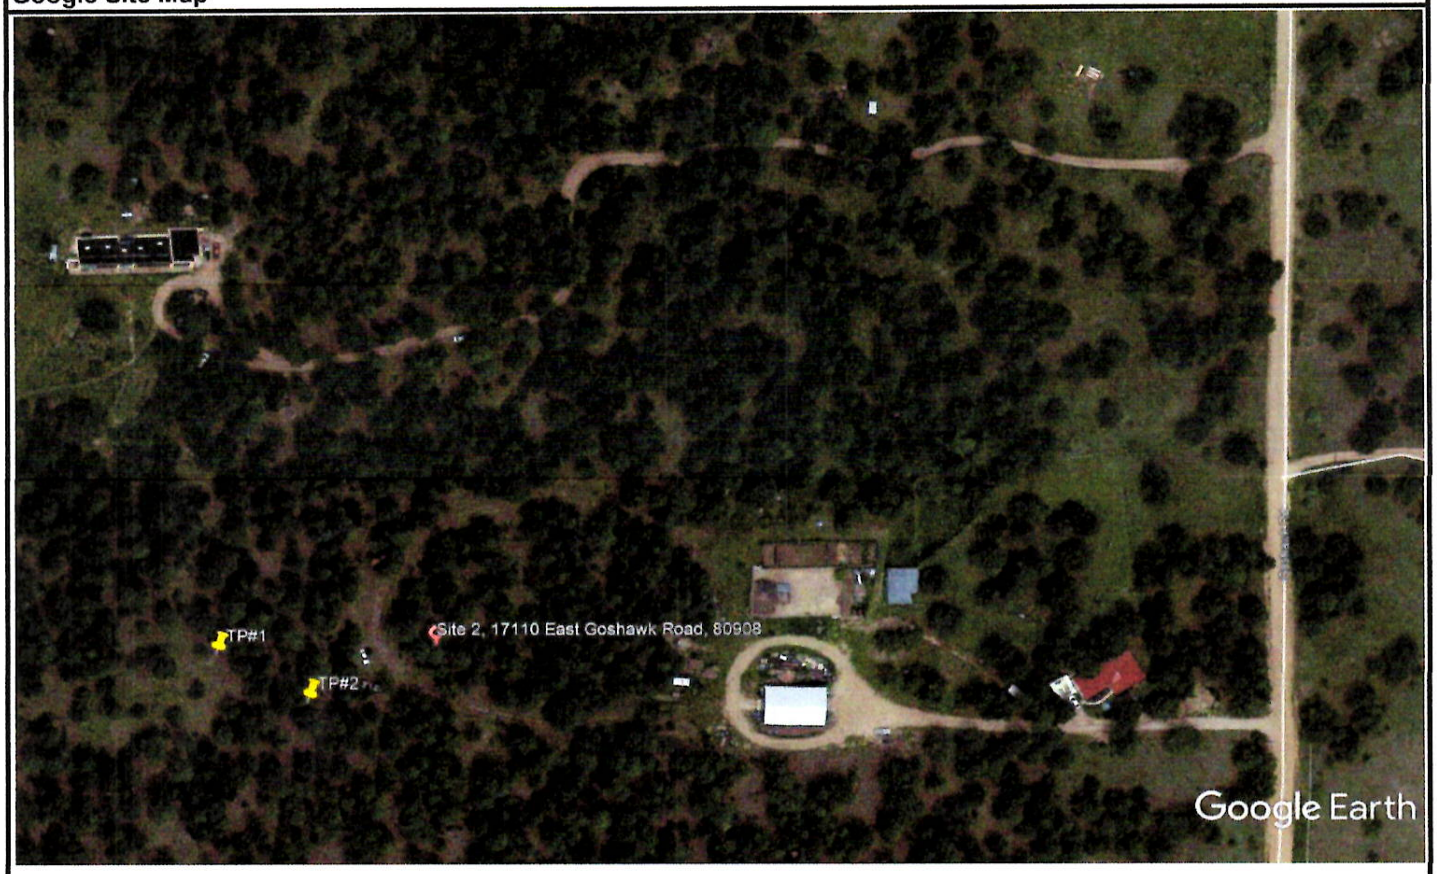
Google Site Map

Recommendations: **(1) An Engineered On-Site Wastewater Treatment system (OWTS) is required for this location due to: (a) Soil Type 4A identified in the treatment zone of Profile Pit #1 & Profile Pit #2.**
