Final Drainage Report

For:
Didleau Subdivision Filing 1

Project No. 2019.012

April 2020

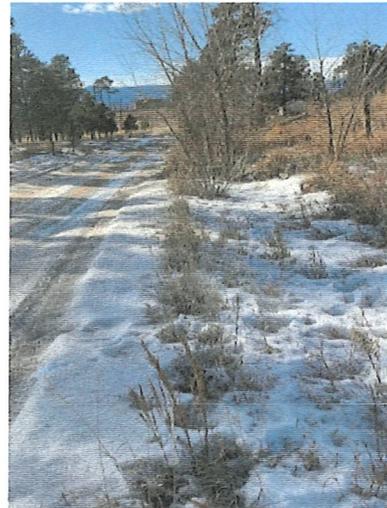
Figure 30: Facing NE along Swale 5

Runoff from Sub basin C (3.9 Acres) is collected via a natural undefined swale, Swale 5, at DP5 (photo 30). The water is directed to Culvert 3 at DP7 via the northerly borrow ditch (photo 33). A substantial number of trees occupy the borrow ditch and as a result have reduced its carrying capacity. There are only small pockets of wetlands located a significant distance upstream of where Swale 5 intersects the northerly borrow ditch along Forest Heights Circle. Accurate boundaries for the wetland areas are beyond the scope of this report

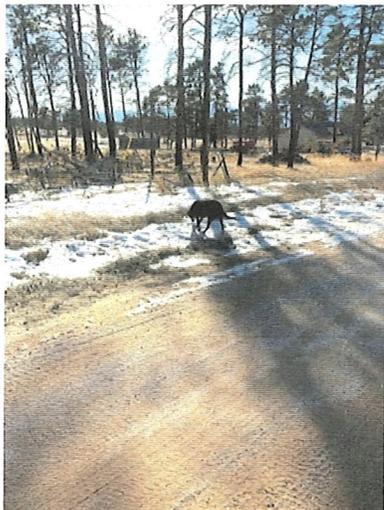
Figure 33: Facing west along north side

DP6 is located on the north side of Forest Heights Circle where the ridge that separates Sub basin C with Sub basin D is located. All of the runoff from Sub basin C enters the northerly borrow ditch along Forest Heights Circle and is directed to the west past DP 6 (photo 33). The runoff from the south side of Forest Heights Circle (photo 34) is also directed to the west along the southerly borrow ditch. This water is directed to Culvert 3. Once under the road the water enters Swale 8.

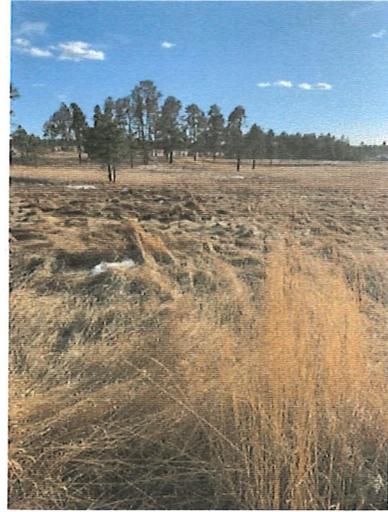
Figure 41: Upstream end Culvert 3

Runoff from Sub basin D (7.5 Acres) is collected by the borrow ditch along the north side of Forest Heights Circle, Swale 7. The water passes under Forest Heights Circle via an 18" corrugated metal culvert, Culvert 3 (photo 41,43). Sub basin D is developed as a single-family home site (photo 42). The majority of the lot is mowed. There is no evidence of wetlands along swale 6 with the exception of immediately upstream of the culvert at DP7. The culvert is almost silted full and passes only a minimal amount of water.

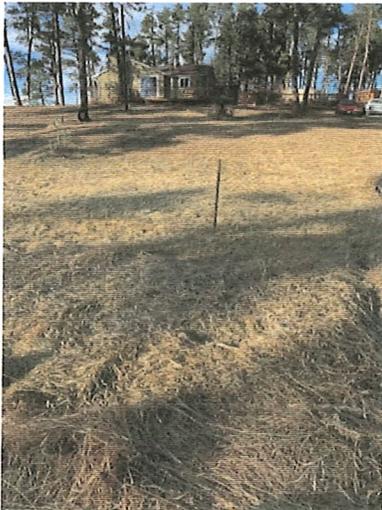
Figure 44: Facing downstream of Culvert 3

Swale 6 is very stable with a minimal amount of erosion. There is an area of wetlands located immediately upstream of the culvert. There are also wetlands southwest of Culvert 3 in Swale 8 (Photo 44). This area will be discussed in DP 10.

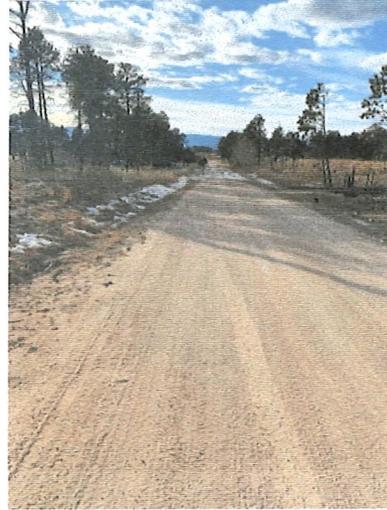
Figure 47: Facing south to culvert under Herring

Runoff from Sub basins B, C, D, E, and I is collected at DP10. Swale 7 combines with water in Swale 6 at DP7 and passes under Forest Heights Circle. The water in Swale 8 is then carried to the southwest (photo 47). There are wetland areas with approximate boundaries indicated on the Drainage Plan included in the back of this report. Accurate identification and boundaries for the wetland areas are beyond the scope of this report.

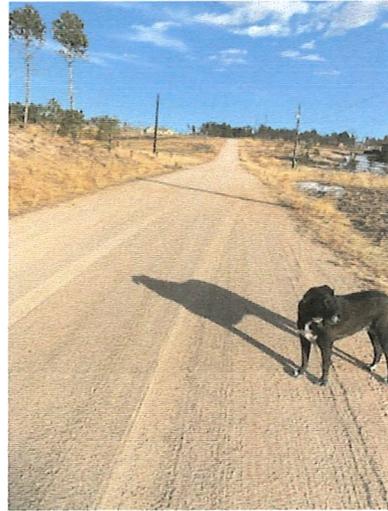
Figure 48: 18" CMP under Drive

Swale 4 is heavily vegetated with areas of wetlands. There is only a negligible amount of erosion. Water in Swale 4 combines with water in Swale 8 at DP11. The water then passes under an existing driveway via an 18" CMP culvert (photo 48). The culvert is clean with very little sediment as a result of the invert being slightly above the flowline of the upstream swale.

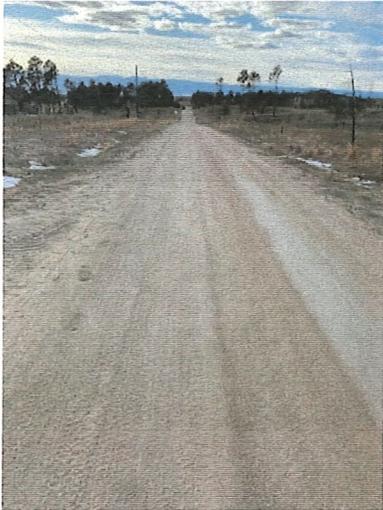
Figure 55: culvert under Herring

Runoff from Sub basins B and H and (44.1 acres) is collected via a natural swale, Swale 4, at DP11 where it combines with water in Swale 8. The water then exits the subdivision via an 18" CMP culvert under an existing concrete driveway (figure 48). The water is then directed in a southwesterly direction to DP11 where it passes under Herring Road via a 36" CMP culvert (photo 55, 56).

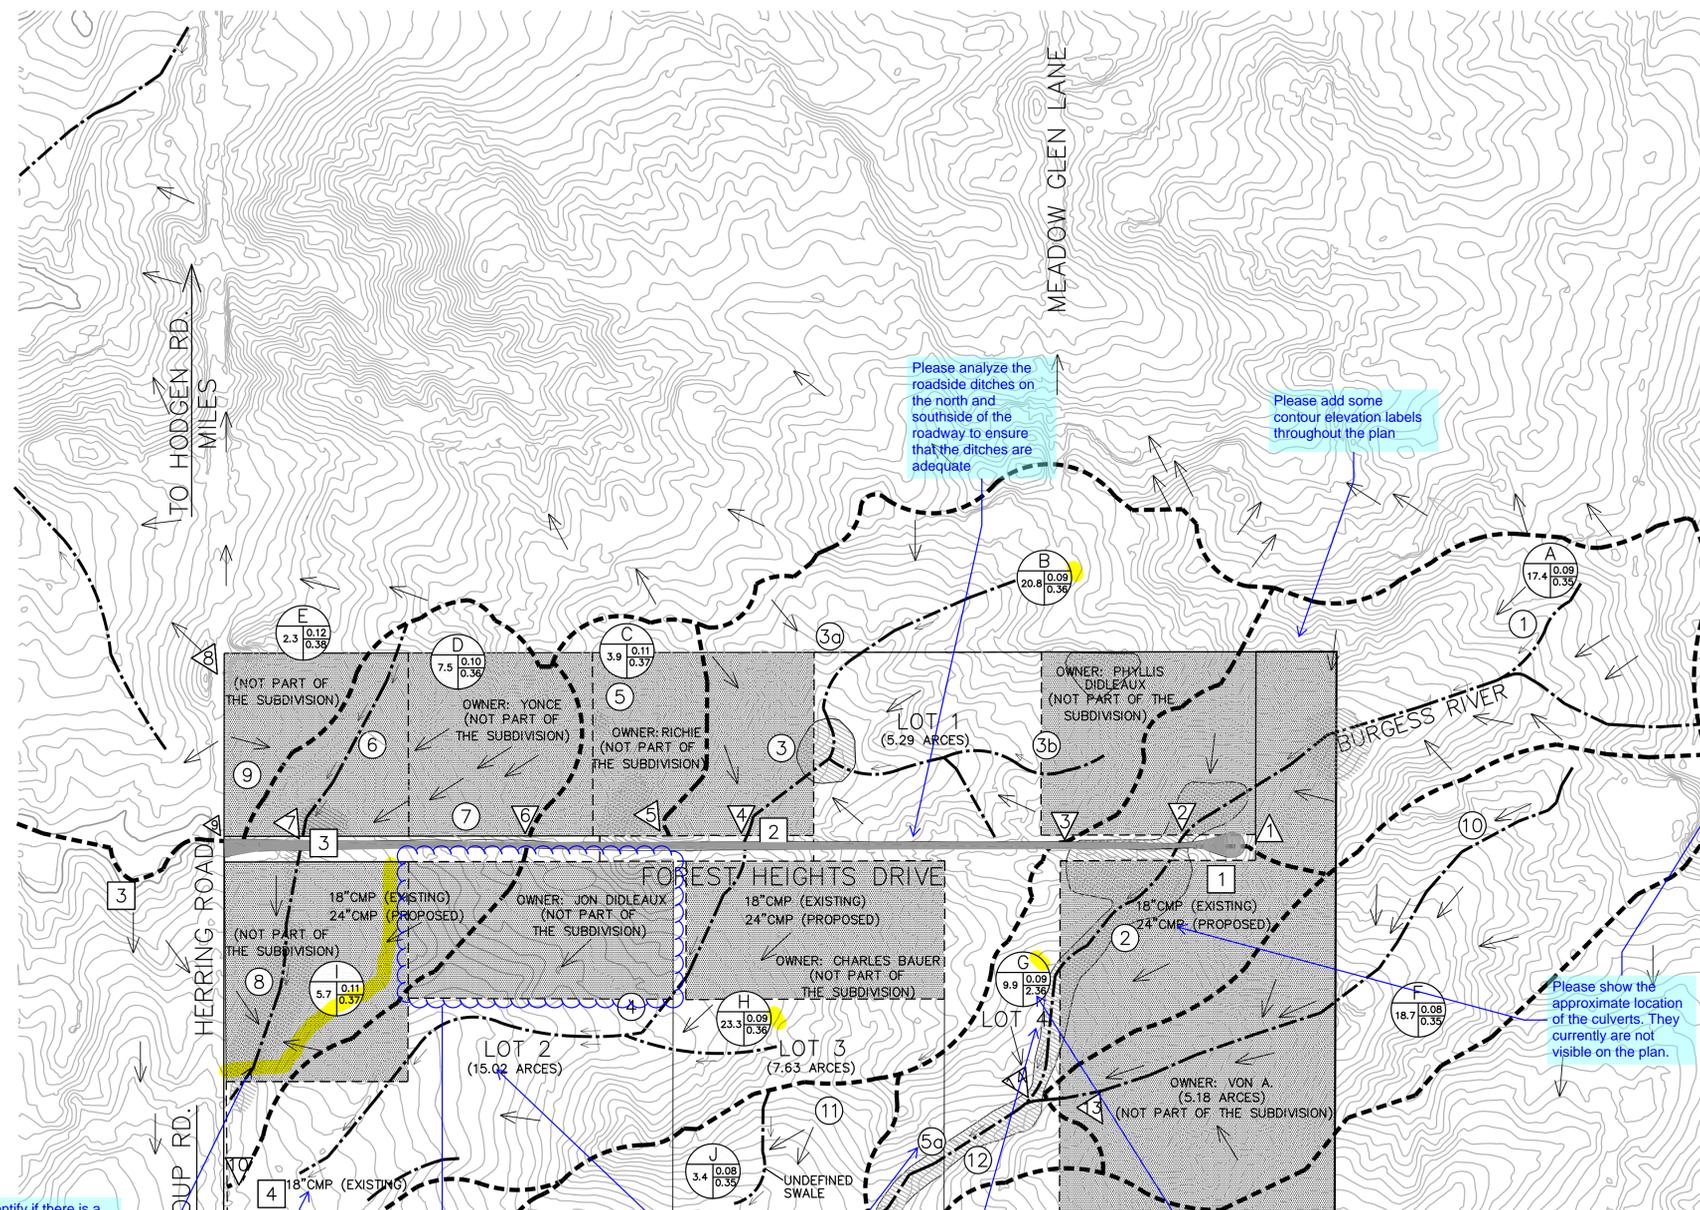
CULVERT #	SIZE	MATERIAL	5 YEAR		100 YEAR		CONDITION
			Q HEADWATER (cfs)	REQUIRED	Q HEADWATER (cfs)	REQUIRED	
1	18"	CMP	3.4	12"	24.6	> 7.5 FT	75% SILTED, ROADWAY OVERTOPPING WITH 100 YR
2	18"	CMP	4.4	14"	29.1	> 9 FT	75% SILTED, ROADWAY OVERTOPPING WITH 100 YR
3	18"	CMP	3.7	1.1 FT	22.2	> 7.5 FT	75% SILTED, ROADWAY OVERTOPPING WITH 100 YR
4	18"	CMP	16.8	4.8 FT	104.2	> 9 FT	CLEAN, ROADWAY OVERTOPPING WITH BOTH 5 YEAR AND 100 YEAR
