**SOIL, GEOLOGY, GEOLOGIC HAZARD,  
AND WASTEWATER STUDY,  
FLYING HORSE NORTH  
PUD SUBMITTAL  
EL PASO COUNTY, COLORADO**

February 22, 2016

Entech Job No. 160118  
AAprojects/2016/160118 county soil geo ww

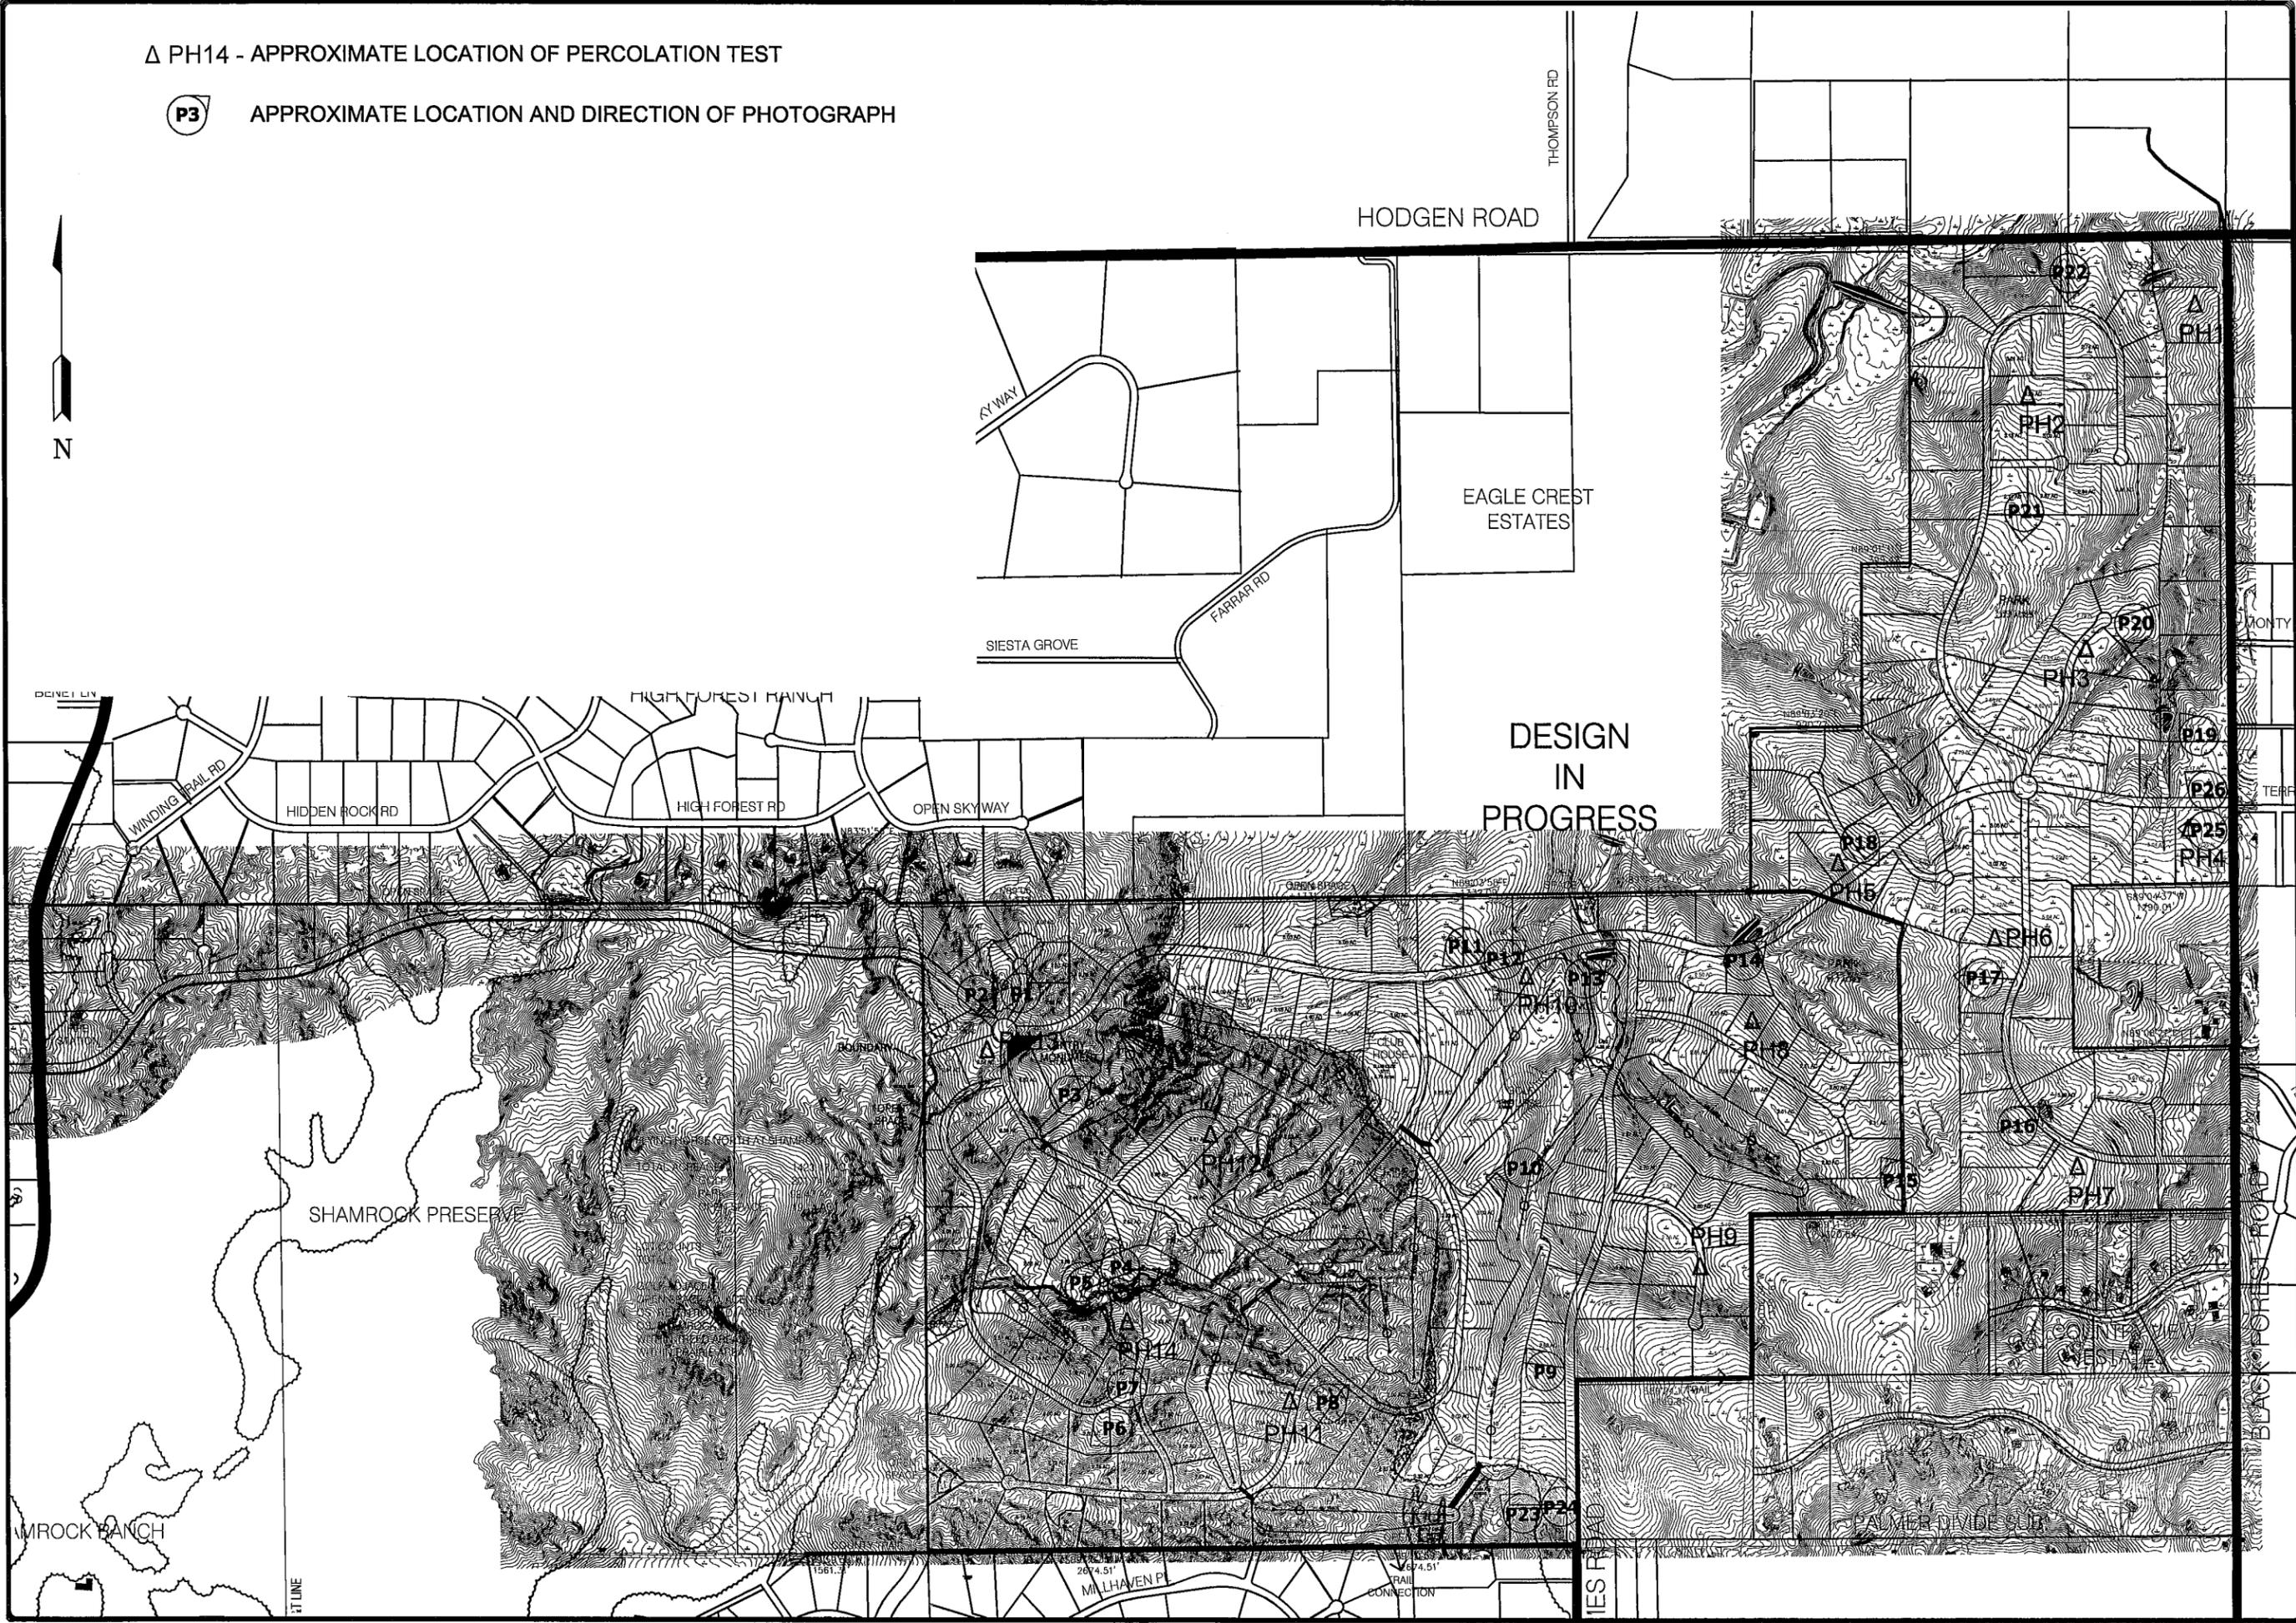
DRAWN	KAH
CHECKED	
DATE	02/12/16
SCALE	AS SHOWN
JOB NO.	160118
FIGURE No.	3

Fourteen (14) percolation tests were performed on the site to determine general suitability of the site for the use of on-site wastewater treatment systems. The locations of the percolation tests are indicated on the Percolation Test Location Map, Figure 3. The Test Boring Logs from the Profile Holes are presented in Appendix B. Results of this testing will be discussed later in this report.

The site was evaluated for individual on-site wastewater treatment systems in accordance with El Paso Land Development Code. Fourteen (14) percolation tests were performed on the property. Percolation tests may not be located in the exact areas of proposed systems. The approximate locations of the percolation tests are indicated on Figure 3 and on the Geology Map, Figure 6 and the Septic Suitability Map Figure 10. A table showing the results of the percolation tests is presented in Table 2. The specific test results are presented in Appendix E of this report.

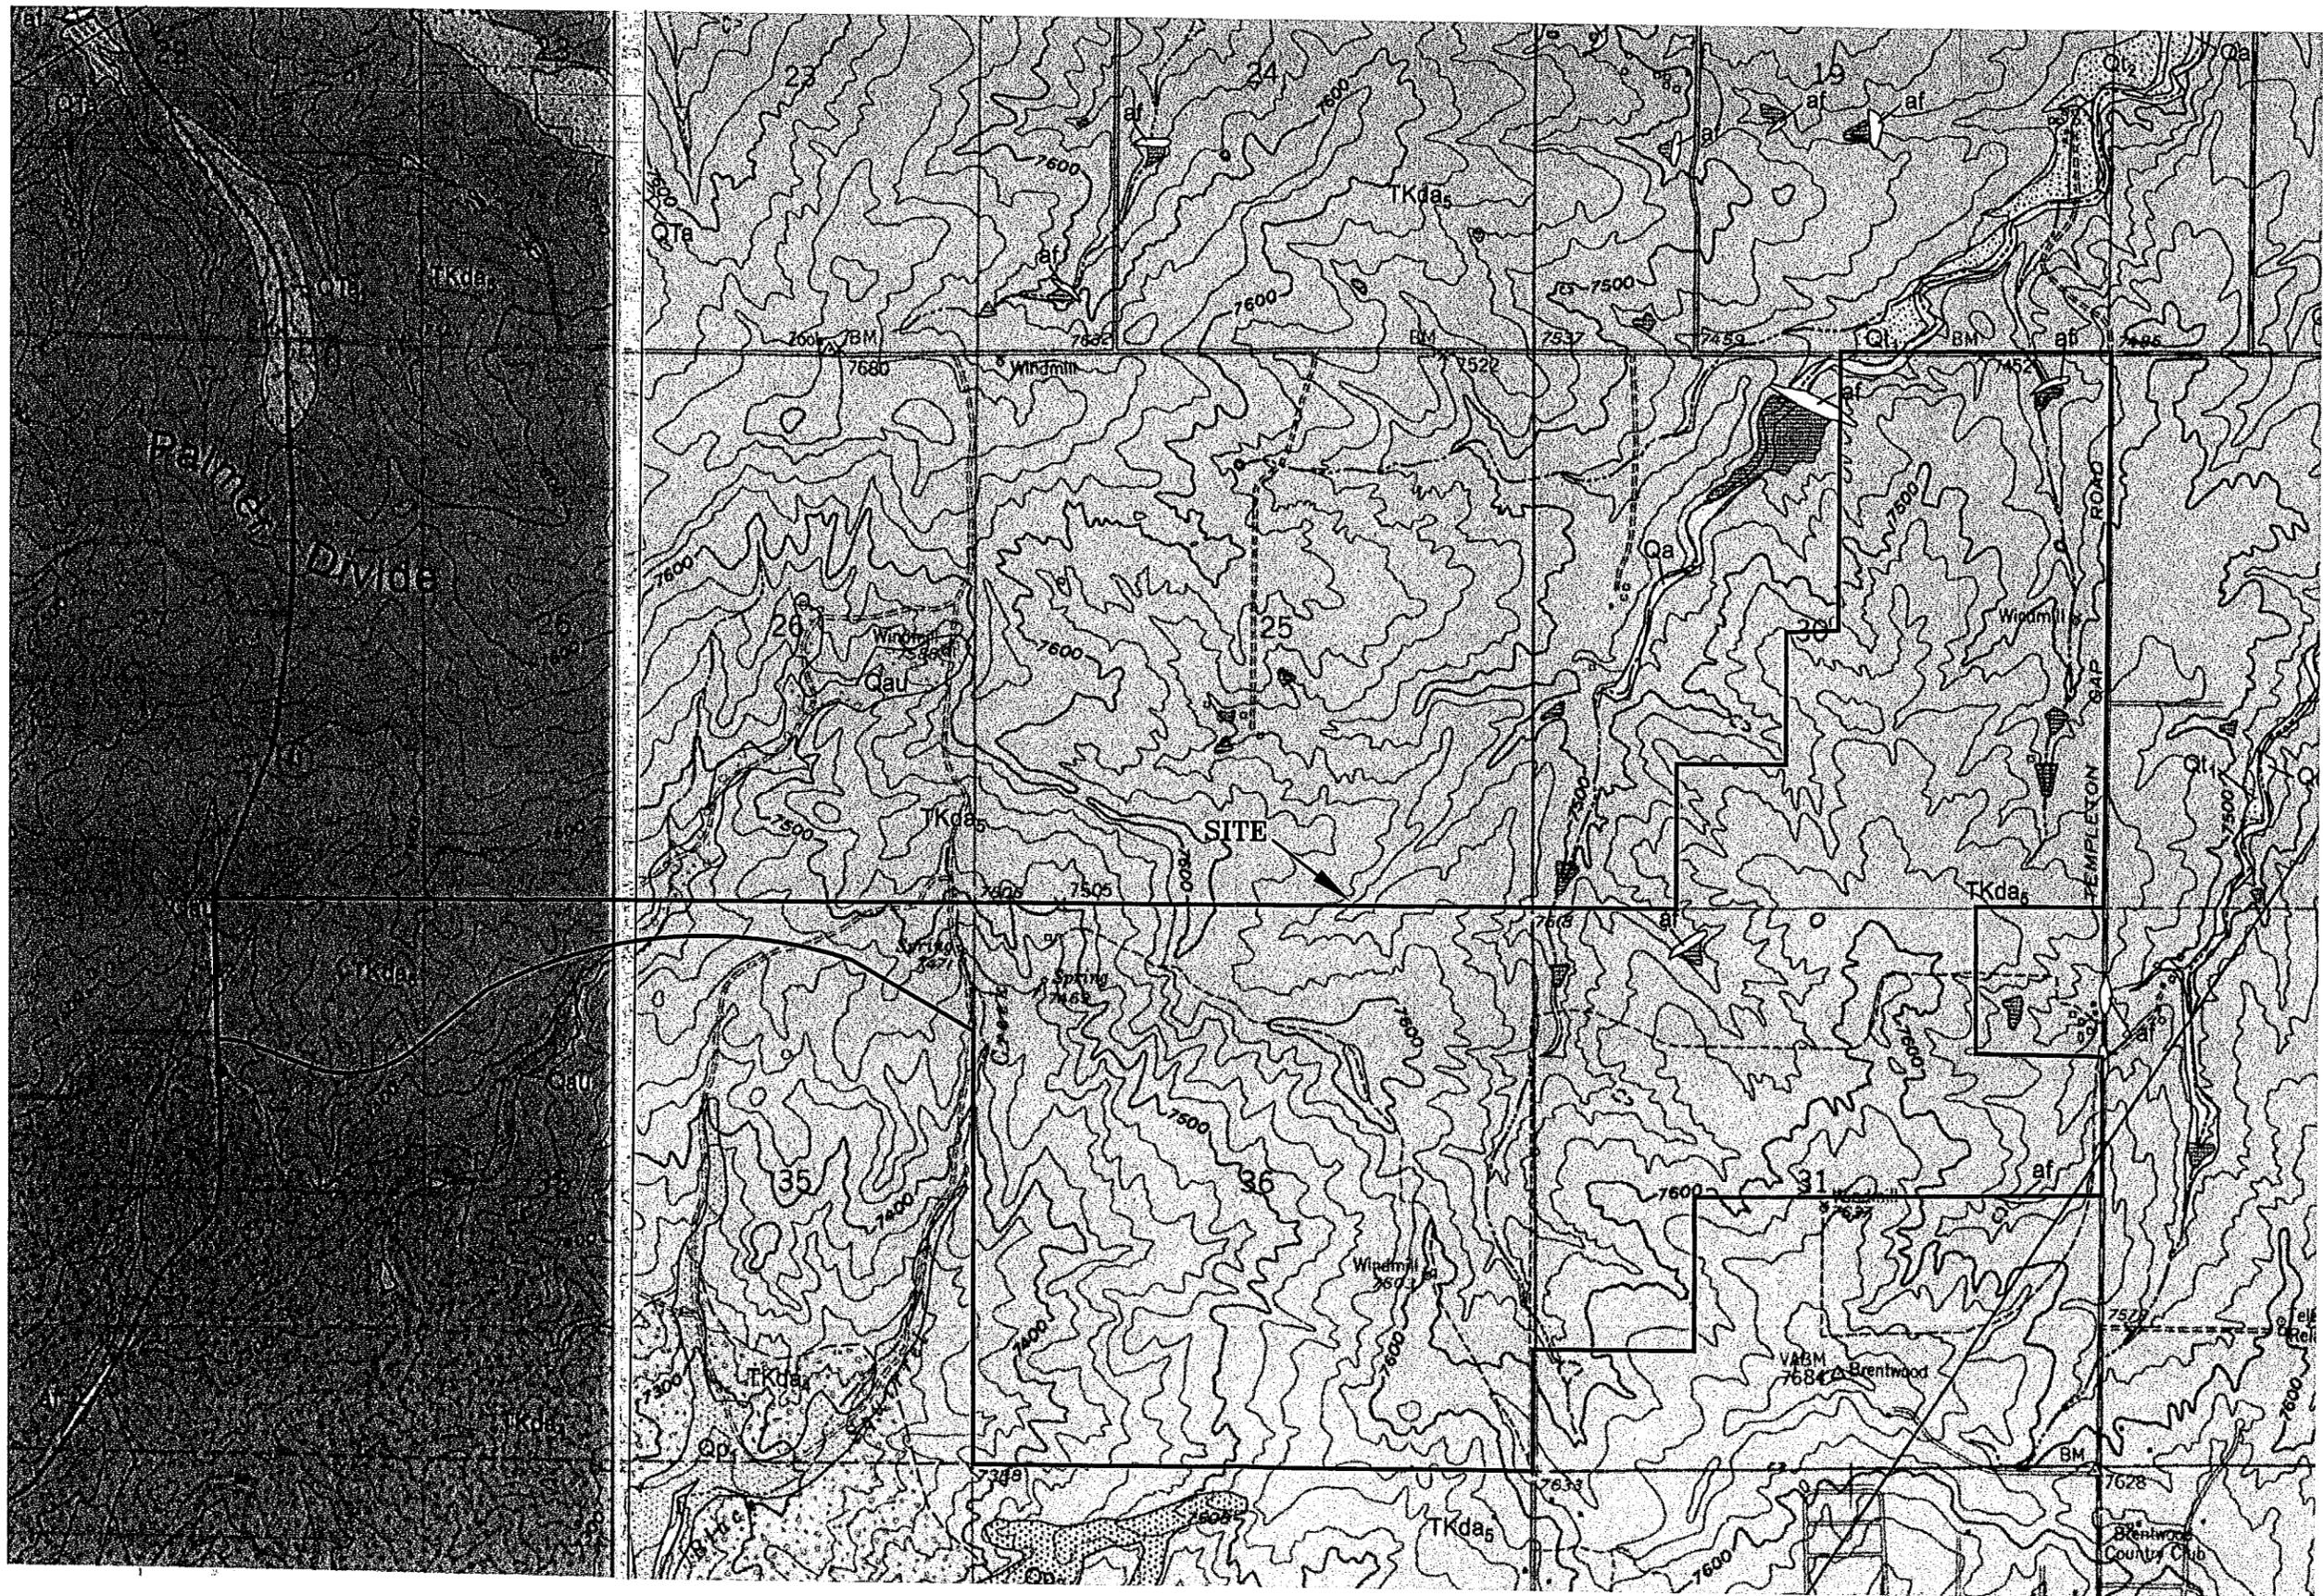
DRAWN	KAH
CHECKED	
DATE	02/22/16
SCALE	AS SHOWN
JOB NO.	160118
FIGURE No.	6

As mentioned previously, detailed mapping has been performed on this site to produce an Engineering Geology Map (Figure 6). This map shows the location of various geologic conditions of which the developers should be cognizant during the planning, design and construction stages of the project. These hazards and the recommended mitigation techniques are as follows:

Areas of seasonal and potentially seasonal high groundwater areas and ponded water were encountered on site. Due to the size of the lots and the proposed development, these areas can be avoided by construction. Septic systems are not recommended in these areas. Structures should not block drainages. Drains may be necessary for structures adjacent to these areas to help prevent the intrusion of water into areas below grade. Typical drain details are presented in Figure 8. The majority of the site does not lie within any floodplain zones according to the FEMA Map Nos. 08041CO295F, 08041CO315F and 08041CO325F, dated March 17, 1997 (Figure 8, Reference 10). A floodplain is mapped in the extreme northern portion of the site. This area is designated as open space and will be avoided by development. Exact locations of floodplain and specific drainage studies are beyond the scope of this report.

Mitigation: Foundations must have a minimum 30-inch depth for frost protection. In areas where high subsurface moisture conditions are anticipated periodically, subsurface perimeter drains are recommended to help prevent the intrusion of water into areas below grade. Typical drain details are presented in Figure 7. Any grading in these areas should be done to direct surface flow around construction to avoid areas of ponded water. Structures should not block drainages. All organic material should be completely removed prior to any fill placement. Septic fields should not be located in areas where there is the potential for shallow groundwater. The majority of the site does not lie within any floodplain zones according to the FEMA Map Nos. 08041CO295F, 08041CO315F, and 08041CO325F dated March 17, 1997 (Figure 8, Reference 10). A minor area in the extreme northern portion of the site is mapped on a floodplain. This area is designated as open space and will be avoided by development. Exact locations of floodplain and specific drainage studies are beyond the scope of this report. Finished floor levels must be located a minimum of one foot above floodplain levels.
