## SOIL AND GEOLOGY STUDY

**Esteban Subdivision  
3 parcels totaling 496.25 acres  
EL Paso County, Colorado**

**JOB NO. 190388**

**April 27, 2023**

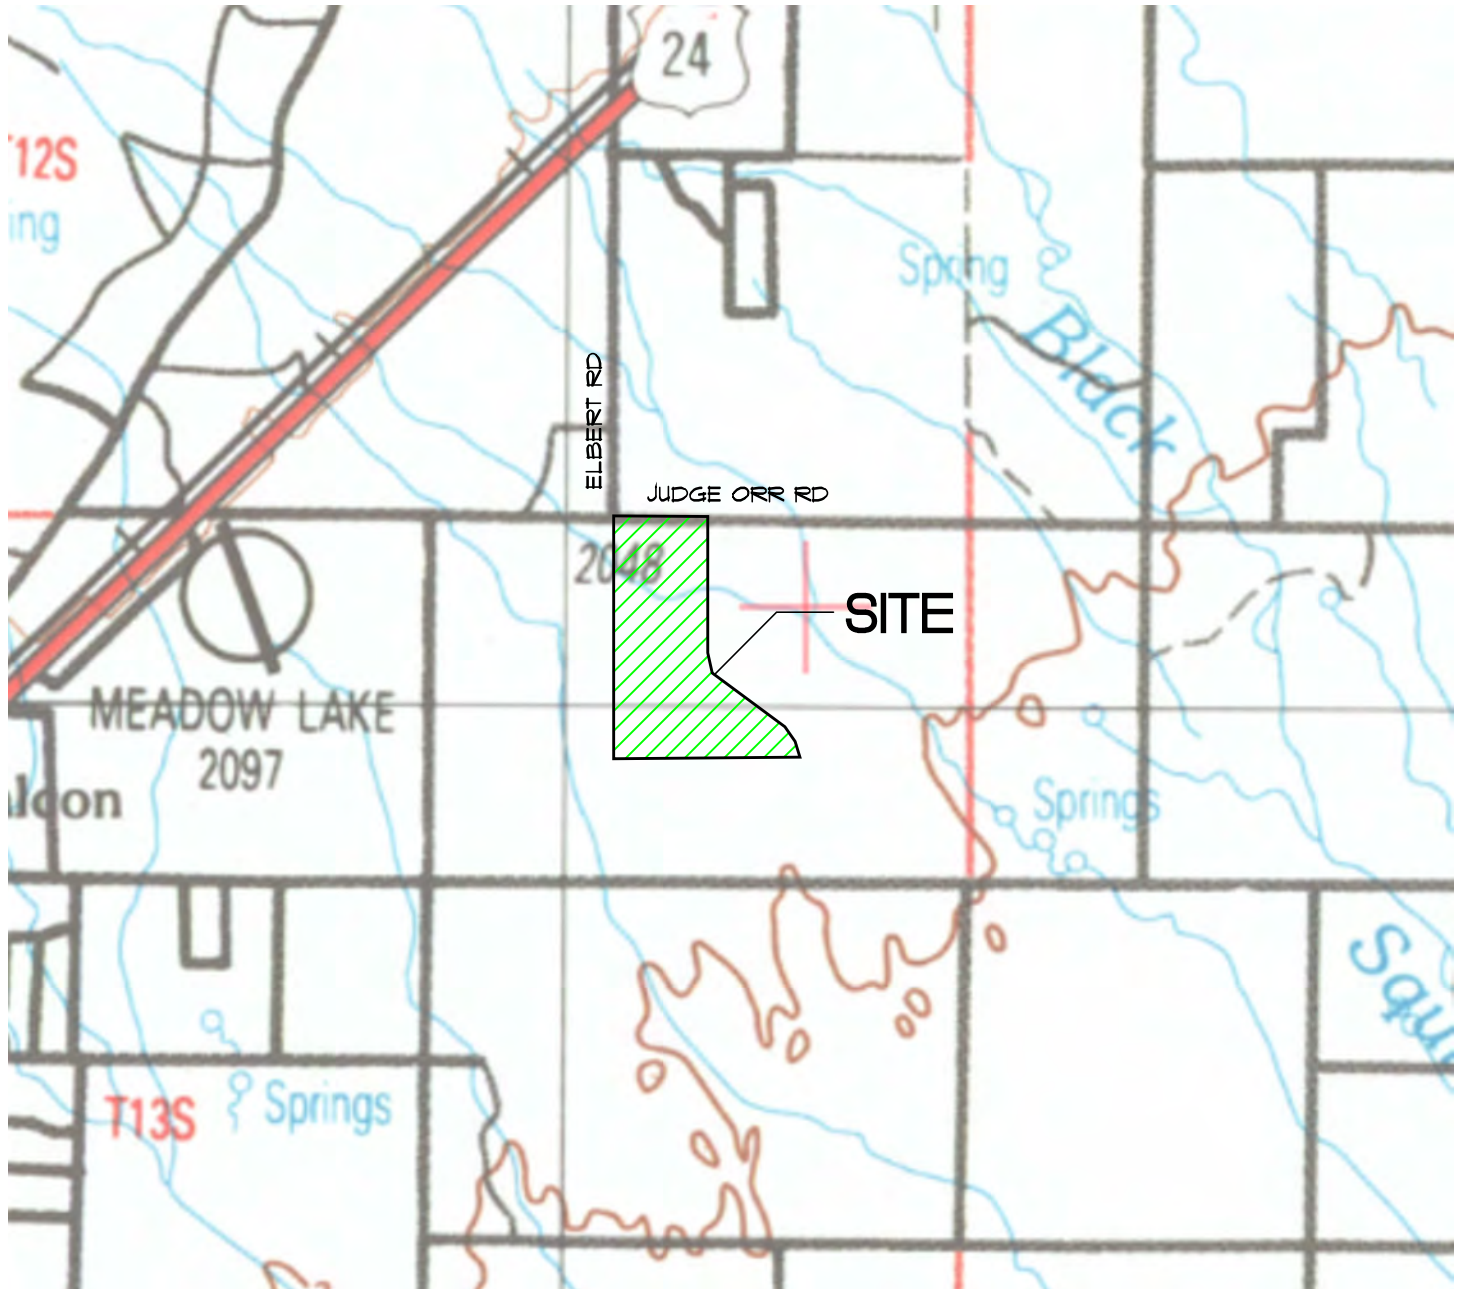
FIG No. 29

A natural drainageway exists near the northern portion of the site running from west to east. The drainageway was dry at the time of the site reconnaissance visits performed by RMG. The USGS Topo Map is presented in Figure 29.

Ponding surface water is likely to be encountered in the low lying drainageway that traverses the northern portion of the site. These areas are denoted as *psw* – *potential seasonally wet* on the Engineering and Geology Map, Figure 29.

- Each lot shall be designed to insure that a minimum of 2 sites are appropriate for a OWTS and do not fall within the restricted areas, potentially seasonally wet and floodplain, as identified on the Engineering and Geology Map, Figure 29.

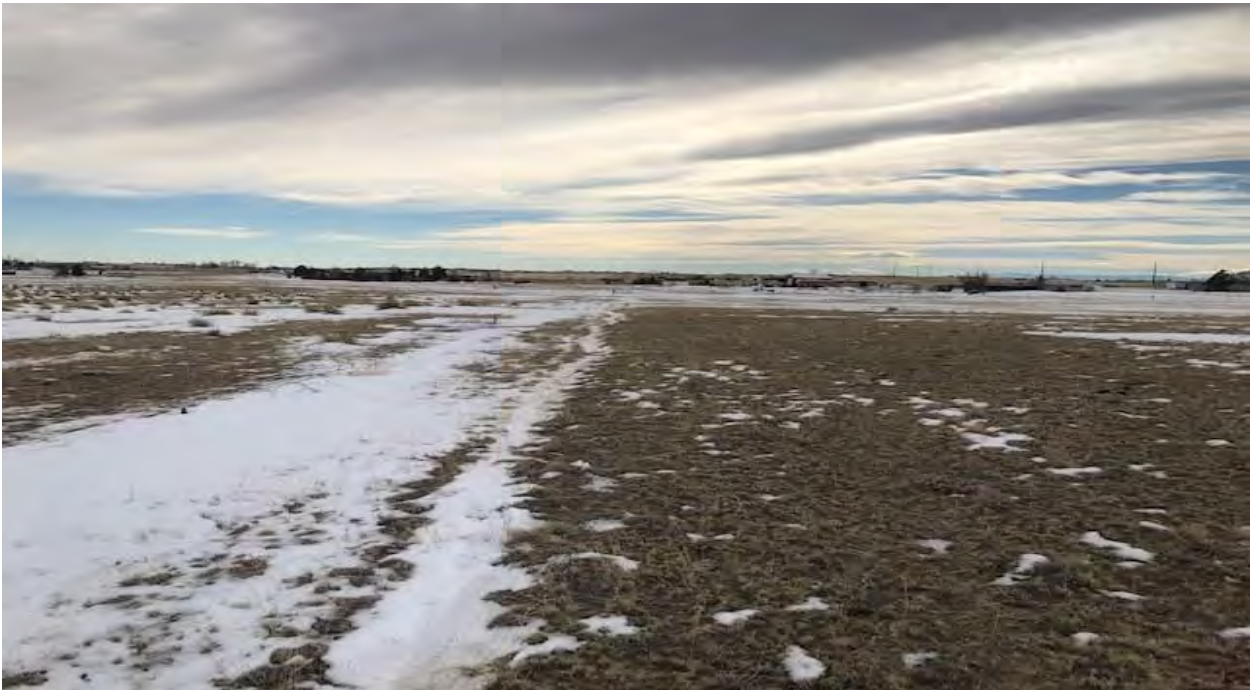
Northern portion of property, looking east

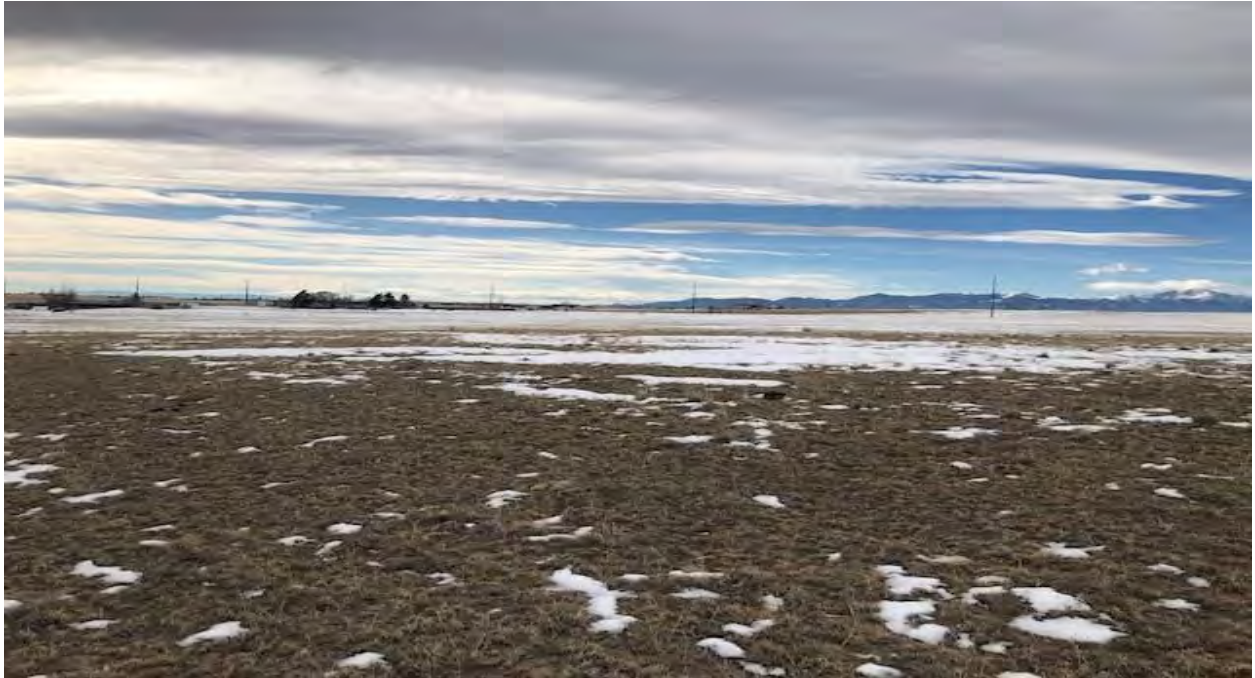
Northern portion of property, looking west
