**Subject: Drive Area Geotechnical Evaluation**  
Existing Commercial Property  
2675 Akers Drive  
Colorado Springs, Colorado  
Project No. 16-173339.2

## PAVEMENT EVALUATION REPORT

2675 AKERS DRIVE  
COLORADO SPRINGS, COLORADO

PROJECT NO: 0305-CS16

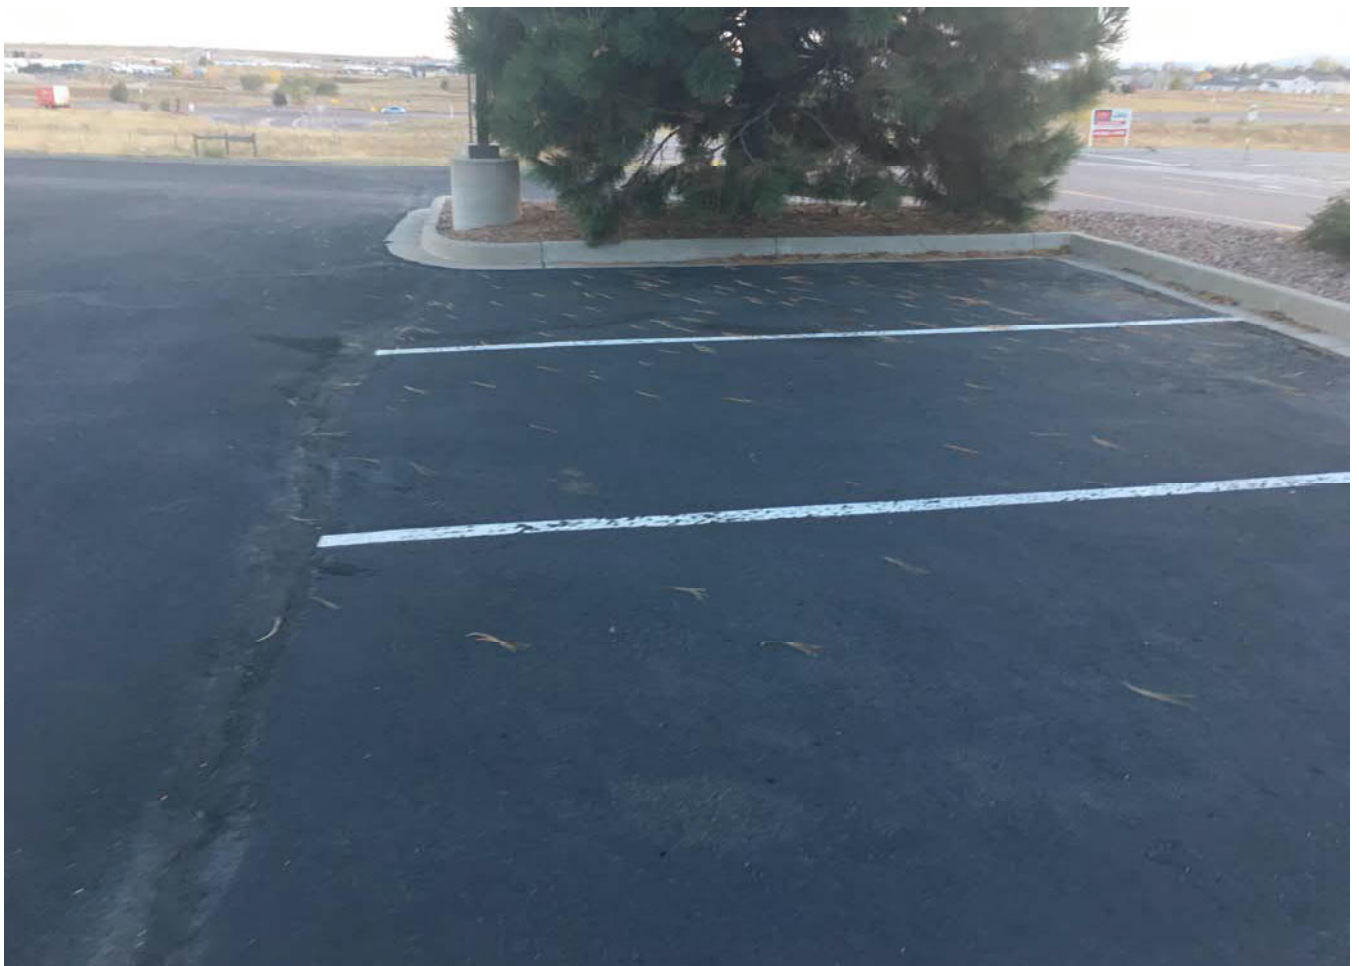
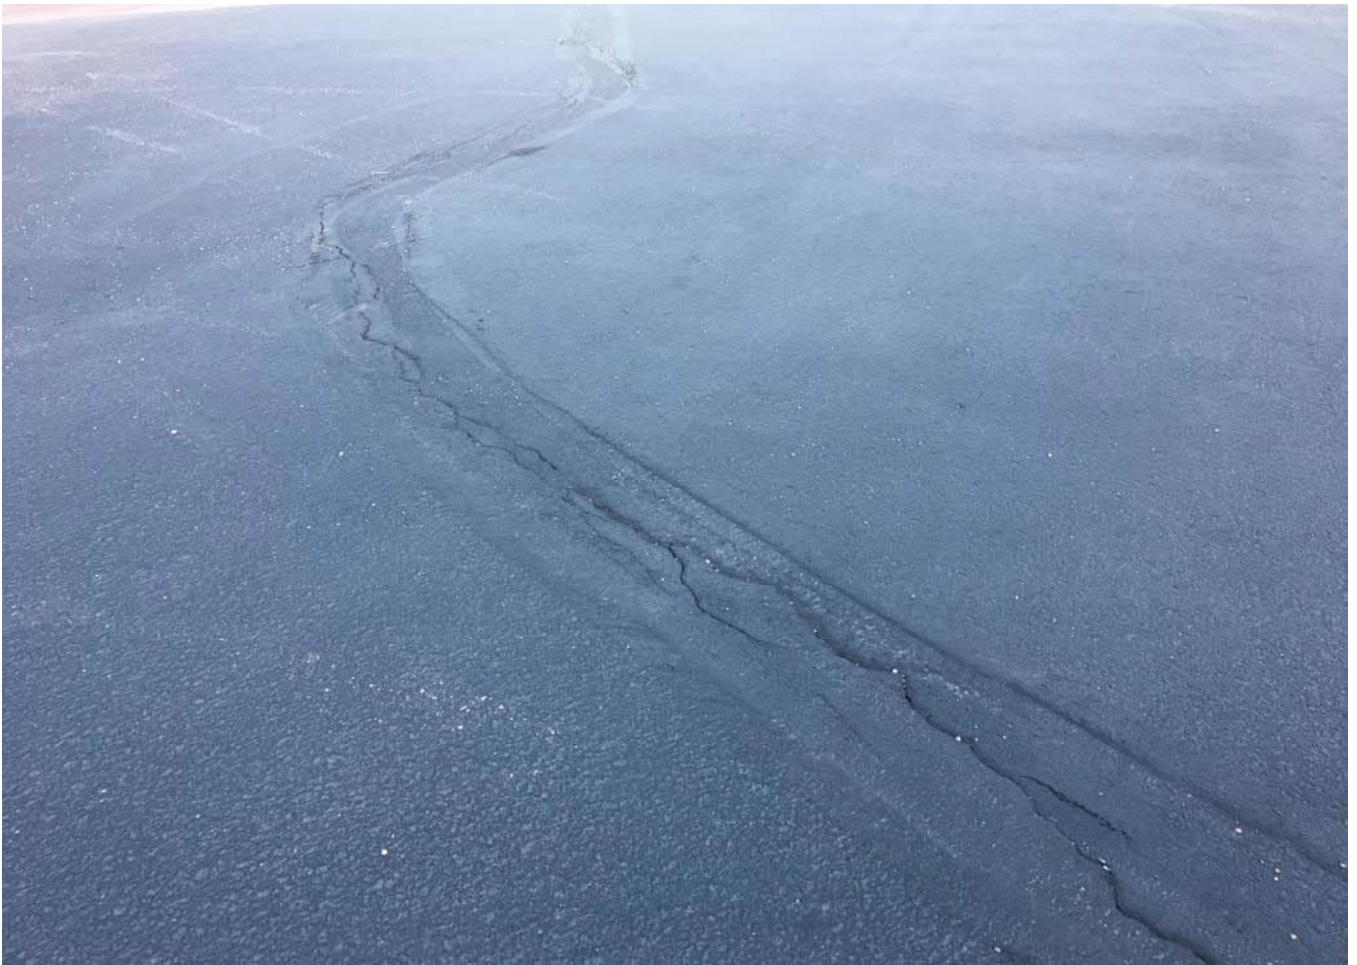
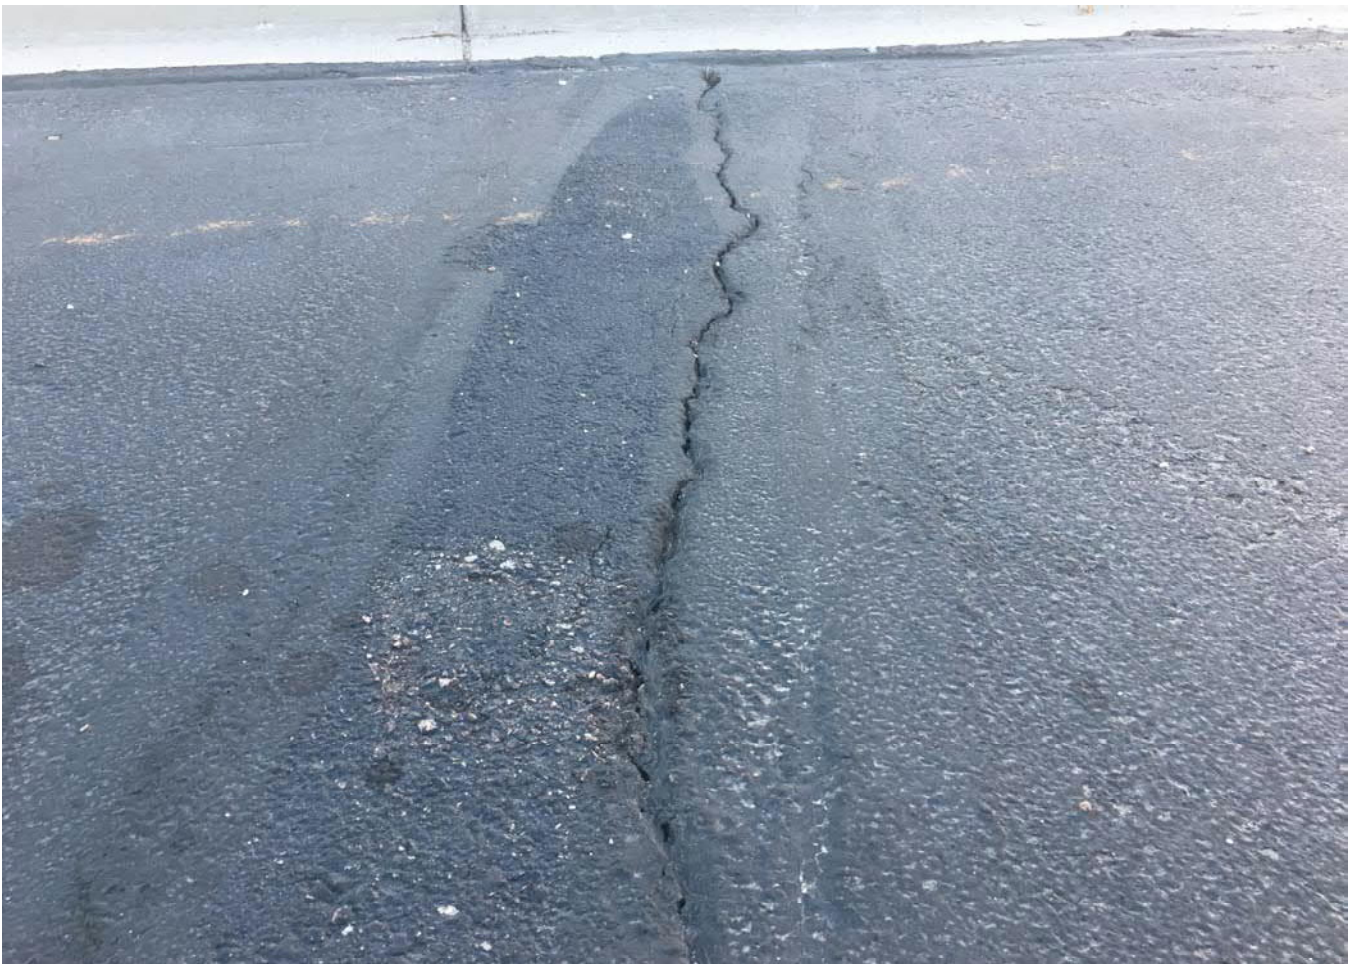
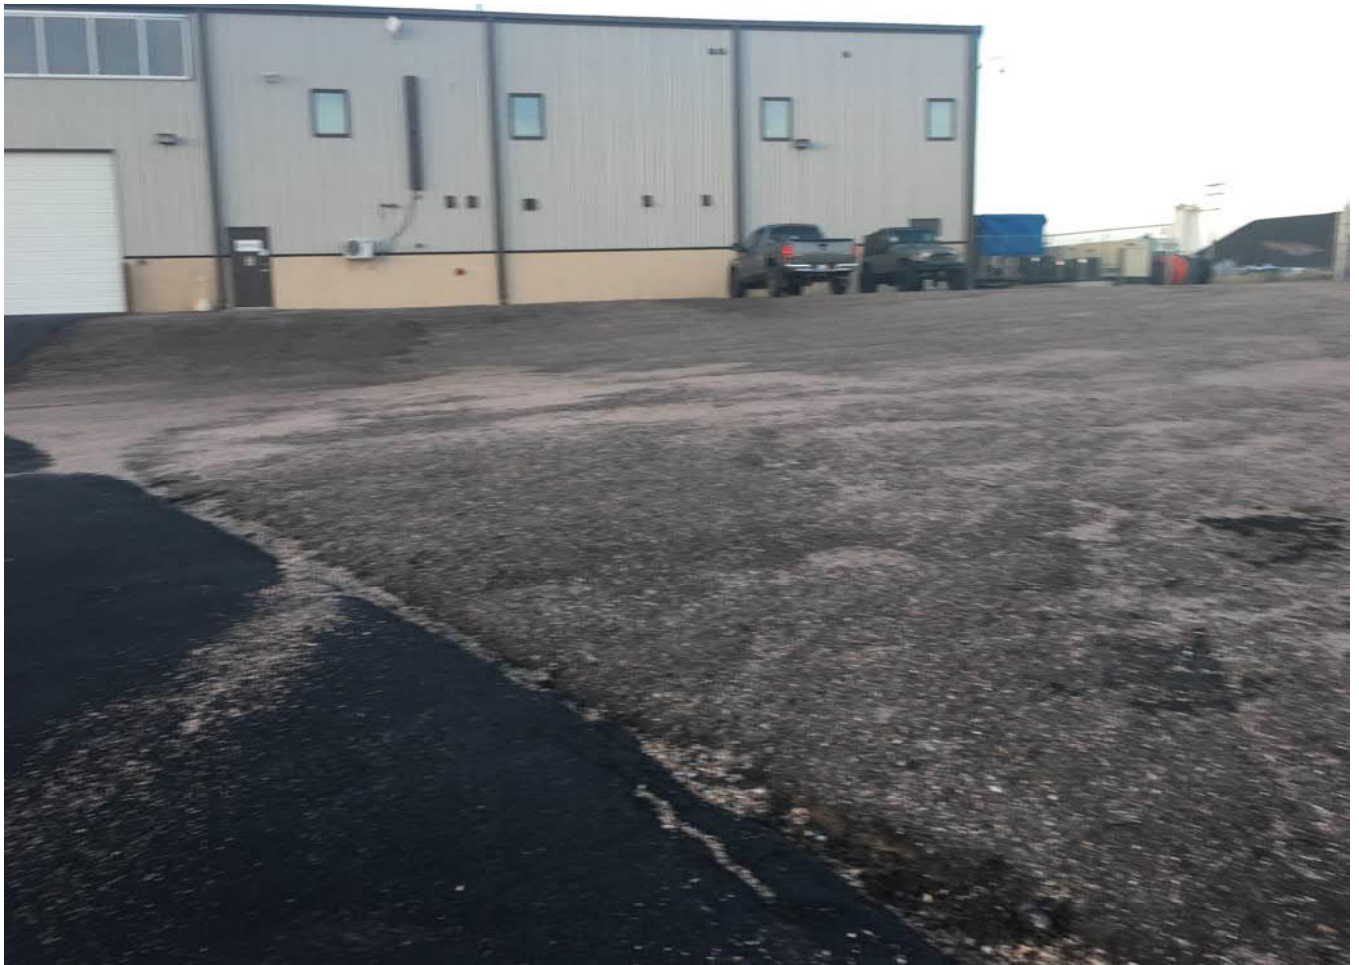
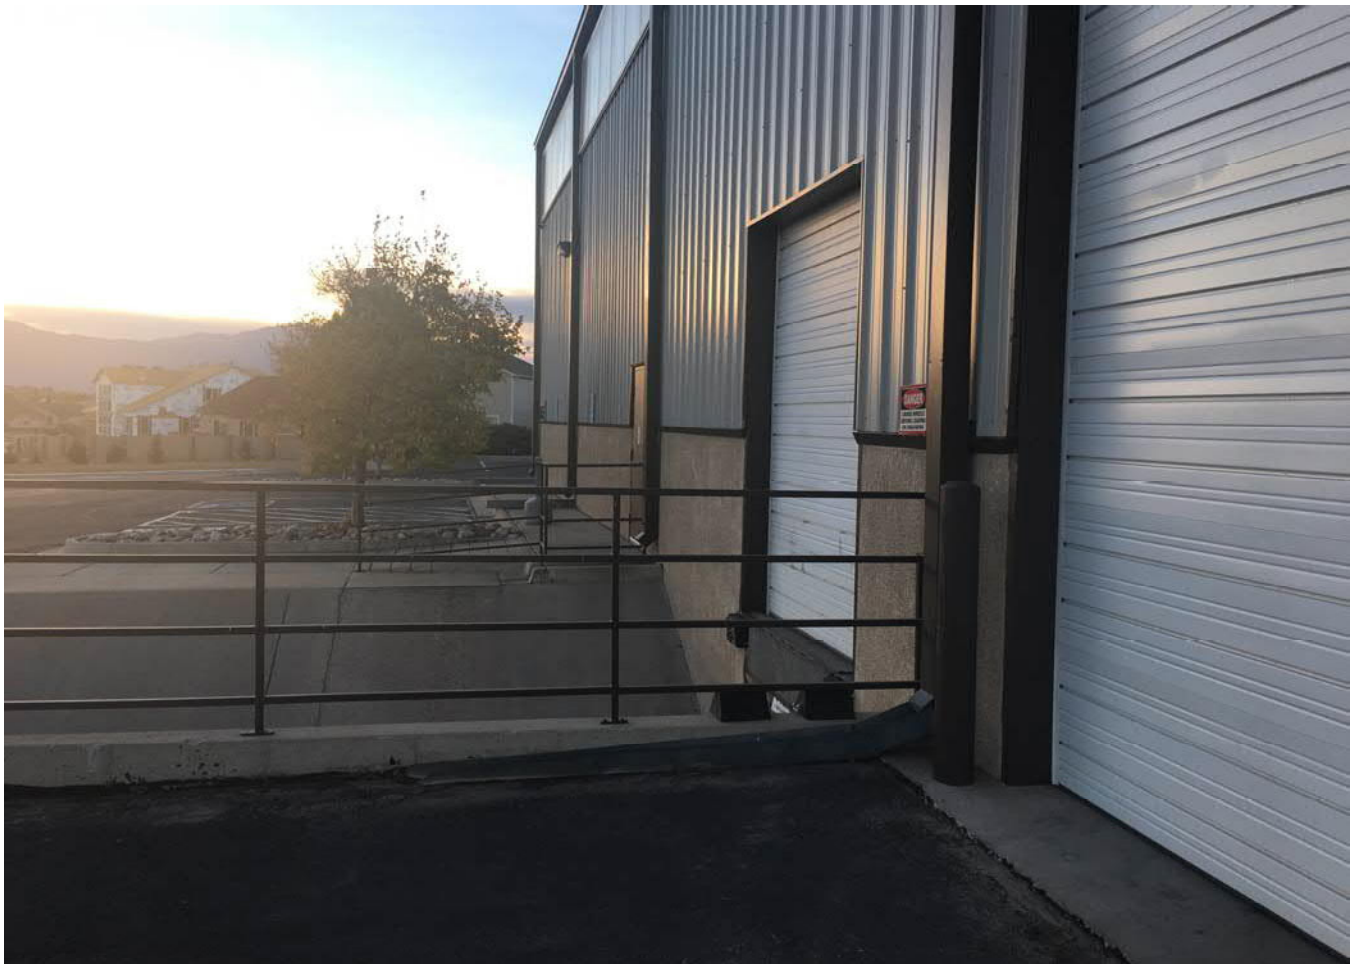
In October 2016, we visited the site (Figure 1 and Figure 2) and performed a visual reconnaissance of the pavement areas. We noted visual evidence of significant ponding and inadequate drainage related damage, and some pavement cracking. Photographic documentation of site conditions is included in Appendix A.

The site is currently developed and has existing utilities in place. The surface parking area is paved with asphaltic concrete and varied in thickness from 4-6 inches. The underlying base layer was averaging approximately 12 inches in thickness of processed aggregate material. Subgrade materials were identified as poorly graded sands and clayey sands, though non-expansive. The asphalt pavement appears to be in relatively good condition, however it did exhibit pavement cracking with widths on the order of ½ to 1 inch. These are indicative of the mature pavement age, and result from seasonal temperature fluctuations. In addition, there were some areas where ponding of surface water was observed. This results from a poor surface water drainage condition.
