**SOILS AND GEOLOGY STUDY
FLYING HORSE NORTH FILING NO. 3
EL PASO COUNTY, COLORADO**

August 23, 2023
Revised February 29, 2024

PCD No. SF2326

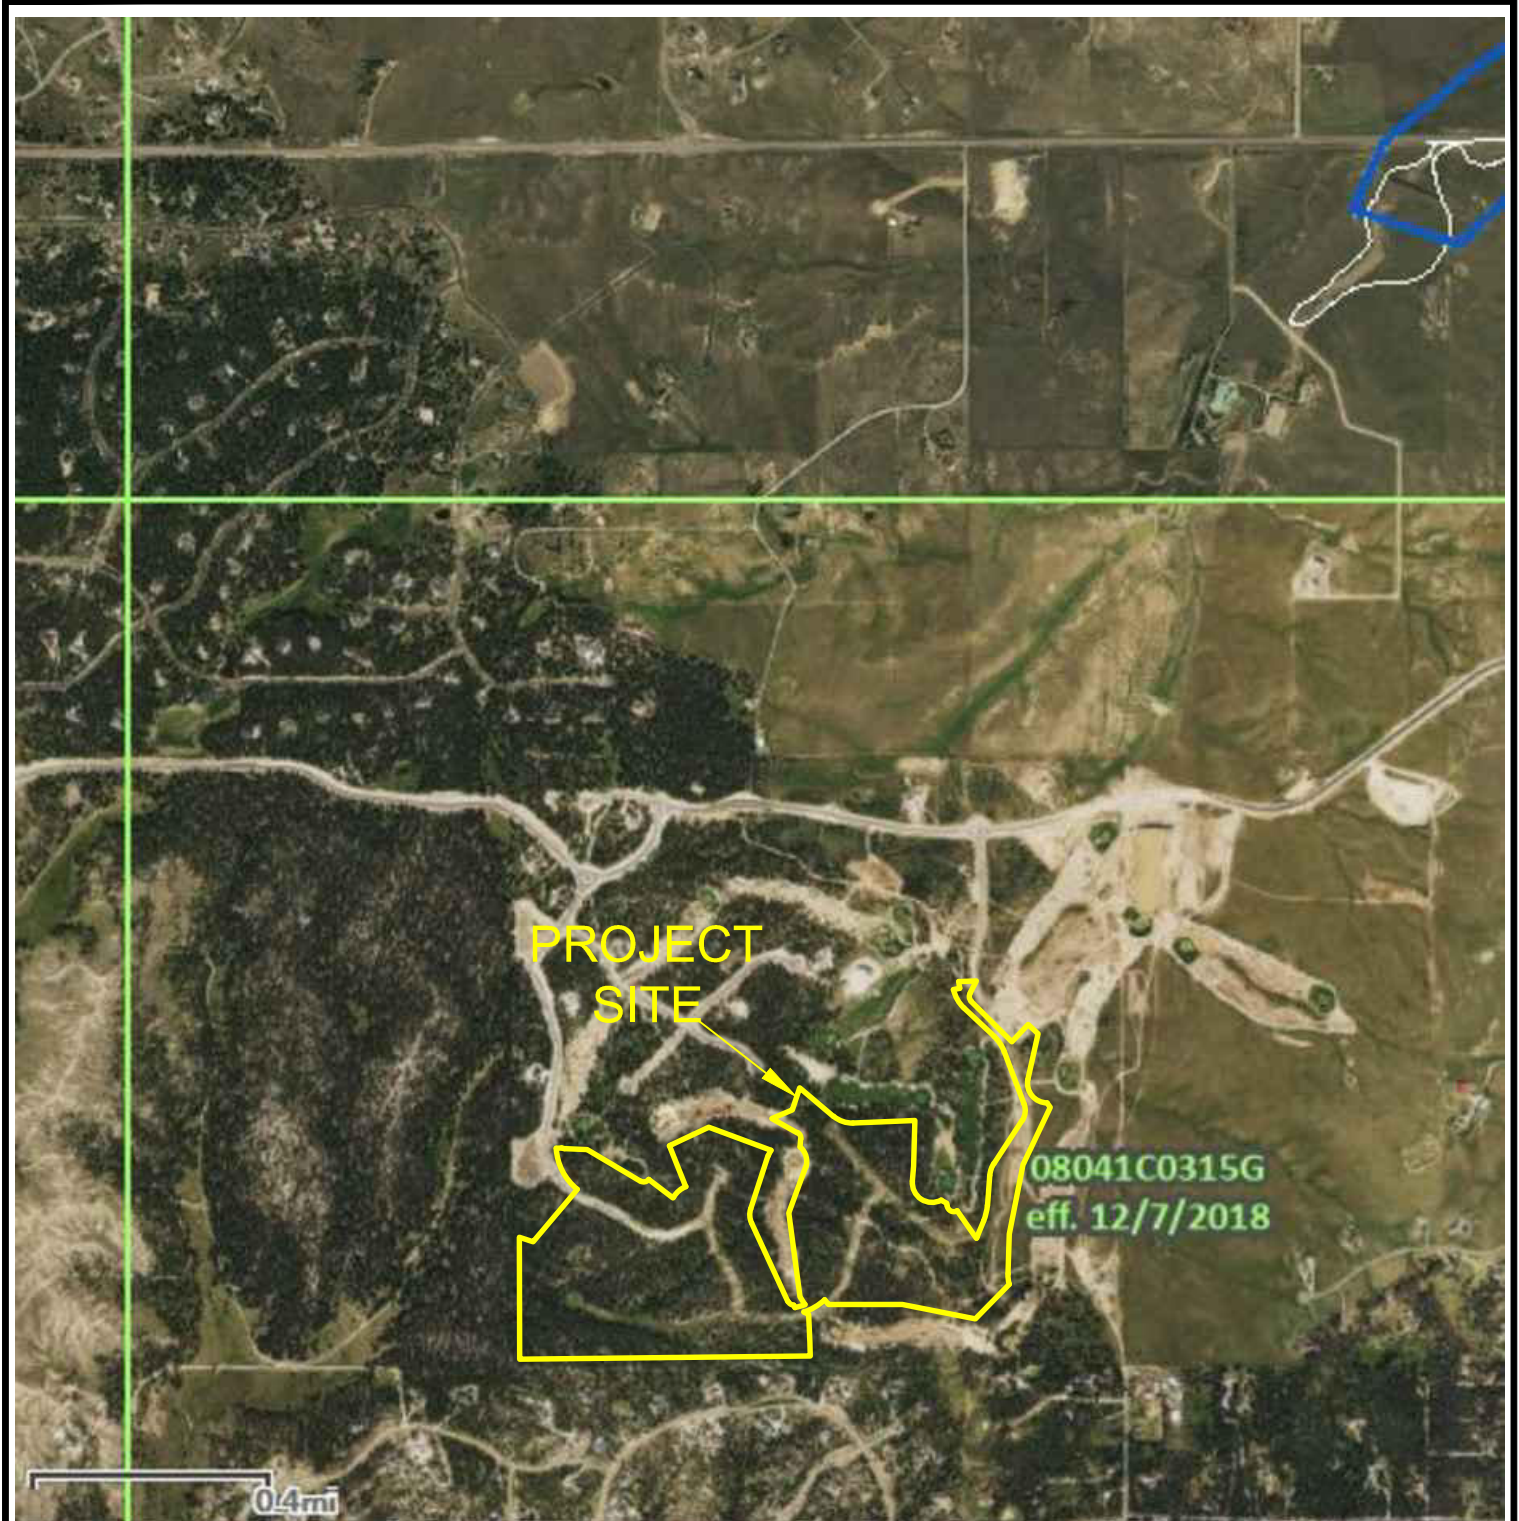
FIG. 7

Drainages are located in the northern and southern portions site, and several minor drainages are located across the site that generally flow in westerly directions. None of the drainages on the site have been mapped within floodplain zones according to the FEMA Map No. 08041CO315G, (Figure 7, Reference 11). Areas where potentially seasonal shallow, seasonal shallow, and ponded water have been indicated on the site geology/engineering geology map, Figure 6. Lots adjacent to the drainages may experience higher groundwater levels during peak flows. Subsurface perimeter drains are recommended for structures with useable below grade space, and additional drains may be required in building areas close drainages to help prevent the intrusion of water into areas below grade. Typical drain details are presented in Figures 8 – 10. Finished floor levels must be a minimum of one floor above the floodplain level. **Exact floodplain locations and drainage studies are beyond the scope of this report.**

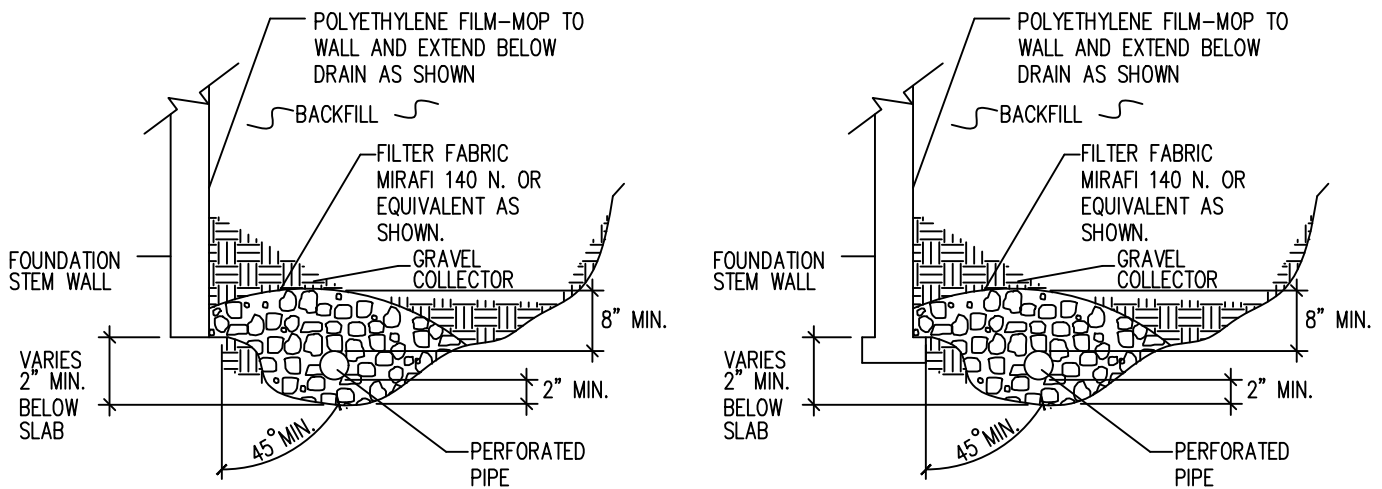
FIG. 8

Groundwater was not encountered in the test borings drilled within Filing No. 3. Areas of seasonally shallow and potential seasonally shallow groundwater, and ponded water were observed on the site and are further discussed below. Buildings should maintain a minimum separation of 3 feet between the lowest foundation grade and the maximum anticipated groundwater level. Shallow groundwater areas can be mitigated with the installation of drains. Typical drain options/details are presented in Figures 8 through 11. These areas are discussed as follows:

Mitigation: In these locations, foundations subject to severe frost heave potential should penetrate sufficient depth so as to discourage the formation of ice lenses beneath foundations. At this location and elevation, foundation depth for frost protection is 30 inches. In areas where high subsurface moisture conditions are anticipated periodically, a subsurface perimeter drain will be necessary to help prevent the intrusion of water into areas located below grade. Subsurface perimeter drains may be necessary to prevent the intrusion of water into areas below grade. Typical drain details are presented in Figure 8. Where shallow groundwater is encountered, underslab drains or interceptor drains may be necessary Figures 9 and 10. Specific recommendations should be made after additional investigation has been completed and building locations have been identified on a lot by lot basis. Swales should be created to intercept surface runoff and carry it safely around and away from structures.
