Subject: Geologic Hazards Evaluation and
Preliminary Geotechnical Investigation
Response to El Paso County Review Comments
Grandview Reserve, Phase 1, Filing 1
Eastonville Road and U.S. Highway 24
Falcon, Colorado
CTL|T Project No. CS19345-115

**GEOLOGIC HAZARD EVALUATION AND
PRELIMINARY GEOTECHNICAL INVESTIGATION
GRANDVIEW RESERVE, FILING 1
EASTONVILLE ROAD AND U.S. HIGHWAY 24
FALCON, COLORADO**

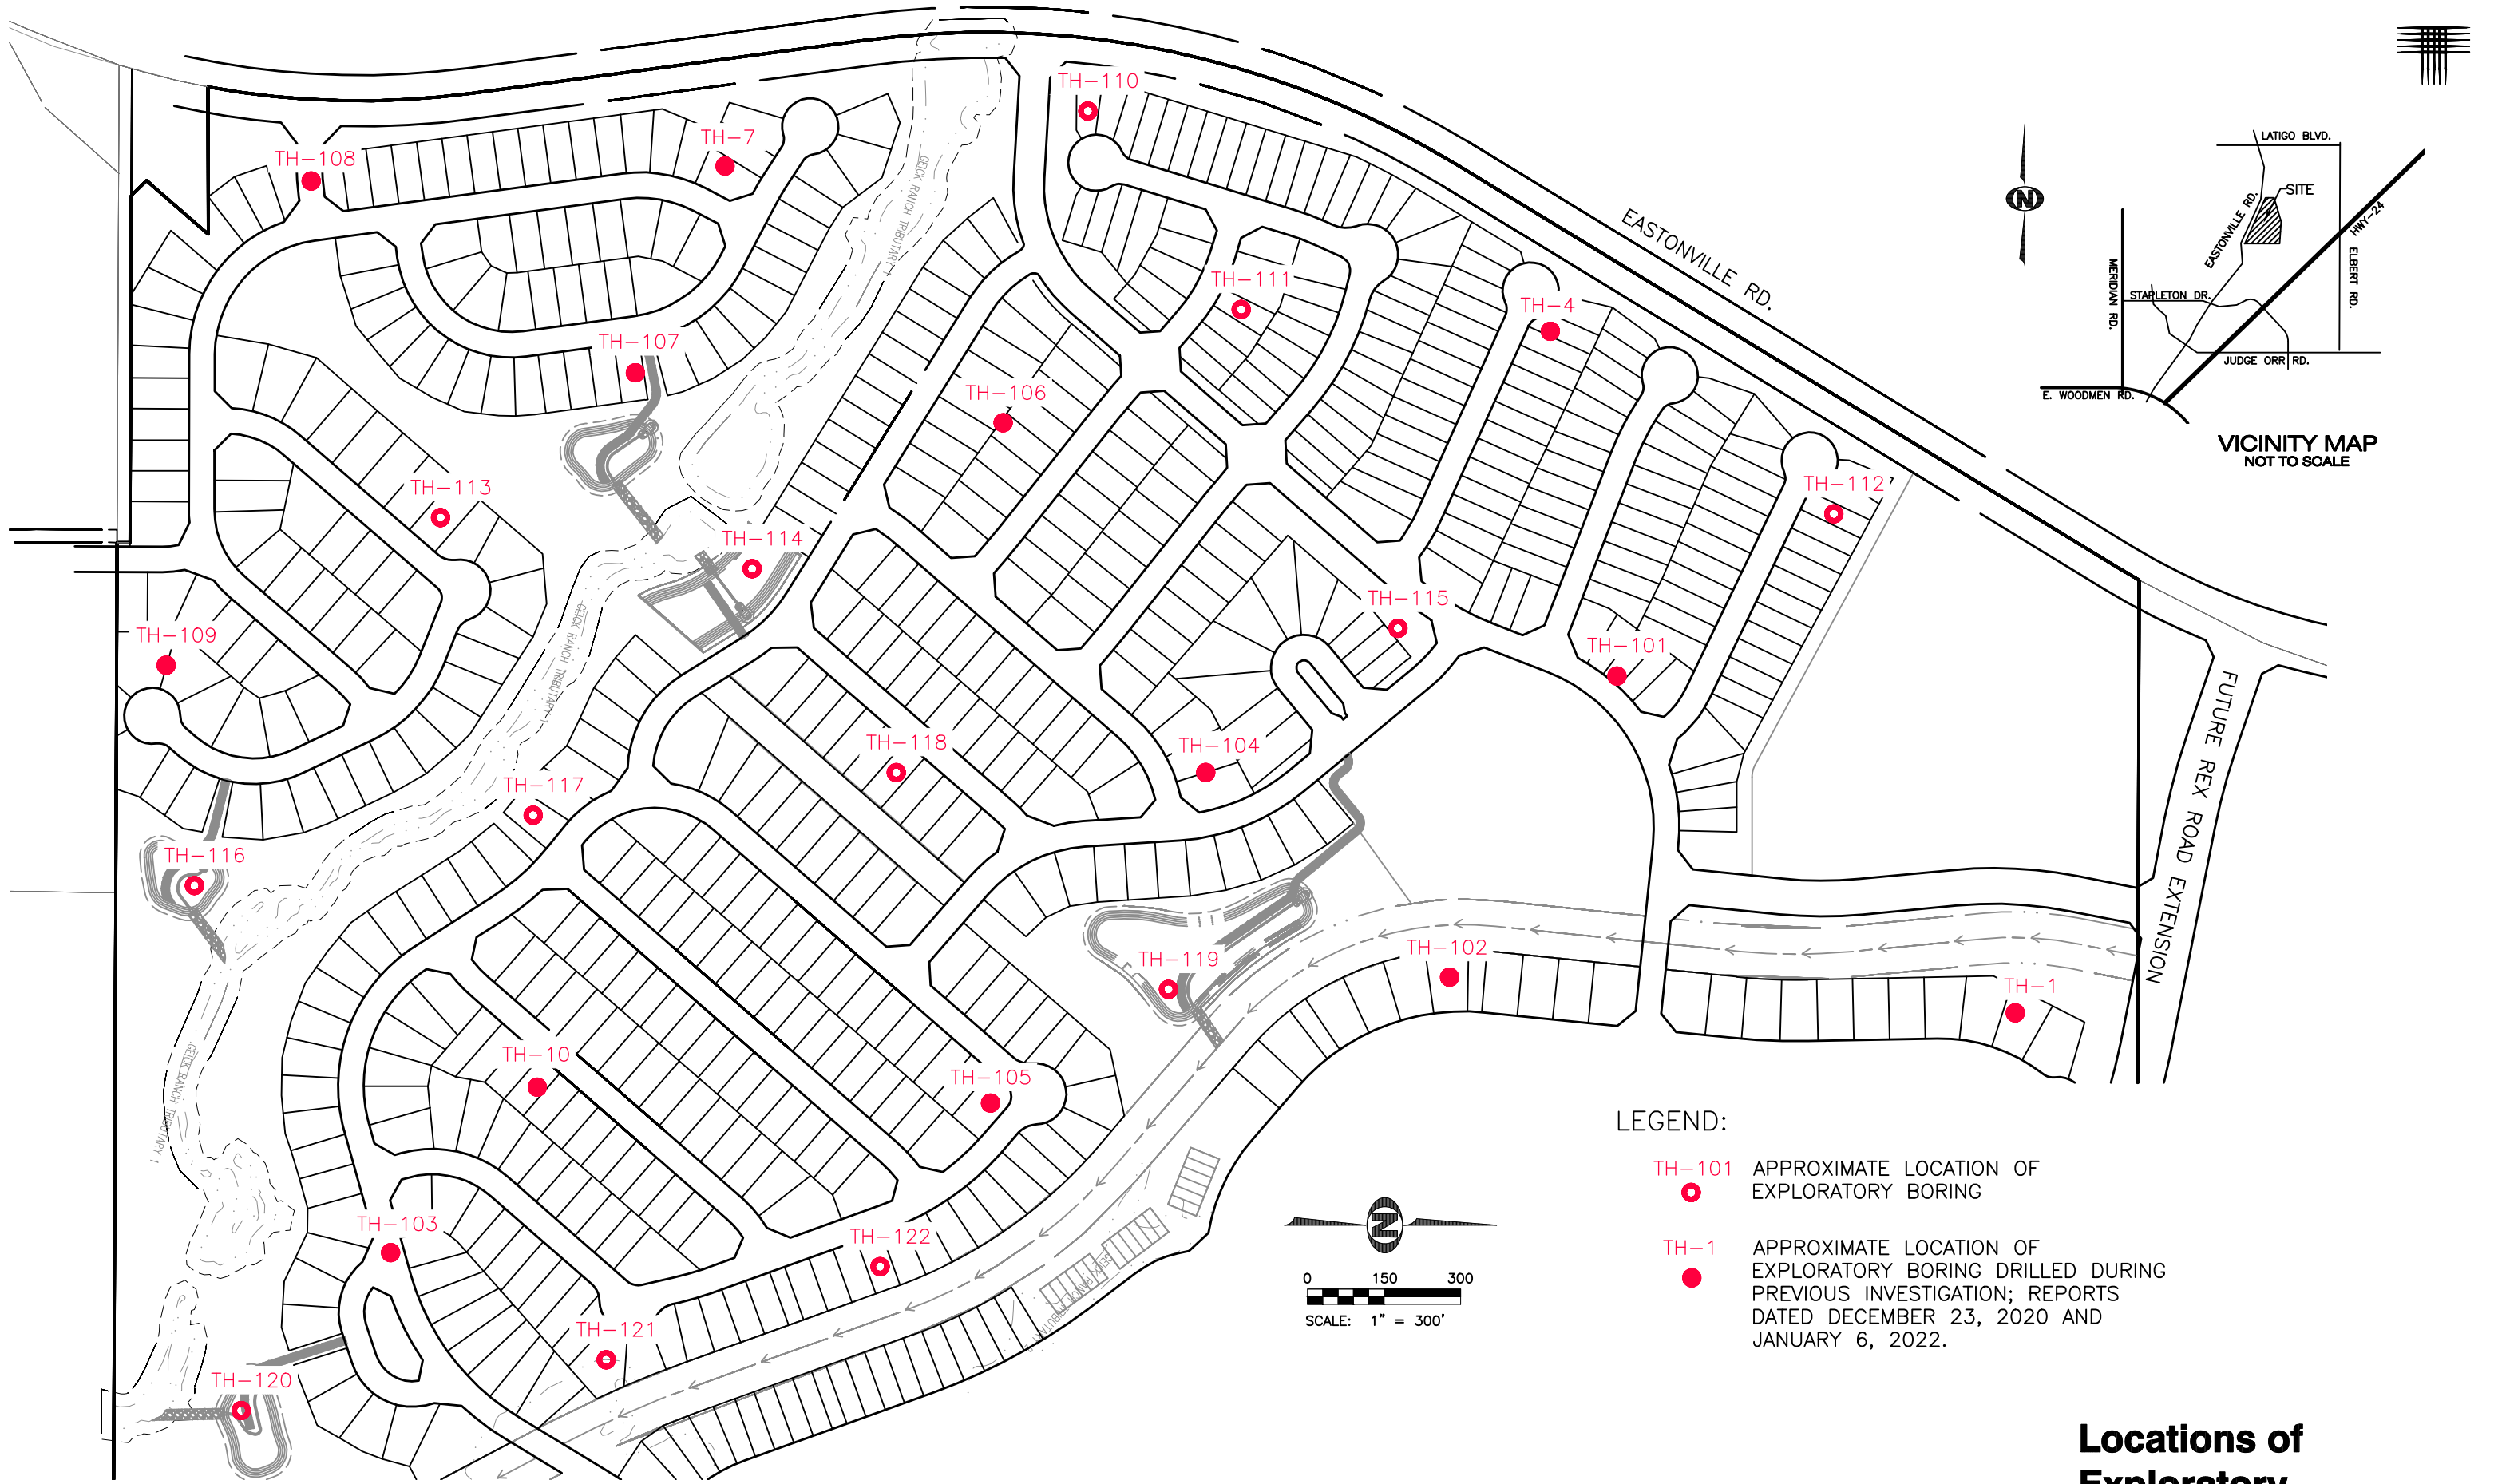
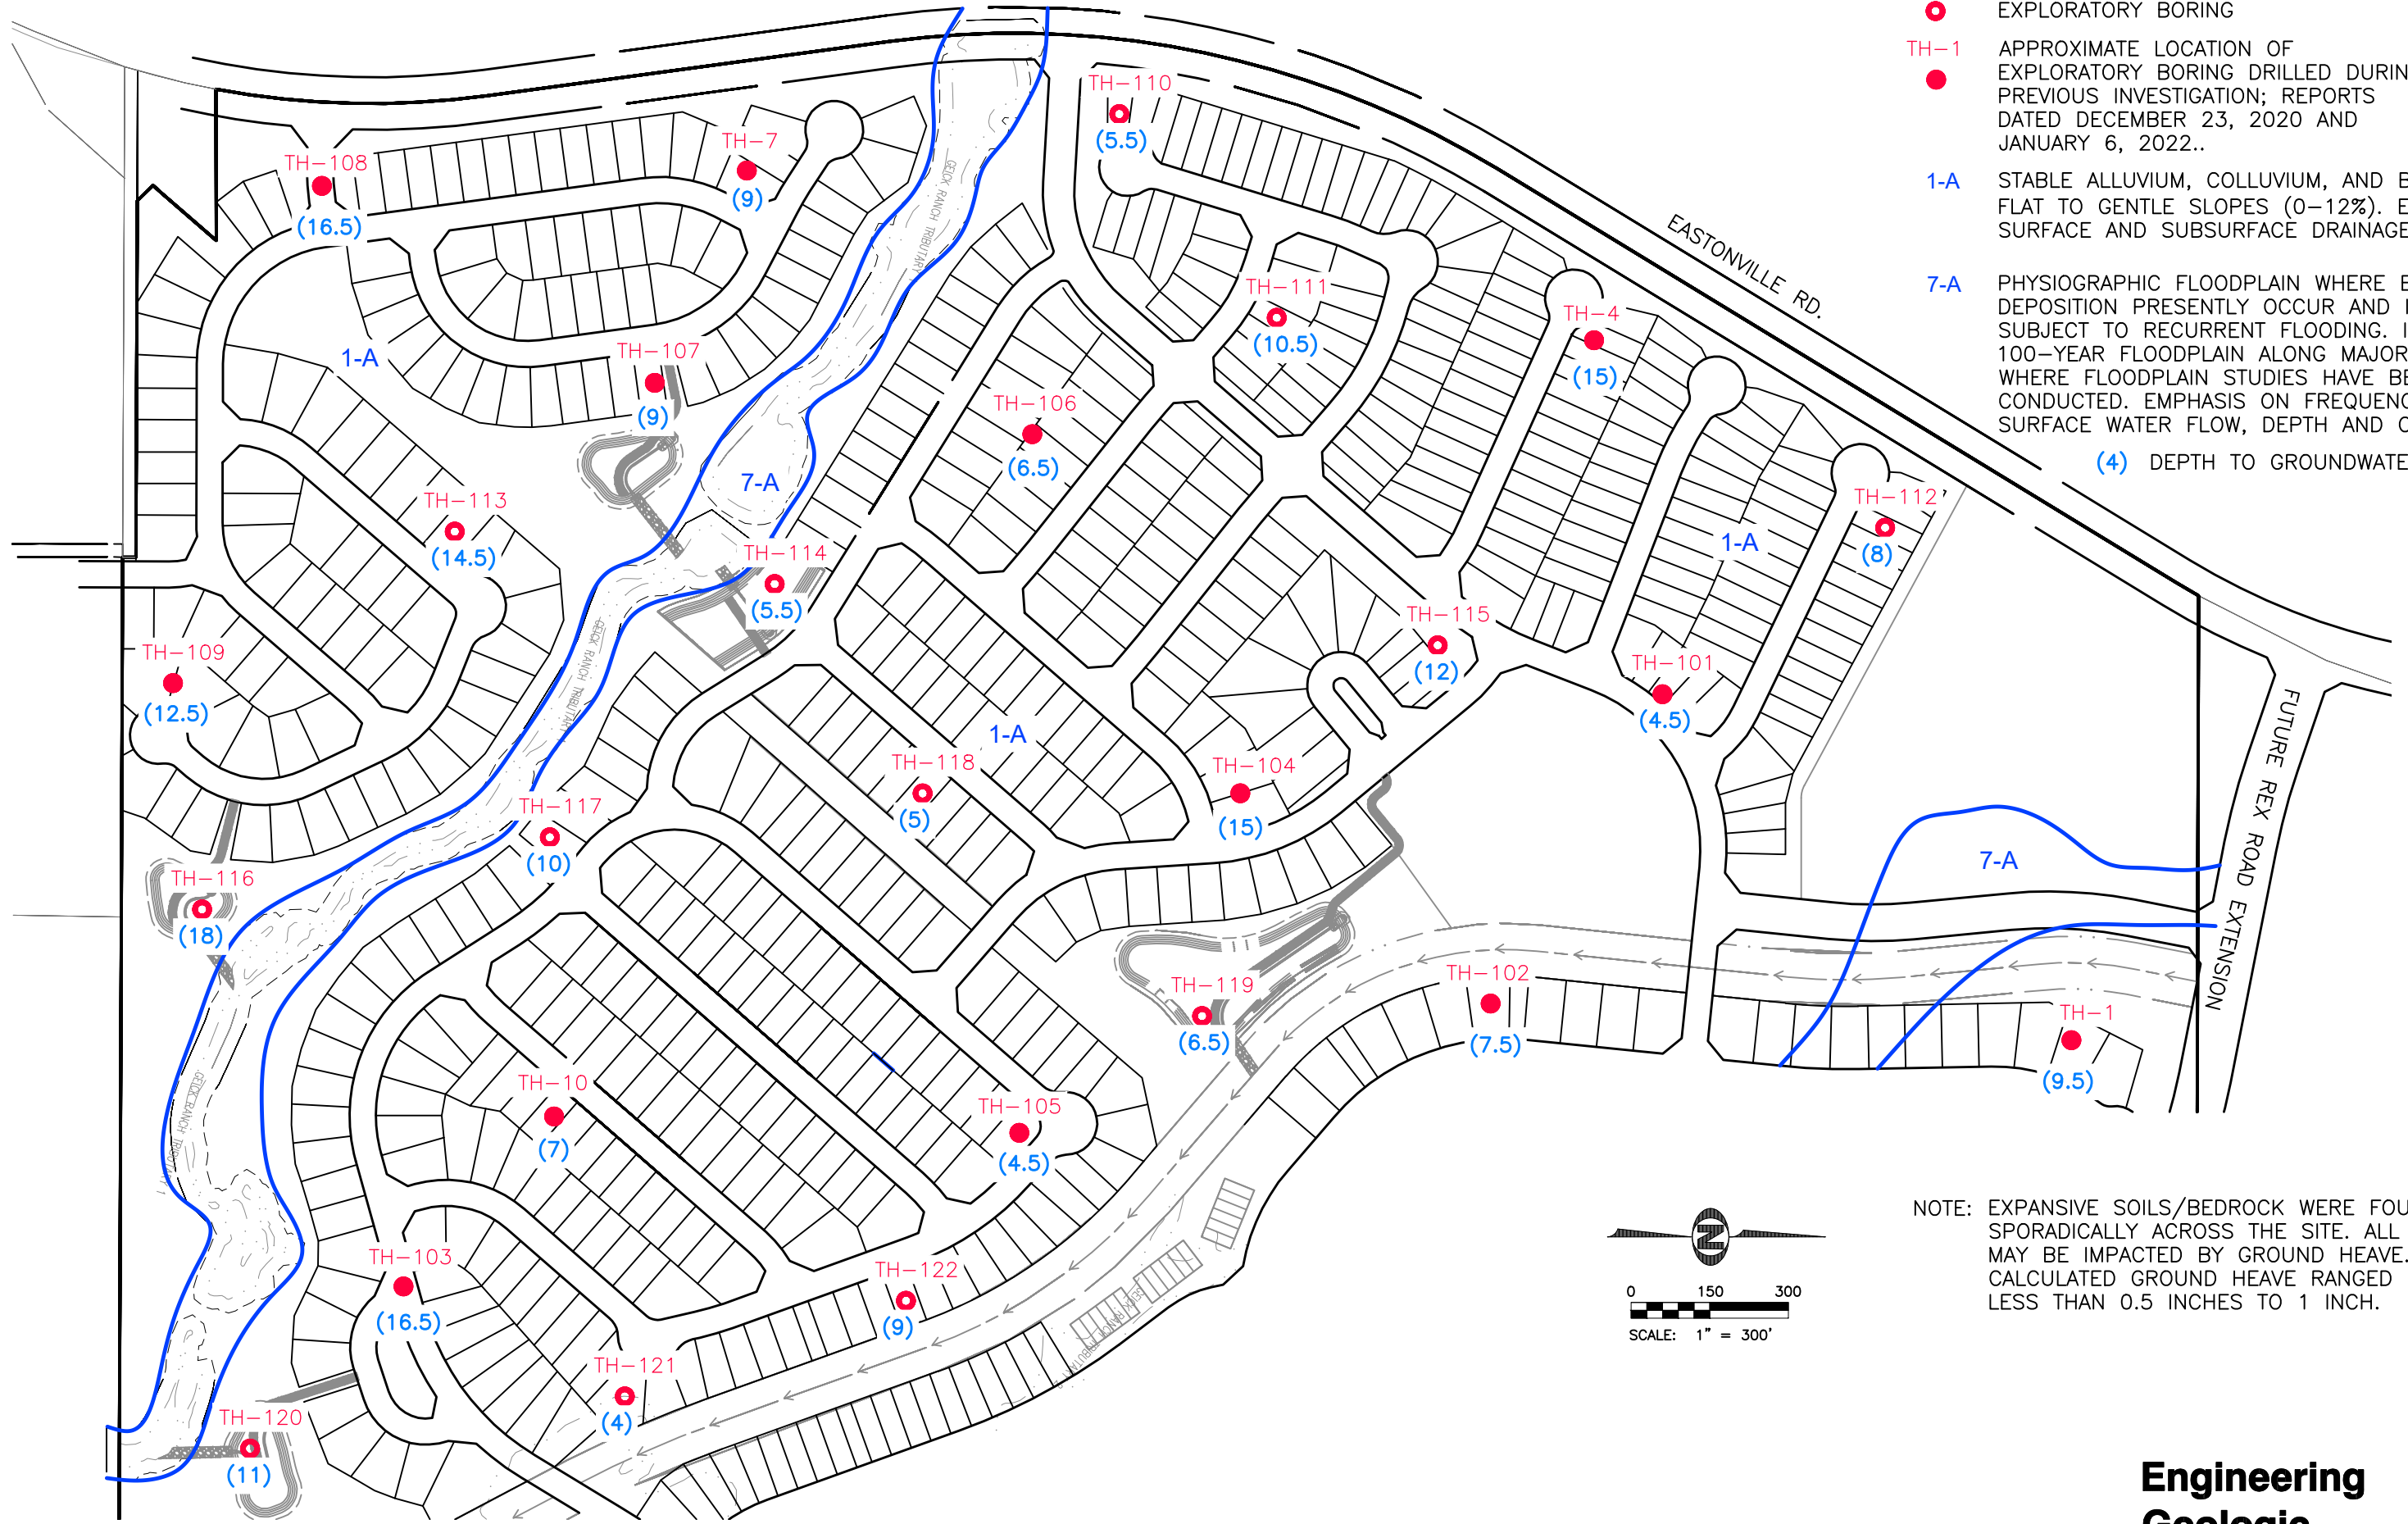
FIG. 2 – ENGINEERING GEOLOGIC CONDITIONS

The referenced report contains a figure titled Engineering Geologic Conditions (Fig. 2). The figure indicates areas of the mapped physiographic floodplain and areas of stable alluvium. We also revised Figure 2 (attached) to clarify our interpretation of the engineering geology and to depict where flowing water may be present (in the channel) and where seasonally shallow groundwater is likely (remainder of site). A note is indicated on Figure 2 that states “Expansive soils/bedrock were found sporadically across the site. All lots may be impacted by ground heave. Total calculated ground heave ranged from less than 0.5 inches to 1 inch.” This note was included because the Dawson Formation, which underlies the site at relatively shallow depths, contains interbed-

The referenced report contains a figure titled Engineering Geologic Conditions (Fig. 2). The figure indicates areas of the mapped physiographic floodplain and areas of stable alluvium. We also revised Figure 2 (attached) to clarify our interpretation of the engineering geology and depict where flowing water may be present (in the channel) and where seasonally shallow groundwater is likely (remainder of site). A note is indicated on Figure 2 that states “Expansive soils/bedrock were found sporadically across the site. All lots may be impacted by ground heave. Total calculated ground heave ranged from less than 0.5 inches to 1 inch.” This note was included because the Dawson Formation, which underlies the site at relatively shallow depths, contains interbedded and discontinuous layers of expansive claystone bedrock. This material cannot be

mapped with any reasonable degree of accuracy, and it should be expected that expansive claystone may be encountered anywhere on the site. As stated in our report, lot specific soils and foundation investigations should be performed, following completion of overlot grading, to determine where expansive claystone is present and provide recommendations for mitigation.

Geologic hazards we identified at the site include expansive soils, hard bedrock, and shallow groundwater. No geologic hazards were noted that we believe preclude the proposed development. We believe potential hazards can be mitigated with proper engineering, design, and construction practices, as discussed in this report. Figure 2 shows our interpretation of the engineering geology modified from the system used by Charles Robinson & Associates (1977).

NOTE: EXPANSIVE SOILS/BEDROCK WERE FOUND SPORADICALLY ACROSS THE SITE. ALL LOTS MAY BE IMPACTED BY GROUND HEAVE. TOTAL CALCULATED GROUND HEAVE RANGED FROM LESS THAN 0.5 INCHES TO 1 INCH.

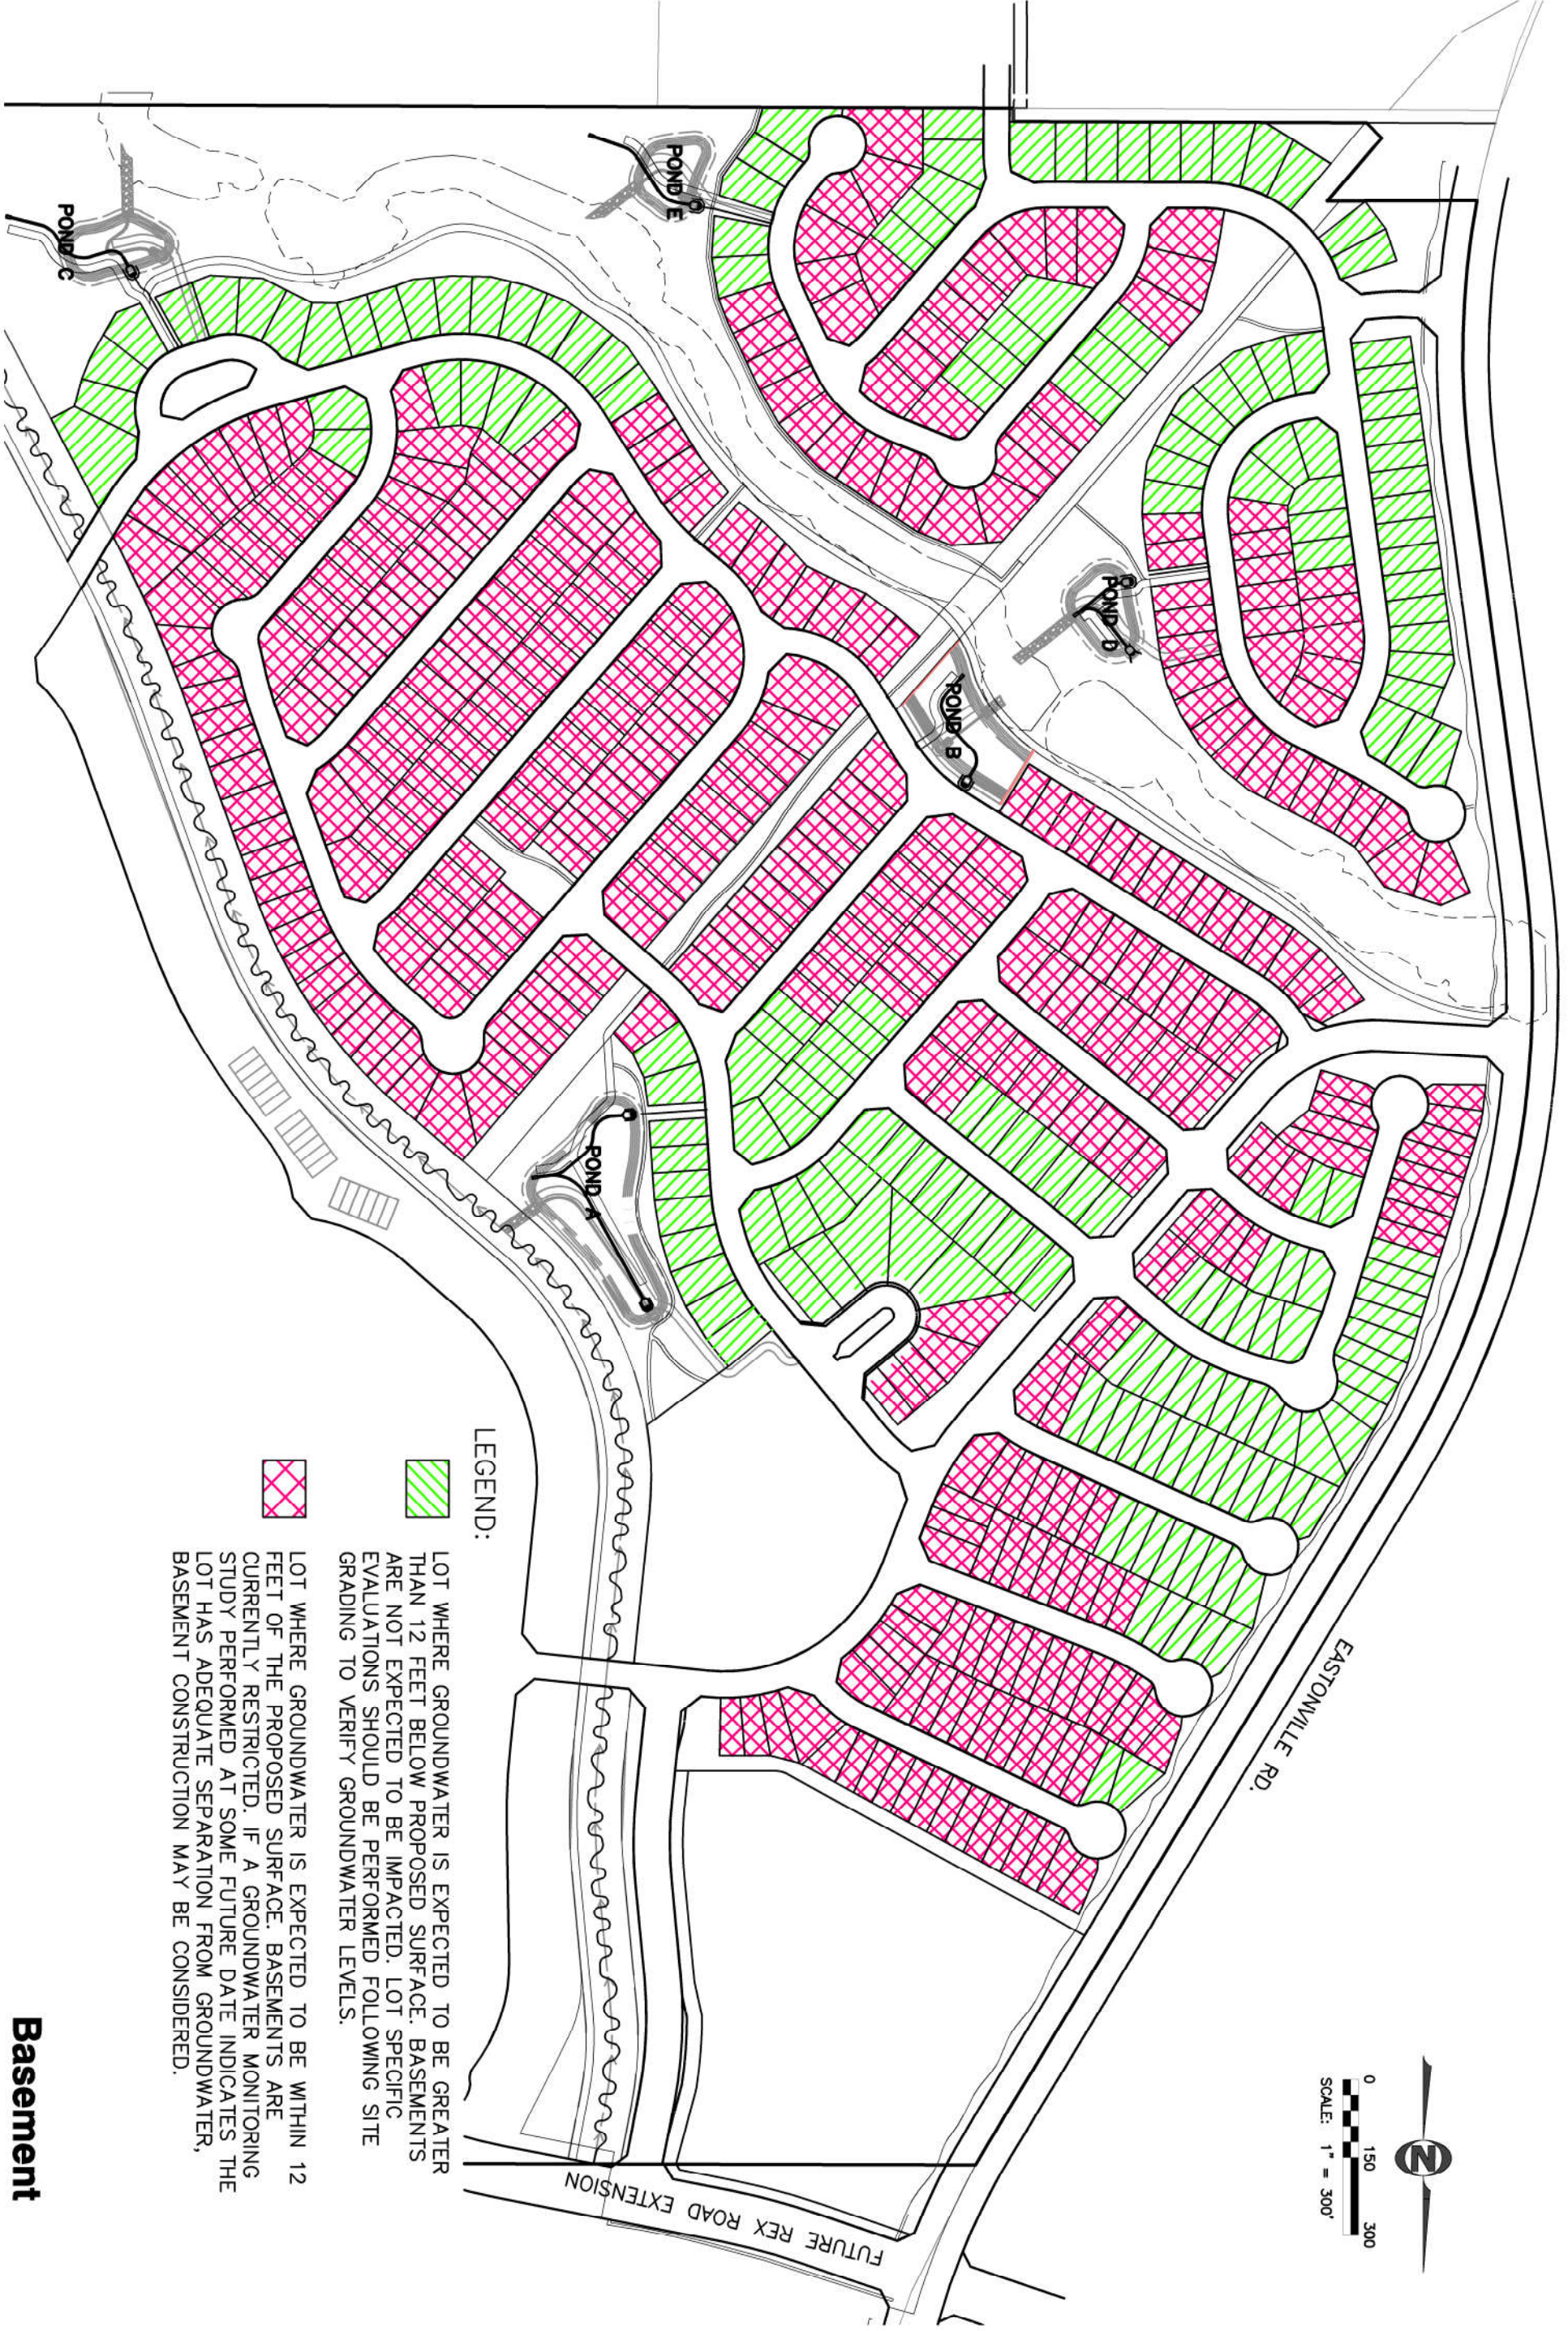
Groundwater Conditions Fig. 3

An additional figure attached with this letter, titled Groundwater Conditions (Fig. 3), was updated for Filing 1, based on the current grading plans. The figure provides approximate groundwater elevation contours and heat mapping depicting a range of approximate depths to groundwater below the proposed finish grades. The figure is based on peak groundwater monitoring data recorded in monitoring wells between July 2023 and May 2024. We also provided an updated figure attached to this letter titled Basement Construction Recommendations (Fig. 4), that depicts lots in Filing 1 that are unsuitable for basement construction based on our groundwater data and analysis.

An additional figure, titled Groundwater Conditions (Fig. 3), was included in our report that provided approximate groundwater elevation contours and heat mapping, that provides an approximate depth to groundwater below the proposed finish grades. We also provided a figure titled Basement Construction Recommendations (Fig. 4), that depicted lots that are unsuitable for basement construction based on our groundwater data and analysis; however, we understand basement construction is not planned for any of the 119 lots included in Filing No. 1. All residential structures will be constructed with either a spread footing foundation supporting a structural floor system over a crawl space or a slab-on-grade foundation system.

groundwater levels. The depth to groundwater is indicated on Fig. 2. Groundwater elevation contours are shown and estimated depth to groundwater from the proposed surface are shown on Fig. 3.

Current groundwater depths indicate proximity of groundwater to basement level foundation systems is a concern throughout portions of the development. The presence of shallow groundwater can impact basement level construction. Lots expected to be impacted by shallow groundwater that will restrict basement construction are shown on Fig. 4. Future groundwater level monitoring studies may be conducted to further evaluate groundwater levels.
