**PRELIMINARY SOIL, GEOLOGY, GEOLOGIC HAZARD,
AND WASTEWATER STUDY,
GRANDVIEW RESERVE
PARCEL NO. 42000-00-396
0 EASTONVILLE ROAD
EL PASO COUNTY, COLORADO**

Entech Job No. 181951

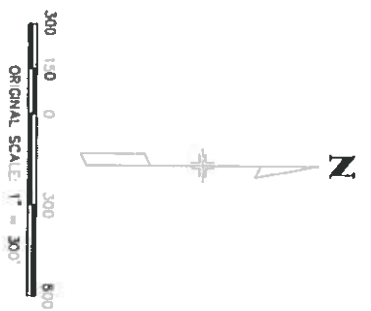
GEOLOGY/ENGINEERING GEOLOGY MAP
 GRANDVIEW RESERVE
 EASTONVILLE ROAD
 EL PASO COUNTY, CO.
 FOR: 4 SITE INVESTMETNS, LLC

The majority of the slopes in the building areas on site are gently to moderately sloping and do not exhibit any past or potential unstable slopes or landslides. However, the steeply sloping areas along the drainage in the eastern portion of the site have been identified as unstable slopes. These areas are identified on the Geology/Engineering Geology Map, Figure 6. The recommendations for these areas are as follows:

The area identified with this hazard is located along a portion of a minor drainage where cut banks have created unstable slopes. Considerable care must be exercised in these areas not to create a condition which would tend to activate instability.

Mitigation: Building should be avoided in these areas. The lots most significantly affected by unstable slopes are Lots 18, 84, 106 and 107. The structures on these lots should be set back a minimum of 30 feet from the crest of these slopes. It appears there is sufficient room on the lots to avoid this hazard. Proper control of drainage at both the surface above the slope and the subsurface is extremely important. Areas of ponded water at the surface should be avoided. Utility trenches, basement excavations and other subsurface features should not

be permitted to become water traps which may promote saturation of the subsurface materials. Drainage should not be permitted over the potentially unstable slope but directed in a non-erosive manner away from the slope. Irrigation above these slopes should be kept to a minimum to prevent saturation of the subsurface soils. The use of xeriscape landscaping utilizing native plantings is recommended to reduce the need for irrigation.

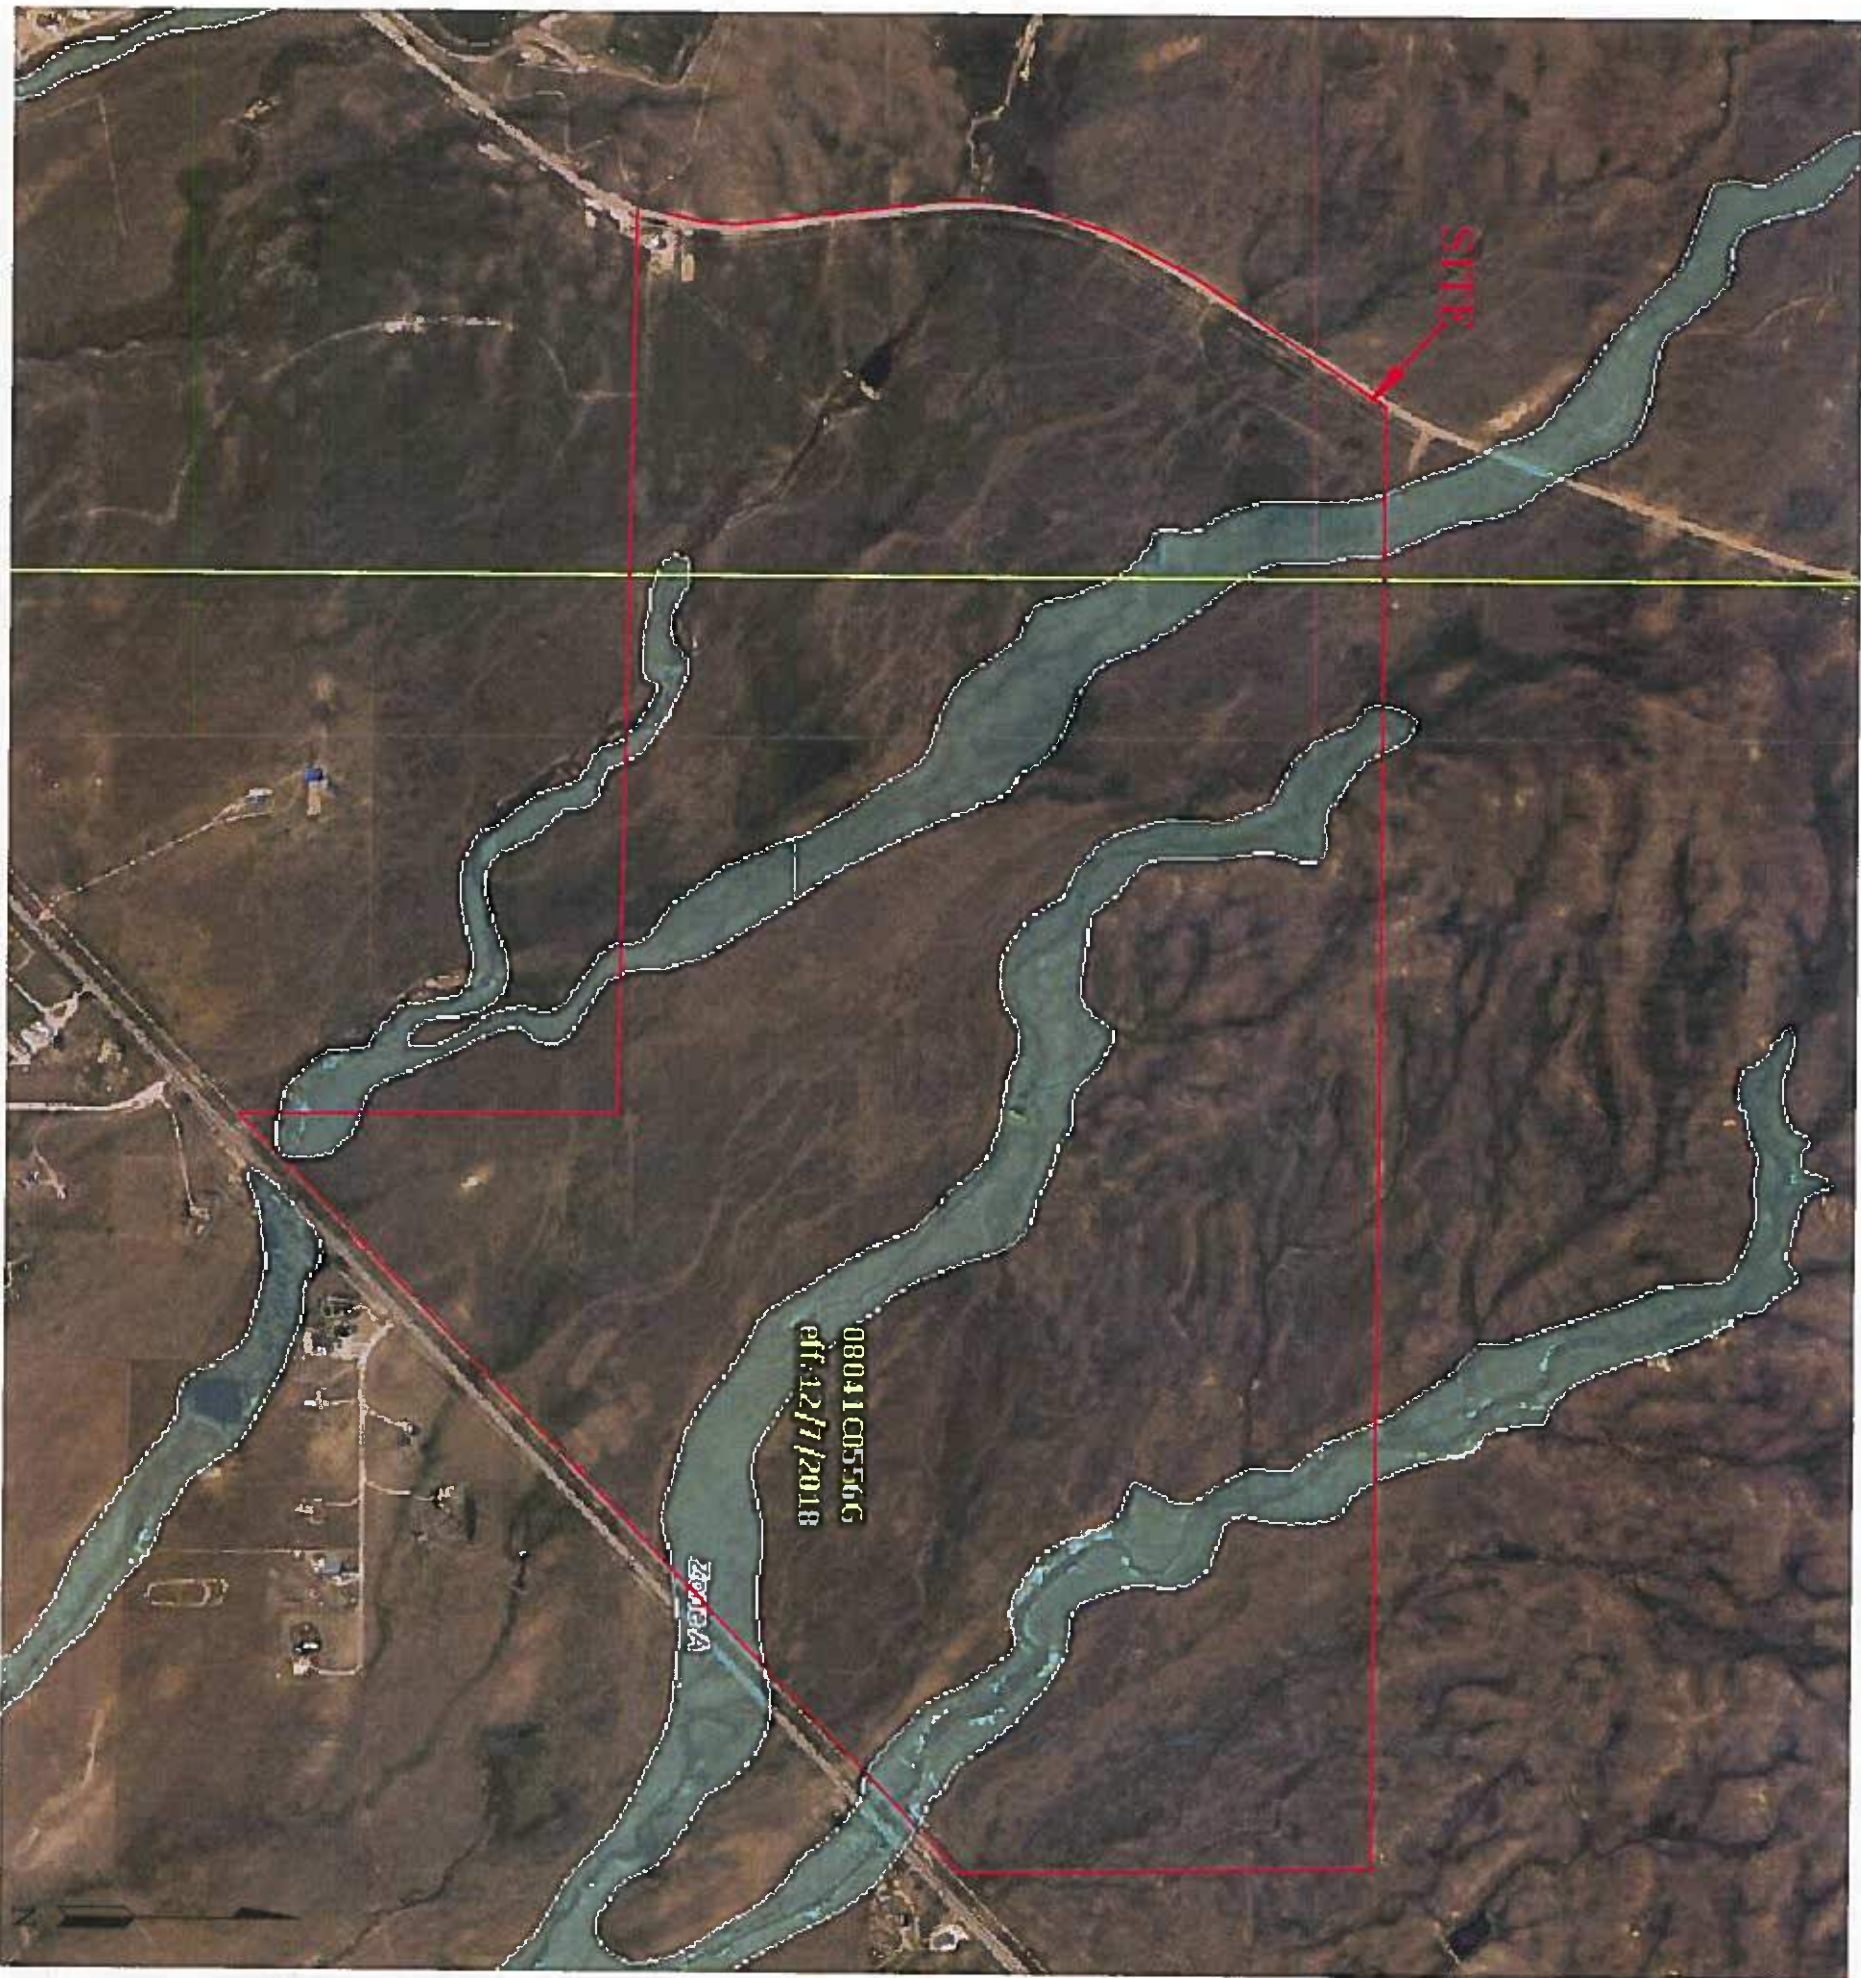
FLOODPLAIN MAP
GRANDVIEW RESERVE
EASTONVILLE ROAD
EL PASO COUNTY, CO.
FOR: 4 SITE INVESTMETNS, LLC

Portions of the site associated with some of the drainages are mapped within a floodplain zones according to the FEMA Map No. 08041CO556G, dated December 7, 2018 (Figure 7, Reference 6). The floodplain areas have been designated as open space and/or can be avoided by construction. An area of ponded water exists in the floodplain that is designated as open space and will be avoided by development. Additionally, areas of seasonal and potentially seasonal shallow groundwater were observed across the site. In these areas, we would anticipate the potential for periodically high subsurface moisture conditions and frost heave potential. These areas lie within the low-lying areas and minor drainages across the site. Water was observed in the drainage in the northeastern portion of the site, but was not observed in any of the other minor drainages at the time of our site investigation, however, water was observed ponded behind an earthen dam in the southeastern portion of the site. These areas can likely be avoided or properly mitigated by development. The floodplain should be avoided by construction unless site-specific floodplain determination and drainage studies are performed. The potential exists for high groundwater levels during high moisture periods and should structures encroach on these areas the following precautions should be followed.

Mitigation: Foundations must have a minimum 30-inch depth for frost protection. In areas where high subsurface moisture conditions are anticipated periodically, subsurface perimeter drains are recommended to help prevent the intrusion of water into areas below grade. Typical drain details are presented in Figure 8. Some of the minor drainage swales can be avoided or regraded. The main drainage that bisects the site is designated as open space and will be avoided. Any grading in these areas should be done to direct surface flow around construction to avoid areas of ponded water. Finished floors must be located at least one foot above floodplain levels. Specific drainage studies and exact floodplain locations are beyond the scope of this report.
