**SOILS AND GEOLOGY STUDY
JAYNES PROPERTY – PRELIMINARY PLAN
POCO ROAD AND VOLLMER ROAD
EL PASO COUNTY, COLORADO**

Prepared for:
**Elite Properties of America, LLC
2138 Flying Horse Club Drive
Colorado Springs, CO 80921**

November 21, 2023

PCD No SP-23-009

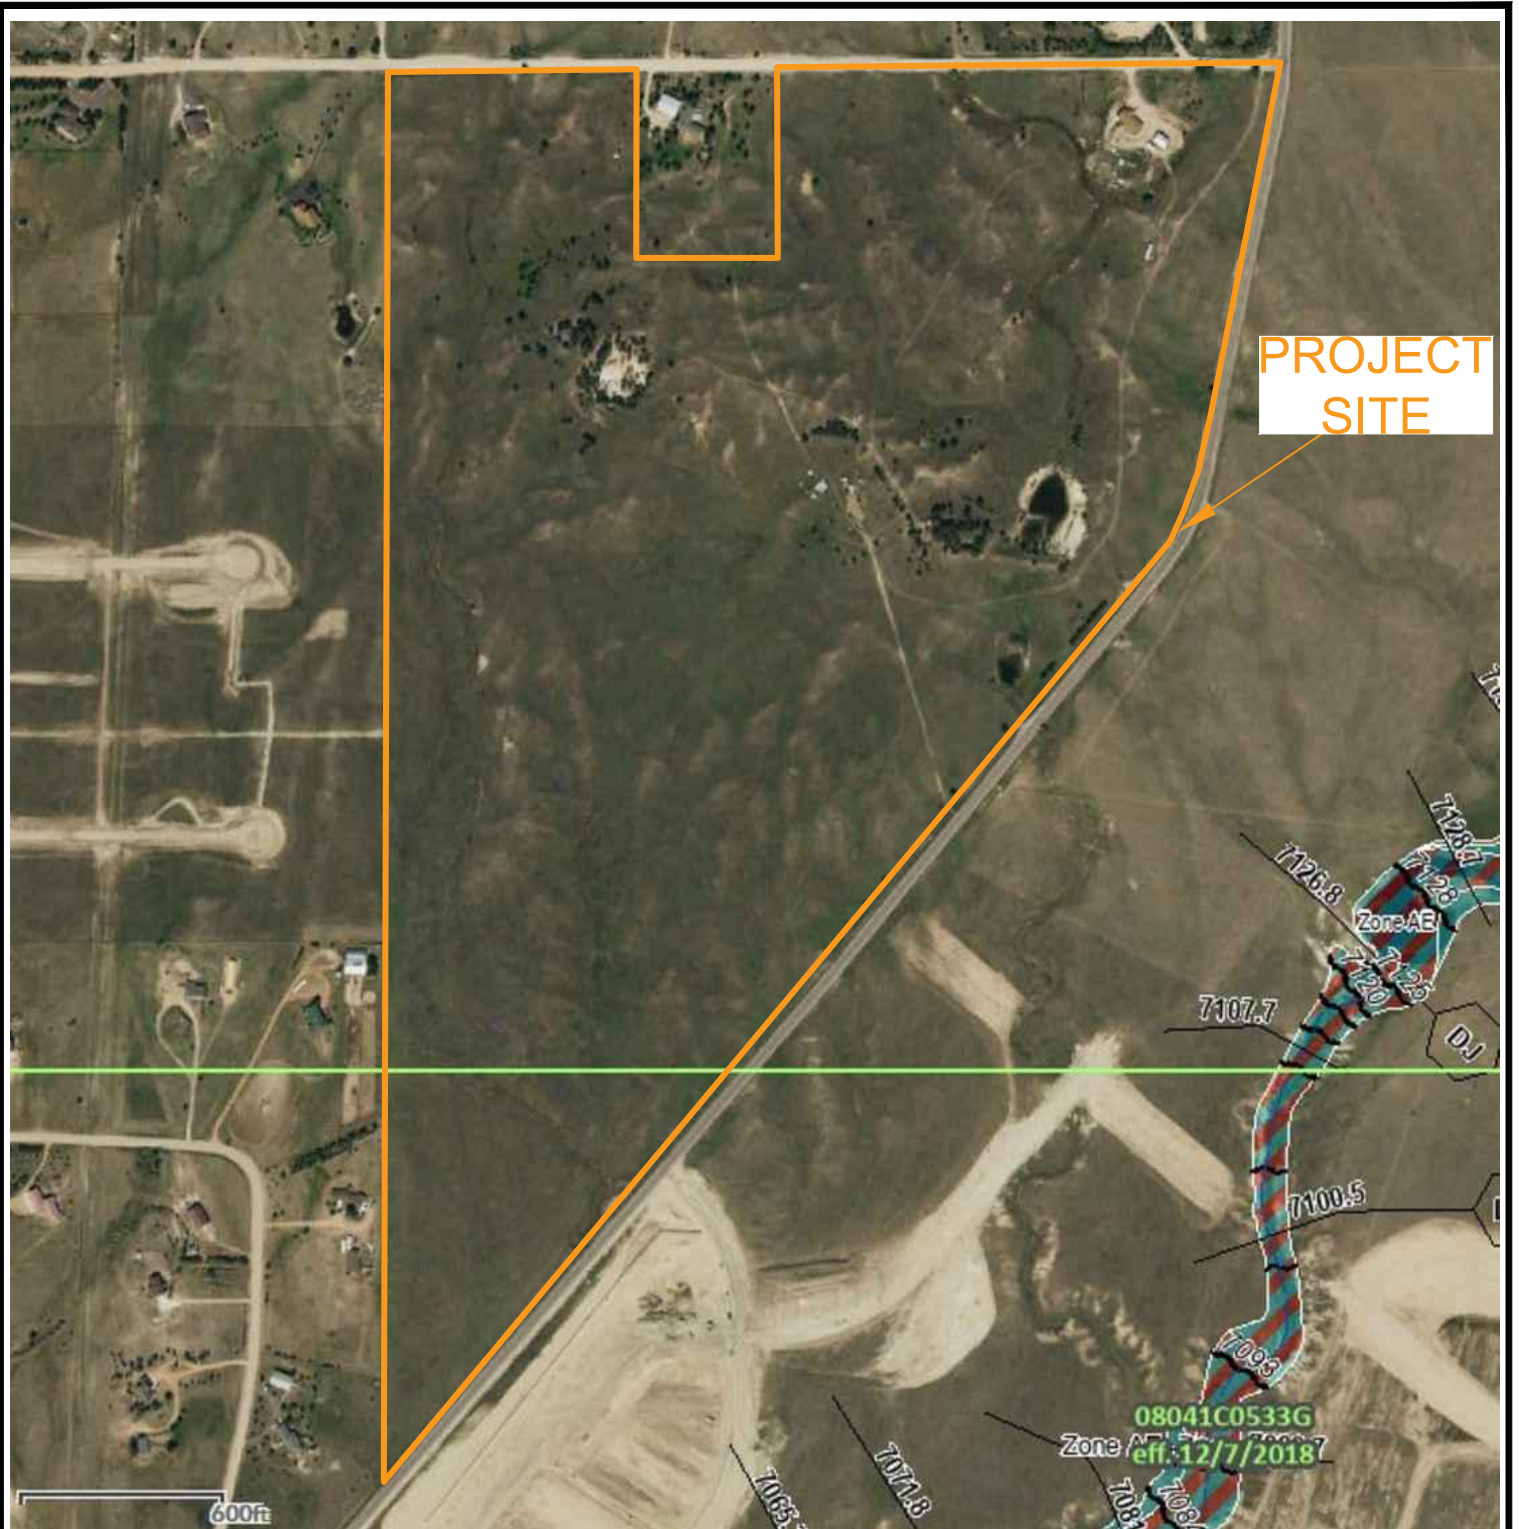
FIG. 7

Two drainages exist in the eastern and western portions of the site that have been identified as areas of seasonally wet and/or seasonally high groundwater areas. Water was observed in the pond located in the eastern portion of the site. Water was not observed in the drainage areas on the site. The site is not mapped within floodplain zones according to the FEMA Map Nos. 08041CO533G and 08041CO535G, Figure 8 (Reference 8). These areas are discussed as follows:

Areas of seasonal and potentially seasonal high groundwater areas and ponded water were encountered on site. The majority of these areas will likely be mitigated with site grading or be avoided by construction. Drains may be necessary for structures adjacent to these areas to help prevent the intrusion of water into areas below grade. Typical drain details are presented in Figures 9 through 11. The site does not lie within any floodplain zones according to the FEMA Map Nos. 08041CO533G and 08041CO535G, dated December 7, 2108 (Figure 8, Reference 8). Exact locations of floodplain and specific drainage studies are beyond the scope of this report.
