**SOIL, GEOLOGY AND
GEOLOGIC HAZARD STUDY
BANNING LEWIS RANCH
FREESTYLE NORTH
COLORADO SPRINGS, COLORADO**

Norwood Development
111 South Tejon Street, Suite 222
Colorado Springs, Colorado 80903

December 14, 2021

Entech Job No. 213235
AAPProjects/2021/213235 soils geo

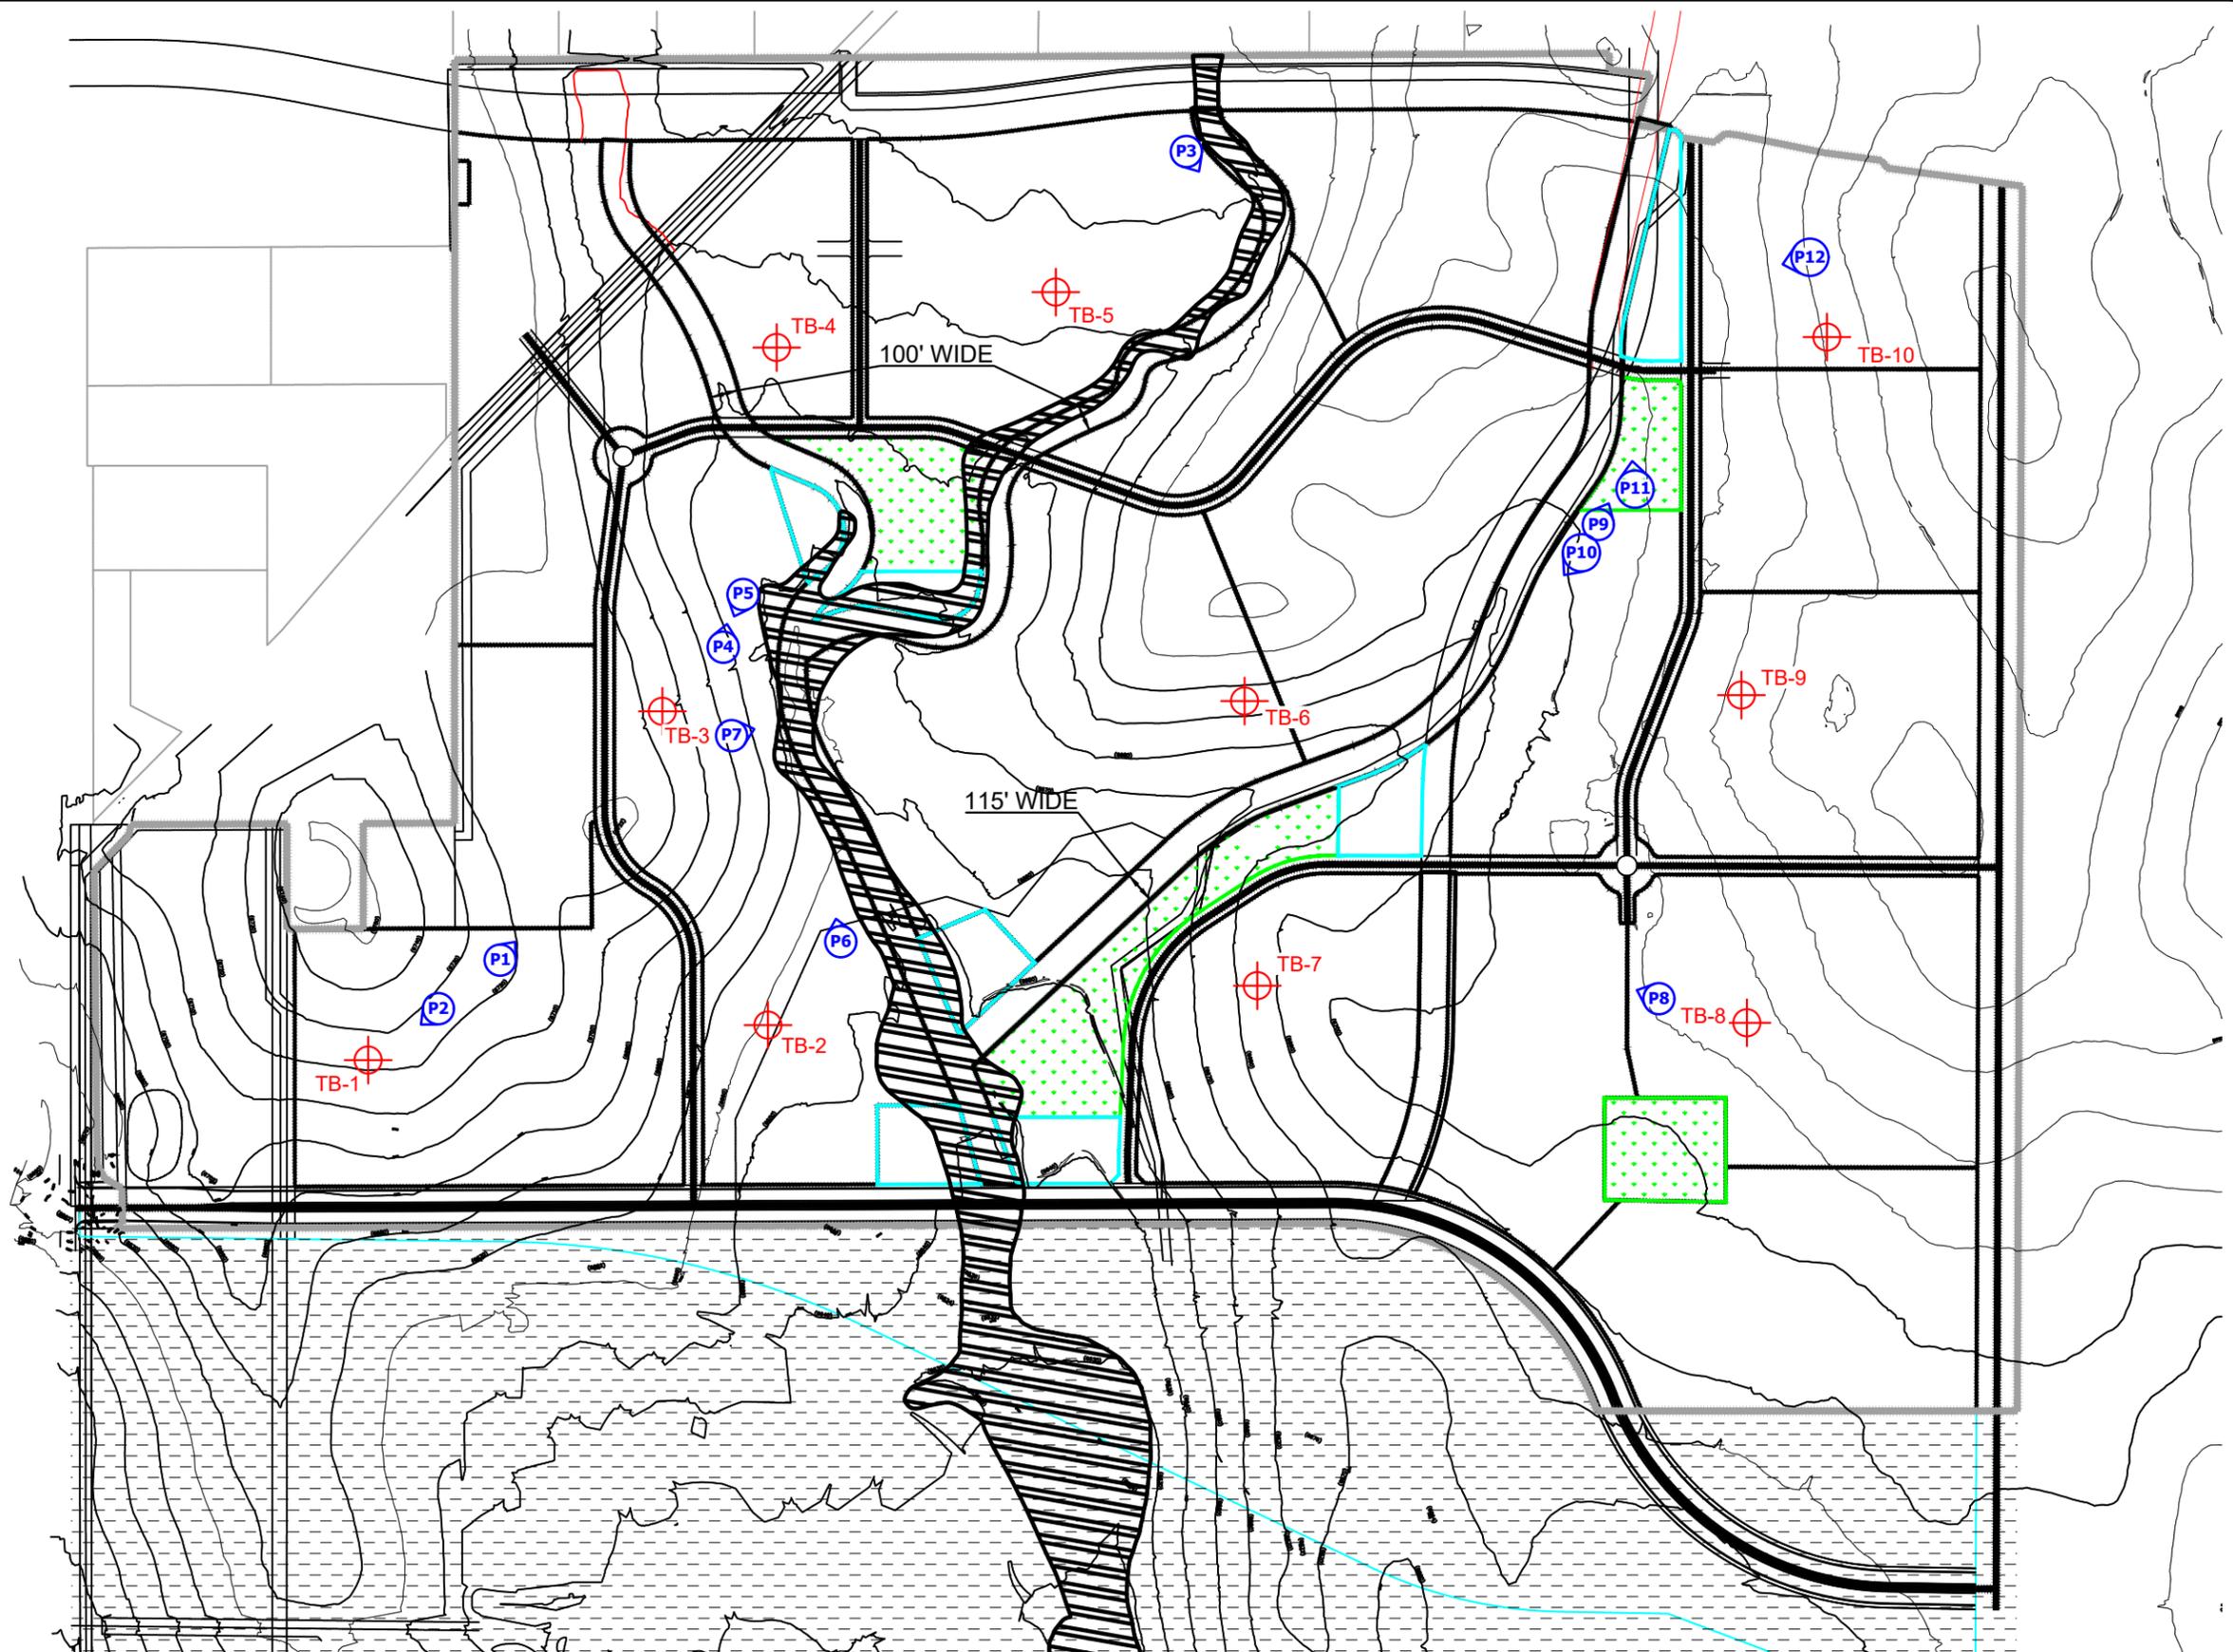
DRAWN	JAC
CHECKED	DPS
DATE	12/14/21
SCALE	AS SHOWN
JOB NO.	213235
FIGURE No.	3

Ten (10) test borings were drilled as a part of the investigation to determine general soil and bedrock conditions. The borings were drilled with a power-driven continuous flight auger drill rig to depths of 20 feet. Samples were obtained during drilling using the Standard Penetration Test, ASTM D-1586, utilizing a 2-inch O.D. Split Barrel Sampler and a California Sampler. Results of the penetration tests are shown on the drilling logs to the right of the sampling point. The location of the test borings is shown on the Test Boring Location Map, Figure 3. The Test Boring Logs are included in Appendix B.

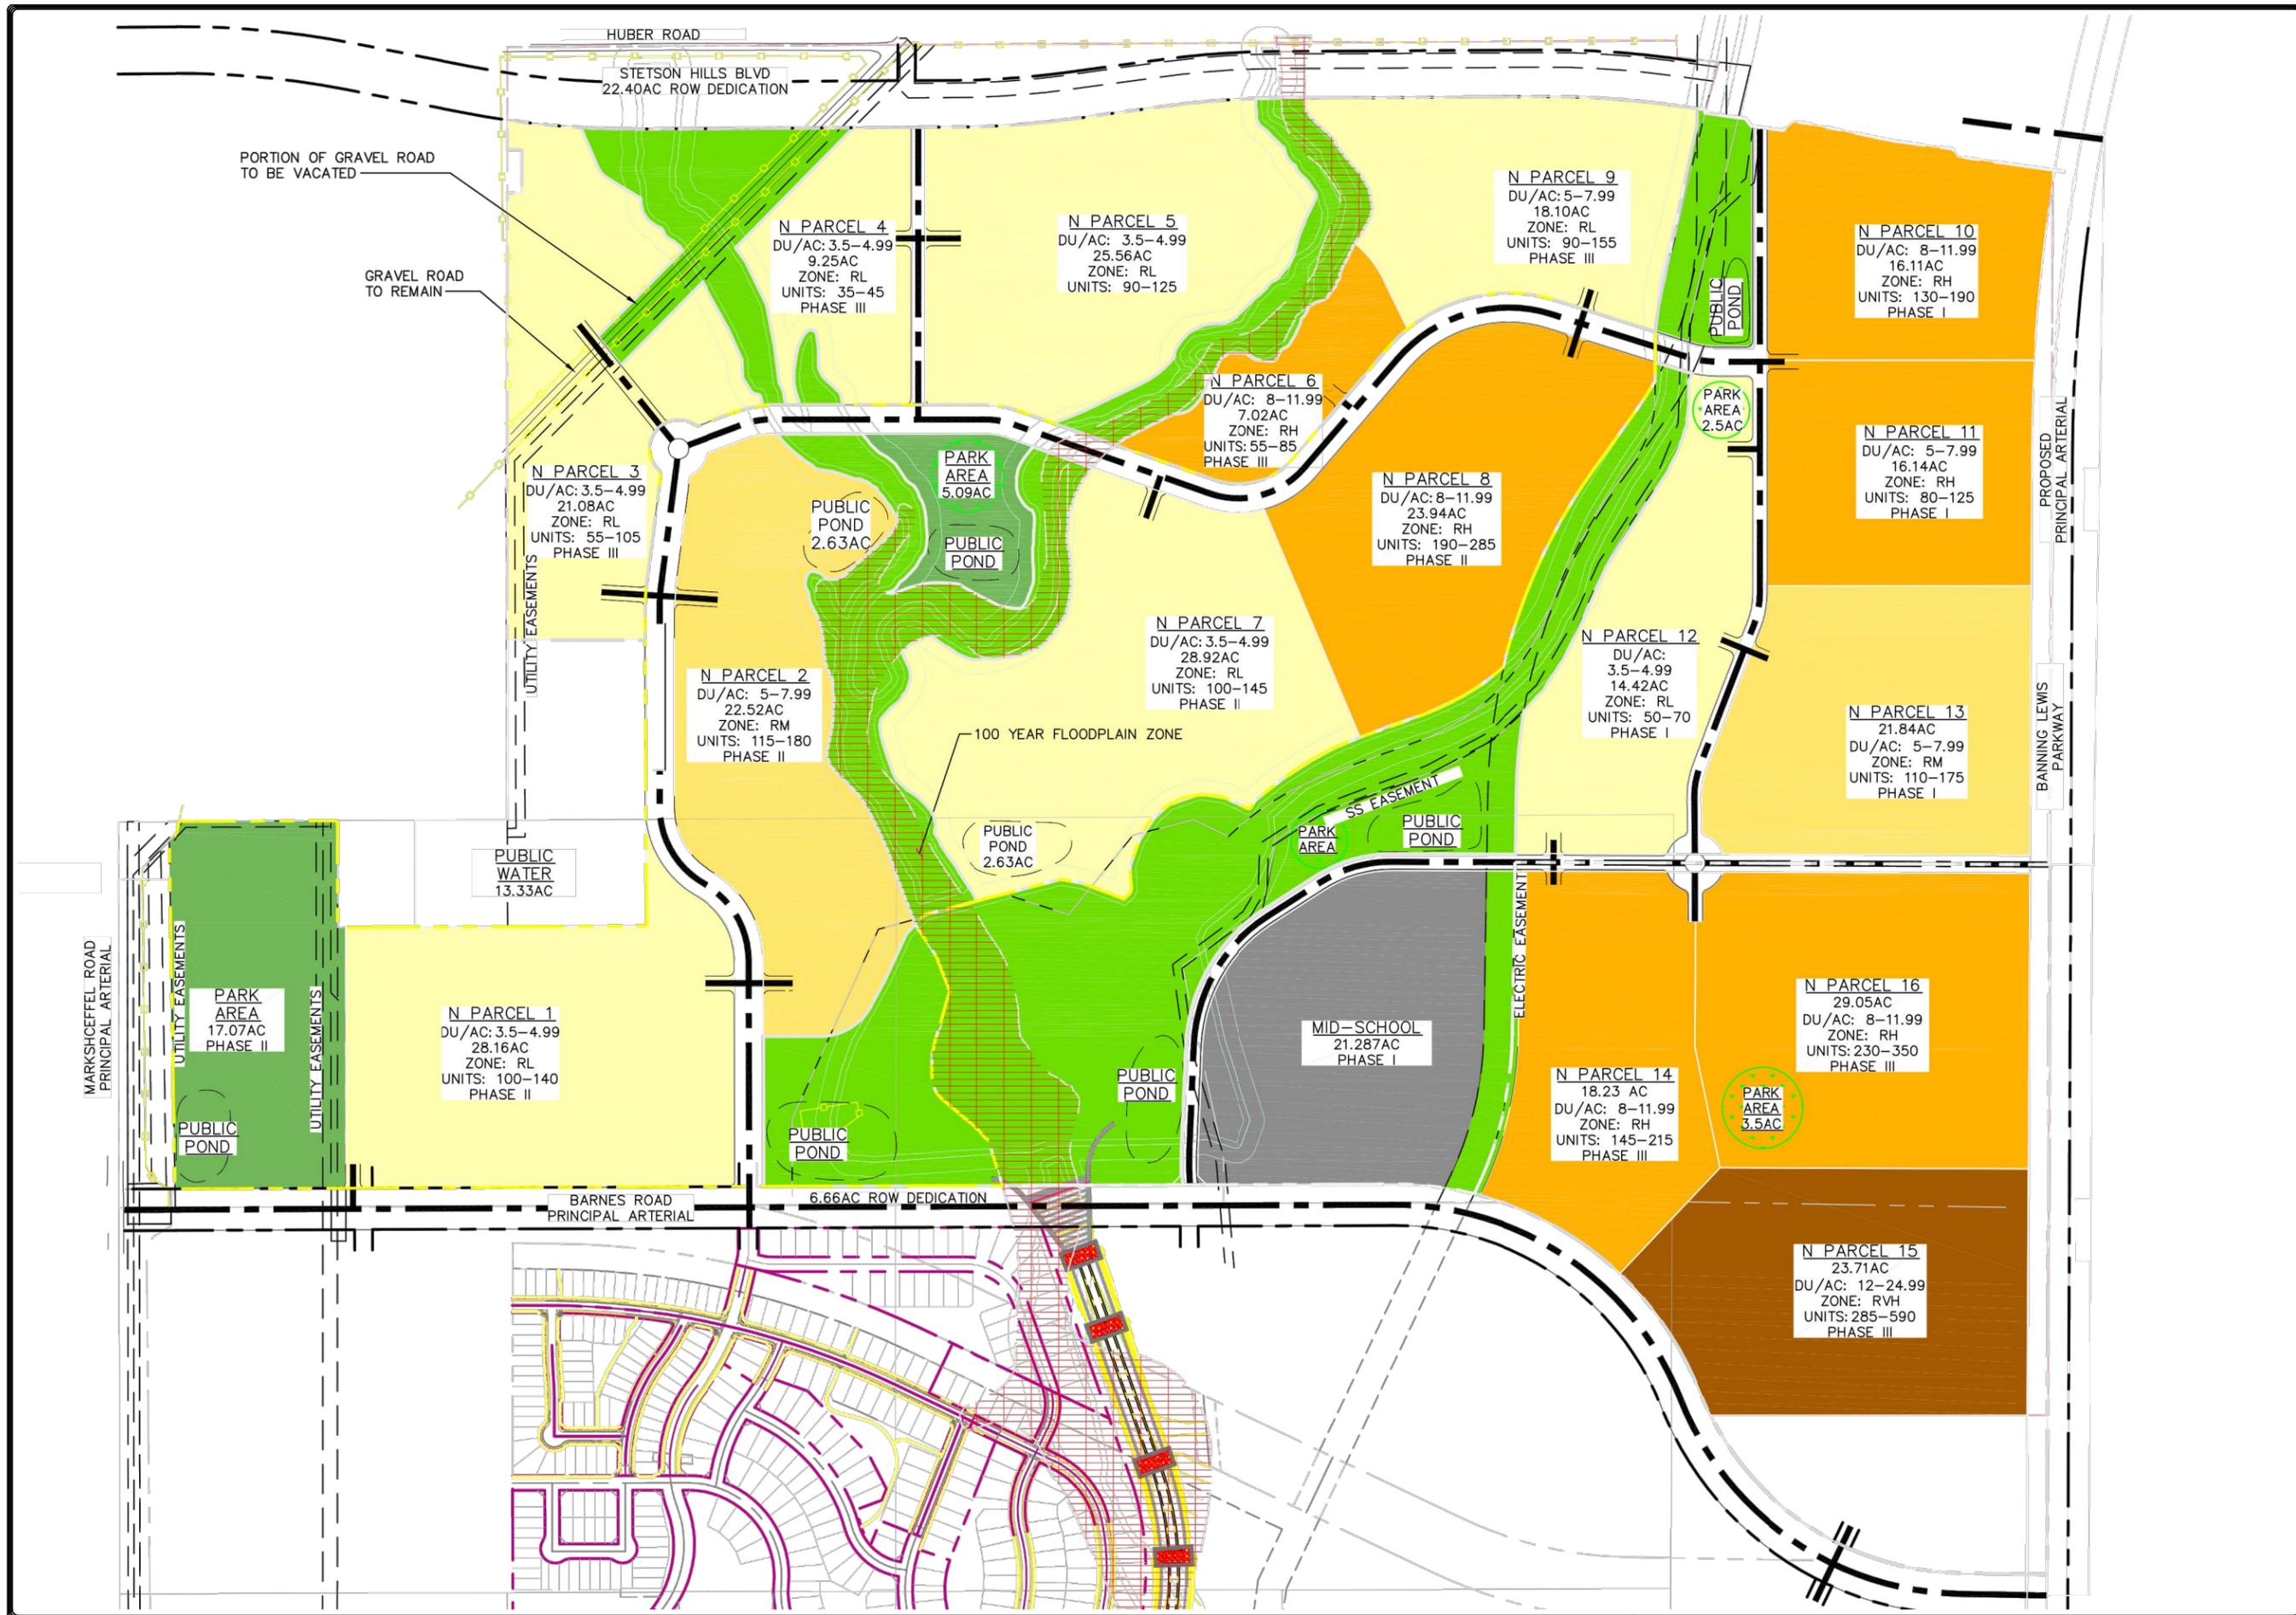
DRAWN	JAC
CHECKED	DPS
DATE	12/14/21
SCALE	AS SHOWN
JOB NO.	213235
FIGURE No.	4

Areas of the site have been mapped as floodplain zone according to the FEMA Map Nos. 08041CO545G and 08041CO561G (Figure 8, Reference 11). According to the Concept Plan Figure 4, it appears these areas are designated as drainage/open space areas and will be avoided by development. Any development with the floodplain will require approval of the drainage plan. Finished floors must be a minimum of one foot above the floodplain level. Exact floodplain locations and drainage studies are beyond the scope of this report.
