**ENTECH**  
ENGINEERING, INC.

**WASTEWATER STUDY  
TIMBERS AT BLACK FOREST SUBDIVISION  
9220 ARROYA LANE  
PARCEL NO. 52054-00-041  
EL PASO COUNTY, COLORADO**

March 5, 2026

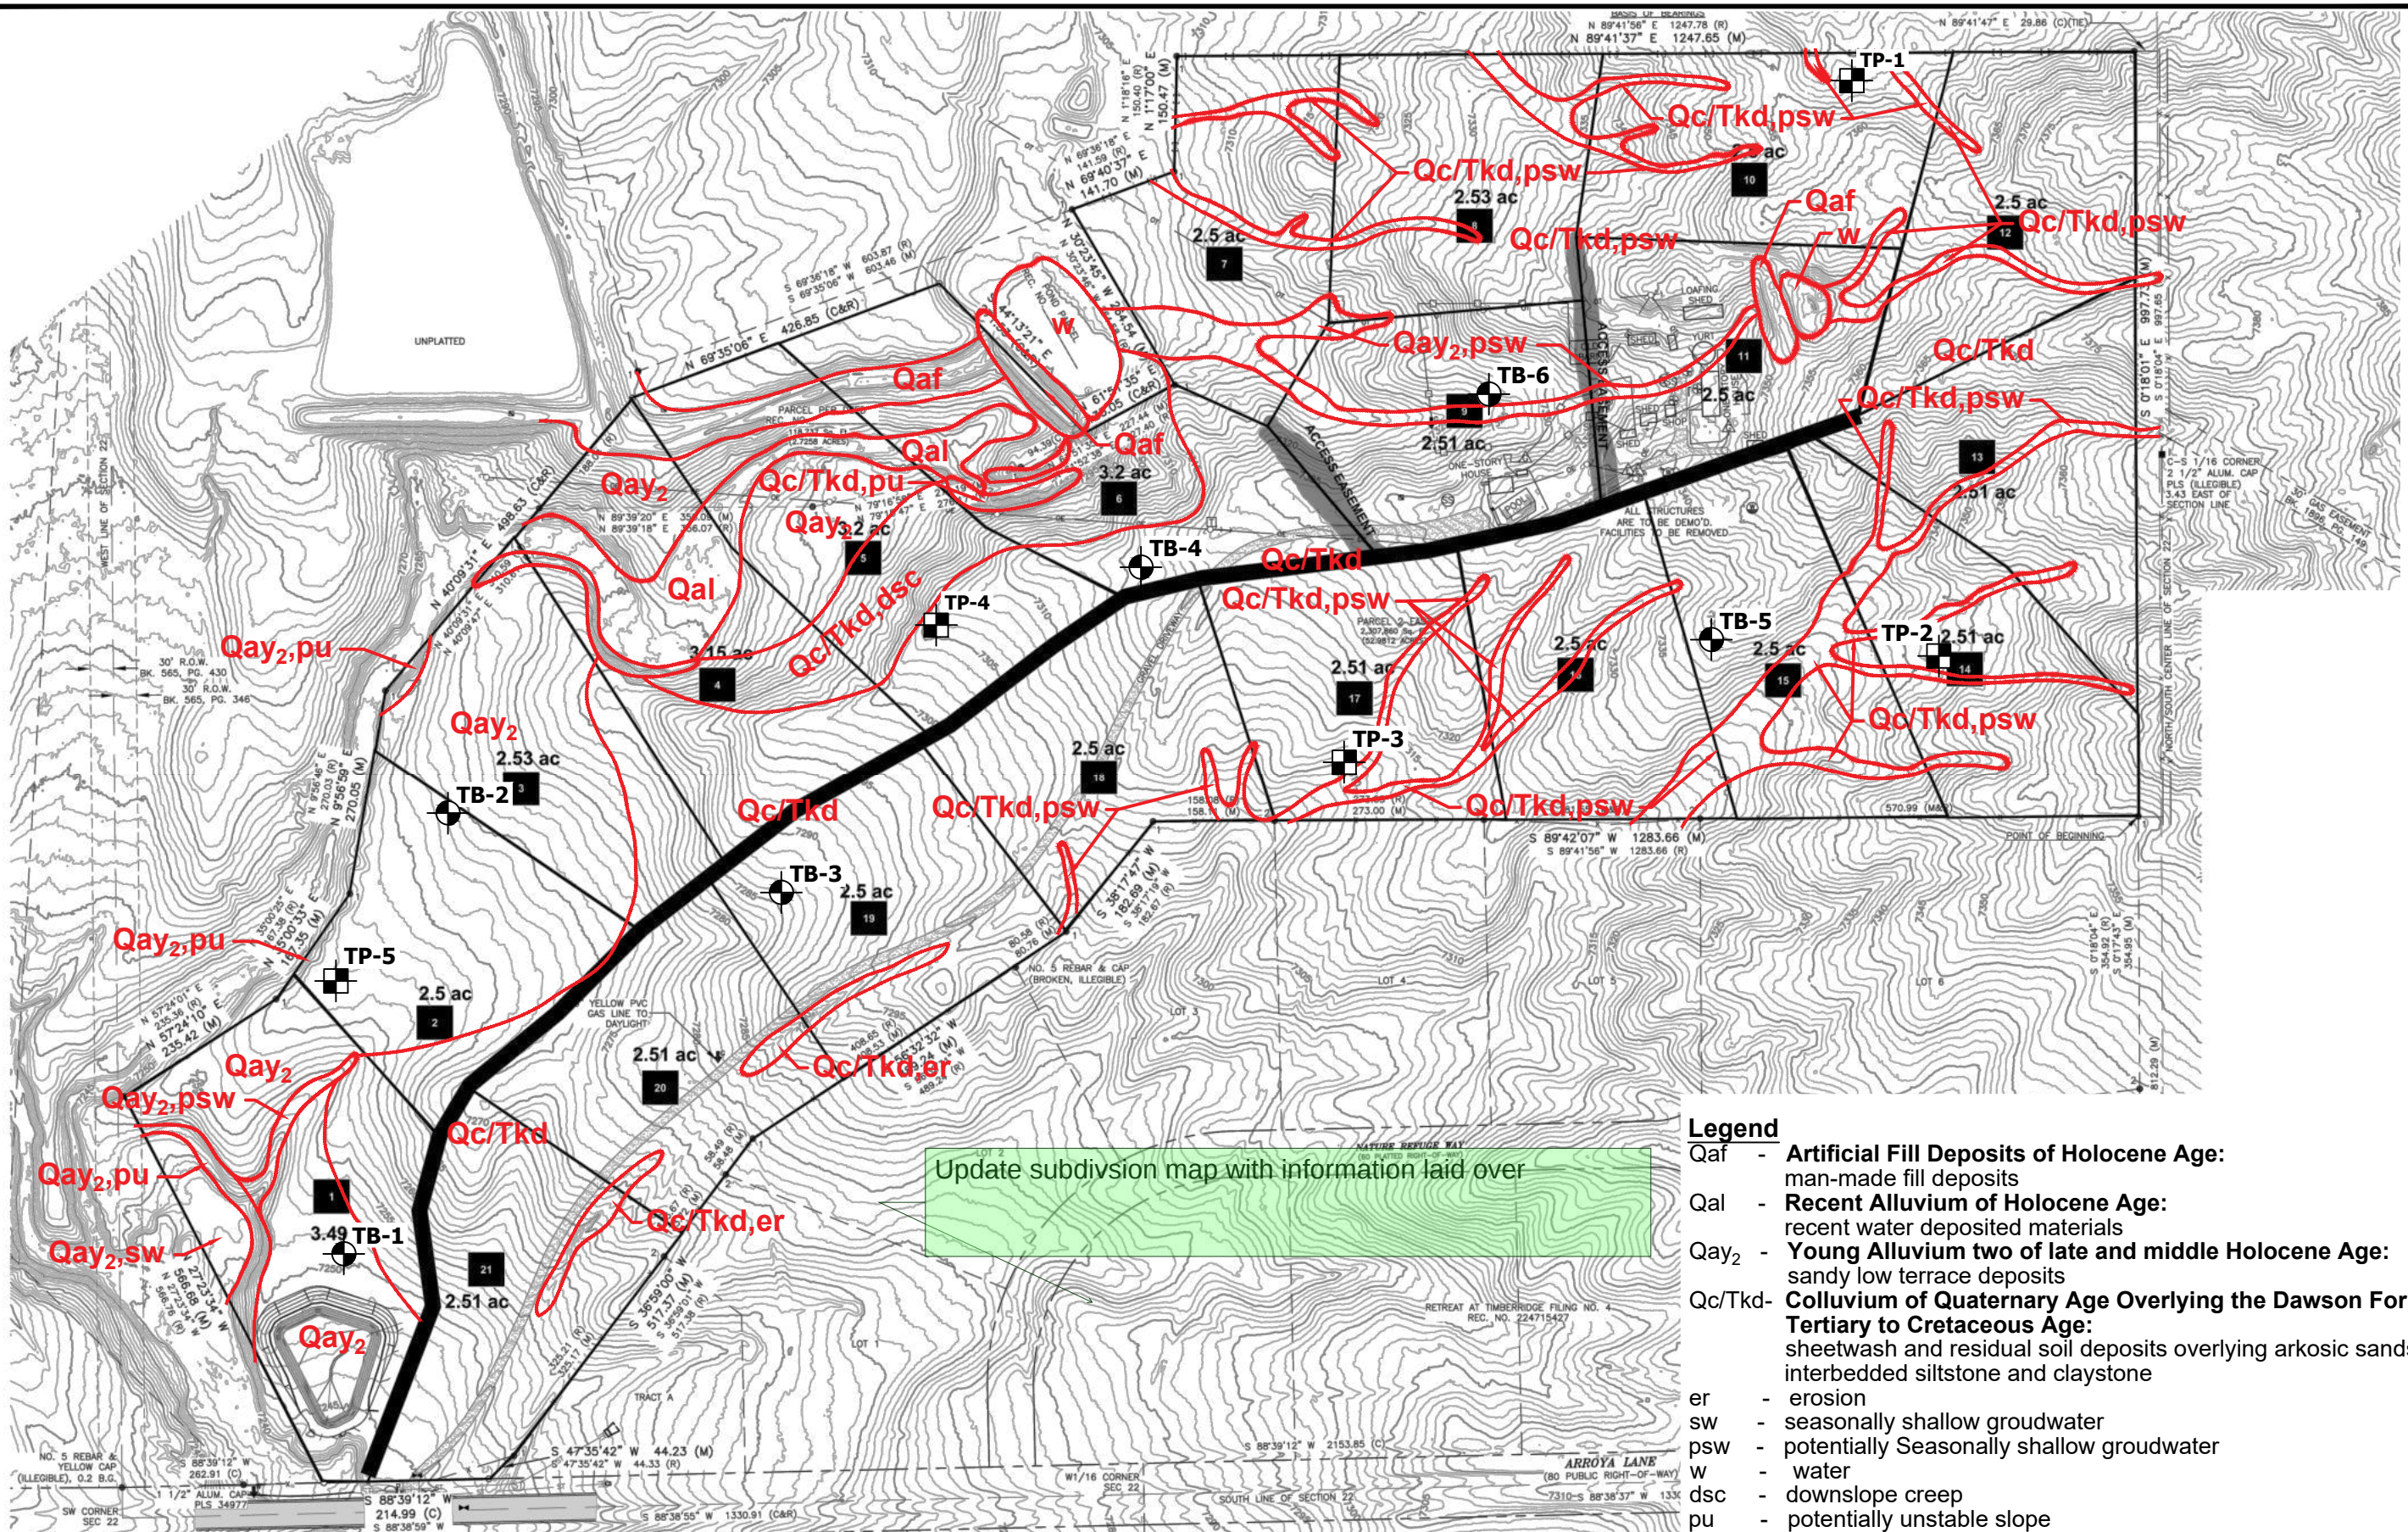
FIG. 6

This site was found to be suitable for the proposed development; however, geologic conditions in certain areas will impose some constraints on development and land use. These include areas of artificial fill, potentially expansive soils, shallow bedrock, seasonal shallow and shallow groundwater areas, drainage areas, downslope creep, potentially unstable slopes, and the potential for elevated radon levels. These conditions are discussed in greater detail in this report.

In general, it is our opinion that the development can be achieved if the observed geologic conditions on site are either properly mitigated or avoided. All recommendations are subject to the limitations discussed in the report.

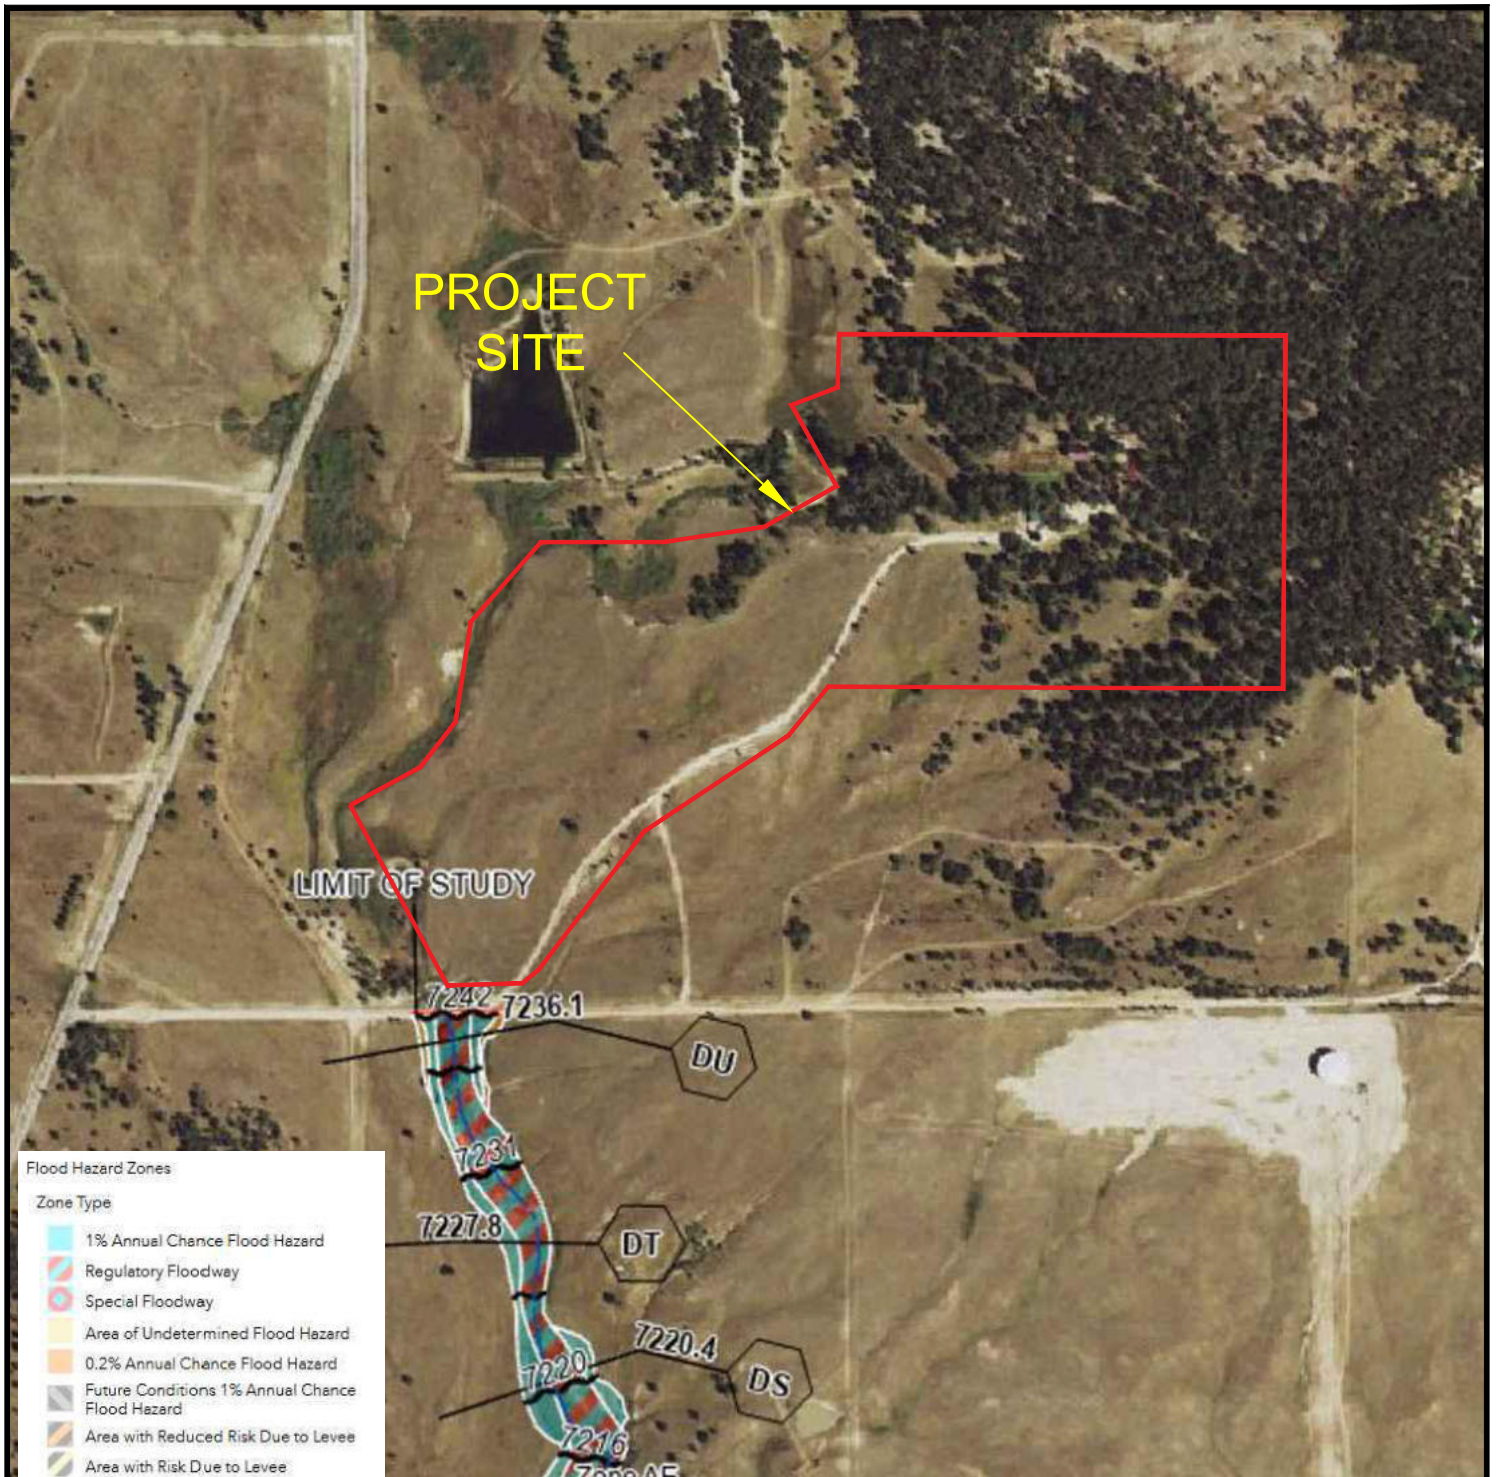
FIG. 7

site is located just north of the limit of study for the FEMA Map No. 08041CO535G, (Figure 7, Reference 12). The drainage/floodplain area will be avoided by the proposed development on the lots.

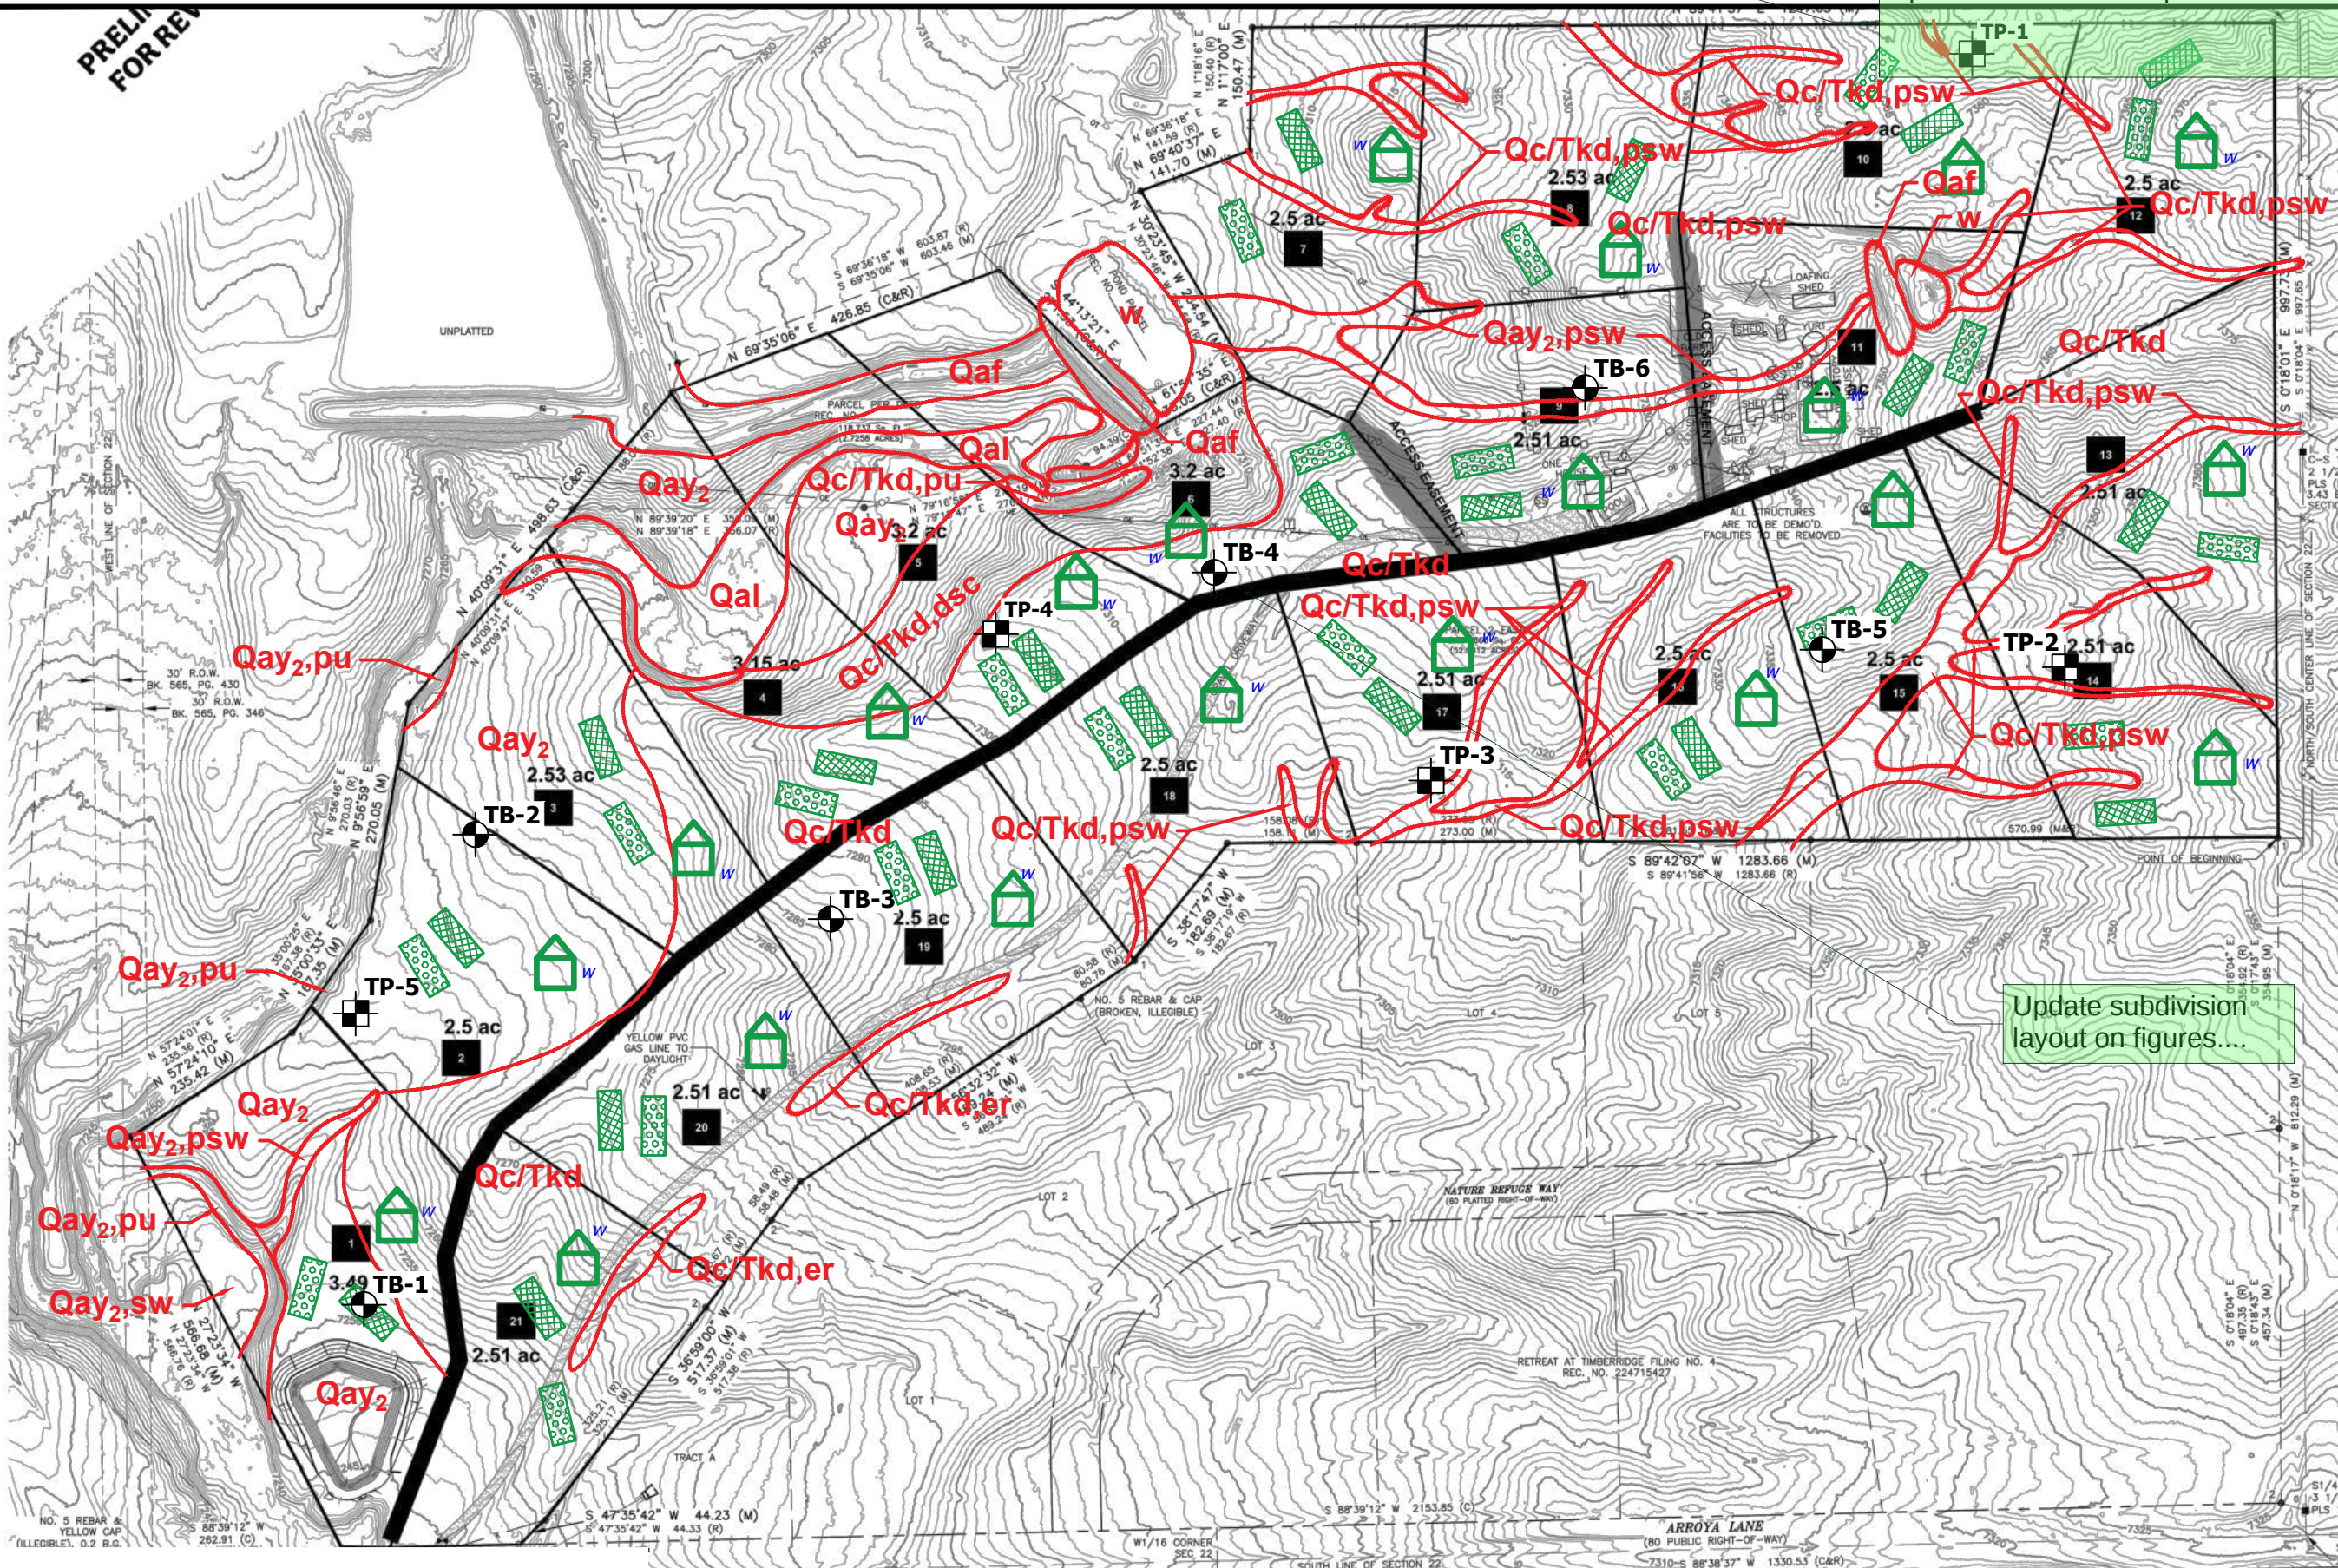
FIG. 9

In summary, it is our opinion that the 2.5 acre lots are suitable for individual on-site wastewater treatment systems (OWTS) and that contamination of surface and subsurface water resources should not occur provided the OWTS sites are evaluated and installed according to El Paso County and State Guidelines and properly maintained. An OWTS Suitability Map is presented in Figure 9. OWTS sites should not be located within defined drainages. Individual soil testing is
