Aquatic Resources Delineation Report
for the
Eagle Forest Subdivision Project
June 2021

Eagle Forest Development, Inc.

Heritage Environmental Consultants

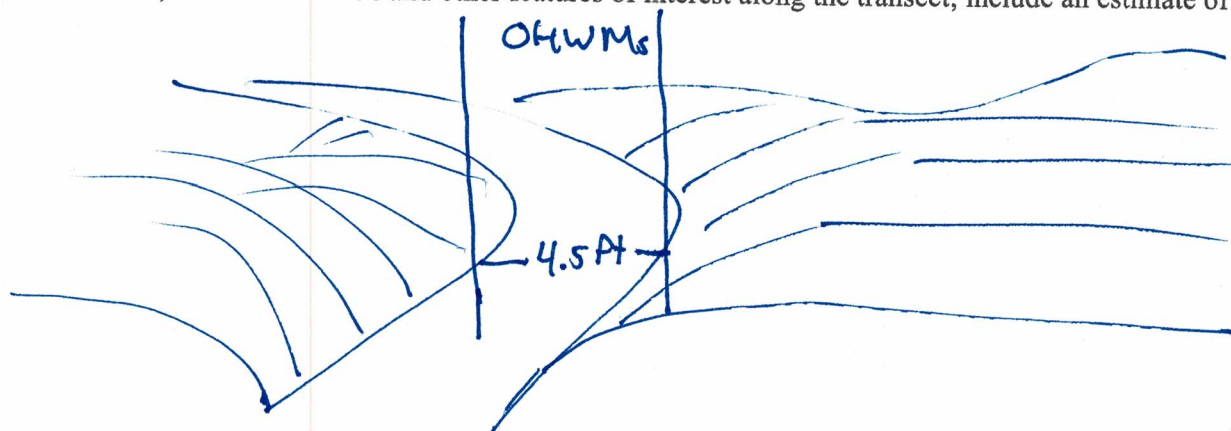
Transect (cross-section) drawing: (choose a location that is representative of the dominant stream characteristics over some distance; label the OHWM and other features of interest along the transect; include an estimate of transect length)

Break in Slope at OHWM: ☐ Sharp ($> 60^\circ$) | ☒ Moderate ($30-60^\circ$) | ☐ Gentle ($< 30^\circ$) | ☐ None

Notes/Description: Slope break varies through reach, but overall moderate
