**GEOLOGIC HAZARD STUDY
KARMAN LINE
SOUTH CURTIS ROAD AND DRENNAN ROAD
EL PASO COUNTY, COLORADO**

October 19, 2022
Revised March 30, 2023

Entech Job No. 230486
AAprojects/2023/230486 Geohaz

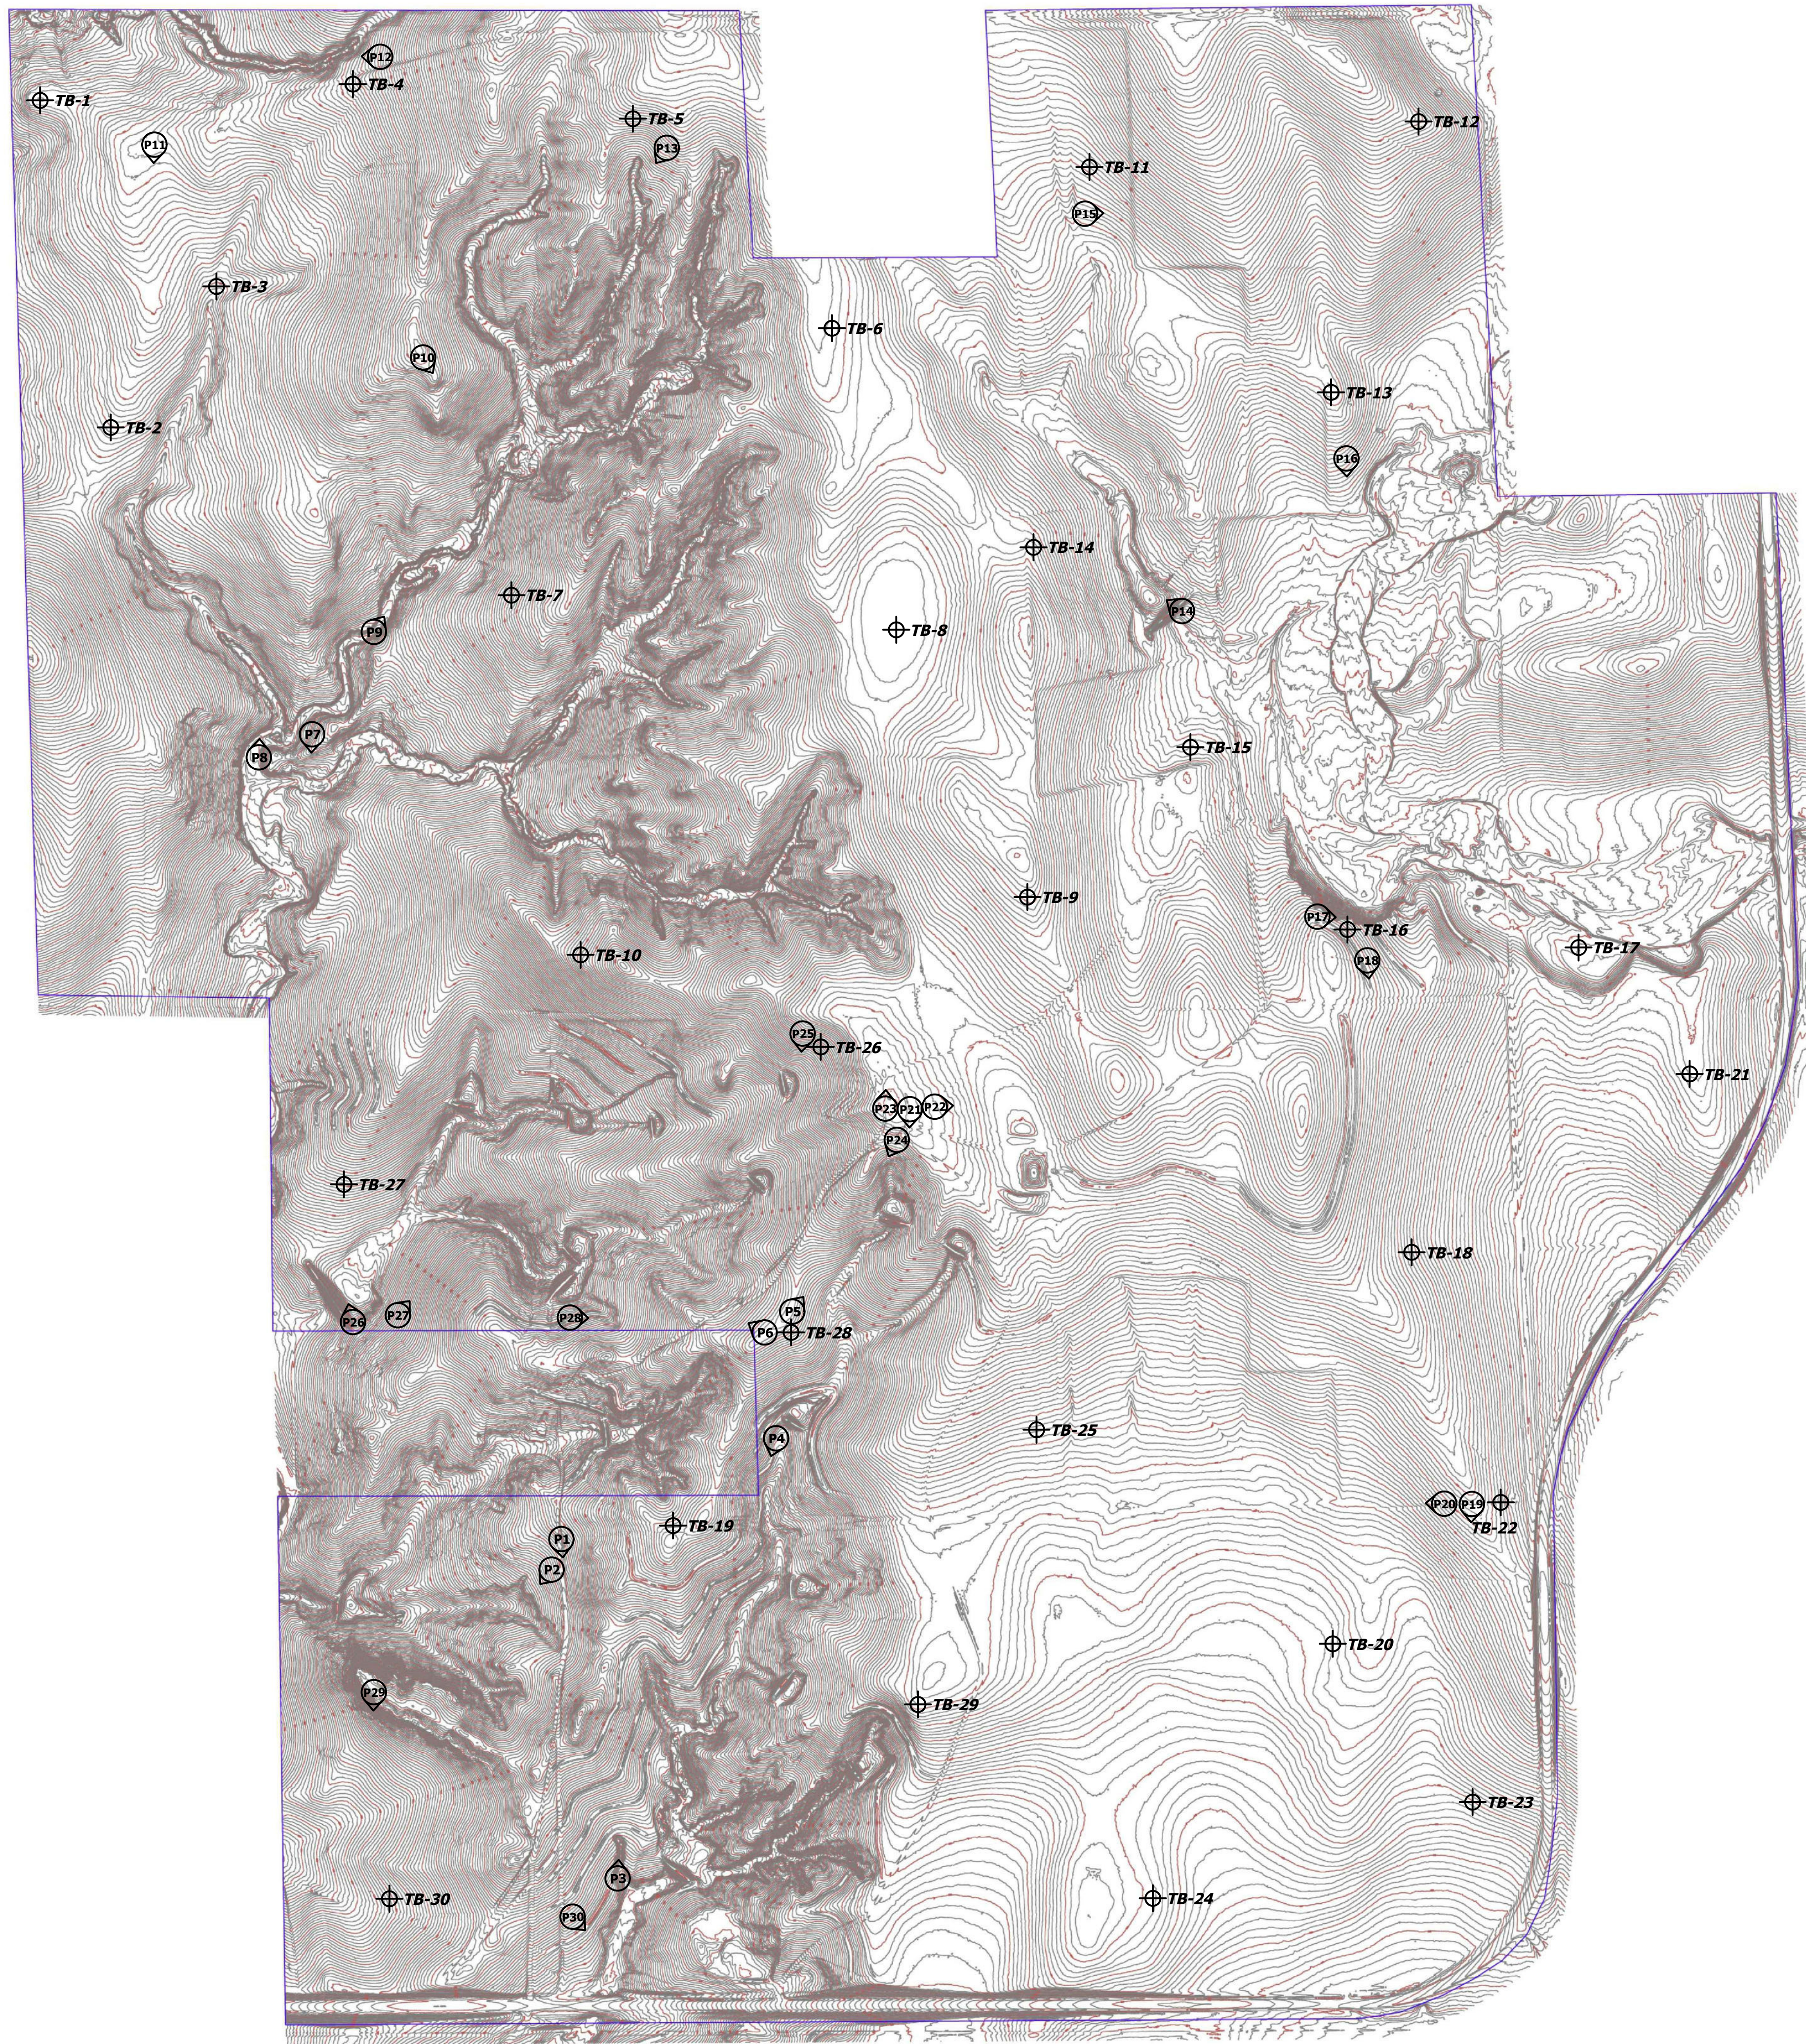
DRAWN LLL CHECKED
DATE 3/30/23
SCALE AS SHOWN
JOB NO. 230486
FIGURE No. 4

Thirty test borings were drilled across the site as part of this investigation to determine general soil and bedrock characteristics. The locations of the test borings are indicated on the Site Plan/Test Boring Location Map, Figure 4. The Test Boring Logs are presented in Appendix B. Results of this testing will be discussed later in this report.

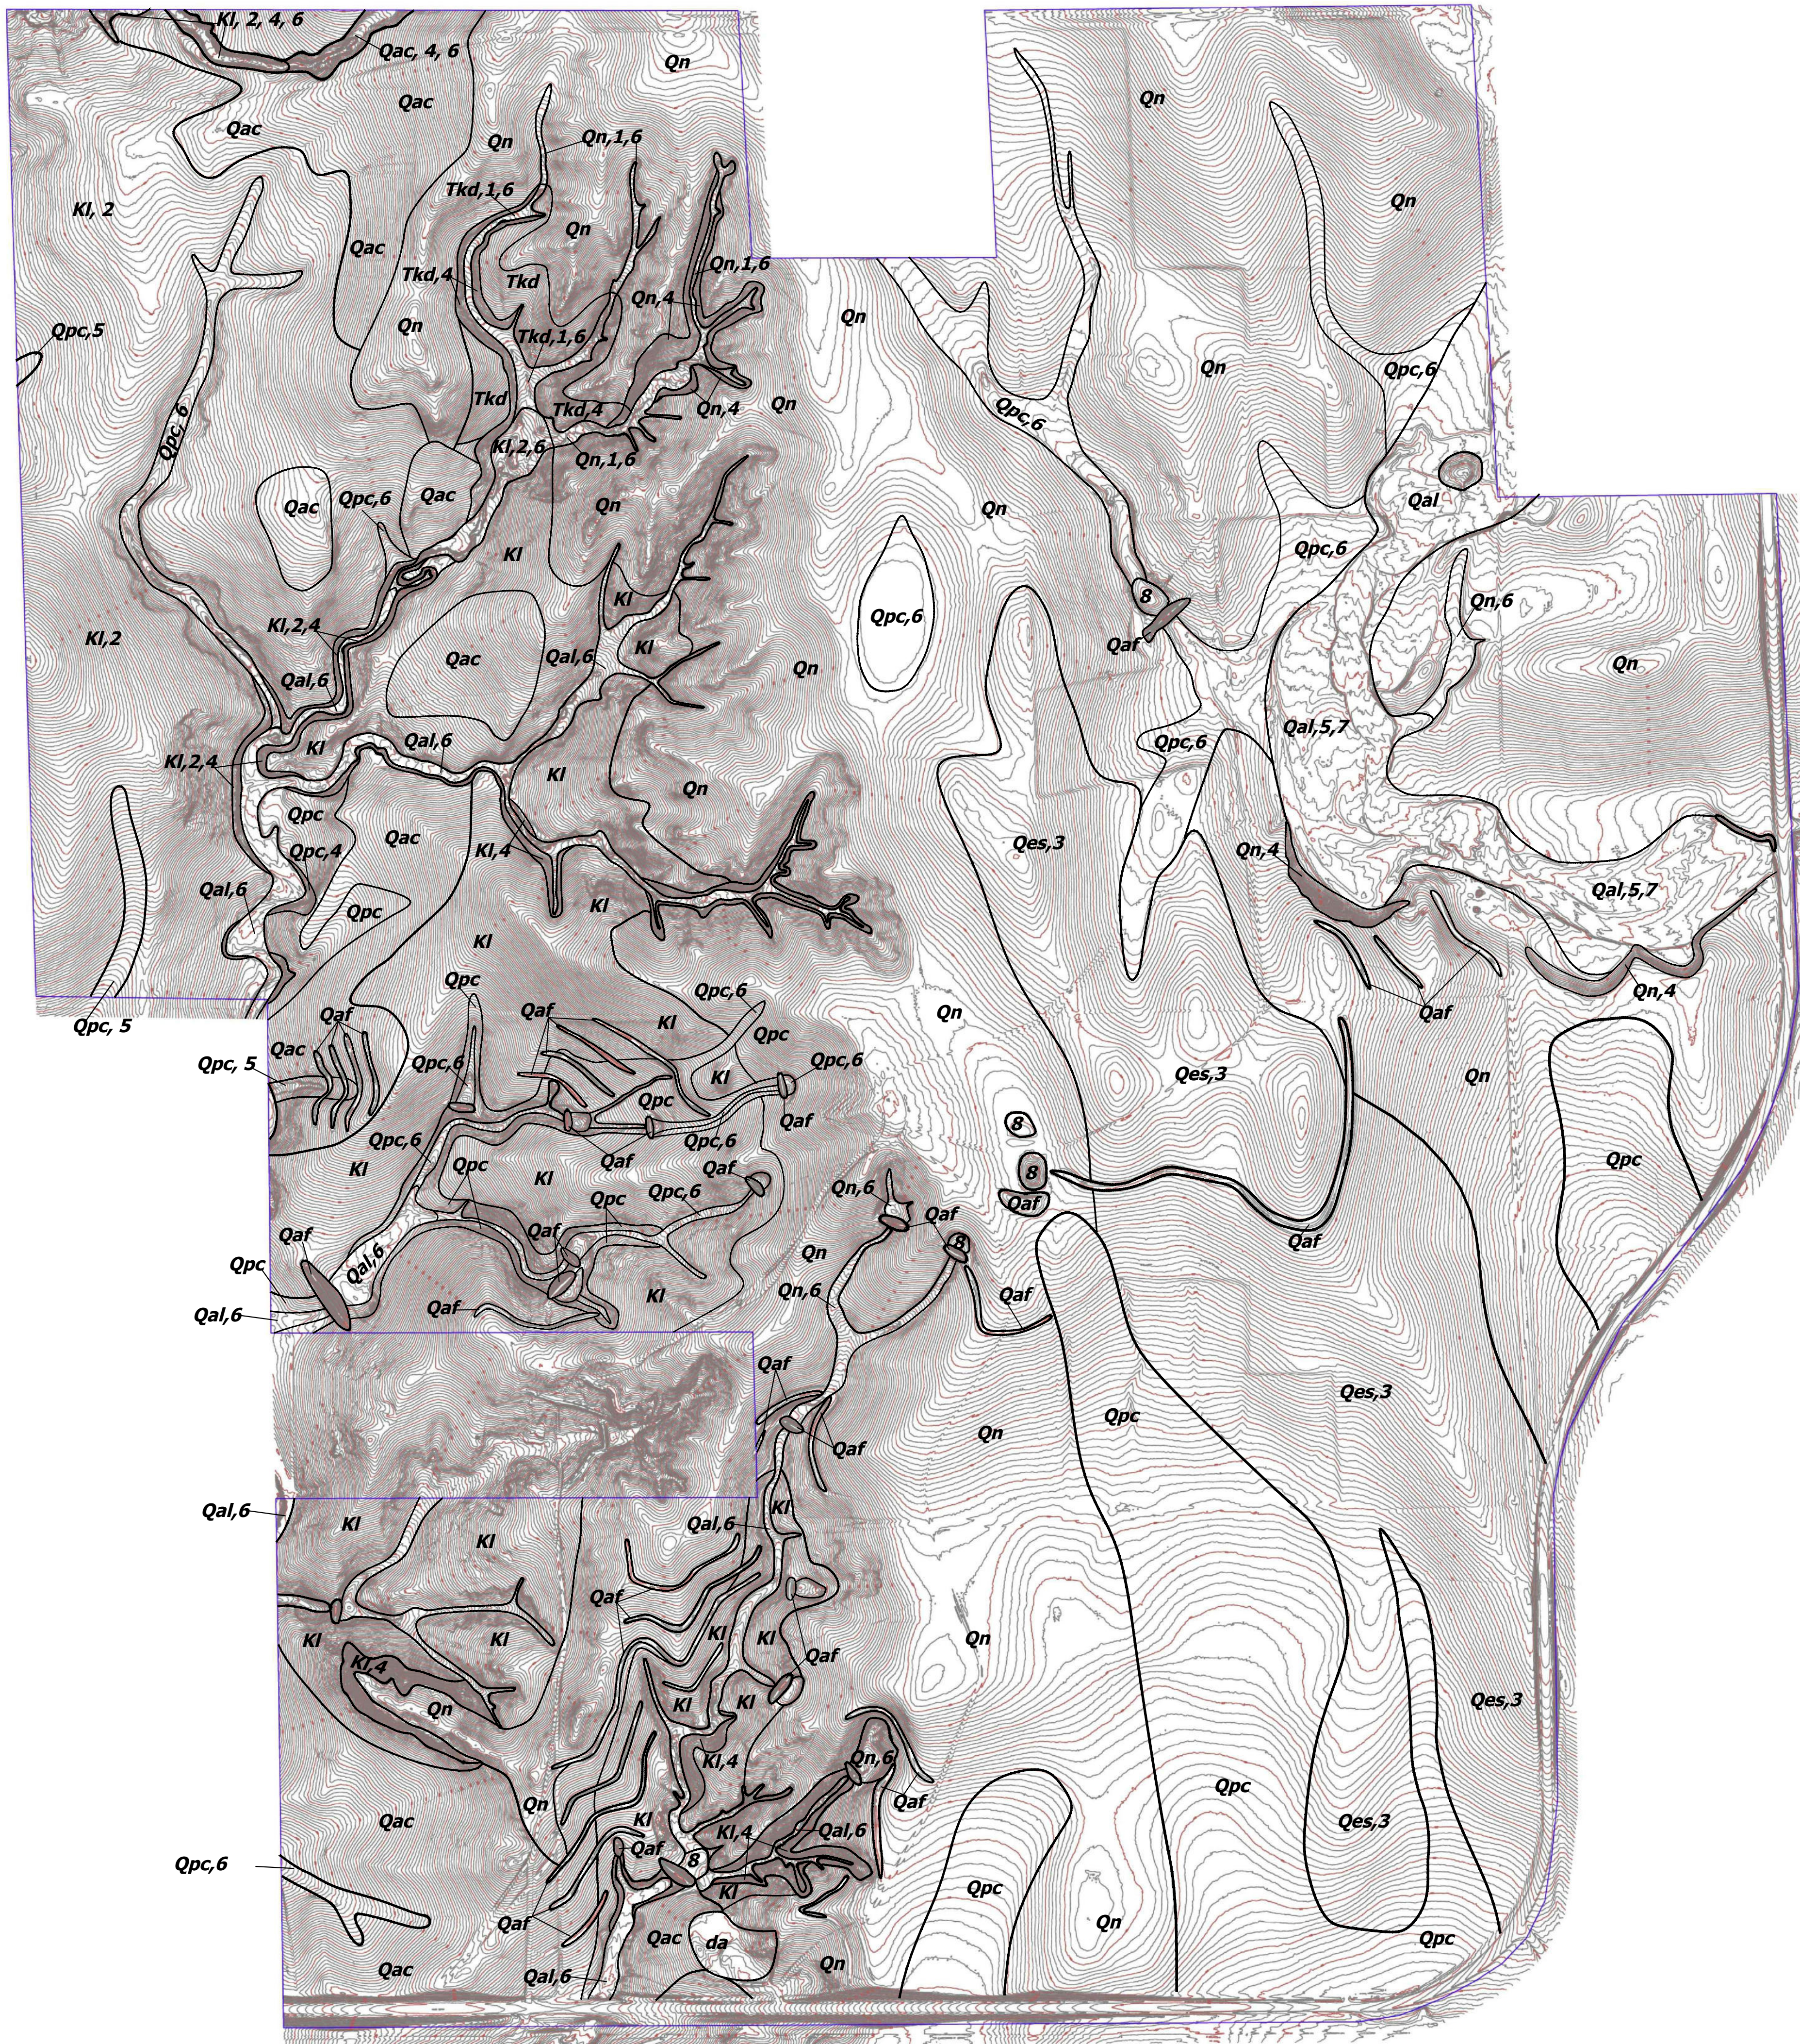
DRAWN	LLL
CHECKED	
DATE	3/30/23
SCALE	AS SHOWN
JOB NO.	230486
FIGURE No.	7

Expansive soils were encountered in some the test borings drilled on site. These occurrences are typically sporadic; they have been indicated on the Geology Map where encountered, Figure 7. The clays and claystone, if encountered at foundation grade, can cause differential movement in structures.

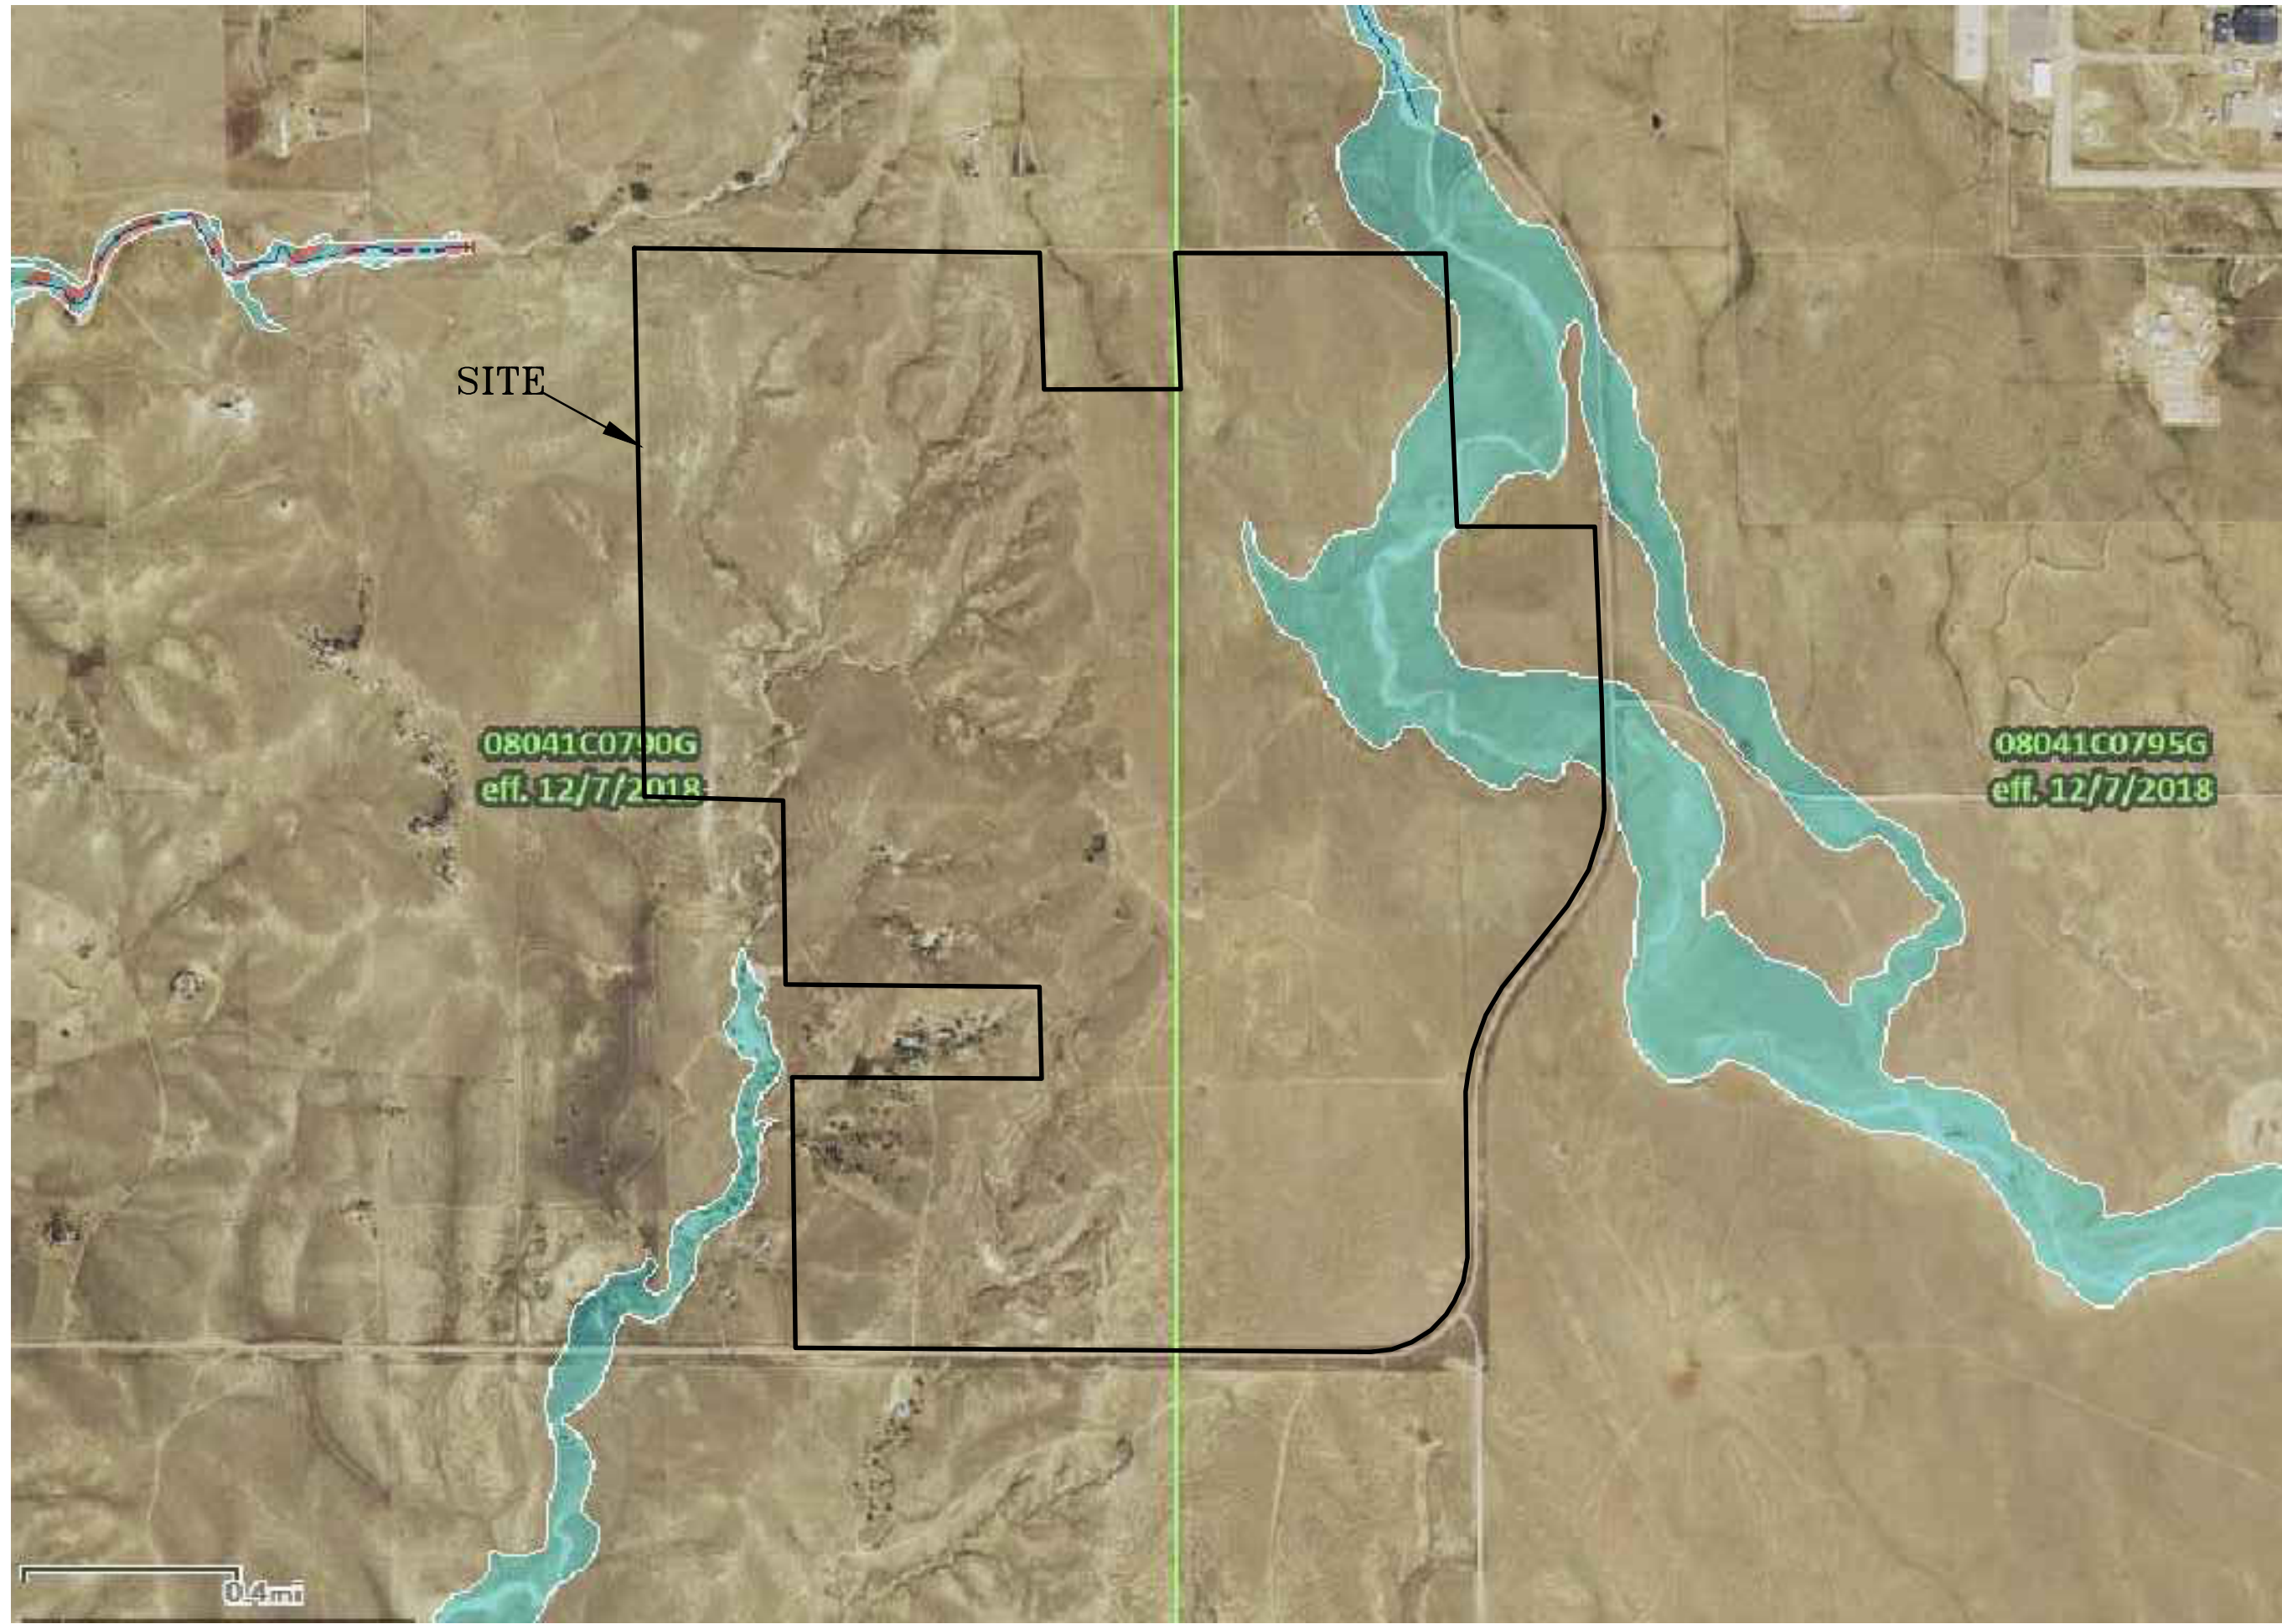
DRAWN LL
CHECKED LL
DATE 3/30/23
SCALE AS SHOWN
JOB NO. 230486
FIGURE No. 8

Williams Creek and associated minor drainages are located in the western portion of the site and an unnamed drainage is located along the eastern side of the site that generally flow in southerly directions. The drainage in the eastern portion of the site has been mapped as floodplain zone according to the FEMA Map Nos. 08041CO790G and 08041CO795G, Figure 8 (Reference 12). Areas where potentially seasonal shallow, seasonal shallow, and ponded water have been indicated on the site geology/engineering geology map, Figure 6. Any construction considered in a floodplain area will require approval. Lots immediately adjacent to the floodplain may experience higher groundwater levels during peak flows. Subsurface perimeter drains are recommended for structures adjacent to the floodplains and drainages to help prevent the intrusion of water into areas below grade. Typical drain details are presented in Figure 10. Finished floor levels must be a minimum of one floor above the floodplain level. **Exact floodplain locations and drainage studies are beyond the scope of this report.**

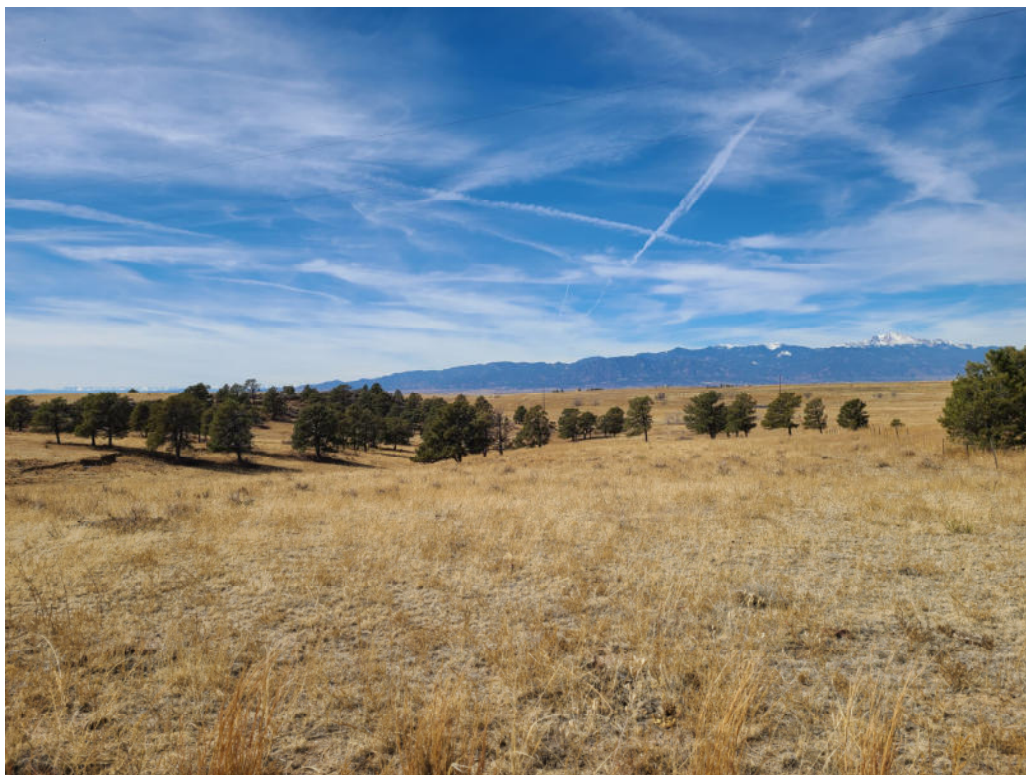
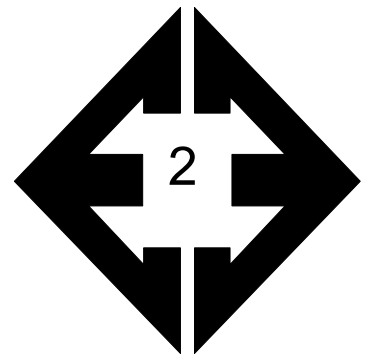
**Looking west toward
rock outcrop and
drainage in the
southwestern portion
of the site.**

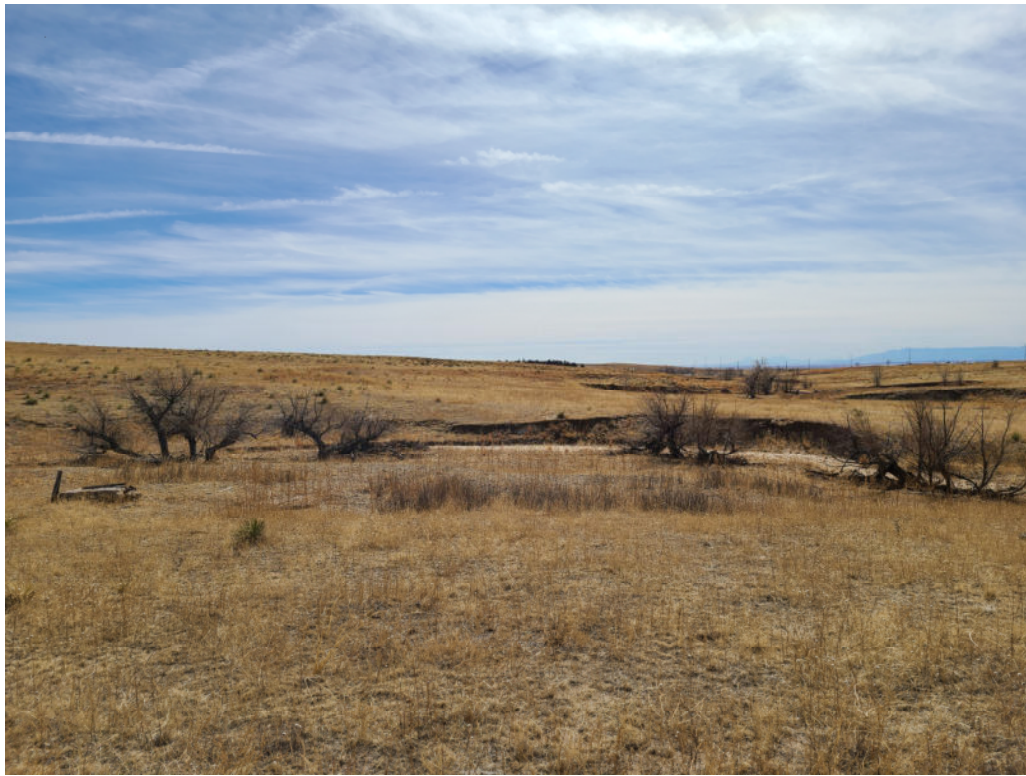
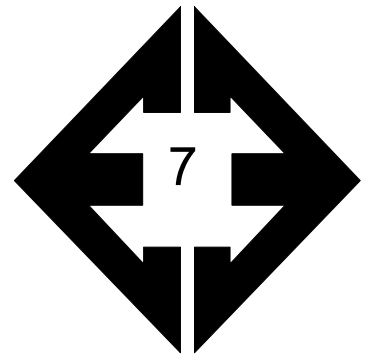
**Looking south from
towards Williams
Creek drainage the
west portion of the
site.**

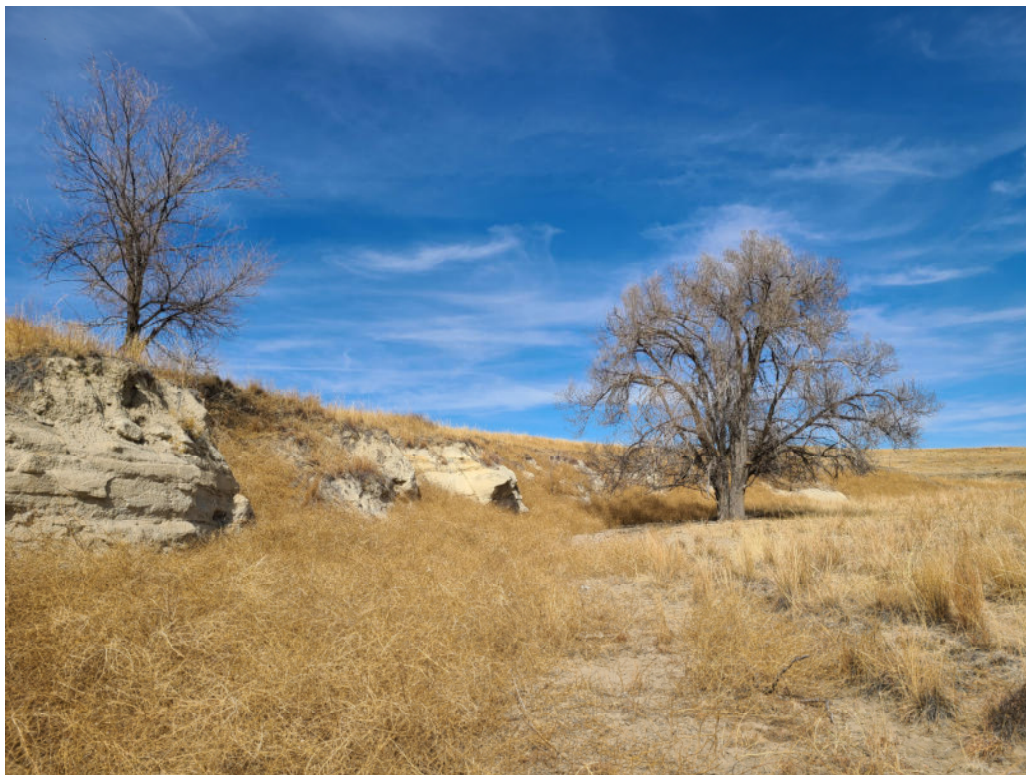
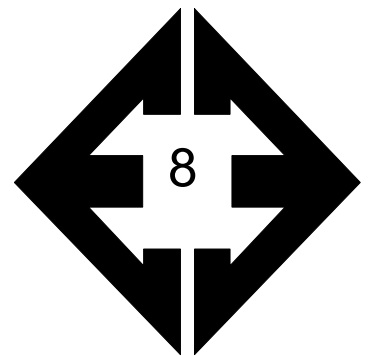
**Looking north along
Williams Creek
drainage in the west
portion of the site.**

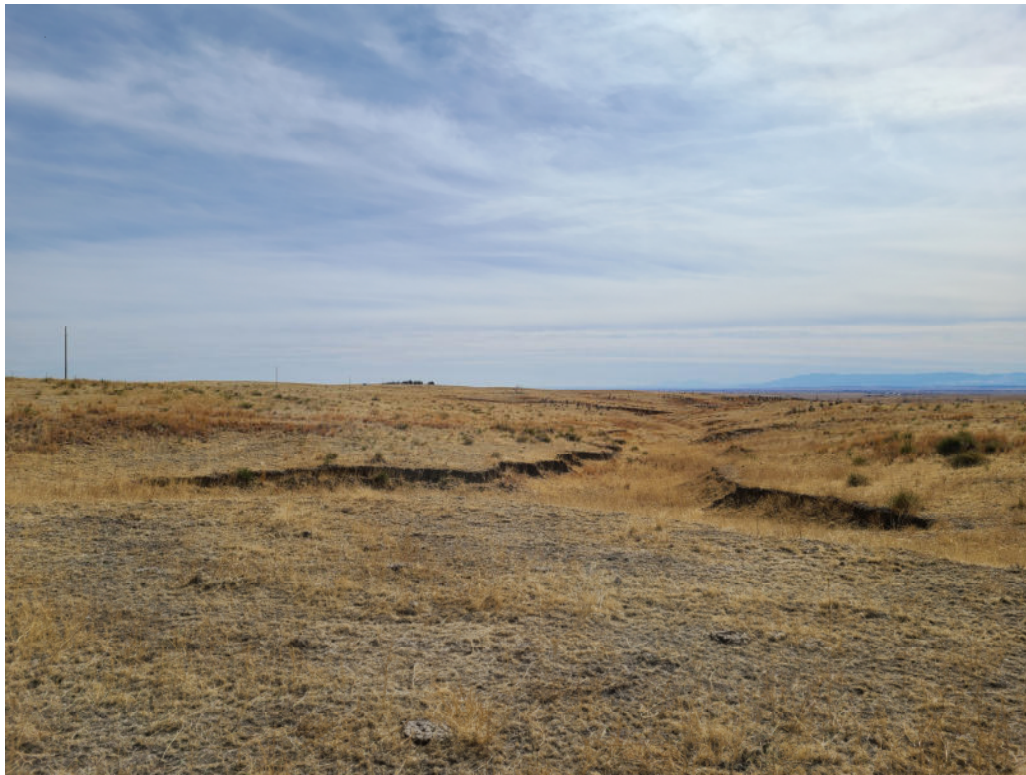
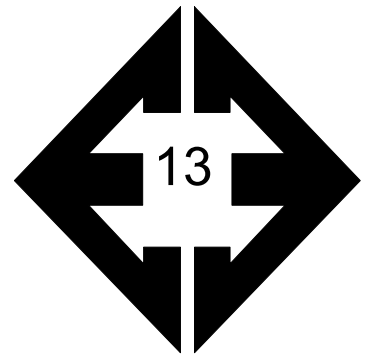
**Looking southwest
along head of drainage
in the northern portion
of the site.**

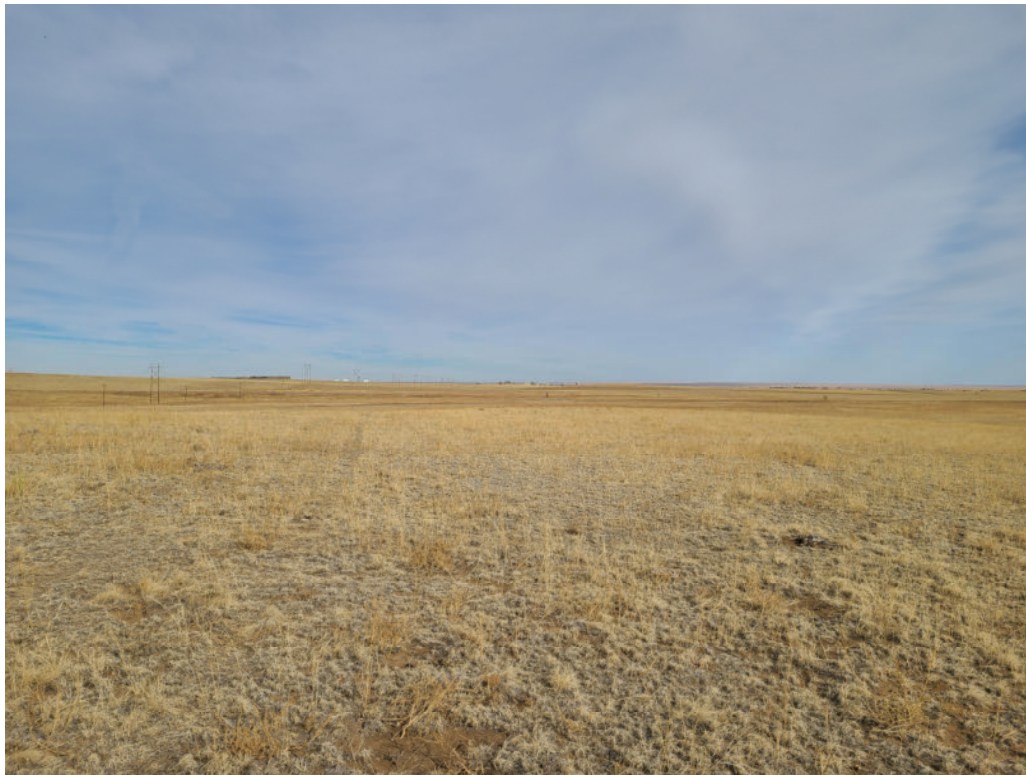
August 15, 2022

**Looking west towards
pond in the
northeastern portion of
the site.**

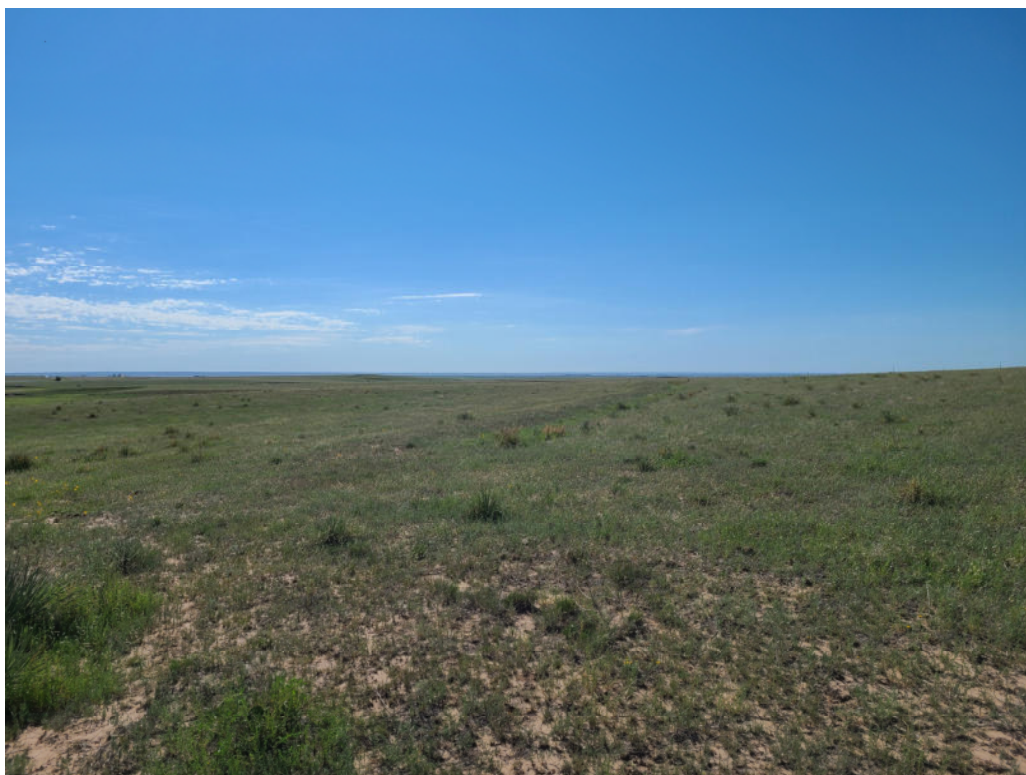
August 15, 2022

**Looking east from
potentially unstable
slopes along drainage
in the east-central
portion of the site.**

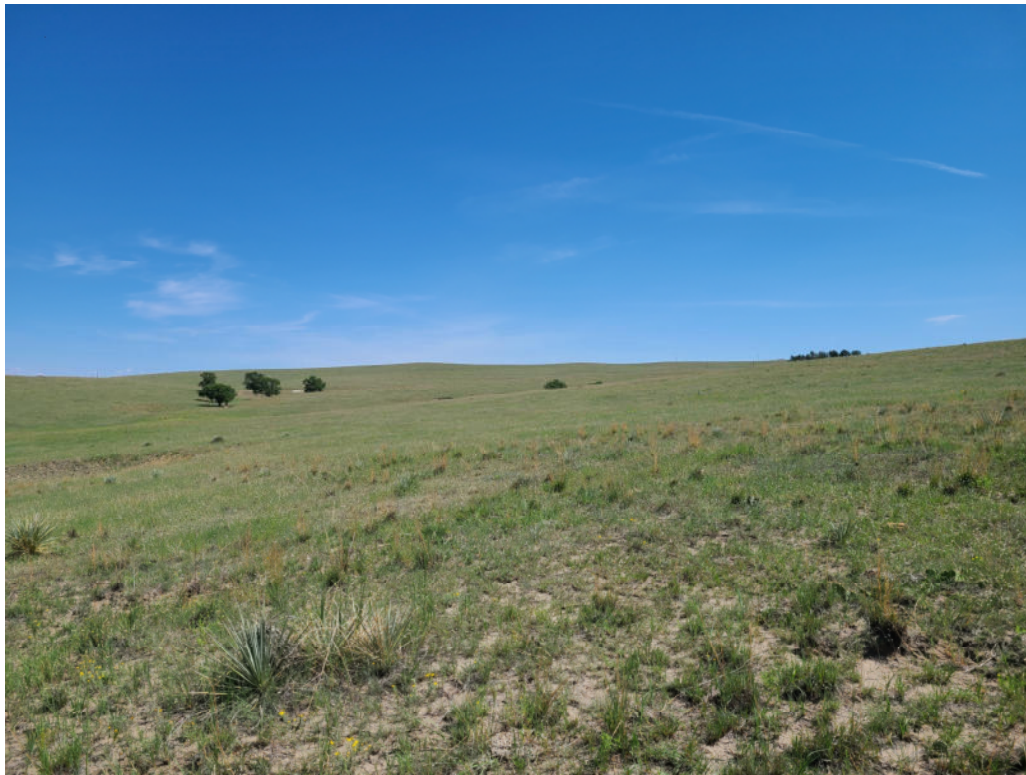
March 14, 2022

Looking north from the western portion of the site along embankment near Williams Creek.

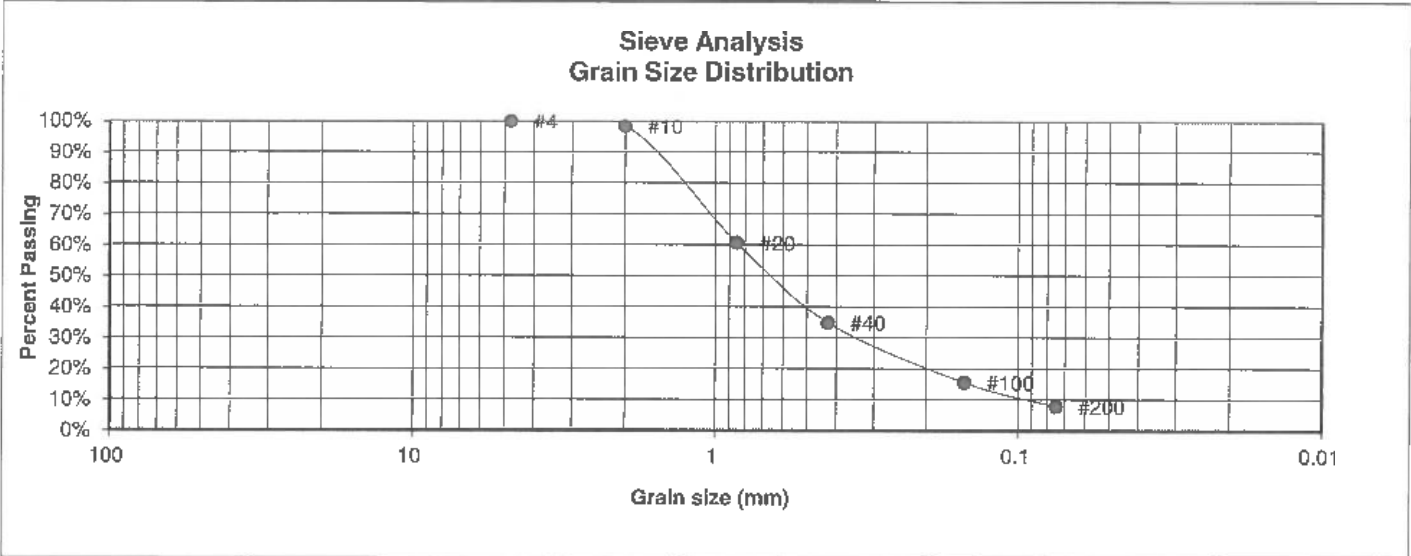
FIG NO.:
C-1

UNIFIED CLASSIFICATION	SM-SW	CLIENT	NORRIS RANCH JOINT VENTURES
SOIL TYPE #	1	PROJECT	NORRIS RANCH
TEST BORING #	16	JOB NO.	230486
DEPTH (FT)	10	TEST BY	BL

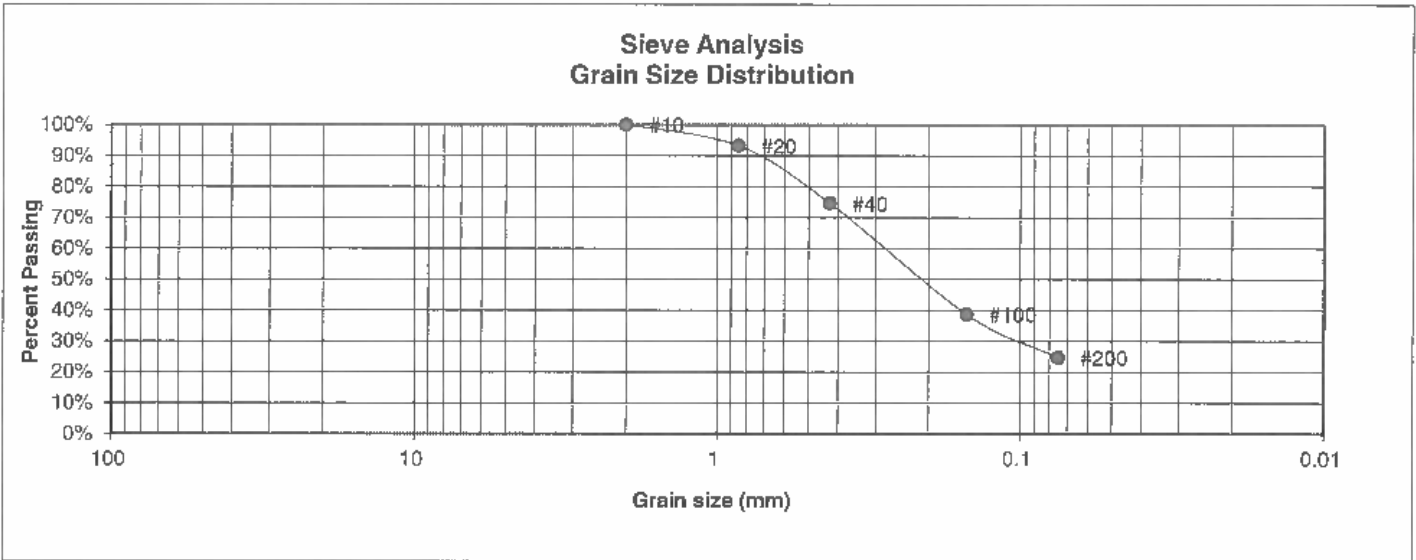
FIG NO.:
C-2

UNIFIED CLASSIFICATION	SM	CLIENT	NORRIS RANCH JOINT VENTURES
SOIL TYPE #	1	PROJECT	NORRIS RANCH
TEST BORING #	6	JOB NO.	230486
DEPTH (FT)	10	TEST BY	BL

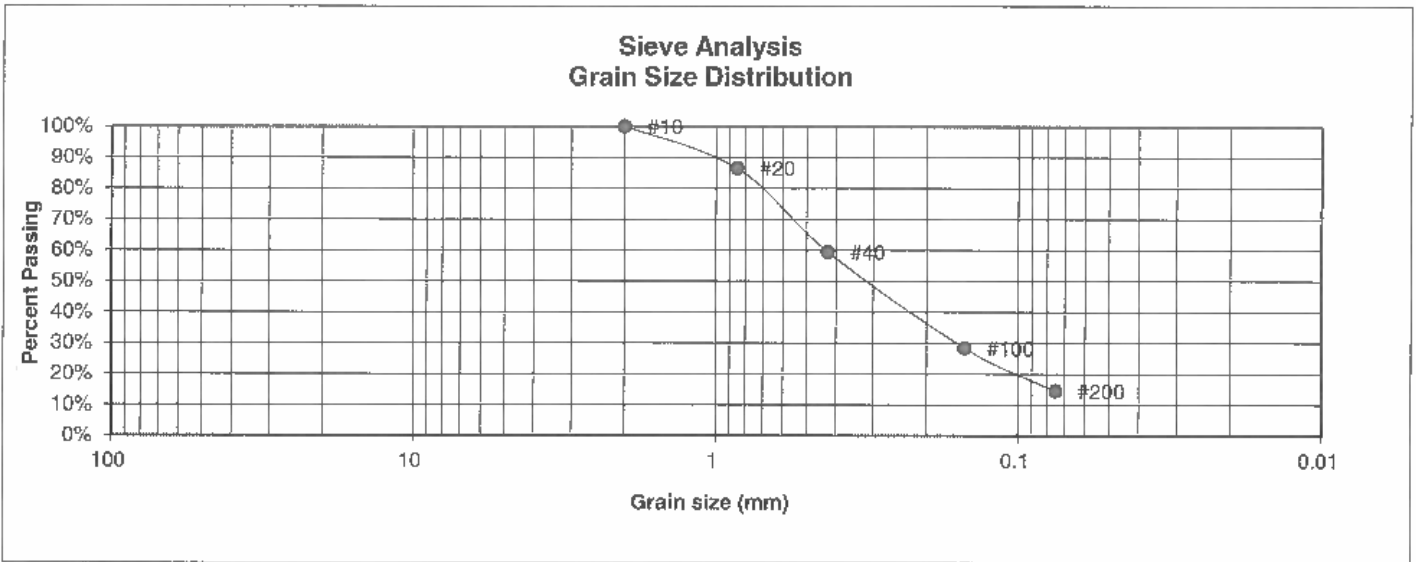
FIG NO.:
C-3

<u>UNIFIED CLASSIFICATION</u>	SM	<u>CLIENT</u>	NORRIS RANCH JOINT VENTURES
<u>SOIL TYPE #</u>	1	<u>PROJECT</u>	NORRIS RANCH
<u>TEST BORING #</u>	9	<u>JOB NO.</u>	230486
<u>DEPTH (FT)</u>	5	<u>TEST BY</u>	BL

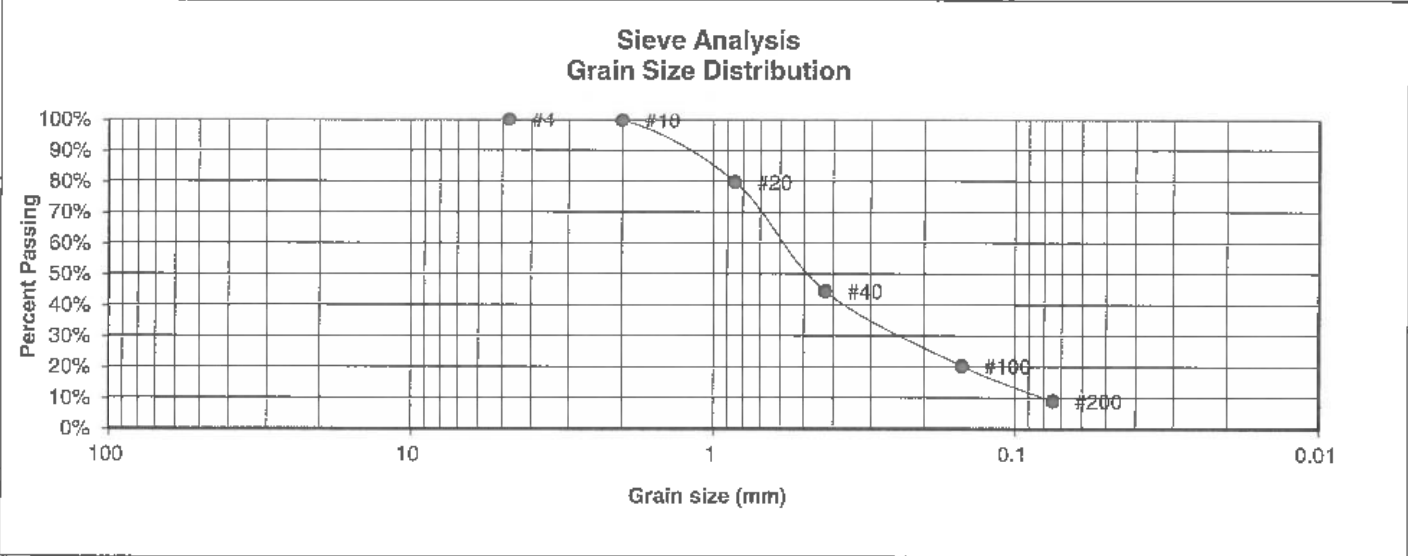
FIG NO.:
C-4

<u>UNIFIED CLASSIFICATION</u>	SM-SW	<u>CLIENT</u>	NORRIS RANCH JOINT VENTURES
<u>SOIL TYPE #</u>	1	<u>PROJECT</u>	NORRIS RANCH
<u>TEST BORING #</u>	10	<u>JOB NO.</u>	230486
<u>DEPTH (FT)</u>	2-3	<u>TEST BY</u>	BL

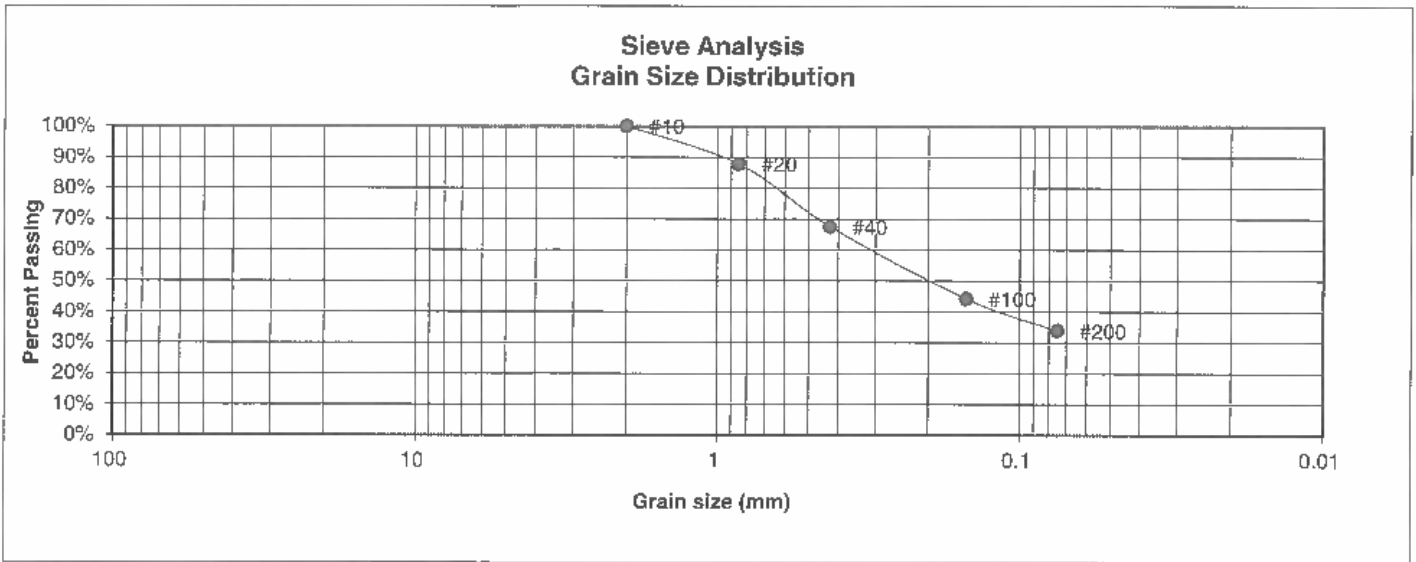
C-5

UNIFIED CLASSIFICATION	SM	CLIENT	NORRIS RANCH JOINT VENTURES
SOIL TYPE #	1	PROJECT	NORRIS RANCH
TEST BORING #	12	JOB NO.	230486
DEPTH (FT)	5	TEST BY	BL

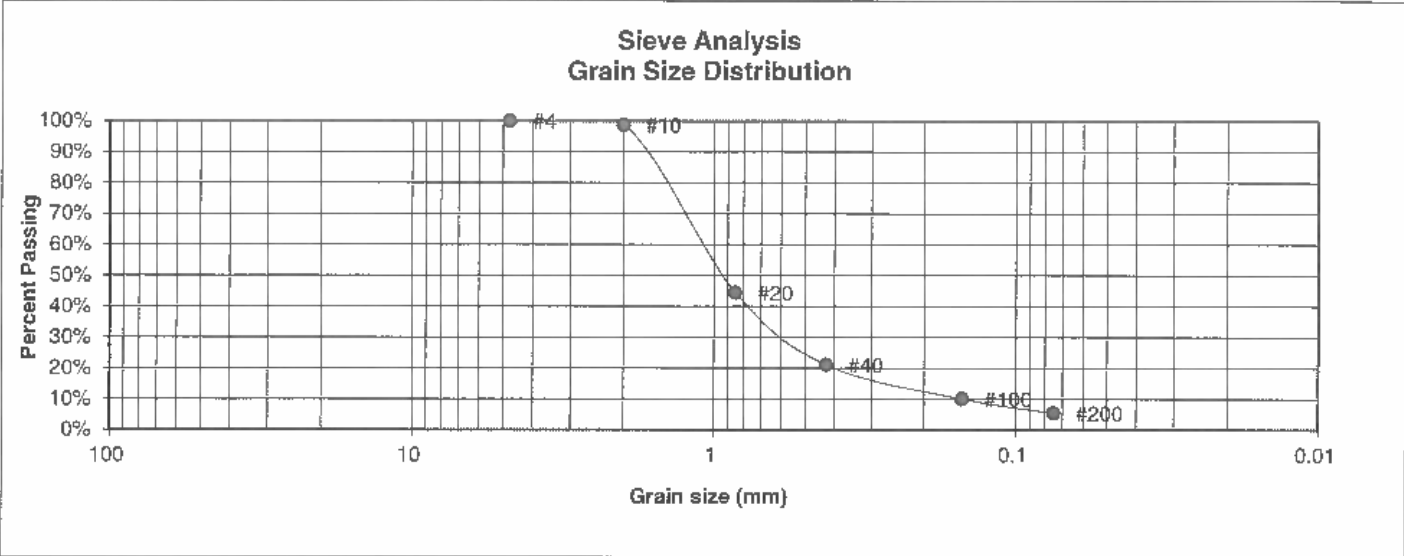
FIG NO.:
L-6

UNIFIED CLASSIFICATION	SM-SW	CLIENT	NORRIS RANCH JOINT VENTURES
SOIL TYPE #	1	PROJECT	NORRIS RANCH
TEST BORING #	13	JOB NO.	230486
DEPTH (FT)	15	TEST BY	BL
