**GEOLOGIC HAZARD STUDY
KARMAN LINE
SOUTH CURTIS ROAD AND DRENNAN ROAD
EL PASO COUNTY, COLORADO**

October 19, 2022
Revised March 30, 2023

Entech Job No. 230486
AAprojects/2023/230486 Geohaz

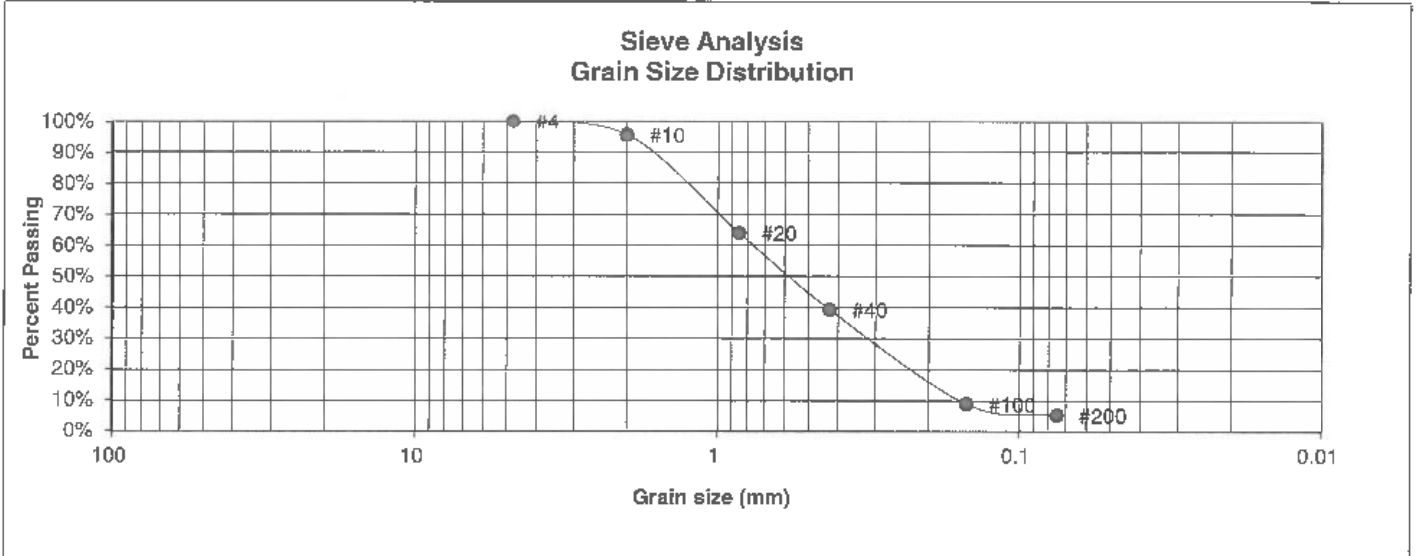
JOB NO.:
230486
FIG NO.:
C-7

UNIFIED CLASSIFICATION	SM-SW	CLIENT	NORRIS RANCH JOINT VENTURES
SOIL TYPE #	1	PROJECT	NORRIS RANCH
TEST BORING #	17	JOB NO.	230486
DEPTH (FT)	5	TEST BY	BL
