WASTEWATER DISPOSAL REPORT

FOR KNECHT SUBDIVISION

DECEMBER 2024 – FINAL REPORT

Project Number W0265.24026

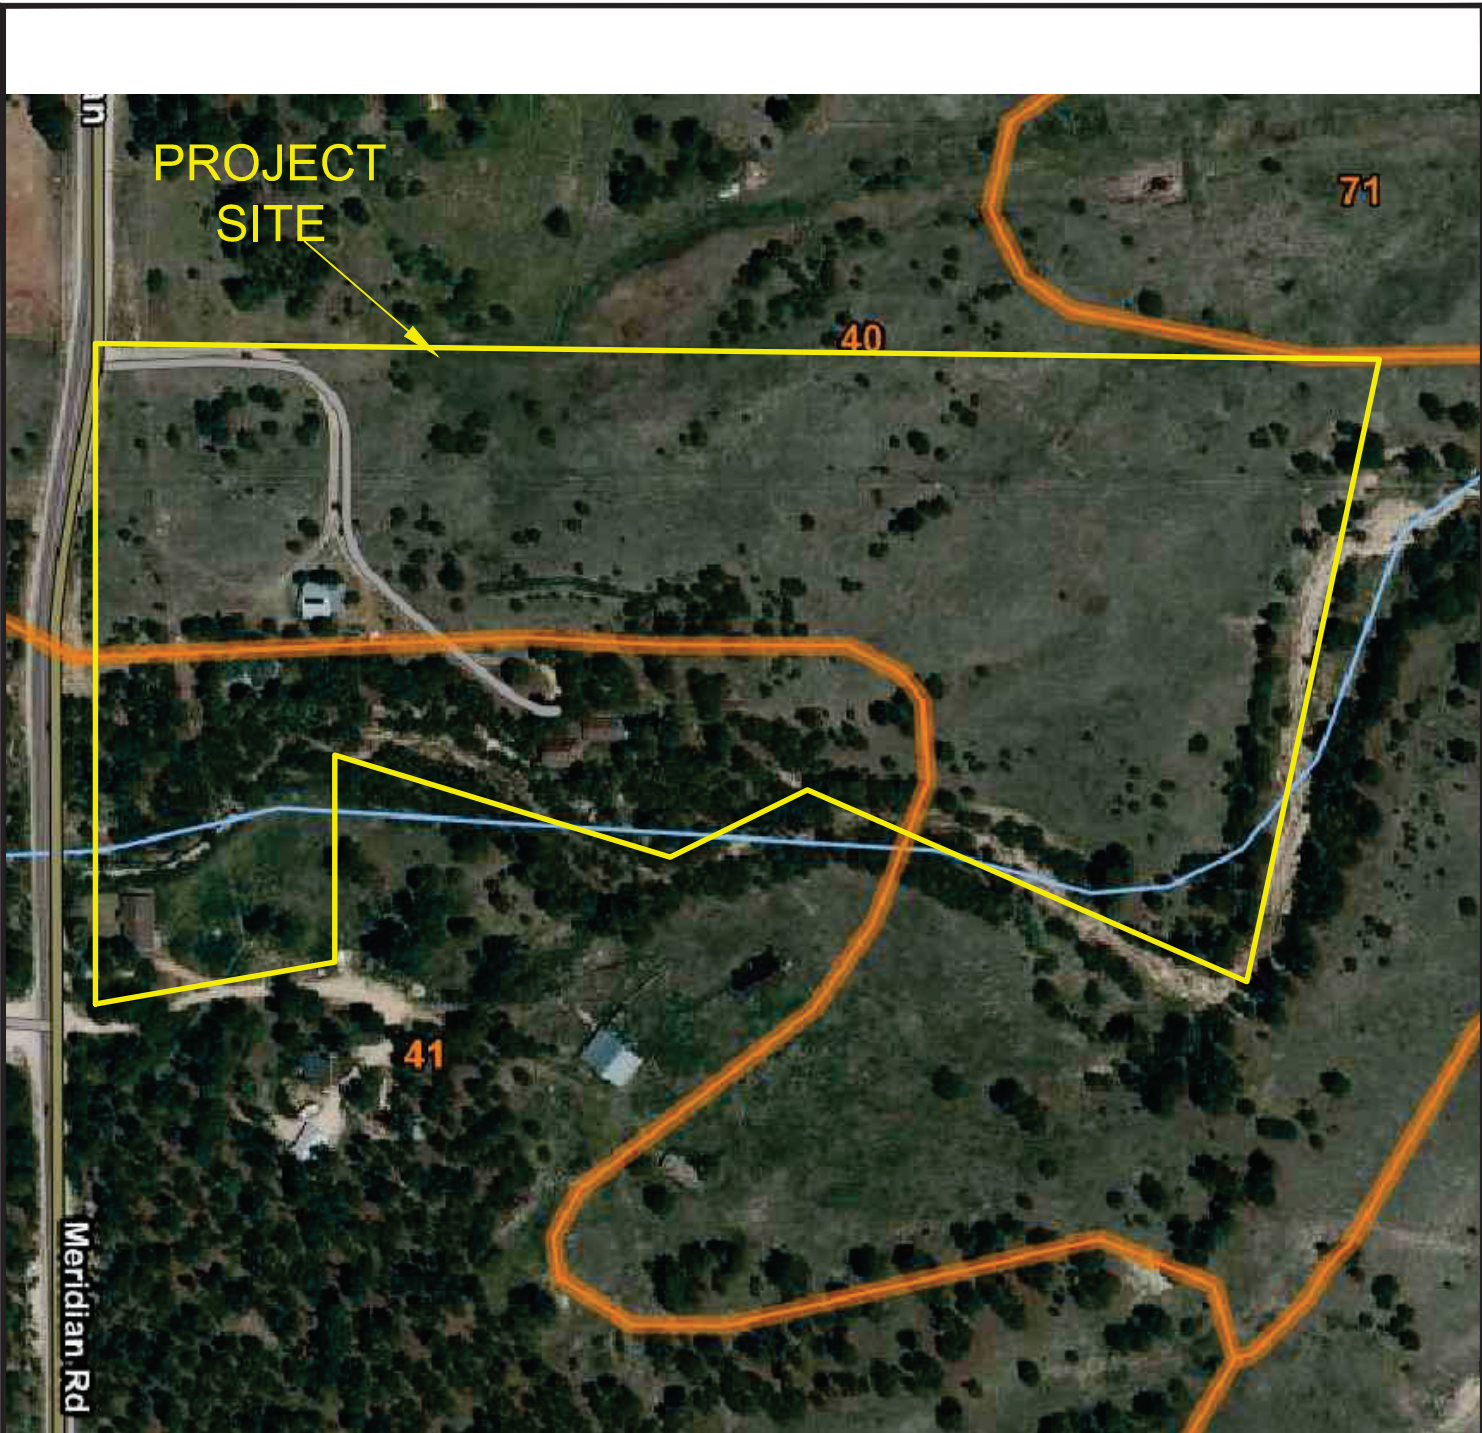
FIG. 4

The soils have been described to have moderate to rapid permeabilities. The soils are described as well suited for use as homesites. Possible hazards with soils erosion are present on the site. The erosion potential can be controlled with vegetation. The soils have been described to have moderate erosion hazards (Reference 2).
