**GEOLOGIC HAZARD INVESTIGATION
SPRINGS RANCH
TAX SCHEDULE NOS. 53301-00-009,
AND 53301-00-020
COLORADO SPRINGS, COLORADO**

September 5, 2019

Job No. 191264

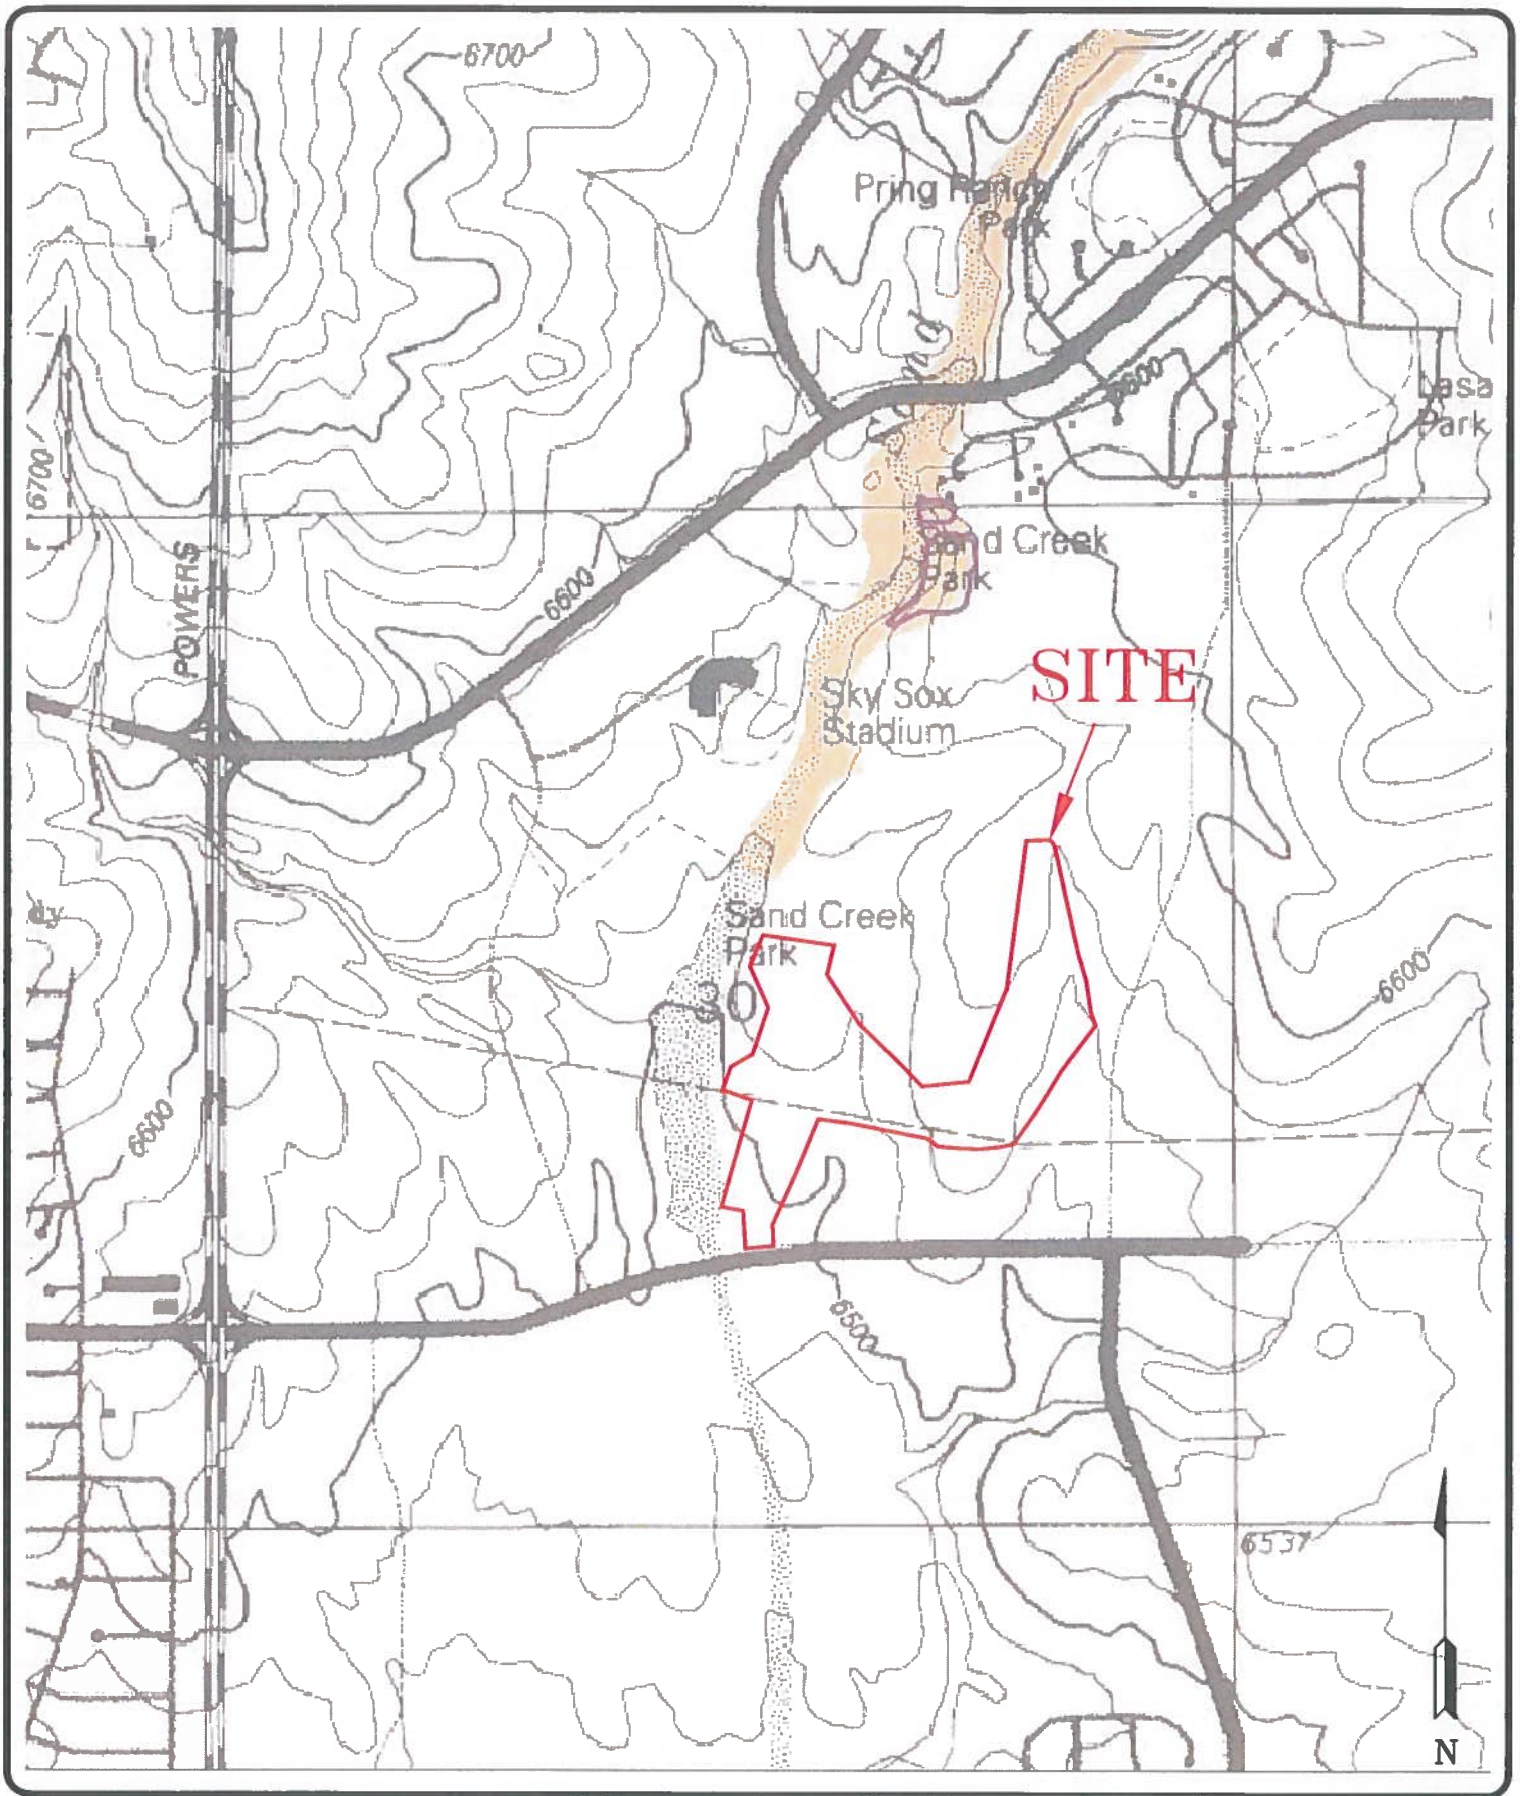
FIG NO.:
 7

The site is not mapped within any past landslide deposits according to the *Map of Potential Areas of Landslide Susceptibility in Colorado Springs* by White and Wait, 2003, distributed by The Colorado Geological Survey (Reference 7, Figure 7). The majority of the site is gently to moderately sloping. The slopes along Sand Creek immediately west of the site are moderately steep. No unstable slopes or past or recent landslide features were observed on the site.
