GEOLOGIC HAZARD STUDY

**The Ridge at Spring Creek, Filing No. 1
Colorado Springs, Colorado**

JOB NO. 197354

October 14, 2024

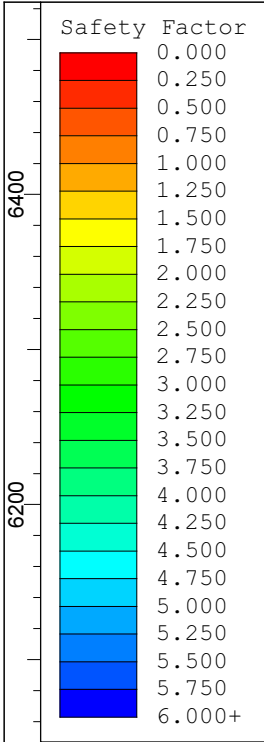
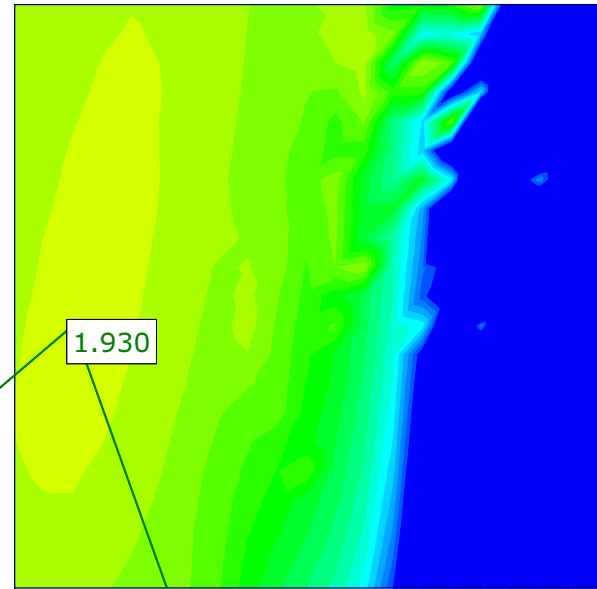
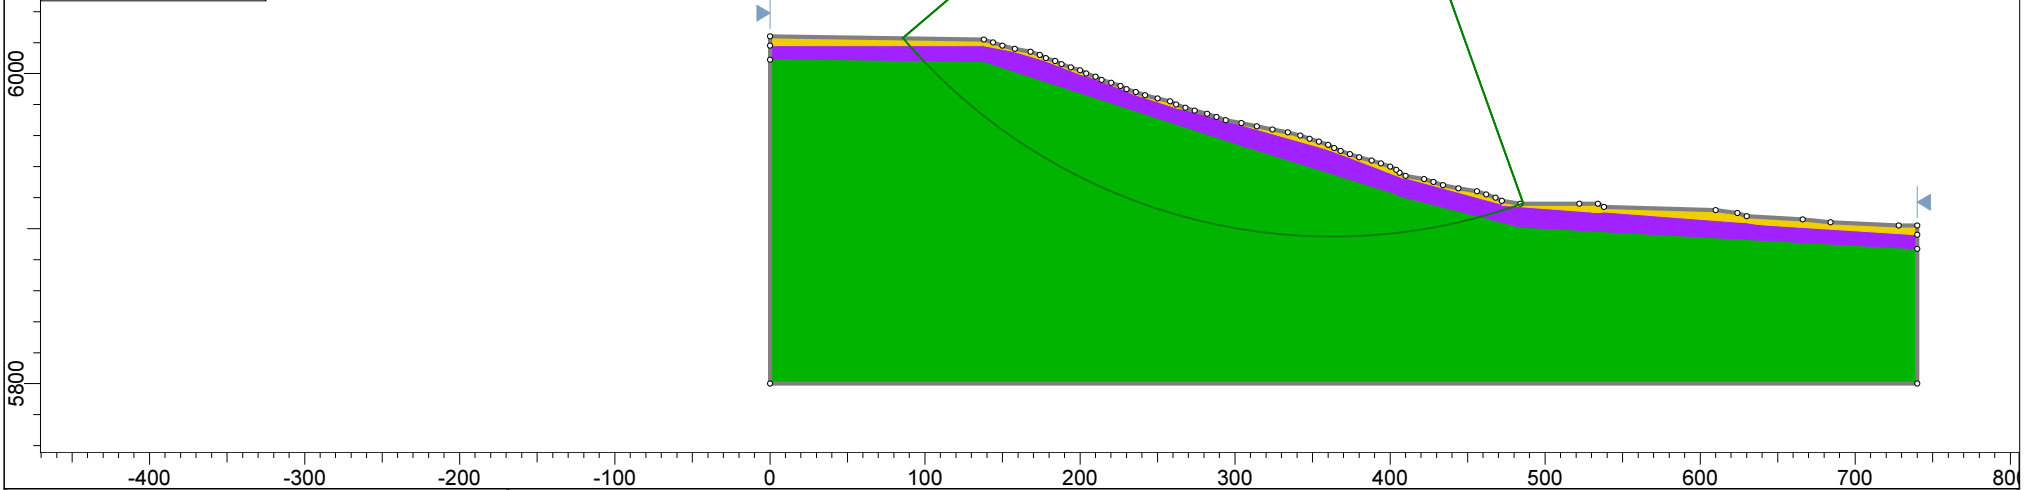
Project			The Ridge at Spring Creek Filing No. 1		
	Analysis Description			A-A Existing		
	Drawn By	Jared	Scale	1:1486	Company	RMG
	Date	10/14/2024	File Name	SlideA-A2_Existing.slim

Output of our Slope Stability Analyses is presented in Appendix A, the slope stability cross-section is presented on Figure 10. The results of our analyses are presented in the following table:

Method Name	Min FS
Bishop simplified	1.930
Janbu corrected	1.897

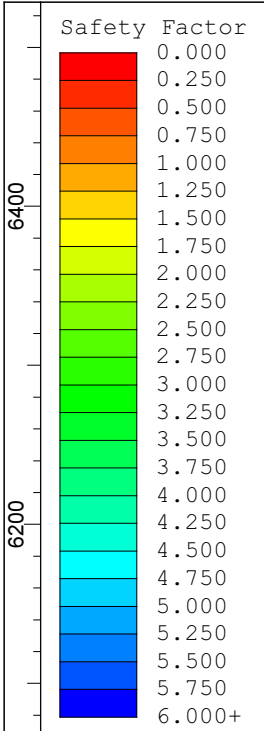
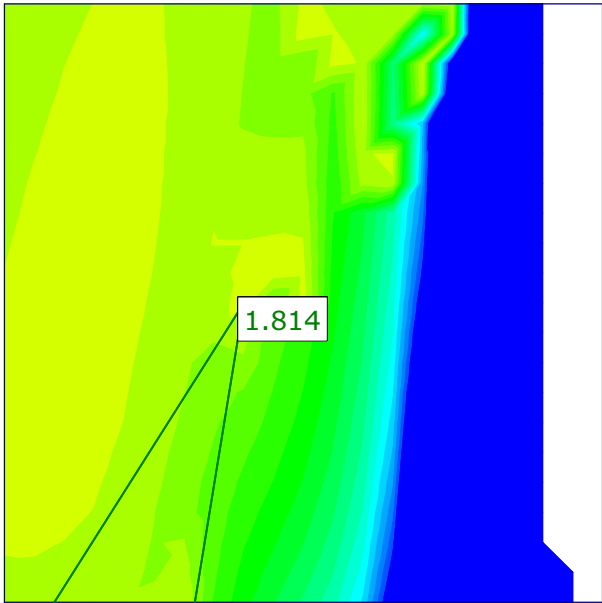
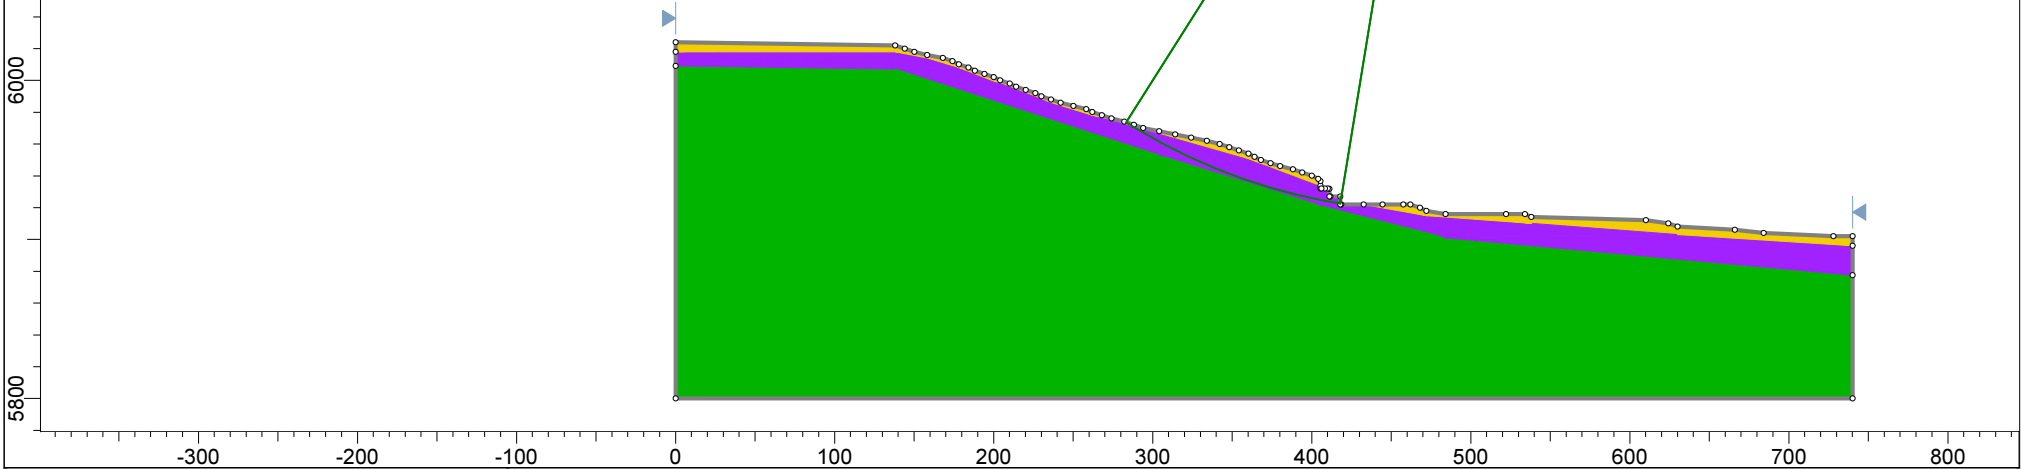
Project			The Ridge at Spring Creek Filing No. 1		
	Analysis Description			A-A Construction		
	Drawn By	Jared	Scale	1:1449	Company	RMG
	Date	10/14/2024	File Name	SlideA-A2_Precon.slim

Method Name	Min FS
Bishop simplified	1.814
Janbu corrected	1.850

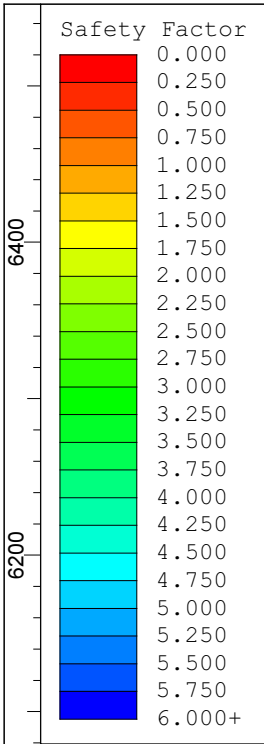
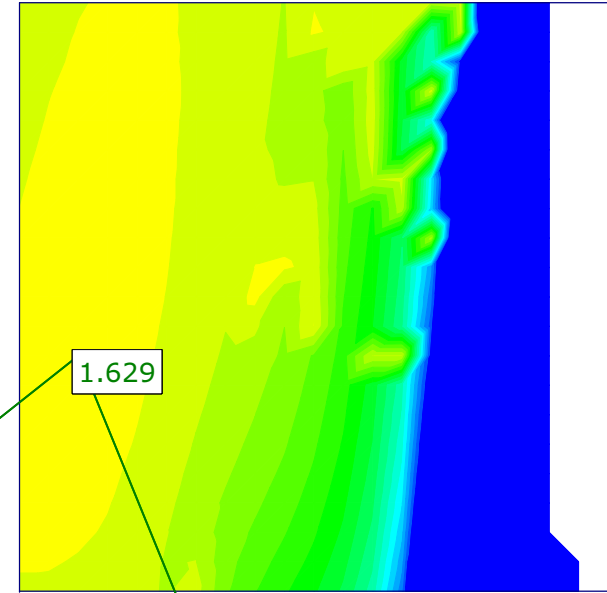
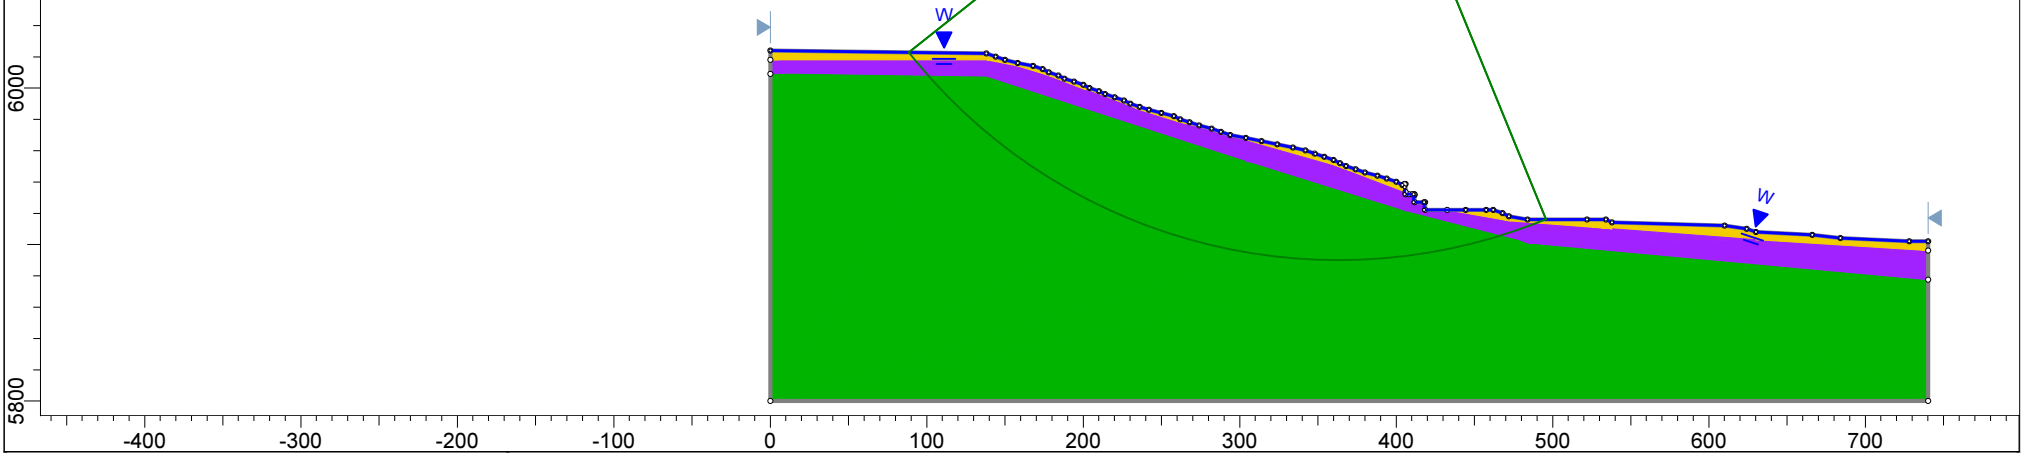
Project			The Ridge at Spring Creek Filing No. 1		
	Analysis Description			A-A Post-Construction with water		
	Drawn By	Jared	Scale	1:1473	Company	RMG
	Date	10/14/2024	File Name	SlideA-A2_Con with water.slim

Method Name	Min FS
Bishop simplified	1.629
Janbu corrected	1.591

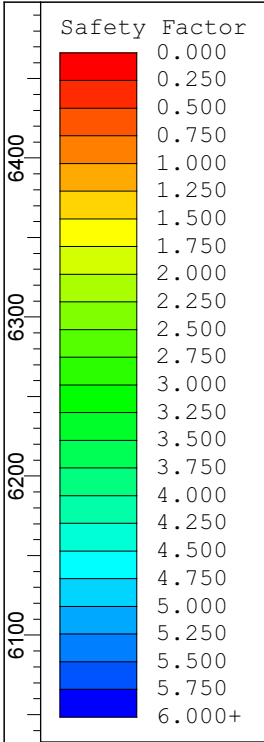
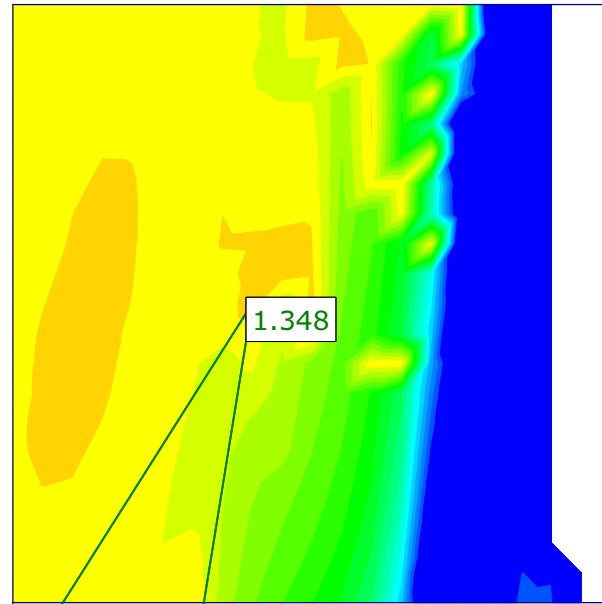
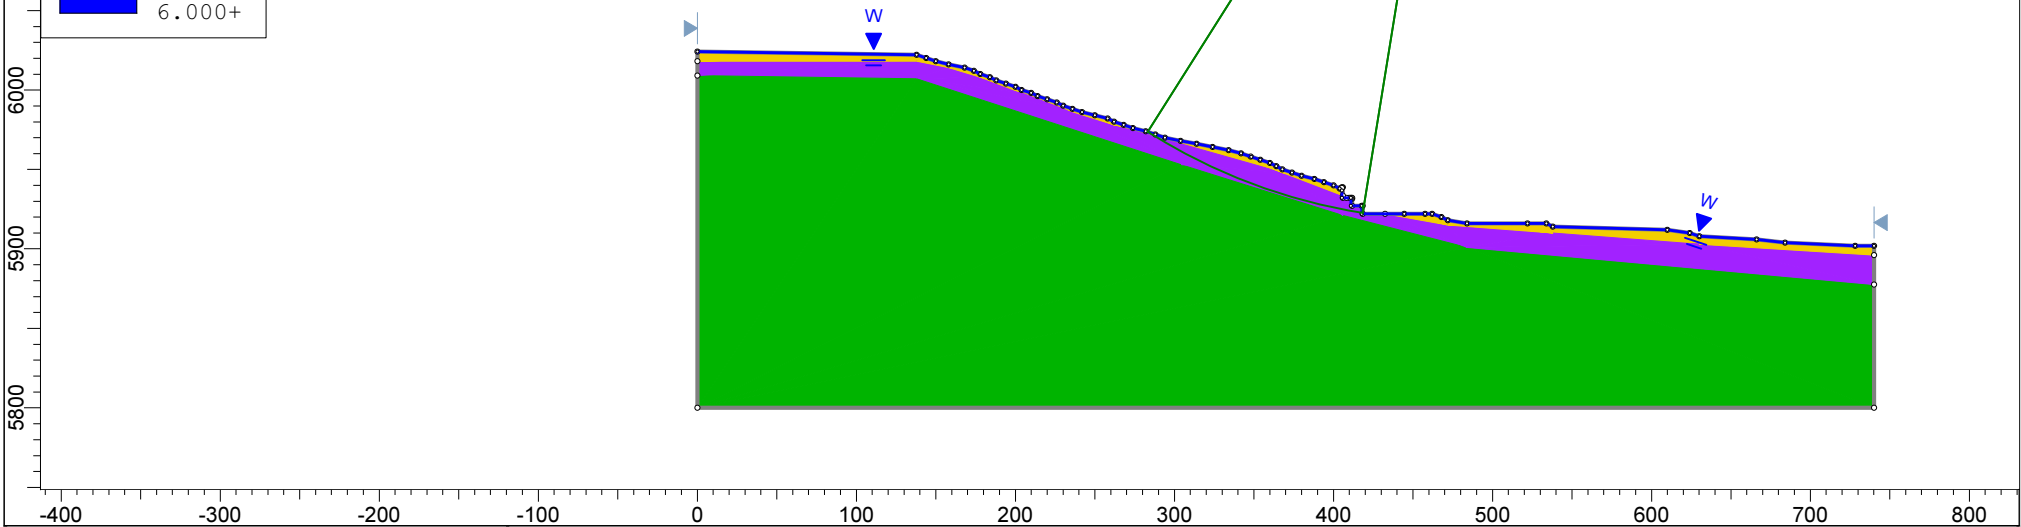
Project			The Ridge at Spring Creek Filing No. 1		
	Analysis Description			A-A Post-Construction with water sensitivity		
	Drawn By	Jared	Scale	1:1449	Company	RMG
	Date	10/14/2024	File Name	SlideA-A2_Con with water sensitivity.slim

Method Name	Min FS
Bishop simplified	1.348
Janbu corrected	1.373
