**SOIL, GEOLOGY, GEOLOGIC HAZARD,
AND WASTEWATER STUDY,
FLYING HORSE NORTH
PUD SUBMITTAL
EL PASO COUNTY, COLORADO**

Pulpit Rock Investments No. 2
6385 Corporate Drive, Suite 200
Colorado Springs, Colorado 80919

February 22, 2016

Entech Job No. 160118
AAprojects/2016/160118 county soil geo ww

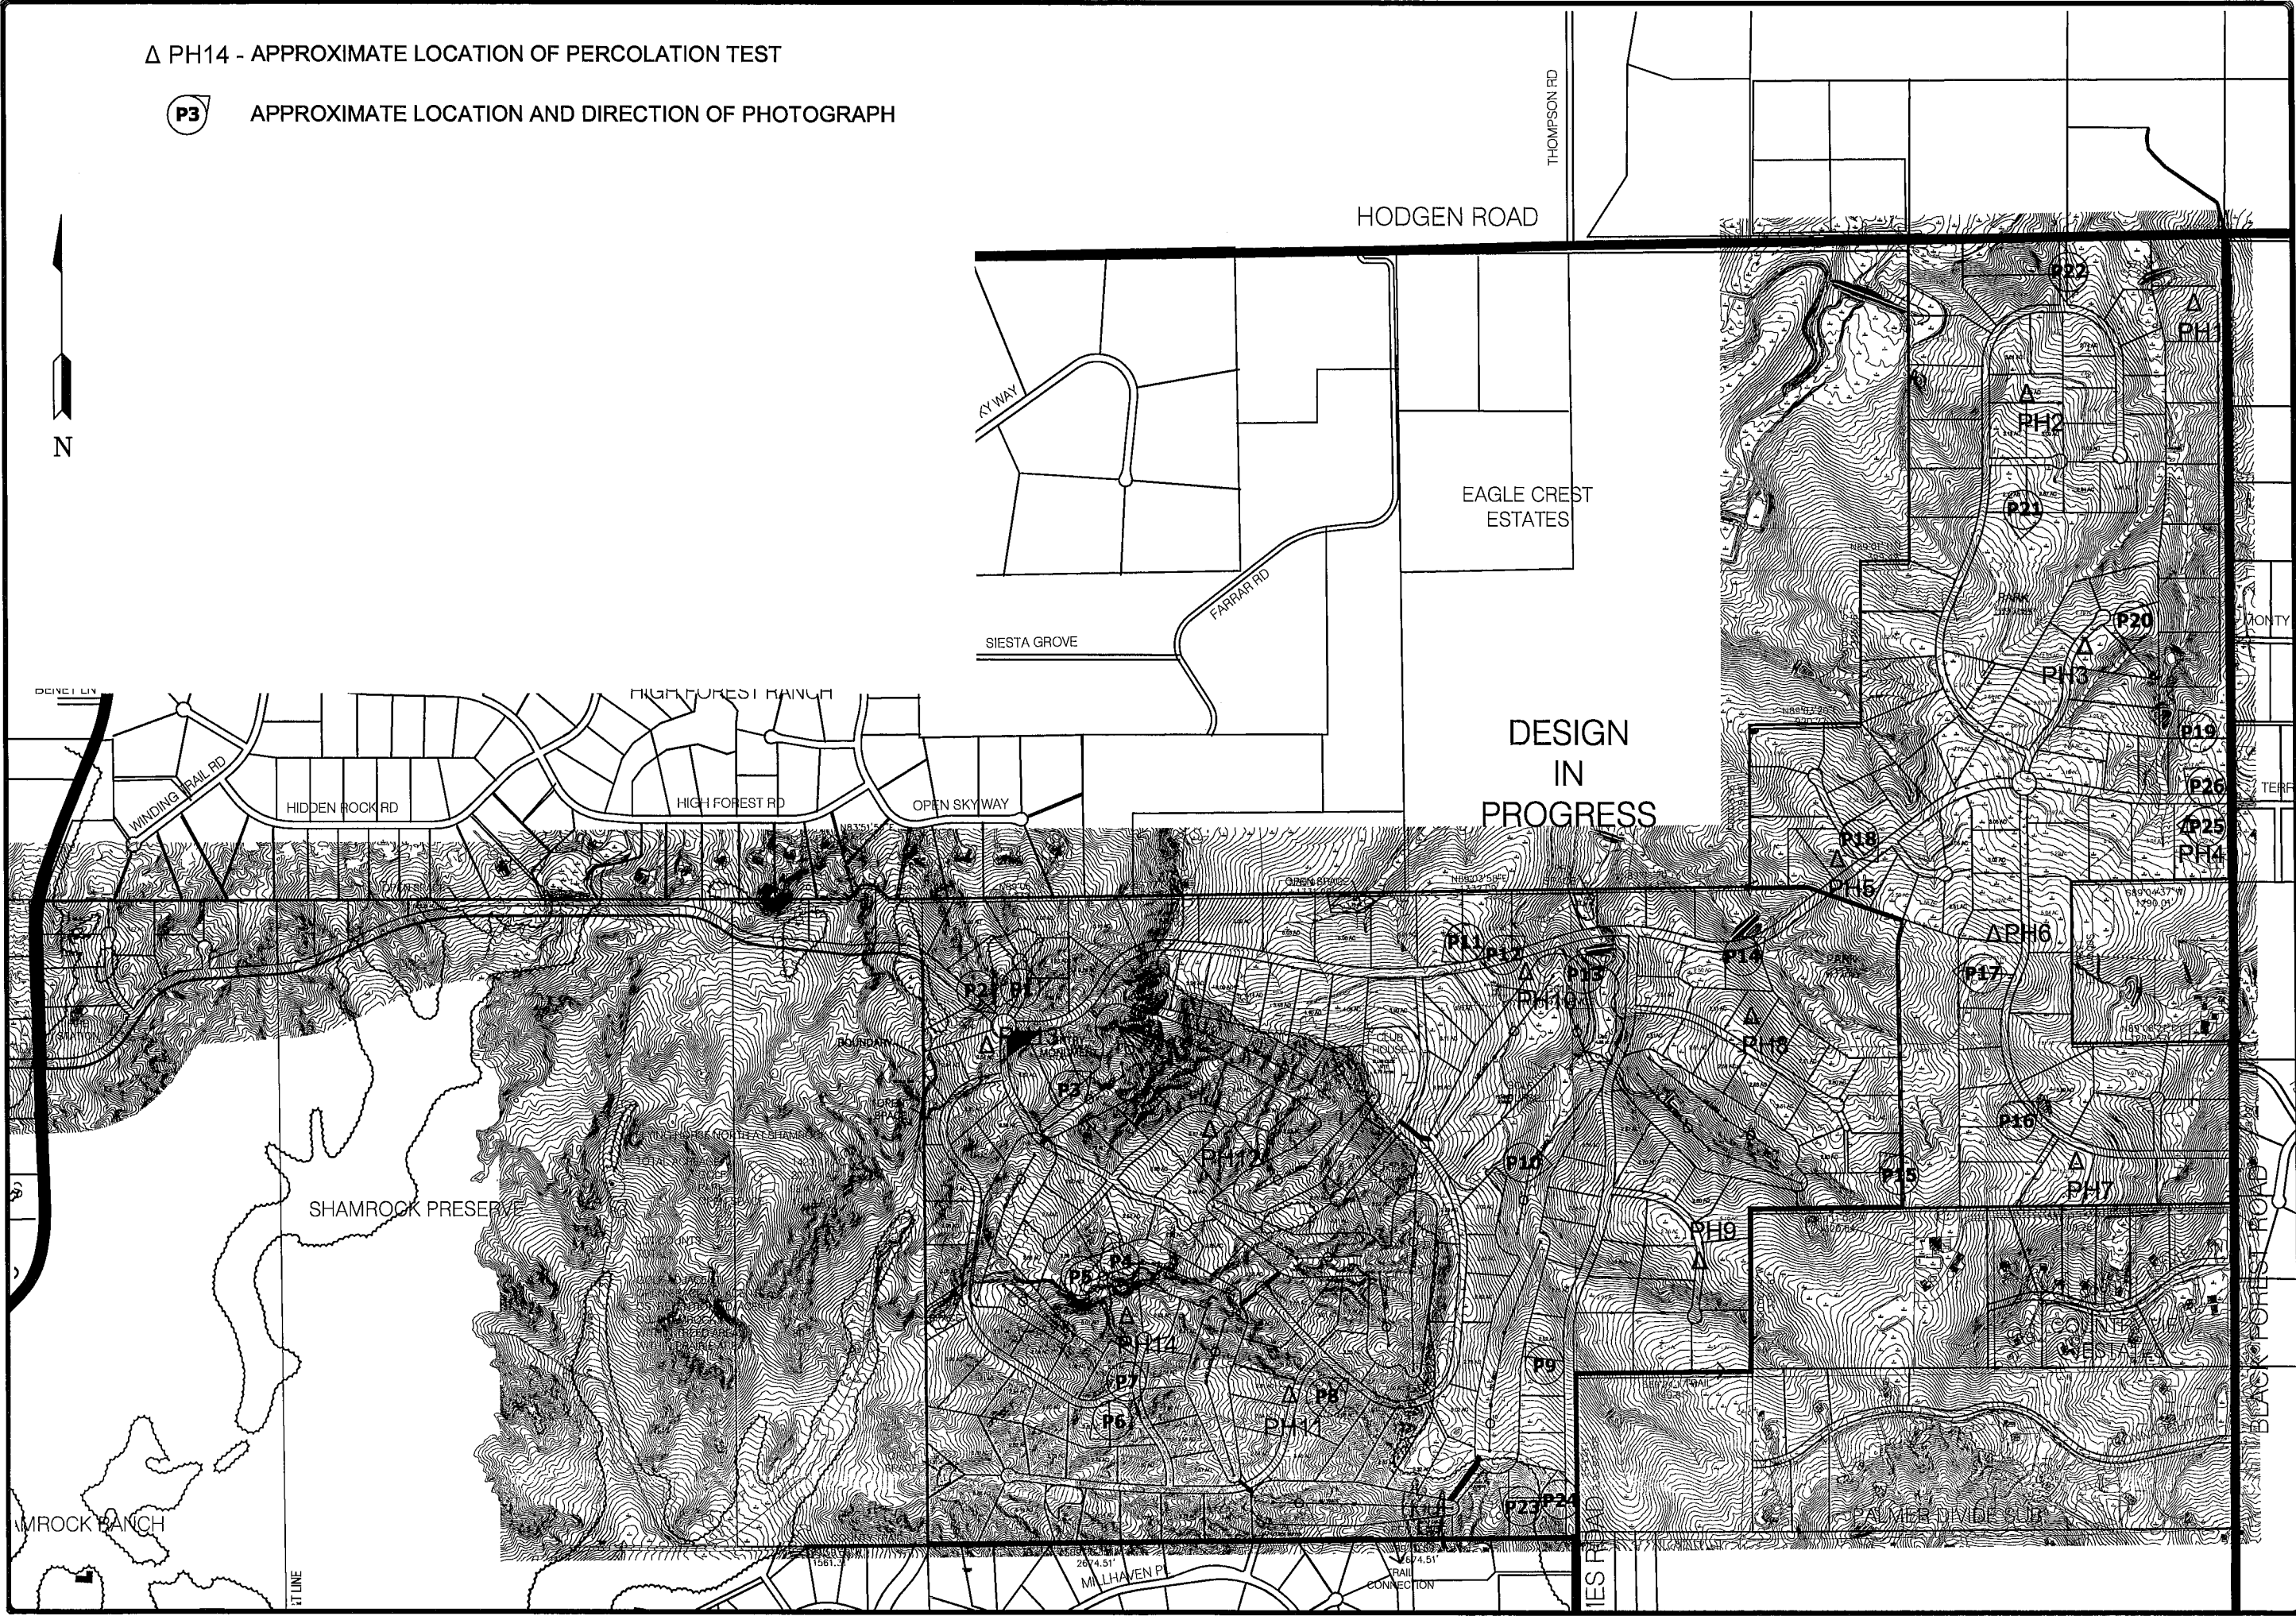
DEVELOPMENT PLAN/
PERCOLATION TEST LOCATION MAP
FLYING HORSE NORTH
EL PASO COUNTY, CO.

Fourteen (14) percolation tests were performed on the site to determine general suitability of the site for the use of on-site wastewater treatment systems. The locations of the percolation tests are indicated on the Percolation Test Location Map, Figure 3. The Test Boring Logs from the Profile Holes are presented in Appendix B. Results of this testing will be discussed later in this report.

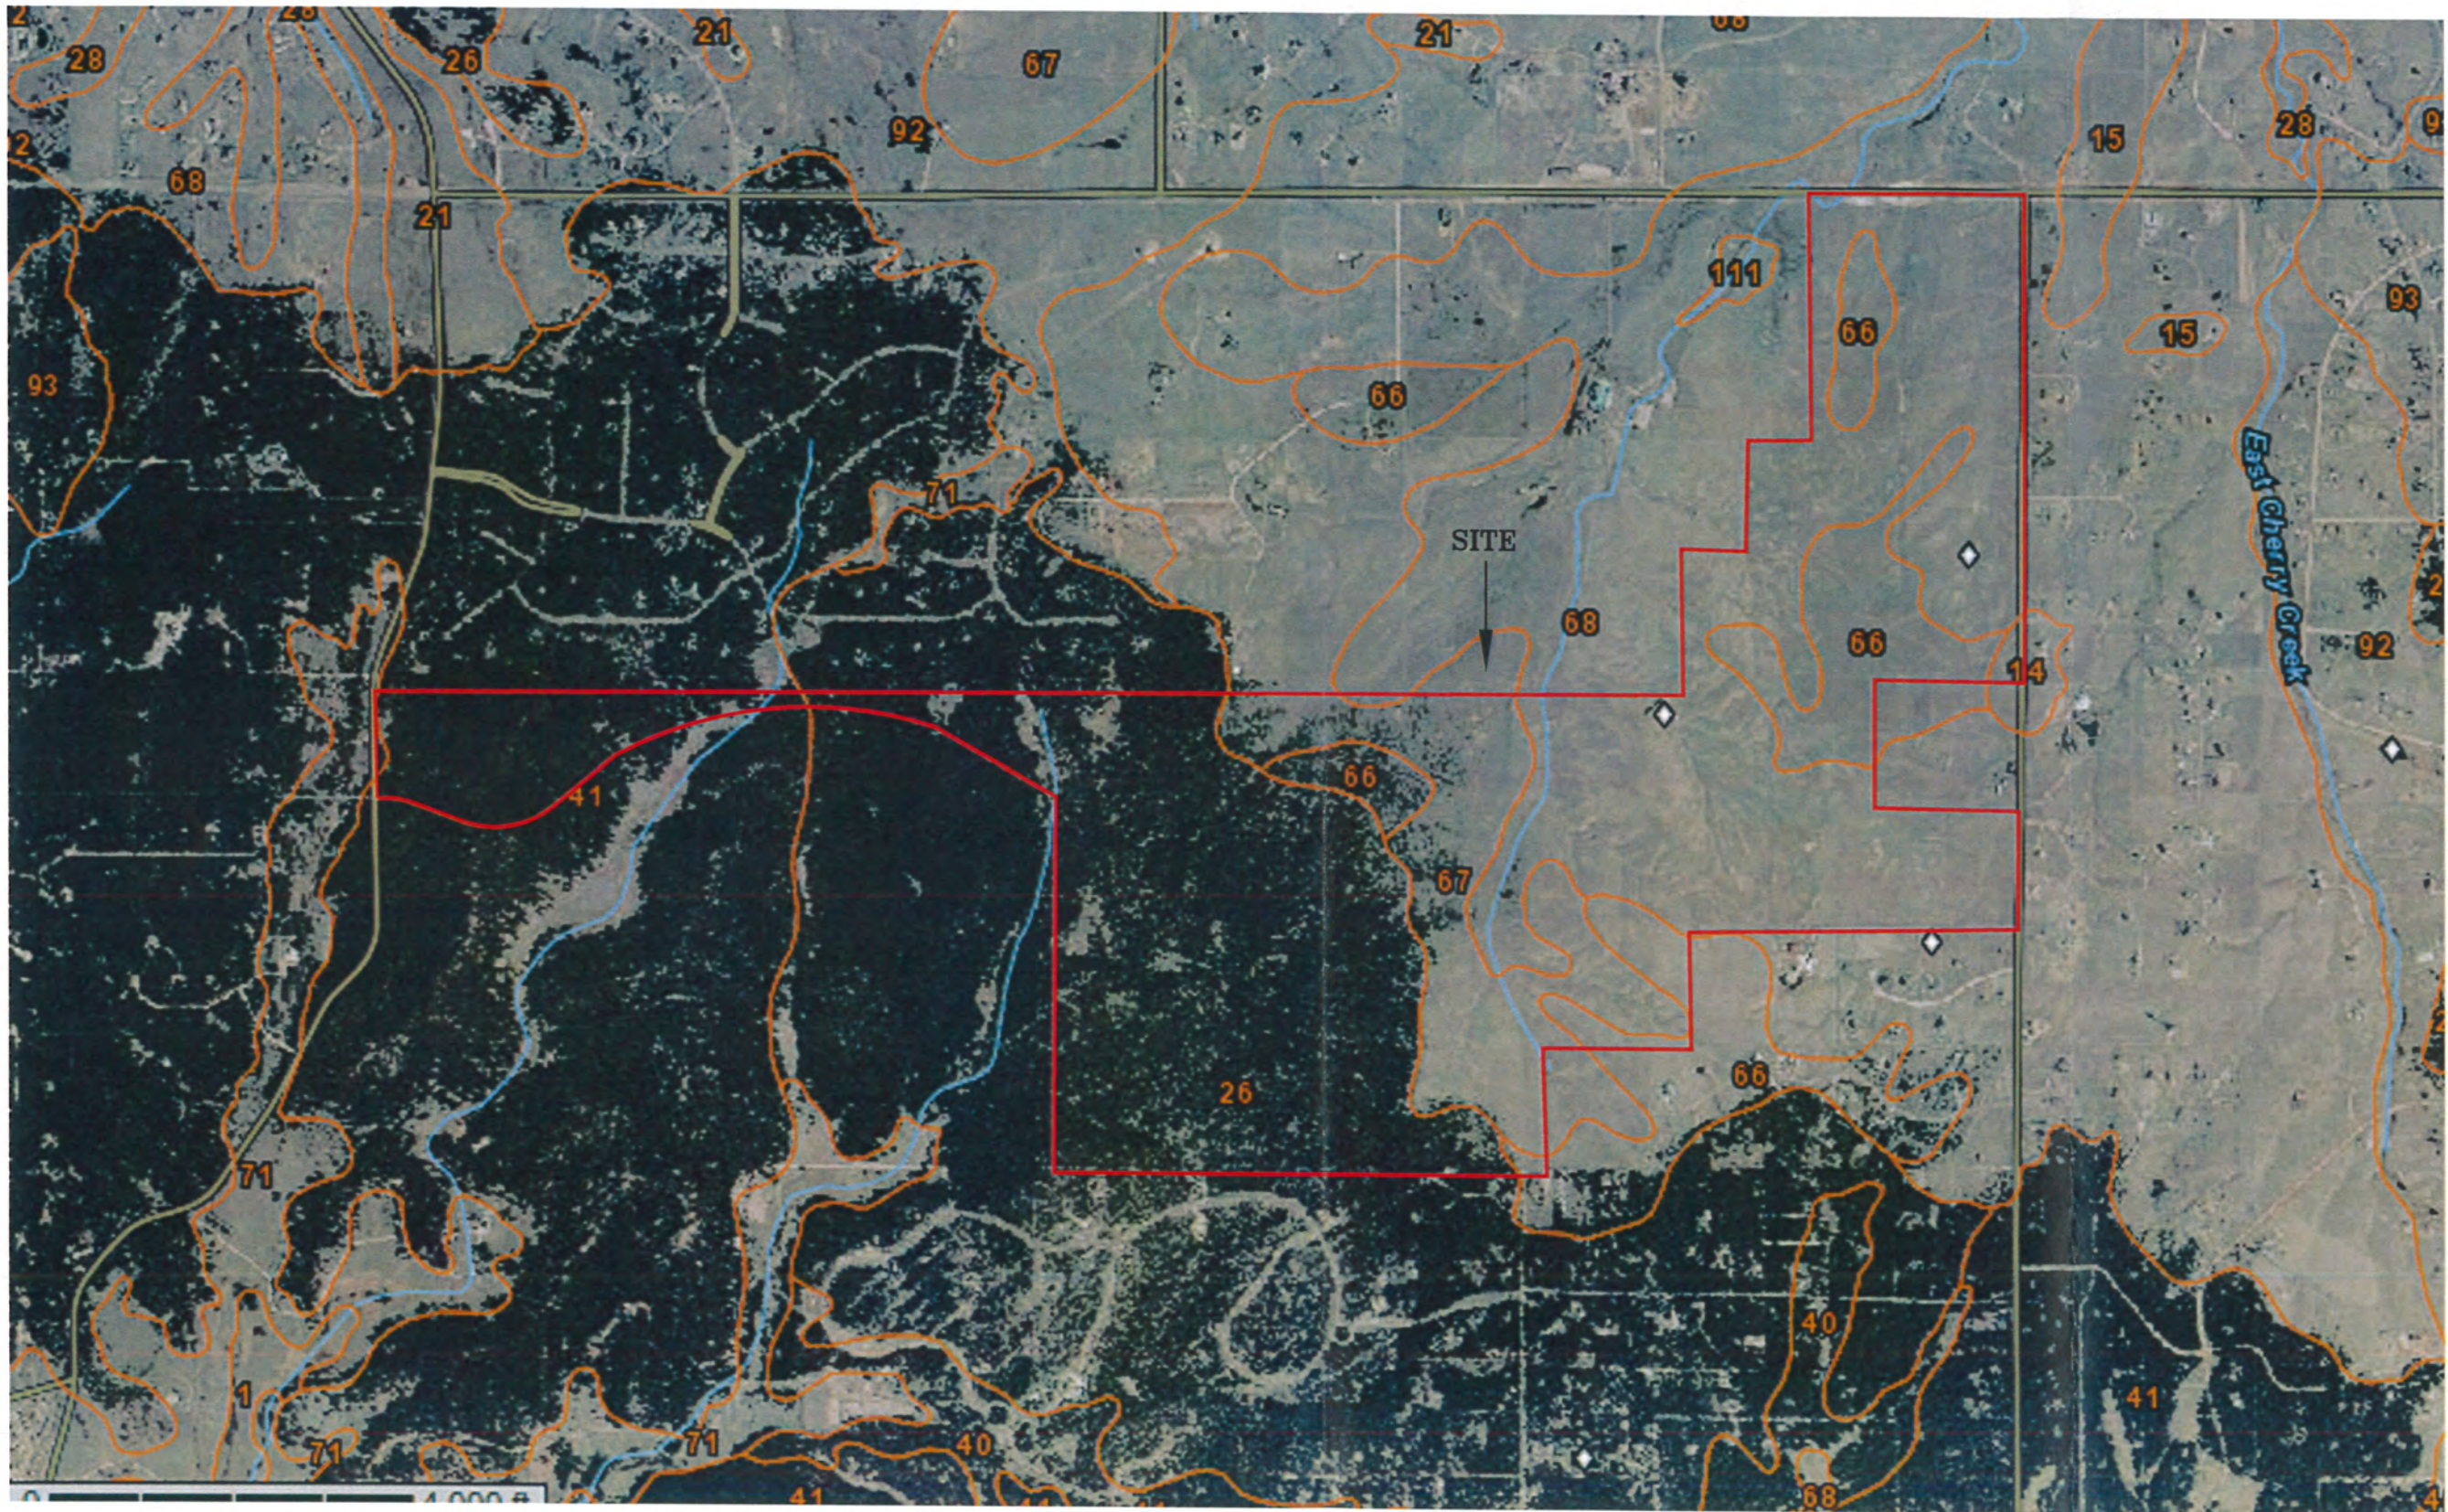
Soil Survey Map
Flying Horse North
El Paso County, CO.

The Natural Resource Conservation Service (Reference 3), previously the Soil Conservation Service (Reference 4) has mapped six soil types on the site (Figure 4). In general, they vary from sandy loam to loam and sandy loam with subsoils of clay loam. The soils are described as follows:

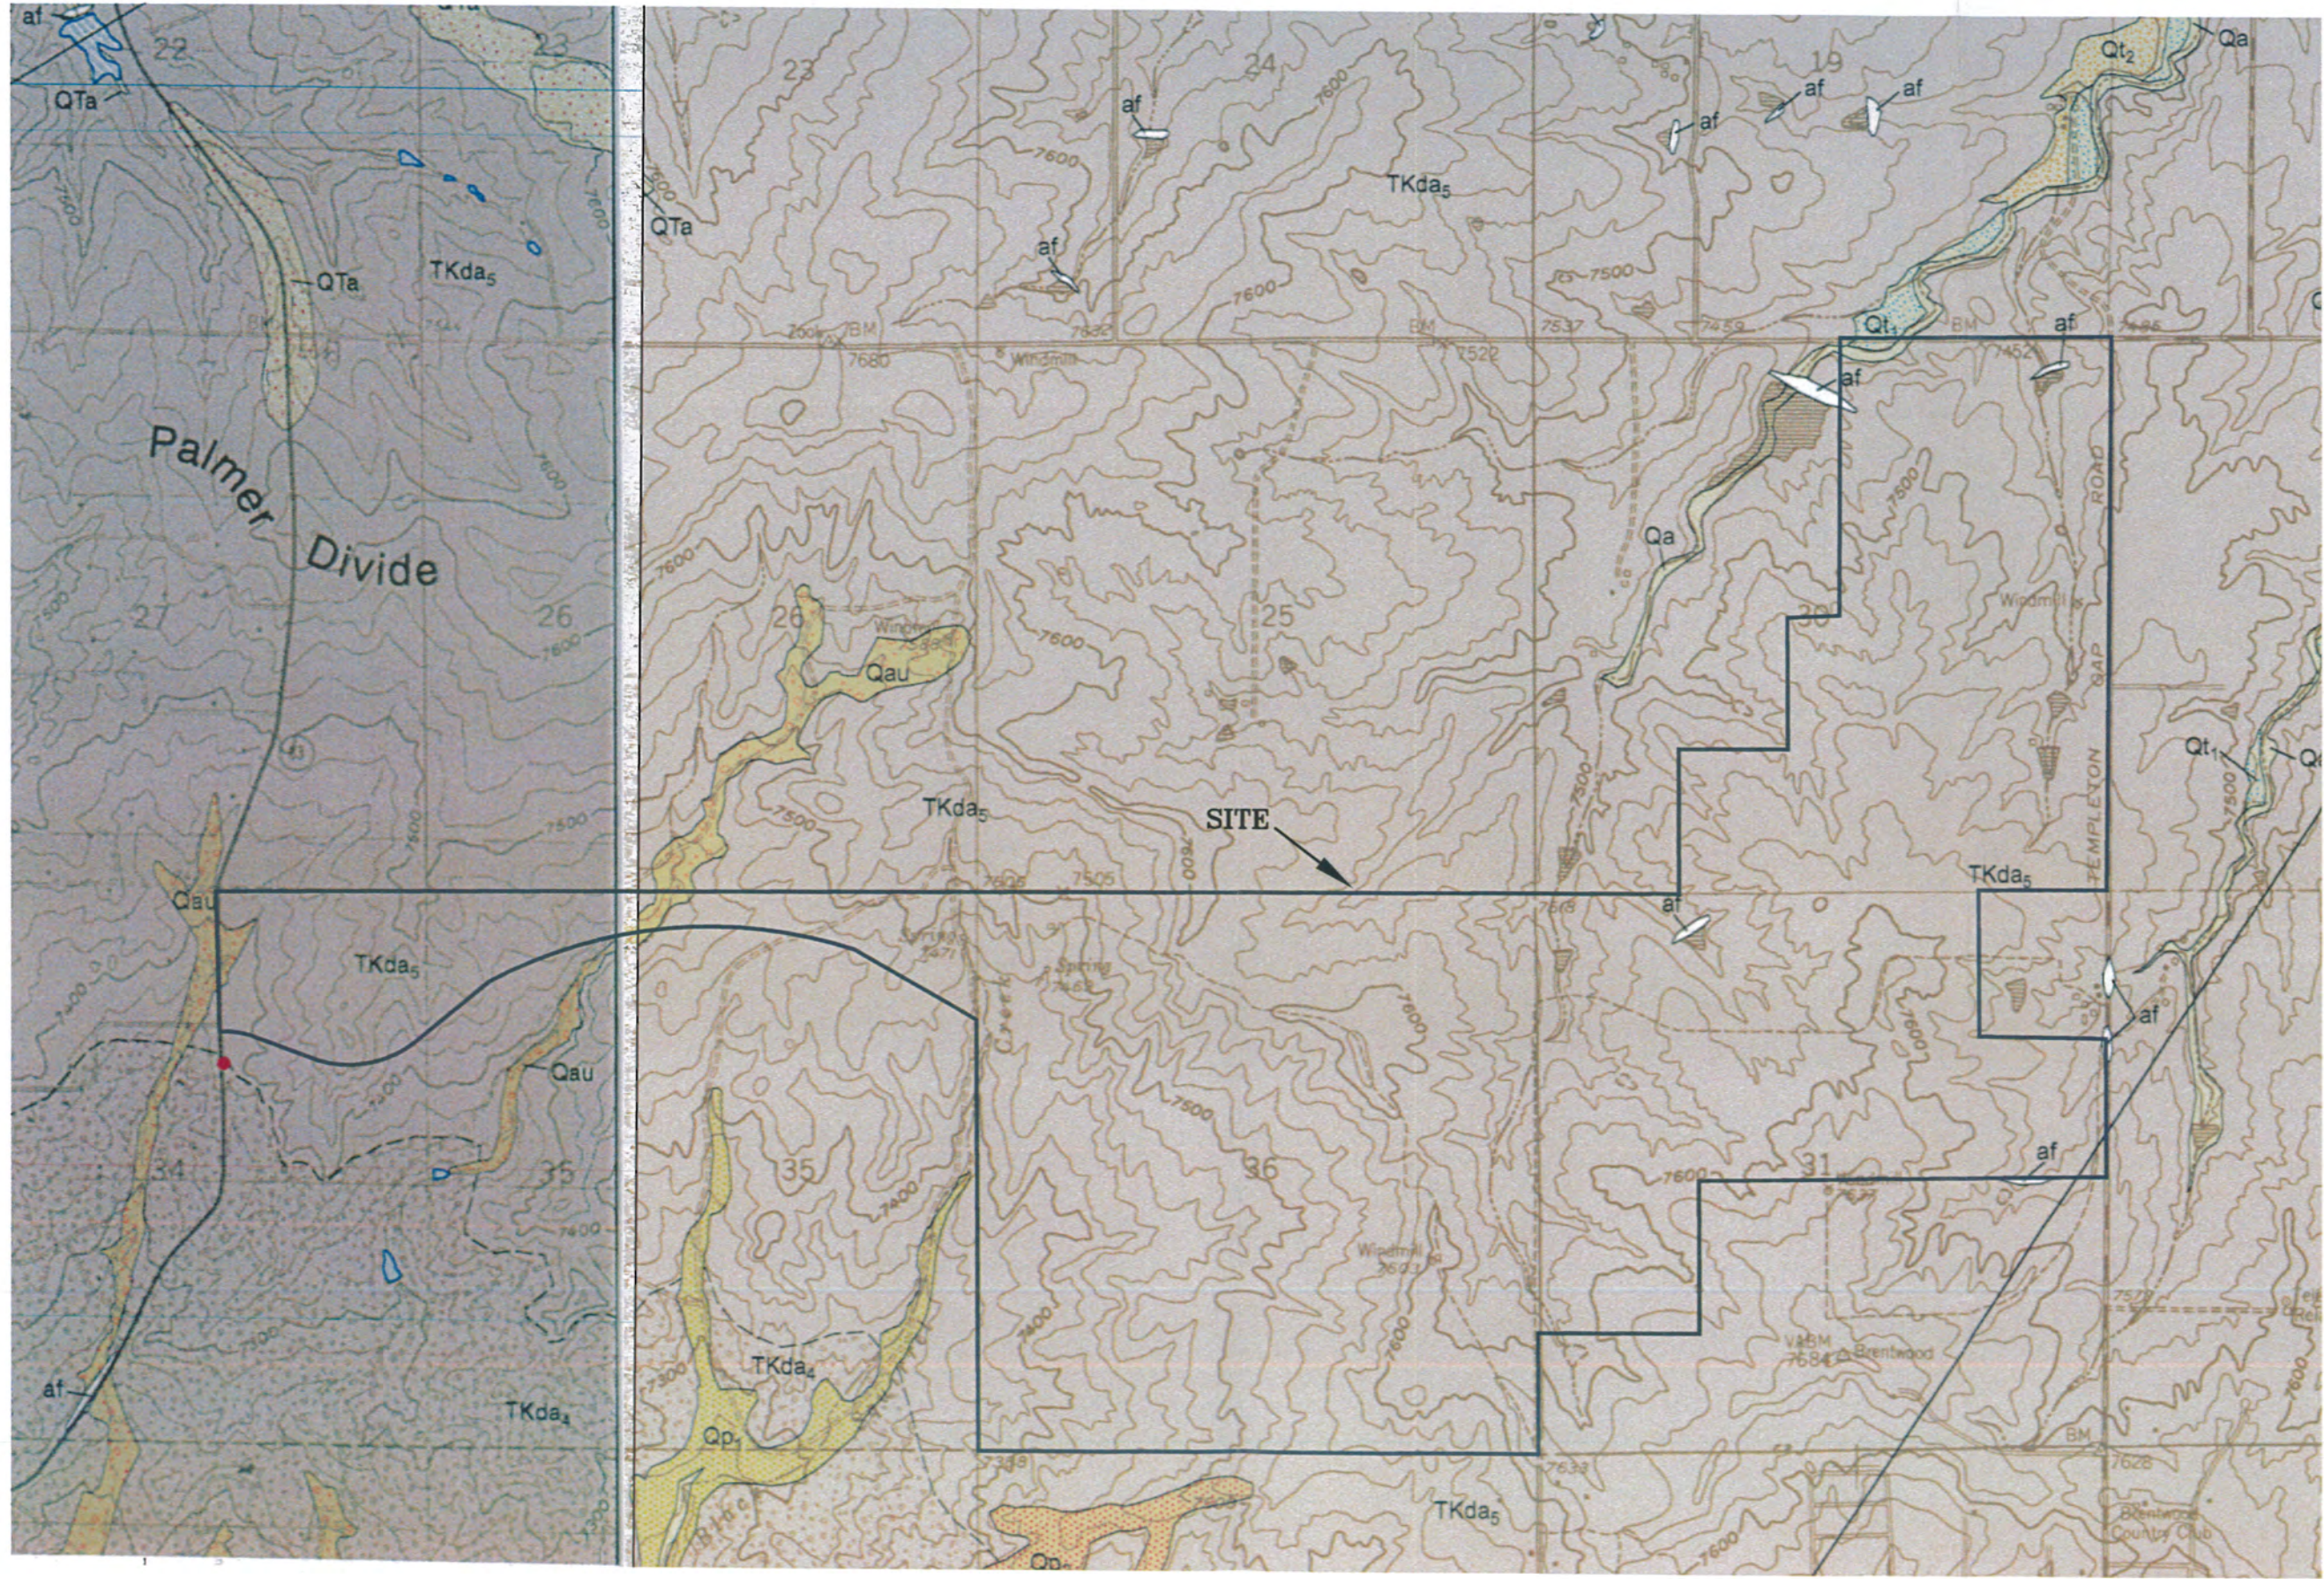
GEOLOGY/ENGINEERING GEOLOGY MAP
FLYING HORSE NORTH
EL PASO COUNTY, CO.

As mentioned previously, detailed mapping has been performed on this site to produce an Engineering Geology Map (Figure 6). This map shows the location of various geologic conditions of which the developers should be cognizant during the planning, design and construction stages of the project. These hazards and the recommended mitigation techniques are as follows:
